ICEM-07

To Be Presented at
The 11th International Conference on Environmental Remediation & Radioactive Waste Management (ICEM)

LESSONS LEARNED FROM CLEANING OUT THE SLUDGE FROM THE SPENT FUEL STORAGE BASINS AT HANFORD

Peter Knollmeyer/Fluor

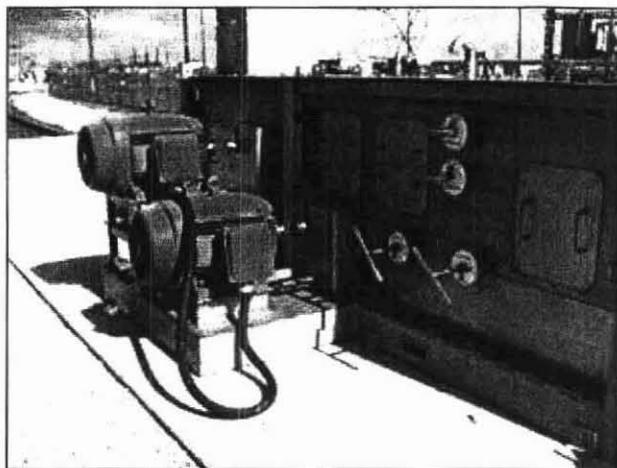
Figure 1 – Sludge Transfer Booster Station (one of four)

specification. This led to the decision to install a spare booster pump in each booster station and to allow it to be valved in from outside the booster station enclosure. The enclosure provides spray tightness in the case of an unexpected leak or rupture disk over pressurization (see Figure 1). The project also decided to install ultrasonic (UT) probes on the eight pumps in those areas where wear was expected to be high. The addition of the UT sensors would allow on line monitoring of pump wall thickness to ensure field performance was consistent with test results and to ensure the shift to the spare pump occurred prior to reaching the minimum allowed wall thickness. This contingency planning proved invaluable. The primary booster pump in Booster Station #2 was taken off line due to vibration and the secondary pump was placed in service early in the project. Thus the contingency to have a second pump for erosion protection saved the project when pump vibration arose as a technical issue. Now making this secondary pump last the life of the project without approaching minimum wall thickness was a challenge. While Booster Station #2 was open for inspection, additional UT measurements were taken to confirm that the location of the four installed UT probes did in fact represent the location of maximum erosion (which was determined in the earlier erosion tests). This revealed that there were several locations that exhibited higher wear than the installed probes. These locations appeared to coincide with the heat affected zone (HAZ) of the discharge nozzle. The base metal and weld filler erosion was low; but, the HAZ erosion was higher. This is consistent with predicted behavior for duplex stainless steel when higher heat is applied during welding. Three additional UT probes were mounted on the booster pumps to add these new areas to the monitoring scheme for a total of seven UT probes per pump housing (Figure 2).

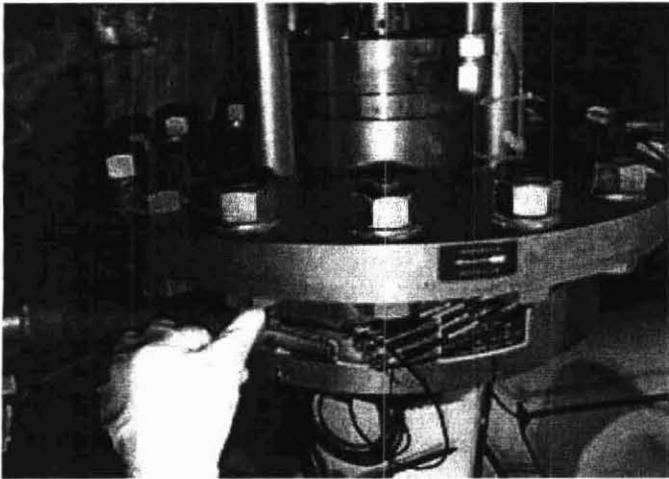
Figure 2 – Additional Ultrasonic Probes on Booster Pump

Monitoring procedures were changed to increase the frequency of monitoring. In the end, all pumps lasted to completion without reaching the allowed minimum wall thickness.

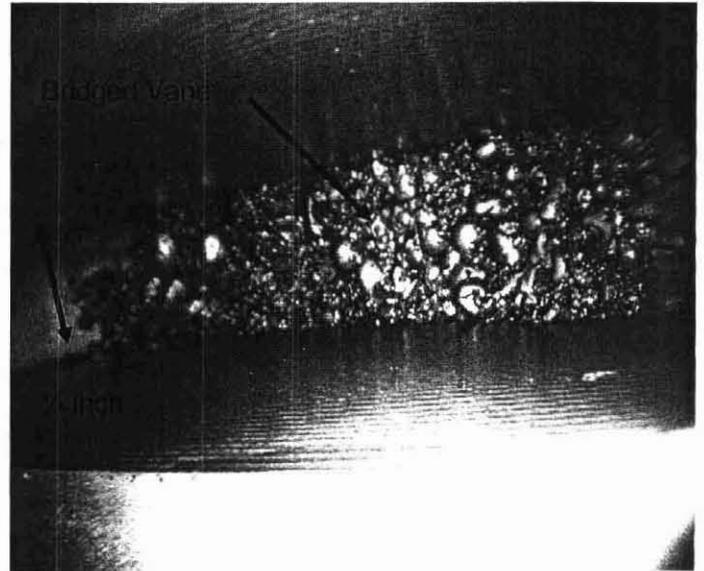
The third major lesson learned stemmed from the last minute changes in design to the centrifugal pumps used in the booster stations. Recall that the redesigned test pump manufactured from duplex stainless steel withstood erosion fairly well. The test pump was a smaller scale version of the pump with lower head requirements. Eight large pumps were ordered (two per booster station) with the same velocity requirement but higher discharge head. The specification required that the pump be able to pump sludge particles up to ¼ inch in diameter. Shortly after startup of the HiH system and before a significant amount of sludge was transferred, the primary pump in one booster station began to show excessive vibration. Detailed inspections of mountings, balance and a fiber-optic inspection of the internals was conducted. These inspections revealed that a bridge of deposits had formed between two vanes of the impeller (Figure 3). Additionally, the back side of each impeller blade had a build up of deposits over a short distance about three fourths of the way to the outer radius (Figure 4). This buildup appeared to be fairly uniform when comparing the five impeller blades.

Figure 3 – Sludge Deposits Bridging Two Impeller Vanes

In order to troubleshoot this problem, Fluor requested the pump vendor's proprietary drawings of the pump impeller. Upon receipt of these drawings, Fluor learned that the impeller clearance was only one quarter inch, not the 3/8 – 3/4 inch that would be expected for a slurry pump designed for up to 1/4 inch particles. Discussion with the vendor indicated that the clearance was reduced in order to add 1/8 inch wiper vanes on the back of the impeller. Fluor also learned that the impeller vanes had been significantly lengthened and flattened by the vendor when compared to the test pump. The pump vendor based this on his model to create the needed discharge head. Fluor commissioned finite element modeling of the existing impeller and predicted the flow vectors on the impeller blades. The finite element modeling confirmed the prediction that tangential velocities went to zero on the backside of the impeller blade. This appeared to explain the uniform deposits on the back side of the vanes; however, the uniform deposits were not likely the cause of the vibration. The bridge between two vanes was the likely initiator of the vibration. Fluor speculated that this bridge was likely caused by one or two particles of approximately 1/4 inch size jamming between the impeller blades, potentially aided by the deposit buildup on the impeller back side. Once a particle jammed, other particles began to dam up behind this and caused the bridge. Additionally, early sludge transfers were plagued by "slugging". Slugging occurred when a large slug of sludge overwhelmed the dilution controller and put a "slug" of sludge into the transfer line. The resulting pressure transient often tripped the pumps off on pressure protection interlocks that were built into the system to protect against this predicted event. In response to this discovery, Fluor put the following corrective actions in place:

1. A new impeller was designed that eliminated the low flow regime and opened up the impeller clearances to be consistent with common slurry pump clearance design guidance.
2. The spare pump was placed in service in the booster station with the fouled pump.

3. A new strainer was placed upstream of the booster stations to screen the sludge through a 3/16 inch screen. This would restore adequate clearance in the existing pumps.
