ORNL/TM-13437

South Tank Farm Underground Storage Tank Inspection Using the Topographical Mapping System for Radiological and Hazardous Environments

Robotics and Process Systems Division

Date Published—July 1997

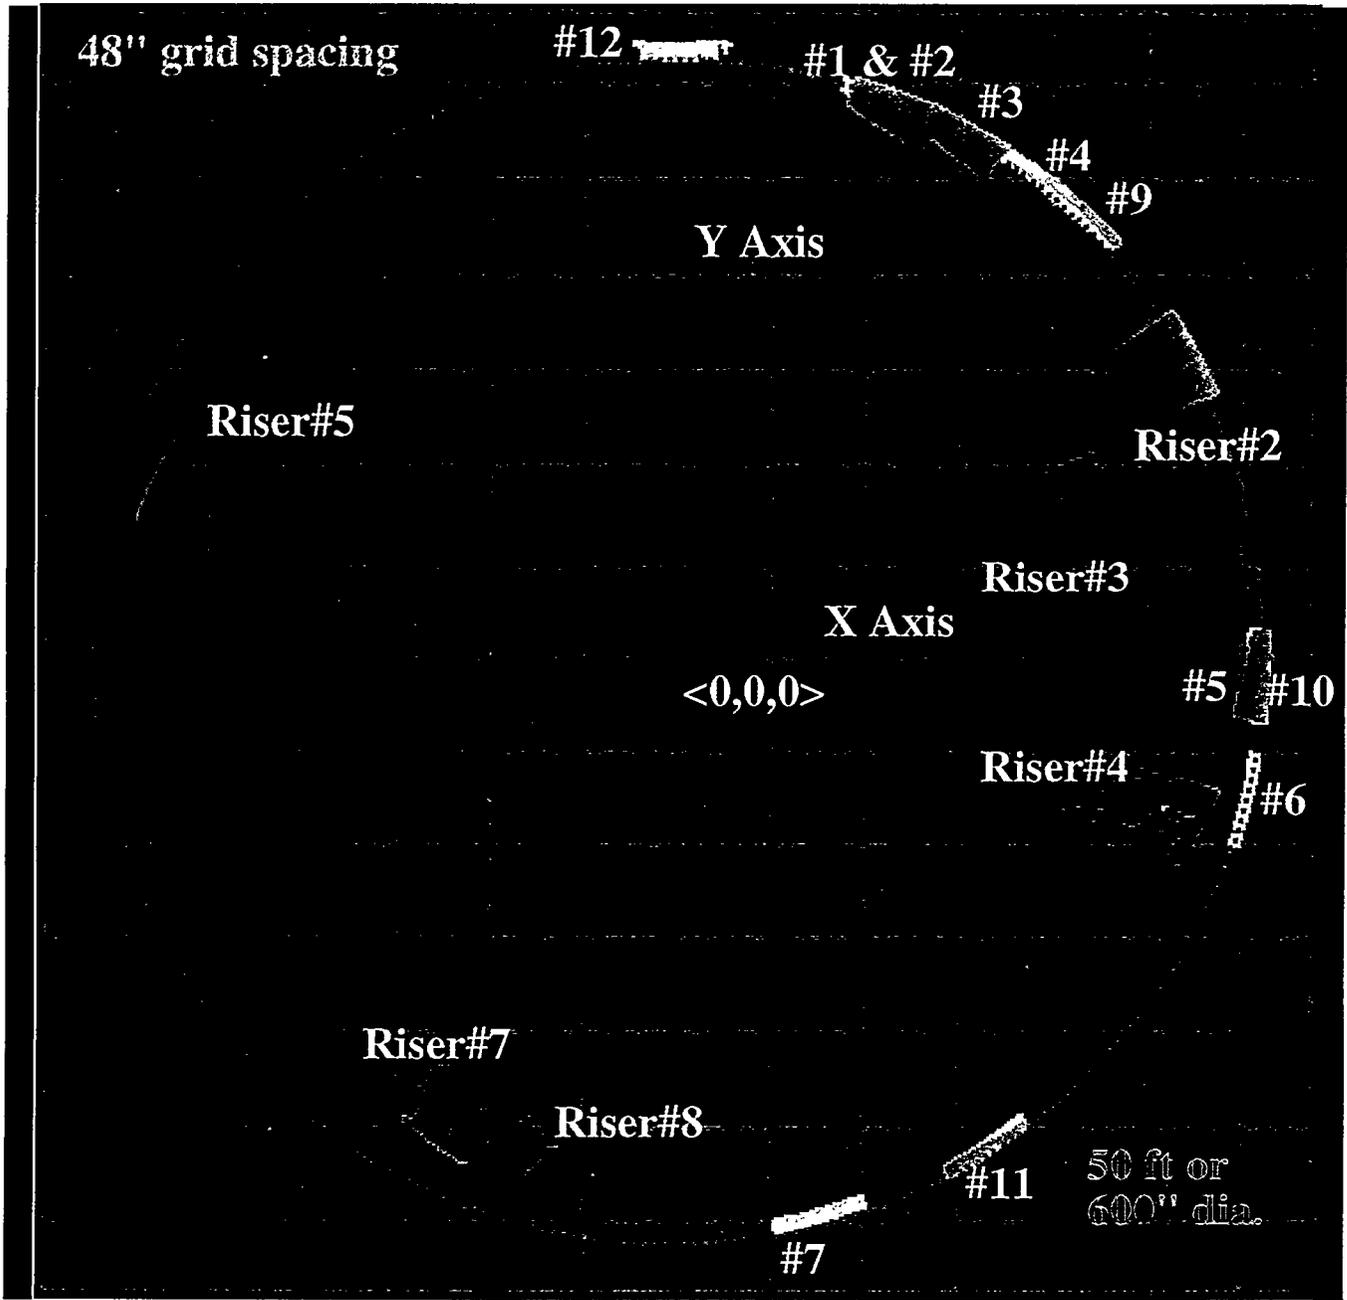
W6 Suspect Areas 1-7, 9-12 & Risers

The mapping and visual inspection in UST W6 found similar anomalies as were observed in UST W5. Again the dark mottled surfaces were observed, surface-mapped, and manually scanned with the laser while being videotaped. The results confirmed that the dark mottled areas in tank W6 were also bitumen exposed when the inner layer of Gunitite had spalled from the tank wall (or in some cases, as a result of being heated up and having run through openings in the Gunitite).

Figure B.1. UST W6 surface maps of suspect areas and risers.

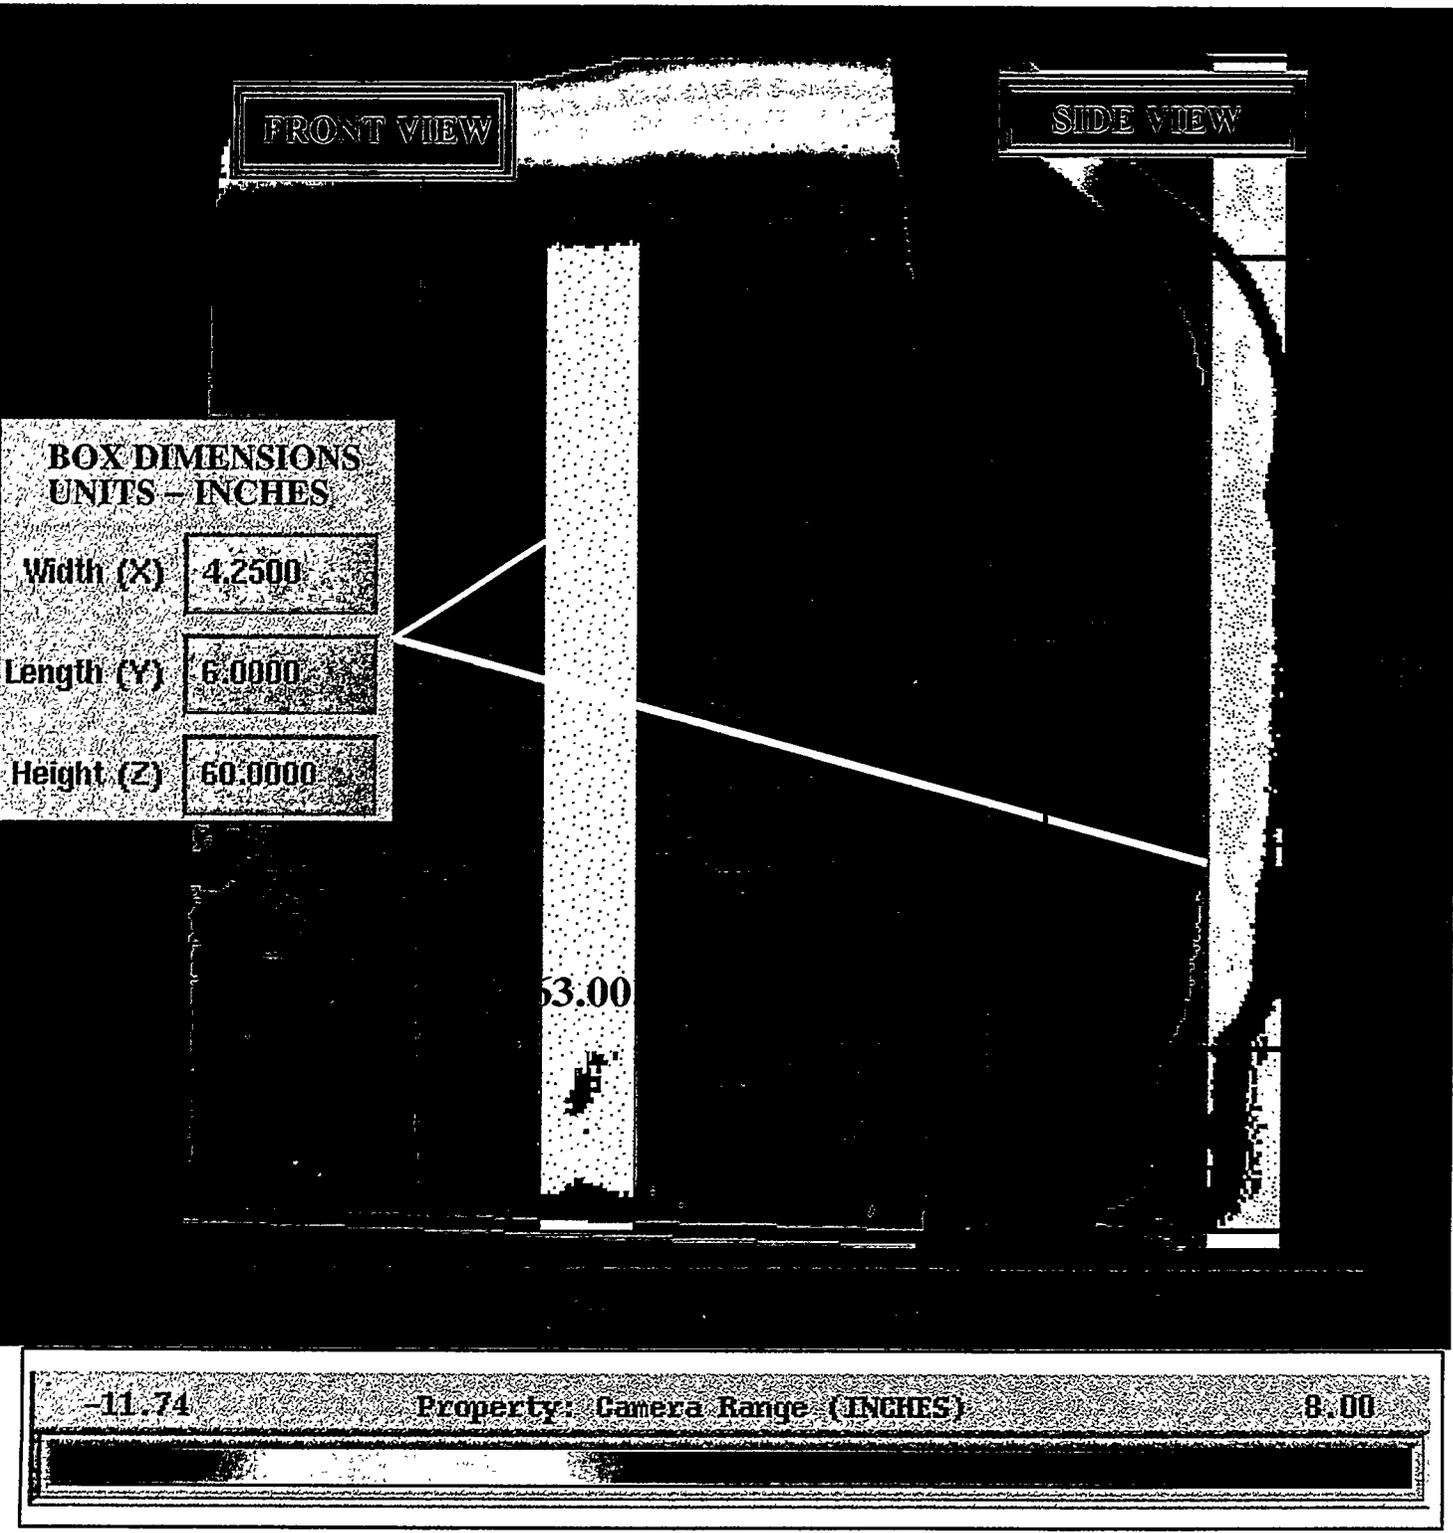
W6 Suspect Area #3

Figure B.4. UST W6 suspect area 3 surface map.
