**Ultrasonic Examination of Double-Shell  
Tank 241-SY-101 Examination  
Completed March 2004**

A.F. Pardini  
G.J. Posakony

July 2004

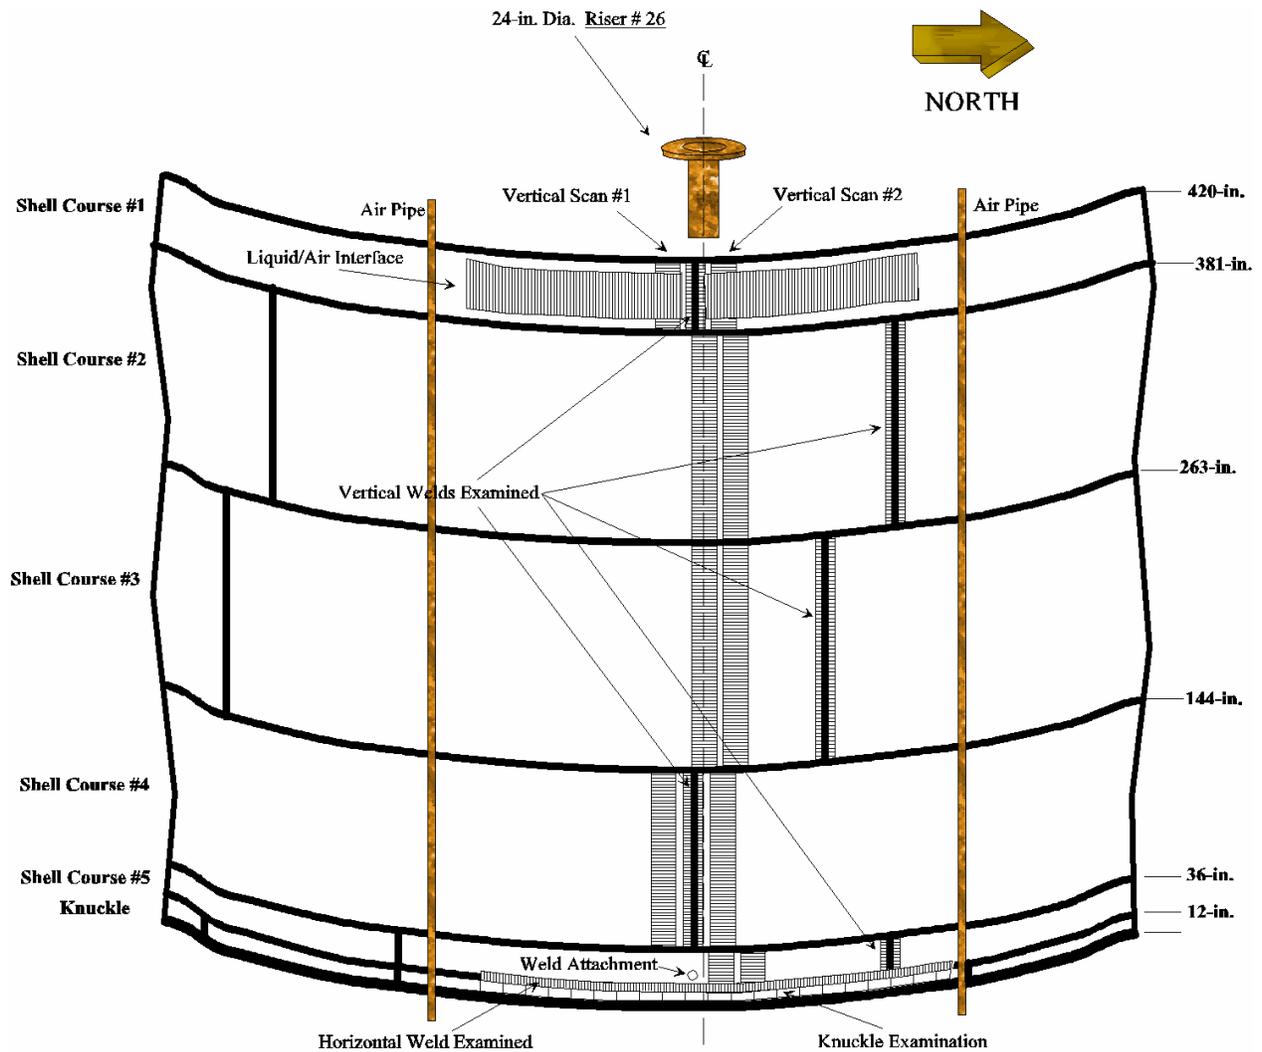
**Figure 4.2.** Sketch of Scan Paths on Tank 241-SY-101

Figure 4.2 describes the areas on the primary wall of Tank 241-SY-101 that were ultrasonically examined. Two 15-in.-wide vertical scan paths were performed on shell courses #1, #2, #3, #4, and #5 below the entrance to Riser 26. Vertical weld HAZ examinations were done on shell courses #1, #2, #3, #4, and #5. A single 25.5-in. wide horizontal scan was done in the liquid/air interface region on shell course #1, and the horizontal weld HAZ examination was done on the transition shell course #5 to knuckle weld. Examination of the upper portion of the knuckle was also performed.

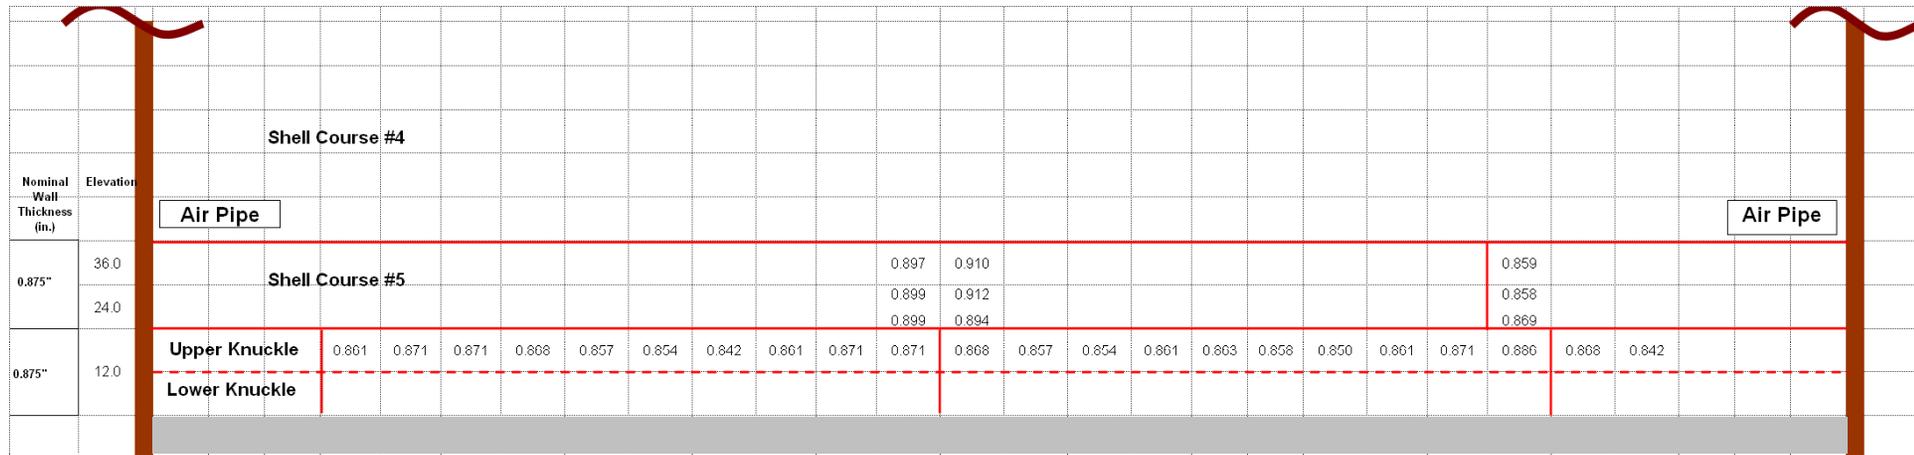
Figure 5.3 UT Data from Tank 241-SY-101 cont.

Figure 5.3 shows the examination performed on the knuckle of the primary tank wall. The readings distributed around the circumference of the tank knuckle represent the minimum reading in each 11-in. long by 12-in. wide portion extending down around the knuckle.

The upper portion of the knuckle area was scanned utilizing the Y-arm scanner attached to the AWS-5D crawler. The Y-arm scanned the transducers down around the knuckle approximately 11-in. from a starting position 1-in. down from the upper knuckle weld joining shell course #5 to the knuckle. The knuckle was examined for wall thinning, pitting, and cracks oriented circumferentially around the primary tank. The results indicated that the minimum measured thickness in the approximately 20 circumferential feet of knuckle area examined with nominal thickness of 0.875-in. was 0.842-in. There were no areas that exceeded the reportable level of 10% of the nominal thickness. No pitting or circumferentially oriented crack-like indications were detected in the upper portion of the knuckle area.
