**Pacific Northwest
National Laboratory**

**Ultrasonic Examination of Double-Shell
Tank 241-AP-104 Examination
Completed August 2004**

A..F Pardini
G.J. Posakony

August 2004

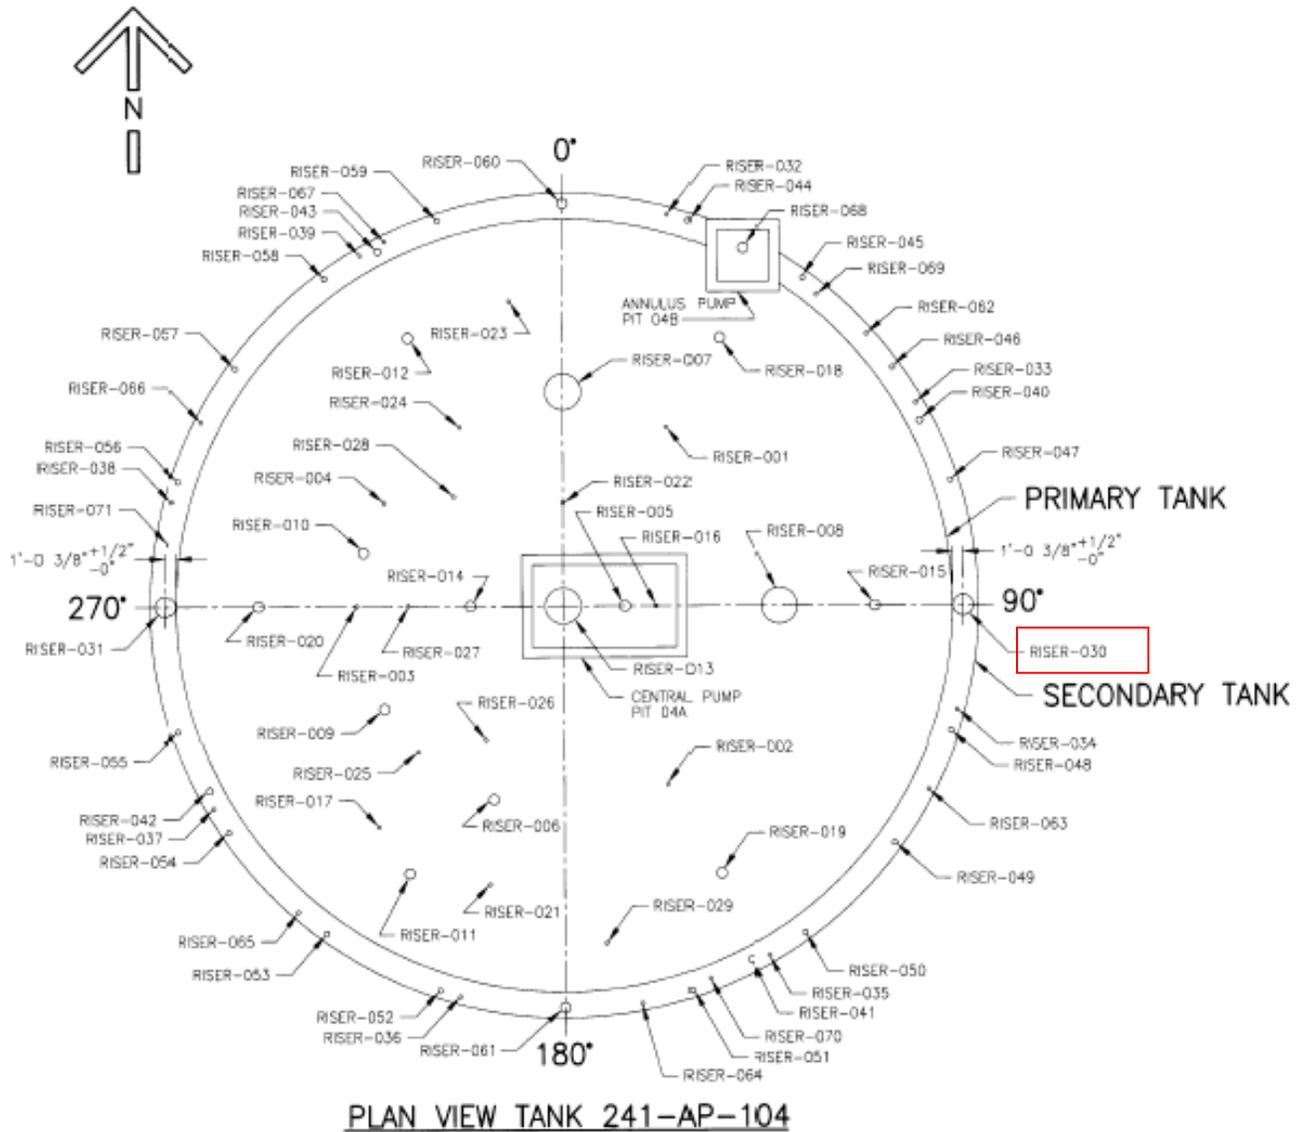
Figure 4.1. UT of 241-AP-104 from Riser 30

Tank 241-AP-104 is located in the Hanford 200 East area in AP Tank Farm. The crawler and associated scanner that hold the transducers were lowered into the 24-in. riser located on the east side of 241-AP-104 and designated as Riser 30. Figure 4.1 provides a graphic of the location of this riser.

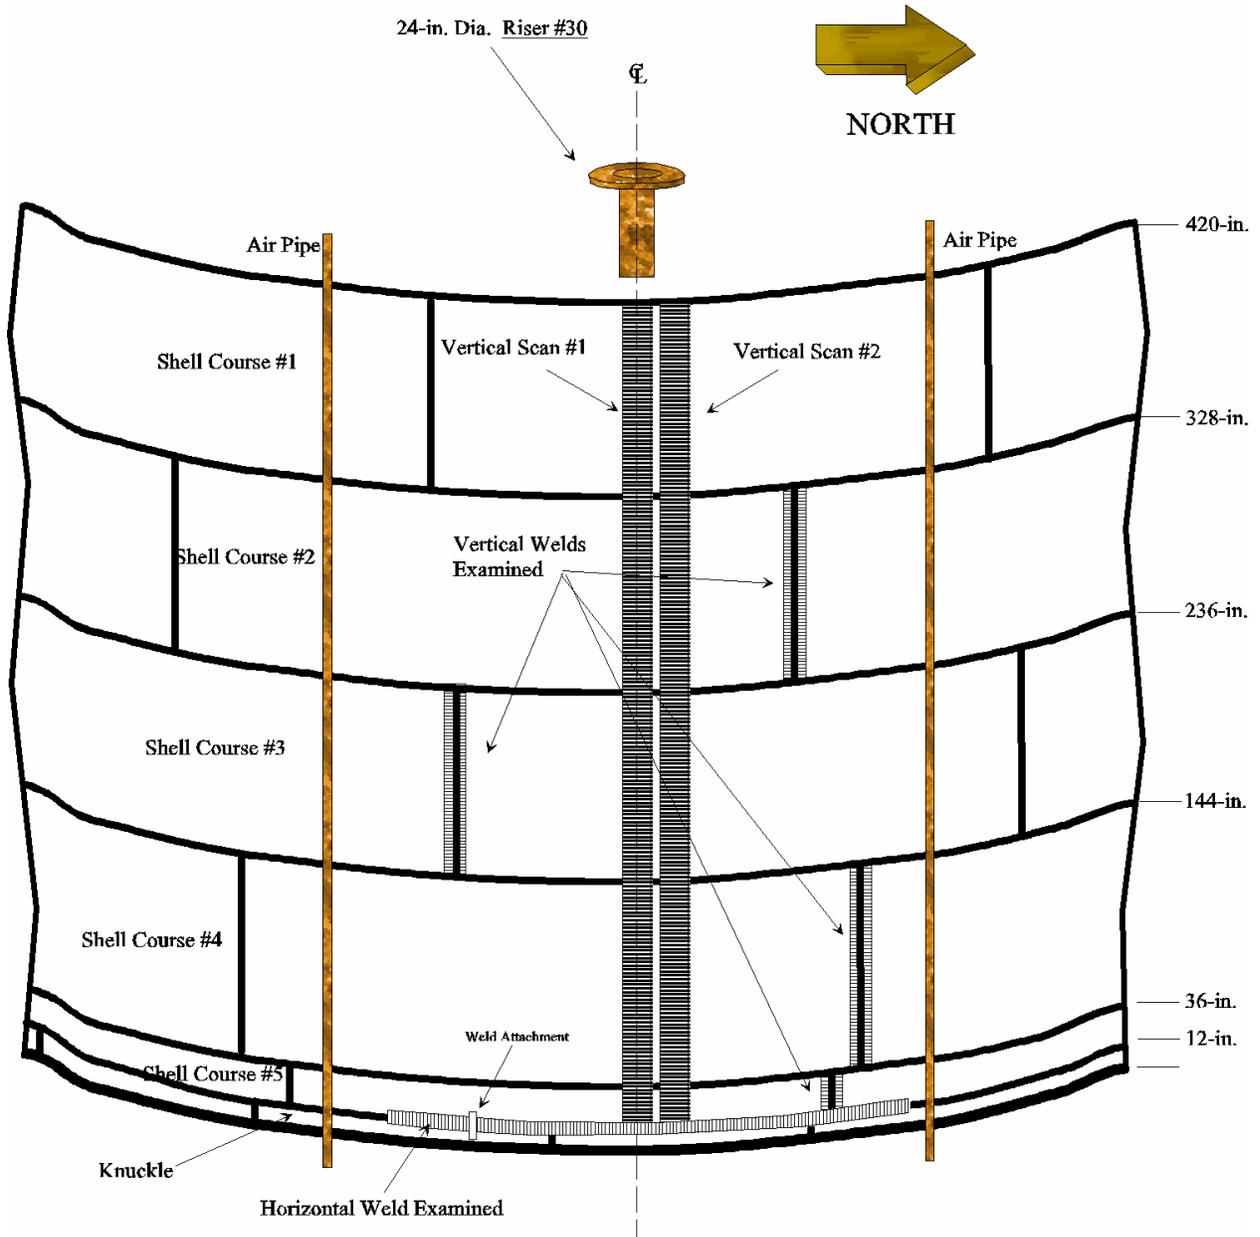
Figure 4.2. Sketch of Scan Paths on Tank 241-AP-104

Figure 4.2 describes the areas on the primary wall of Tank 241-AP-104 that were ultrasonically examined. Two 15-in.-wide vertical scan paths were performed on shell courses #1, #2, #3, #4, and #5 below the entrance to Riser 30. Vertical weld HAZ examinations were done on shell courses #2, #3, #4, and #5, and the horizontal weld HAZ examination was done on the transition shell course #5 to knuckle weld.
