**Pacific Northwest  
National Laboratory**

**Ultrasonic Examination of  
Double-Shell Tank 241-AP-102  
Examination Completed February 2005**

AF Pardini  
GJ Posakony

March 2005

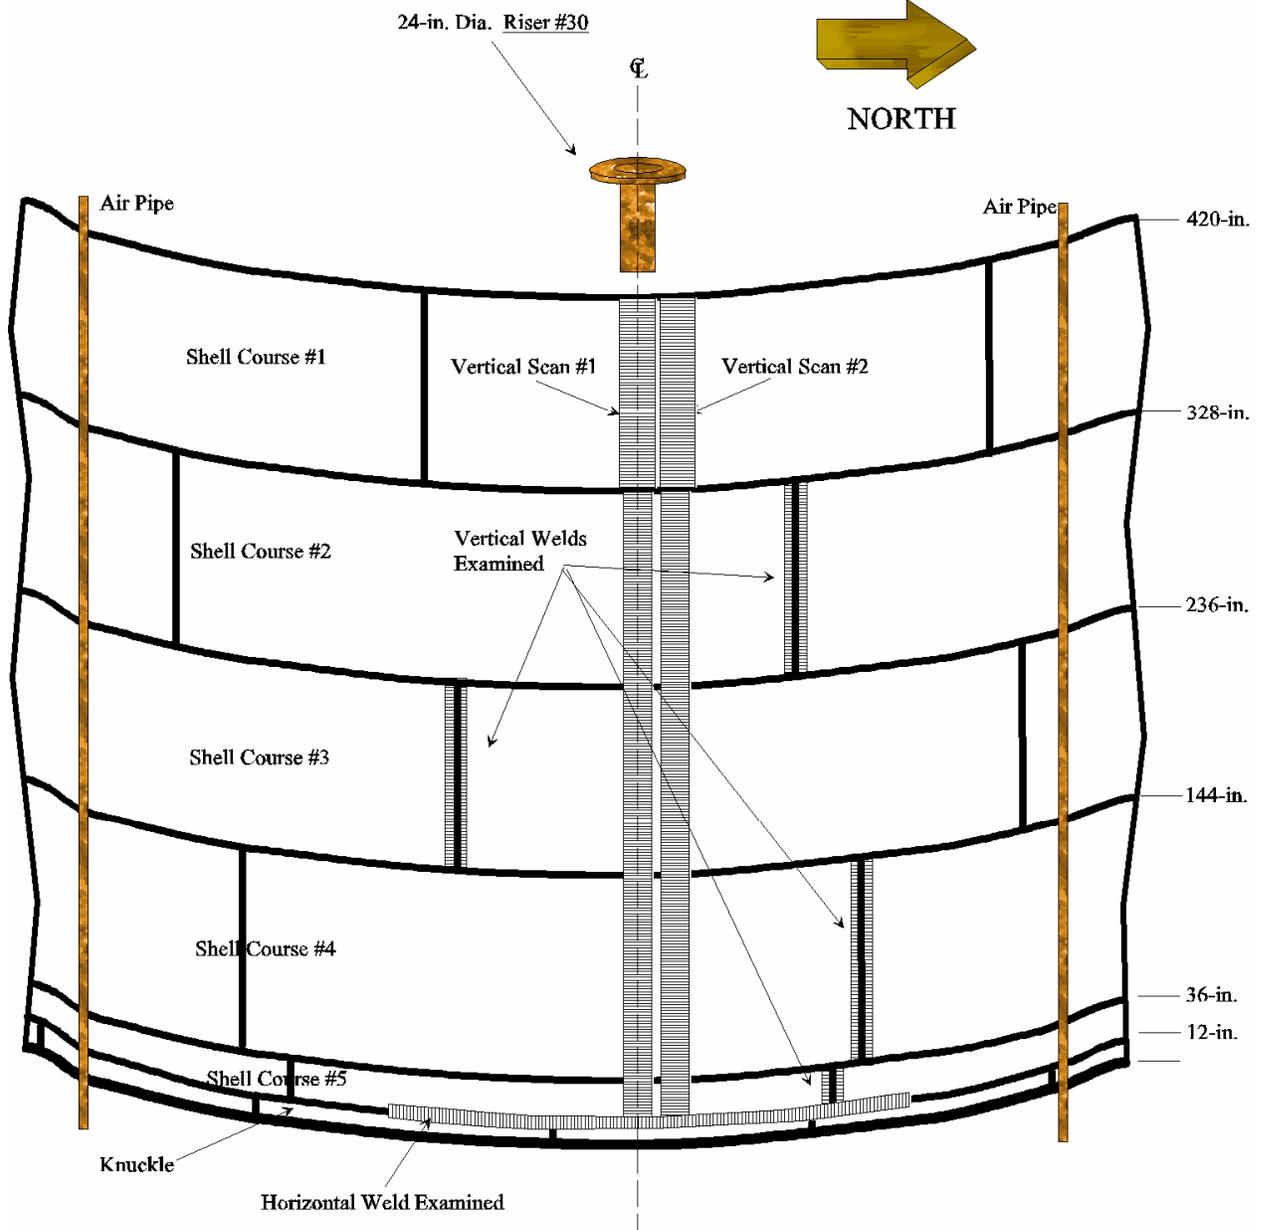
Figure 4.2. Sketch of Scan Paths on Tank 241-AP-102

Figure 4.2 describes the areas on the primary wall of Tank 241-AP-102 that was ultrasonically examined. Two 17-in. wide vertical scan paths were performed on shell course #1 and two 15-in.-wide vertical scan paths were performed on shell courses #2, #3, #4, and #5 below the entrance to Riser 30. Vertical weld HAZ examinations were done on shell courses #2, #3, #4, and #5, and the horizontal weld HAZ examination was done on the transition shell course #5 to knuckle weld.

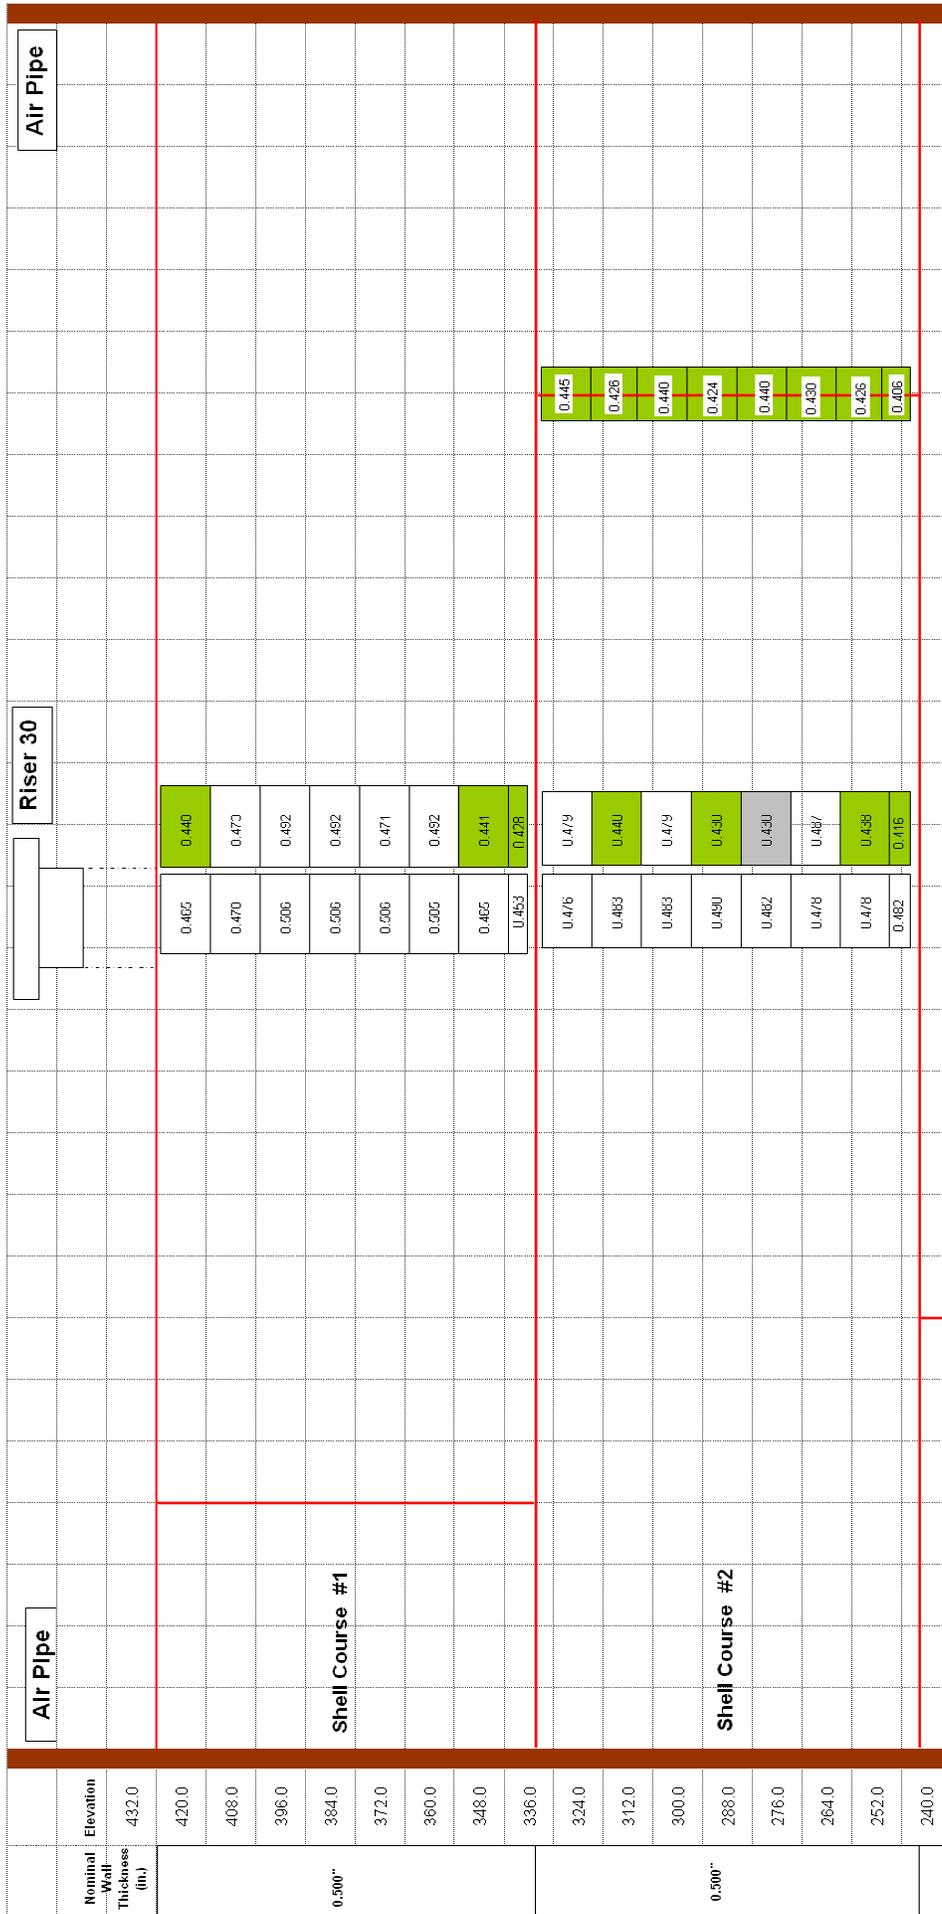
Figure 5.1. UT Data from Tank 241-AP-102

Figures 5.1 and 5.2 show the wall thickness examination results for the primary tank wall and the HAZs of both vertical and horizontal welds. The examination consisted of two vertical paths beneath the 24-in. diameter riser. Vertical scan #1 was 17-in. wide on shell course #1 and 15-in. wide on shell courses #2, #3, #4, and #5 near the centerline of the 24-in. riser. Vertical scan #2 was adjacent to vertical scan #1 and was also 17-in. wide on shell course #1 and 15-in. wide on shell courses #2, #3, #4, and #5. The HAZs of vertical welds in shell courses #2, #3, #4, and #5 were examined and the HAZ in the horizontal weld between shell course #5 and the knuckle section was also examined. Weld area exams include approximately 5-in. on each side of the weld. Areas in the figures that show two measurements in the same box are the result of the vertical scan paths overlapping the horizontal HAZ scan paths. Figures 5.1 and 5.2 display the minimum readings taken in each 15-in. (17-in. for shell course #1) wide by 12-in. long area of the scan. In the overlapping areas, both minimum readings from each of vertical and horizontal scan paths are given. The gray highlighted areas indicate that the minimum wall thickness exceeded the reportable level of 10% of the nominal wall thickness. The green highlighted areas indicate that the minimum wall thickness exceeded the 10% level, but the UT Level III has characterized these as pit-like indications. None of these pit-like indications exceed the pitting criteria of 25% of nominal thickness and are therefore not reportable. One area on the knuckle side had a surface condition that limited data acquisition. This area is designated with a NR for “no reading”.

The nominal thickness of shell course #1 is 0.500-in. Shell course #1 results indicate three areas that exceed the minimum thinning reportable level of 10% of the nominal thickness. However, these three areas (with remaining ligament of 0.440-in., 0.441-in., and 0.428-in.) were analyzed by the UT Level III and were considered pit-like and therefore do not exceed the reportable pitting level of 25% of the nominal thickness. No vertical crack-like indications were detected in shell course #1.

The nominal thickness of shell course #2 is 0.500-in. Shell course #2 results indicate five areas that exceed the minimum thinning reportable level of 10% of the nominal thickness. However, four of these areas (with remaining ligament of 0.440-in., 0.430-in., 0.438-in., and 0.416-in.) were analyzed by the UT Level III and were considered pit-like and therefore do not exceed the reportable pitting level of 25% of the nominal thickness. One of the five areas was evaluated by the UT Level III and was considered wall thinning with a minimum thickness of 0.430-in. and does exceed the reportable level of 10% of the nominal thickness. No vertical crack-like indications were detected in shell course #2.

The nominal thickness of shell course #3 is 0.5625-in. Shell course #3 results indicate six areas that exceed the minimum thinning reportable level of 10% of the nominal thickness. However, these six areas (with remaining ligament of 0.489-in., 0.503-in., 0.506-in., 0.491-in., 0.505-in., and 0.506-in.) were analyzed by the UT Level III and were considered pit-like and therefore do not exceed the reportable pitting level of 25% of the nominal thickness. No vertical crack-like indications were detected in shell course #3.

The nominal thickness of shell course #4 is 0.750-in. and the minimum thickness in this area was 0.684-in. Shell course #4 results indicate no areas that exceed the minimum thinning reportable level of 10% of the nominal thickness. No pitting or vertical crack-like indications were detected in shell course #4.

The nominal thickness of shell course #5 is 0.875-in. and the minimum thickness in this area was 0.790-in. Shell course #5 results indicate no areas that exceed the minimum thinning reportable level of 10% of the nominal thickness. No pitting or vertical crack-like indications were detected in shell course #5.

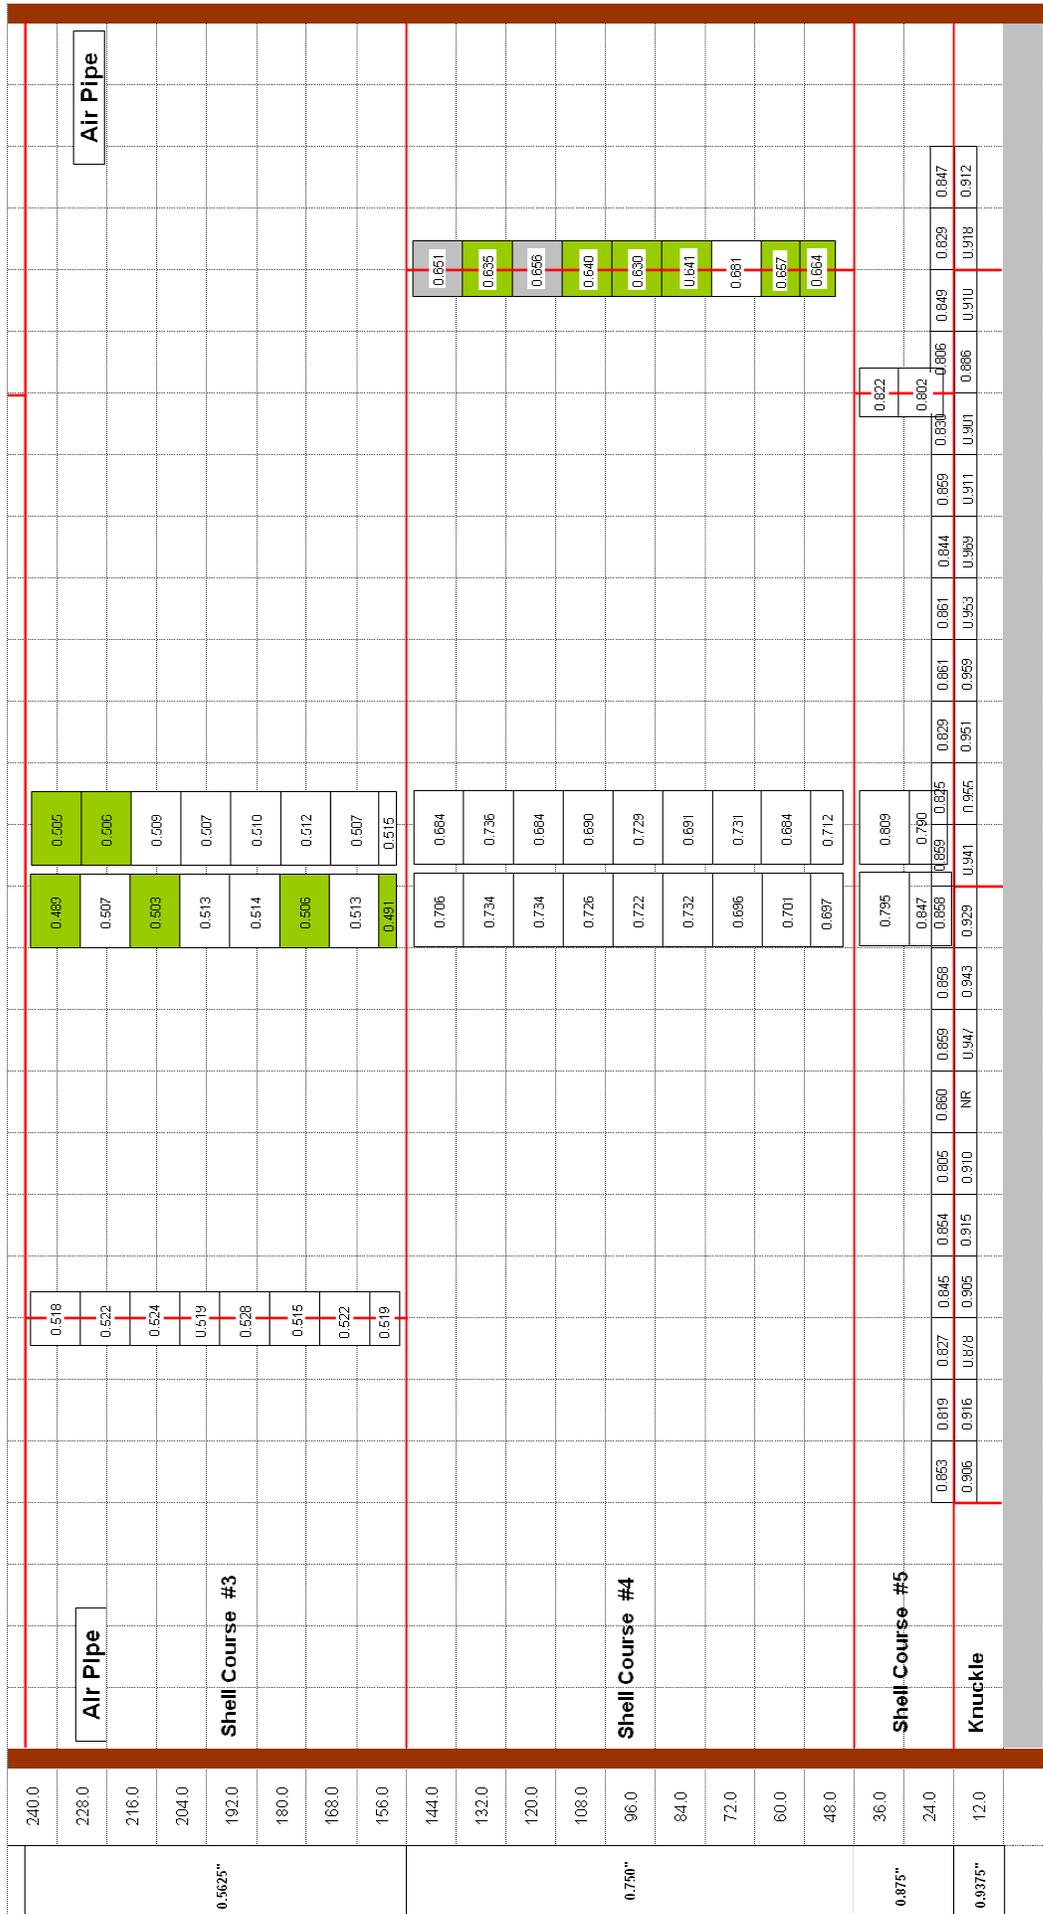
Figure 5.2 UT Data from Tank 241-AP-102 cont.

The nominal thickness of shell course #2 is 0.500-in. Shell course #2 results indicate eight areas that exceed the minimum thinning reportable level of 10% of the nominal thickness. However, all eight of these areas (with remaining ligament of 0.445-in., 0.426-in., 0.440-in., 0.424-in., 0.440-in., 0.430-in., 0.426-in., and 0.406-in.) were analyzed by the UT Level III and were considered pit-like and therefore do not exceed the reportable pitting level of 25% of the nominal thickness. No crack-like indications were detected in the weld areas in shell course #2.

The nominal thickness of shell course #3 is 0.5625-in. and the minimum thickness in this area was 0.515-in. Shell course #3 results indicate no areas that exceed the minimum thinning reportable level of 10% of the nominal thickness. No pitting or crack-like indications were detected in the weld areas in shell course #3.

The nominal thickness of shell course #4 is 0.750-in. Shell course #4 results indicate eight areas that exceed the minimum thinning reportable level of 10% of the nominal thickness. However, six of these areas (with remaining ligament of 0.635-in., 0.640-in., 0.630-in., 0.641-in., 0.657-in., and 0.664-in.) were analyzed by the UT Level III and were considered pit-like and therefore do not exceed the reportable pitting level of 25% of the nominal thickness. Two of the eight areas were evaluated by the UT Level III and were considered wall thinning with a minimum thickness of 0.651-in. and 0.656-in. and do exceed the reportable level of 10% of the nominal thickness. No crack-like indications were detected in shell course #4.

The nominal thickness of shell course #5 is 0.875-in. and the minimum thickness in this area was 0.802-in. Shell course #5 results indicate no areas that exceed the minimum thinning reportable level of 10% of the nominal thickness. No pitting or crack-like indications were detected in the weld areas in shell course #5.

The HAZ of the horizontal weld between shell course #5 and the tank knuckle was examined for wall thinning, pitting and cracks oriented either perpendicular or parallel to the weld. The results indicated that the minimum thickness in the weld area with nominal thickness of 0.875-in. on shell course #5 was 0.805-in. The minimum thickness in the weld area with nominal thickness of 0.9375-in. on the knuckle was 0.878-in. There were no areas of wall thinning that exceeded the reportable level of 10% of the nominal thickness. No pitting or crack-like indications were detected in the weld areas on shell course #5 side or on the knuckle side of the horizontal weld.
