**Pacific Northwest
National Laboratory**

**Ultrasonic Examination of
Double-Shell Tank 241-AY-101
Examination Completed March 2007**

AF Pardini
DR Weier

June 2007

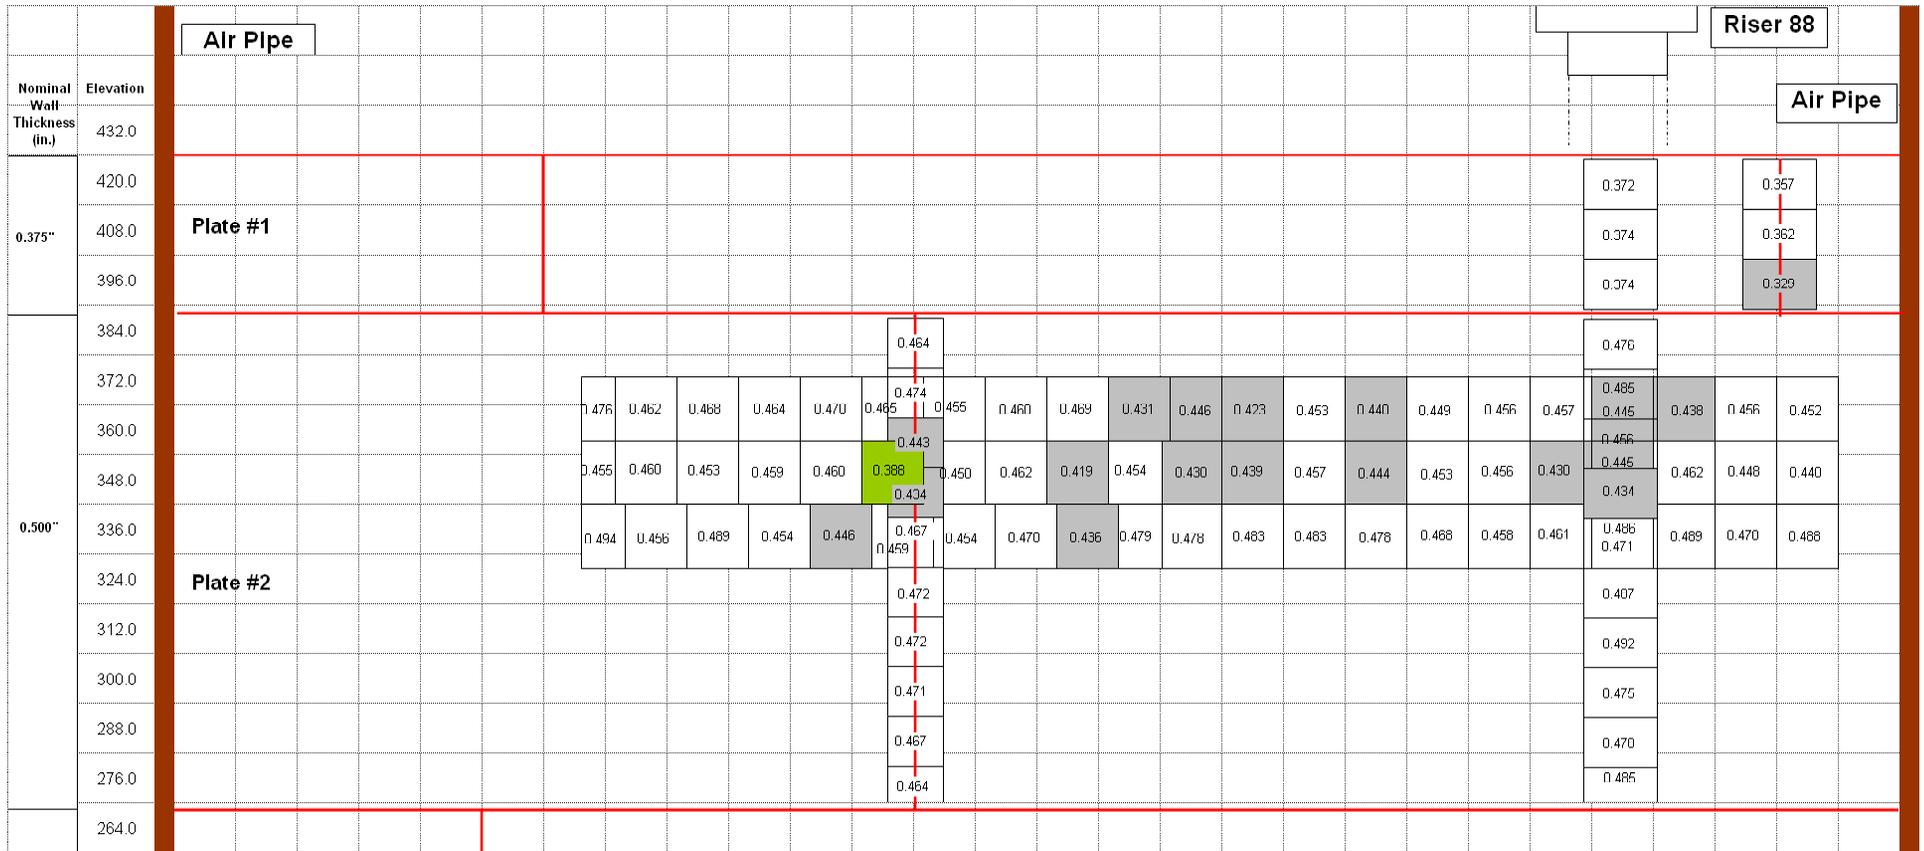
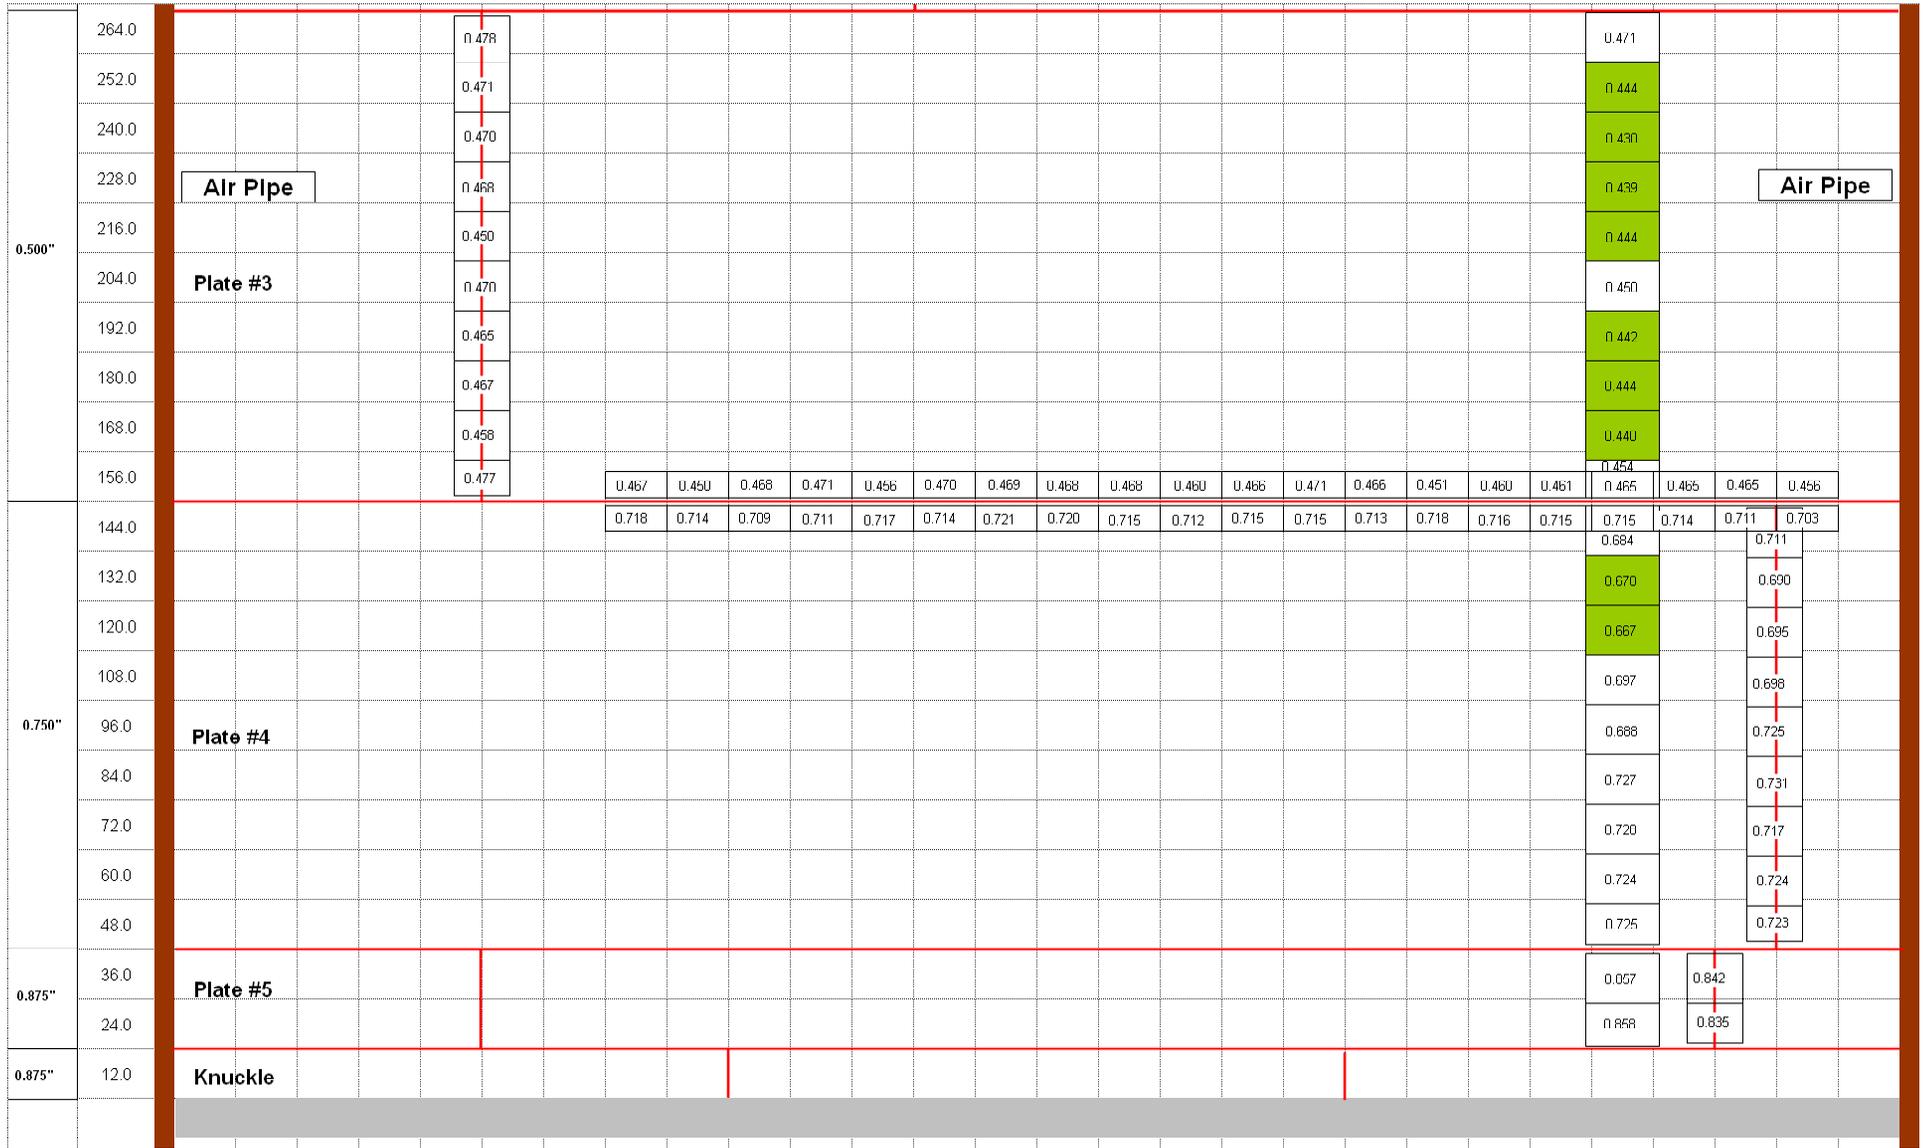
Figure 5.1. UT Data from Tank 241-AY-101 Primary Tank Riser 88

Figures 5.1 and 5.2 show the wall thickness examination results for the primary tank wall and the HAZs of both vertical and horizontal welds from Riser 88. The examination consisted of one 15-in.-wide vertical path beneath the centerline of the 24-in. diameter riser on Plates #1, #2, #3, #4, and #5. Vertical scan was conducted in the downward direction. Three horizontal scans were performed in the LAI region on Plate #2. Figures 5.1 and 5.2 display the minimum readings taken in each 15-in.-wide by 12-in.-long area of the scan. The HAZs of vertical welds in Plates #1, #2, #3, #4, and #5 were examined and the HAZ in the horizontal weld between Plate #3 and Plate #4 was also examined. Weld area exams include approximately 5-in. on each side of the weld. Areas in the figures that show two measurements in the same box are the result of the vertical scan paths overlapping the horizontal scan paths. In the overlapping areas, both minimum readings from each vertical and horizontal scan paths are given. The gray highlighted areas indicate that the minimum wall thickness exceeded the reportable level of 10% of the nominal wall thickness. The green highlighted areas indicate that the minimum wall thickness exceeded the 10% level, but the UT Level III has characterized these as pit-like indications. None of these pit-like indications exceed the pitting criteria of 25% of nominal thickness and are therefore not reportable.

One 15-in.-wide vertical scan path was performed on Plates #1, #2, #3, #4, and #5 from Riser 88. The plates were examined for wall thinning, pitting, and cracks oriented vertically on the primary tank wall.

- The nominal thickness of Plate #1 is 0.375-in. and the minimum thickness in this area was 0.372-in. Plate #1 results indicate no areas that exceed the minimum thinning reportable level of 10% of the nominal thickness. No pitting or vertical crack-like indications were detected in Plate #1.

- The nominal thickness of Plate #2 is 0.500-in. Plate #2 results indicate one area with minimum thickness of 0.434-in. exceeds the minimum thinning reportable level of 10% of the nominal thickness. No pitting or vertical crack-like indications were detected in Plate #2.

- The nominal thickness of Plate #3 is 0.500-in. Plate #3 results indicate seven areas that exceed the minimum thinning reportable level of 10% of the nominal thickness. However, these seven areas (with remaining ligament of 0.430-in., 0.439-in., 0.440-in., 0.442-in., 0.444-in., 0.444-in., and 0.444-in.) were analyzed by the UT Level III and were considered pit-like and therefore do not exceed the reportable pitting level of 25% of the nominal thickness. No vertical crack-like indications were detected in Plate #3.

- The nominal thickness of Plate #4 is 0.750-in. Plate #4 results indicate two areas that exceed the minimum thinning reportable level of 10% of the nominal thickness. However, these two areas (with remaining ligament of 0.667-in., and 0.670-in.) were analyzed by the UT Level III and were considered pit-like and therefore do not exceed the reportable pitting level of 25% of the nominal thickness. No vertical crack-like indications were detected in Plate #4.

- The nominal thickness of Plate #5 is 0.875-in. and the minimum thickness in this area was 0.857-in. Plate #5 results indicate no areas that exceed the minimum thinning reportable level of 10% of the nominal thickness. No pitting or vertical crack-like indications were detected in Plate #5.

Three 15-in.-wide horizontal scan paths were performed in the liquid-air interface region on Plate #2 from Riser 88. The plates were examined for wall thinning, pitting, and cracks oriented in a circumferential direction on the primary tank wall. The results indicated that the minimum thicknesses in the areas that were scanned with nominal thickness of 0.500-in. are as follows;

- LAI scan #1 results indicated six areas (with remaining ligament of 0.423-in., 0.431-in., 0.438-in., 0.440-in., 0.445-in., and 0.446-in. exceed the minimum thinning reportable level of 10% of the nominal thickness. No pitting or circumferentially oriented crack-like indications were detected in LAI scan #1.

- LAI scan #2 results indicated nine areas (with remaining ligament of 0.388-in., 0.419-in., 0.430-in., 0.430-in., 0.439-in., 0.440-in., 0.444-in., 0.445-in., and 0.448-in. exceed the minimum thinning reportable level of 10% of the nominal thickness. However, one of these areas (0.388-in.) was analyzed by the UT Level III and was considered pit-like and therefore does not exceed the reportable pitting level of 25% of the nominal thickness. No circumferentially oriented crack-like indications were detected in LAI scan #2.

- LAI scan #3 results indicated two areas (with remaining ligament of 0.436-in., and 0.446-in. exceed the minimum thinning reportable level of 10% of the nominal thickness. No pitting or circumferentially oriented crack-like indications were detected in LAI scan #3.

The HAZ of vertical welds in Plates #1, #2, #3, #4, and #5 from Riser 88 were examined for wall thinning, pitting and cracks oriented either perpendicular or parallel to the weld.

- The nominal thickness in Plate #1 is 0.375-in. Plate 1 indicates one area with a minimum thickness of 0.329-in. that exceeded the minimum thinning reportable level of 10% of the nominal thickness. No pitting or crack-like indications were detected in the weld areas in Plate #1.

- The nominal thickness in Plate #2 is 0.500-in. Plate 2 indicates two areas with a minimum thickness of 0.434-in. and 0.443-in. that exceeded the minimum thinning reportable level of 10% of the nominal thickness. No pitting or crack-like indications were detected in the weld areas in Plate #2.

- The nominal thickness in Plate #3 is 0.500-in. and the minimum thickness in this weld area was 0.450-in. There were no areas of wall thinning that exceeded the reportable level of 10% of the nominal thickness. No pitting or crack-like indications were detected in the weld areas in Plate #3.

- The nominal thickness in Plate #4 is 0.750-in. and the minimum thickness in this weld area was 0.690-in. There were no areas of wall thinning that exceeded the reportable level of 10% of the nominal thickness. No pitting or crack-like indications were detected in the weld areas in Plate #4.

- The nominal thickness in Plate #5 is 0.875-in. and the minimum thickness in this weld area was 0.835-in. There were no areas of wall thinning that exceeded the reportable level of 10% of the nominal thickness. No pitting or crack-like indications were detected in the weld areas in Plate #5.

The HAZ of the horizontal weld between Plate #3 and Plate #4 from Riser 88 was examined for wall thinning, pitting and cracks oriented either perpendicular or parallel to the weld. The results indicated that the minimum thickness in the weld area with nominal thickness of 0.500-in. on Plate #3 was 0.450-in. The minimum thickness in the weld area with nominal thickness of 0.750-in. on Plate #4 was 0.703-in. There were no areas of wall thinning that exceeded the reportable level of 10% of the nominal thickness. No pitting or crack-like indications were detected in the weld areas on Plate #3 side or on Plate #4 side of the horizontal weld.

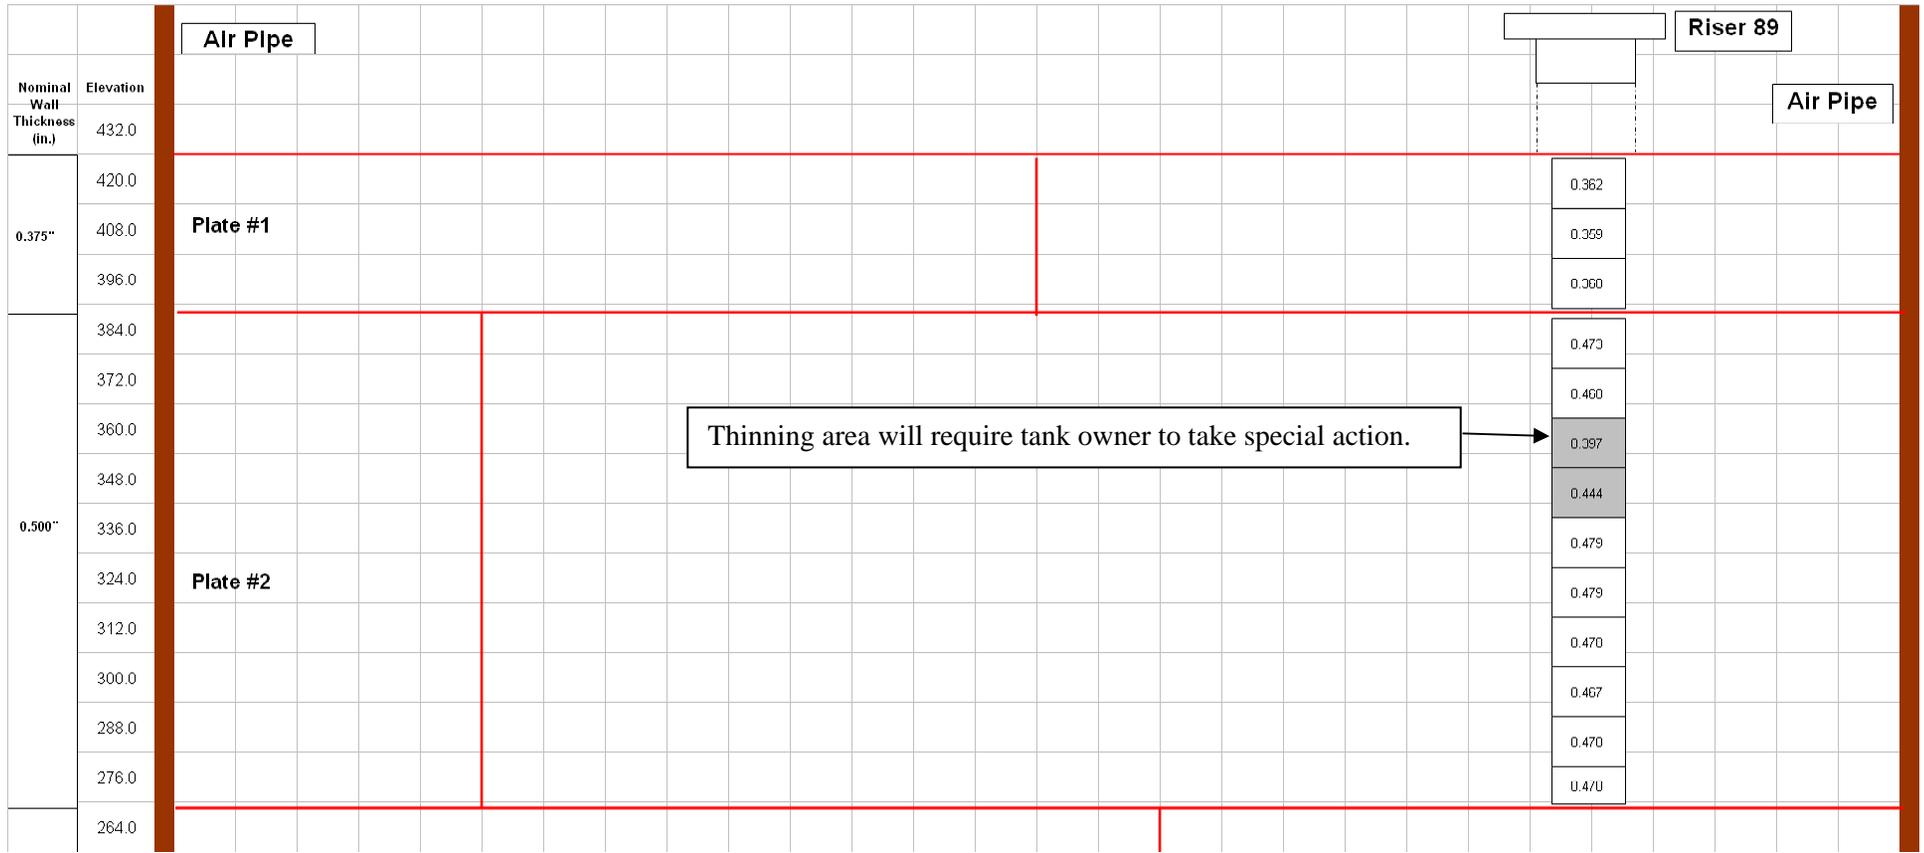
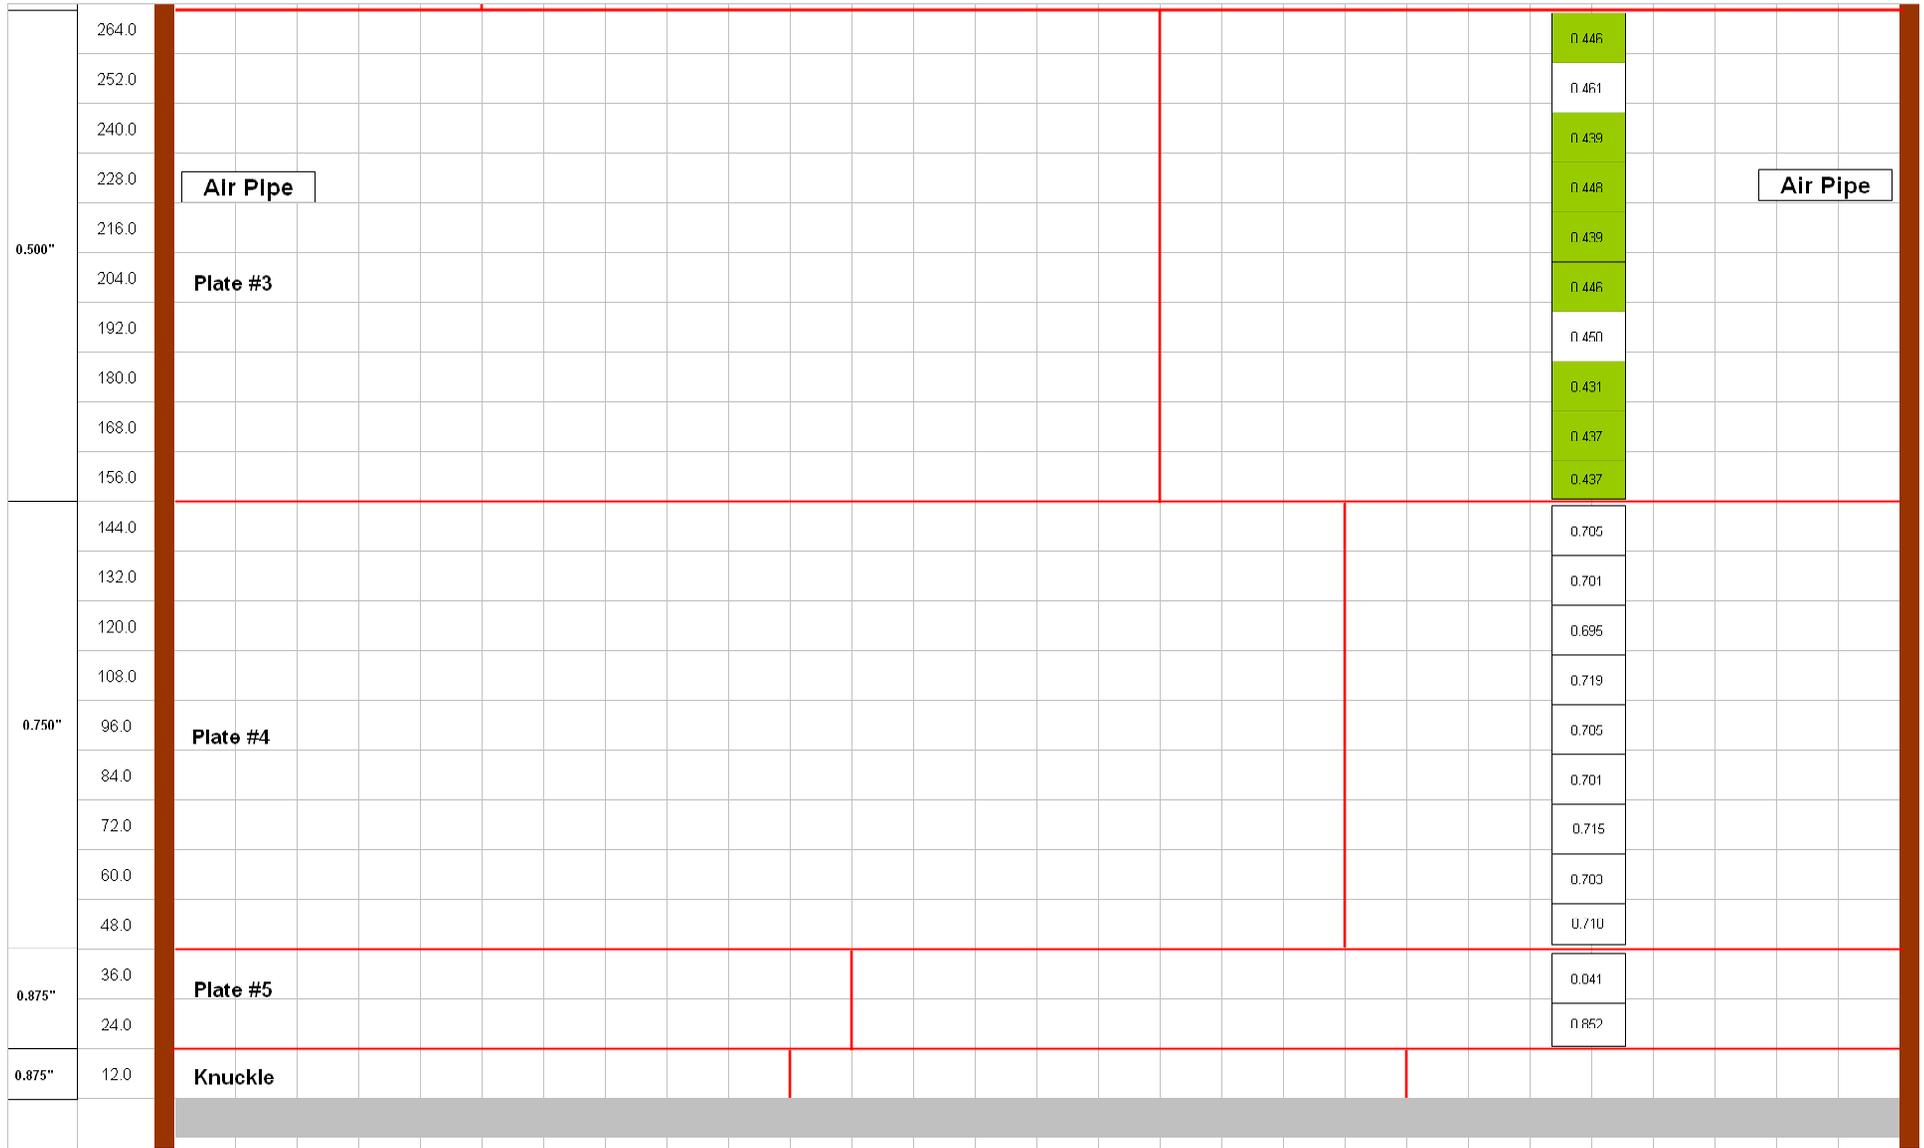
Figure 5.3. UT Data from Tank 241-AY-101 Primary Tank Riser 89

Figures 5.3 and 5.4 show the wall thickness examination results for the primary tank wall from Riser 89. The examination consisted of one vertical path beneath the centerline of the 24-in. diameter riser on Plates #1, #2, #3, #4, and #5. Vertical scan was conducted in the downward direction. Figures 5.3 and 5.4 display the minimum readings taken in each 15-in.-wide by 12-in.-long area of the scan. The gray highlighted areas indicate that the minimum wall thickness exceeded the reportable level of 10% of the nominal wall thickness. The 0.397-in. shown as a gray highlighted area exceeded the acceptance criteria of 20% and will require the tank owner to take special action. The green highlighted areas indicate that the minimum wall thickness exceeded the 10% level, but the UT Level III has characterized these as pit-like indications. None of these pit-like indications exceed the pitting criteria of 25% of nominal thickness and are therefore not reportable.

One 15-in.-wide vertical scan path was performed on Plates #1, #2, #3, #4, and #5 from Riser 89. The plates were examined for wall thinning, pitting, and cracks oriented vertically on the primary tank wall.

- The nominal thickness of Plate #1 is 0.375-in. and the minimum thickness in this area was 0.359-in. Plate #1 results indicate no areas that exceed the minimum thinning reportable level of 10% of the nominal thickness. No pitting or vertical crack-like indications were detected in Plate #1.

- The nominal thickness of Plate #2 is 0.500-in. Plate #2 results indicate two areas with minimum thickness of 0.397-in. and 0.444-in. that exceed the minimum thinning reportable level of 10% of the nominal thickness. The 0.397-in. area exceeded the acceptance criteria of 20% and will require the tank owner to take special action. No pitting or vertical crack-like indications were detected in Plate #2.

- The nominal thickness of Plate #3 is 0.500-in. Plate #3 results indicate eight areas that exceed the minimum thinning reportable level of 10% of the nominal thickness. However, these eight areas (with remaining ligament of 0.431-in., 0.437-in., 0.437-in., 0.439-in., 0.439-in., 0.446-in., 0.446-in., and 0.448-in.) were analyzed by the UT Level III and were considered pit-like and therefore do not exceed the reportable pitting level of 25% of the nominal thickness. No vertical crack-like indications were detected in Plate #3.

- The nominal thickness of Plate #4 is 0.750-in. and the minimum thickness in this area was 0.695-in. Plate #4 results indicate no areas that exceed the minimum thinning reportable level of 10% of the nominal thickness. No pitting or vertical crack-like indications were detected in Plate #4.

- The nominal thickness of Plate #5 is 0.875-in. and the minimum thickness in this area was 0.841-in. Plate #5 results indicate no areas that exceed the minimum thinning reportable level of 10% of the nominal thickness. No pitting or vertical crack-like indications were detected in Plate #5.

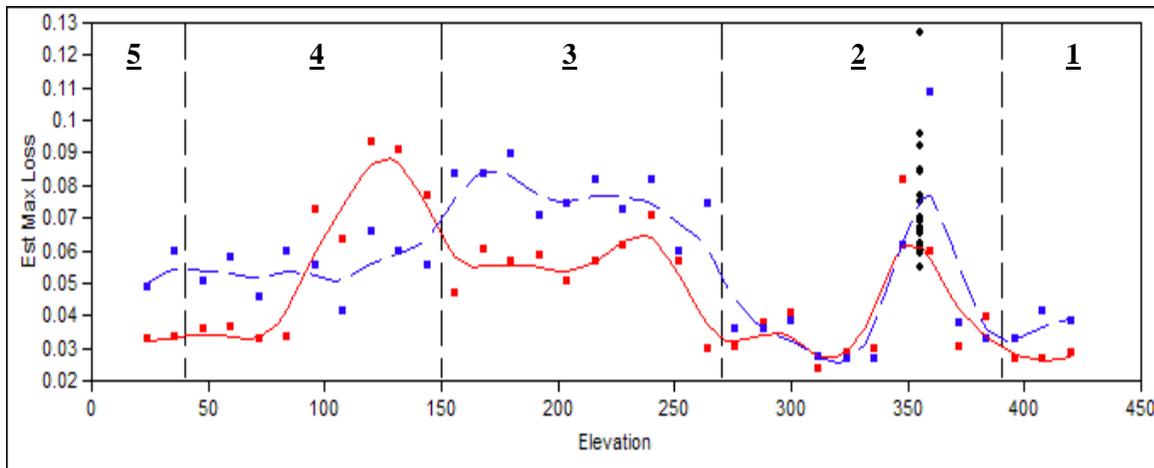
Figure 6.2. Estimated Maximum Wall Thickness Loss by Riser Path

Maximum wall thickness loss results obtained in the manner described above are shown for each riser in Figure 6.2. Red points with the solid red curve are for Riser 88, while blue points with the dashed blue line are for Riser 89. Numbered sections of the graphs represent the different plate courses; note that the top of the tank is to the right on the figure. Within Plate #2 the increased corrosion associated with the LAI is readily apparent. The greater corrosion in the LAI was addressed in Weier, Anderson, Berman 2005 where LAI measurements were treated separately for extreme value estimation.

Additional UT inspection was done along the LAI in the current efforts. Three horizontal paths about 20 feet long were measured generating about 20 images per path. But since the paths were “stacked” vertically, the minimum value for each linear foot from the three paths was used to represent the minimum wall thickness at that point of the LAI. The resulting values are the vertical set of black points at an elevation of about 355 on the figure.

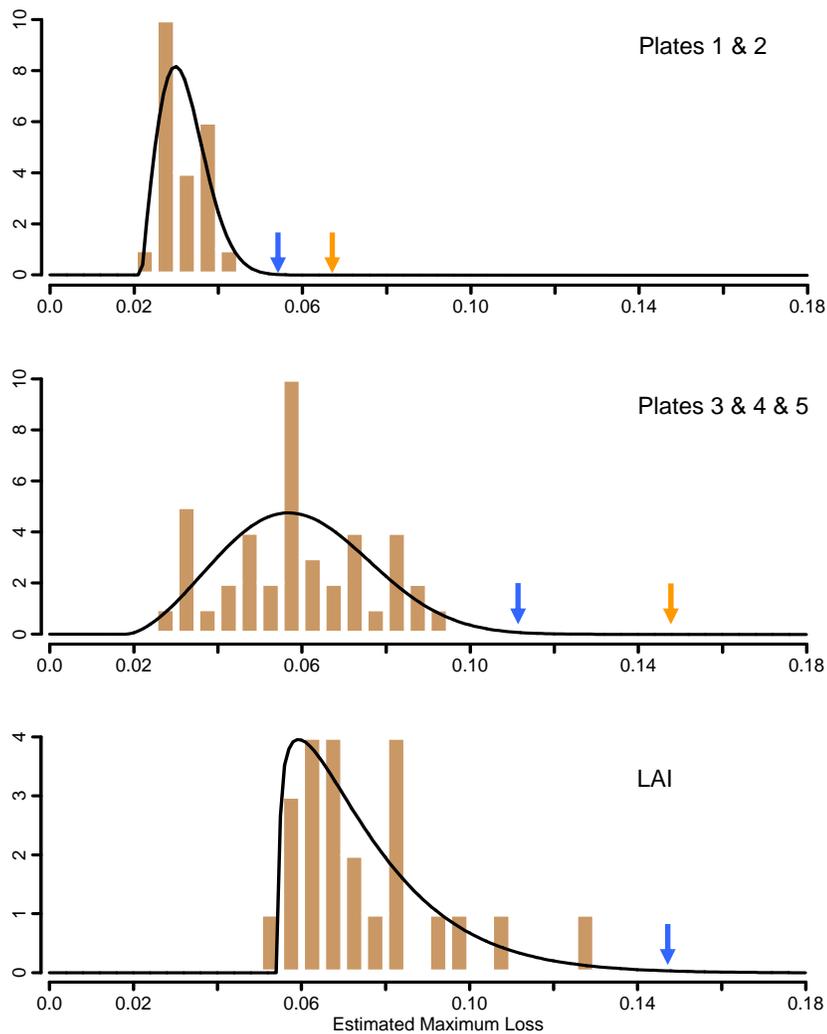
Figure 6.3. Weibull Distribution Fits to UT Maximum Wall Thickness Loss

The histograms in Figure 6.3 show such wall thickness loss data for the indicated plate groupings. Three parameter Weibull distributions are fit to these histograms and are shown as the smooth curves. The total surface area of a plate course combination, and thus the number of 15-in. by 12-in. UT images needed to 100% inspect the entire plate course combination, is computed. The percentile of the distribution that then corresponds to the maximum expected loss among this many UT images, based on the distribution fit to the histogram, is considered as the estimated worst case loss. For the LAI, the linear feet inspected were used analogously with the required worst case percentile based on the total circumference of the tank at the LAI.

Three parameter Weibull distributions were fit to combinations of plate course measurements as well as to the measurements for the LAI. Plates #1 & #2 combined generate a worst case measured wall thickness loss of 0.054-in. that might be expected if the entire surface area of the tank wall in these plates, but outside the LAI in Plate #2, were UT inspected. A 95% confidence bound is computed based on the uncertainty in the Weibull parameters caused by the relatively minimal amounts of data for distribution
