**Pacific Northwest  
National Laboratory**

**Ultrasonic Examination of  
Double-Shell Tank 241-AP-107  
Examination Completed February 2008**

AF Pardini  
DR Weier  
KK Anderson

April 2008

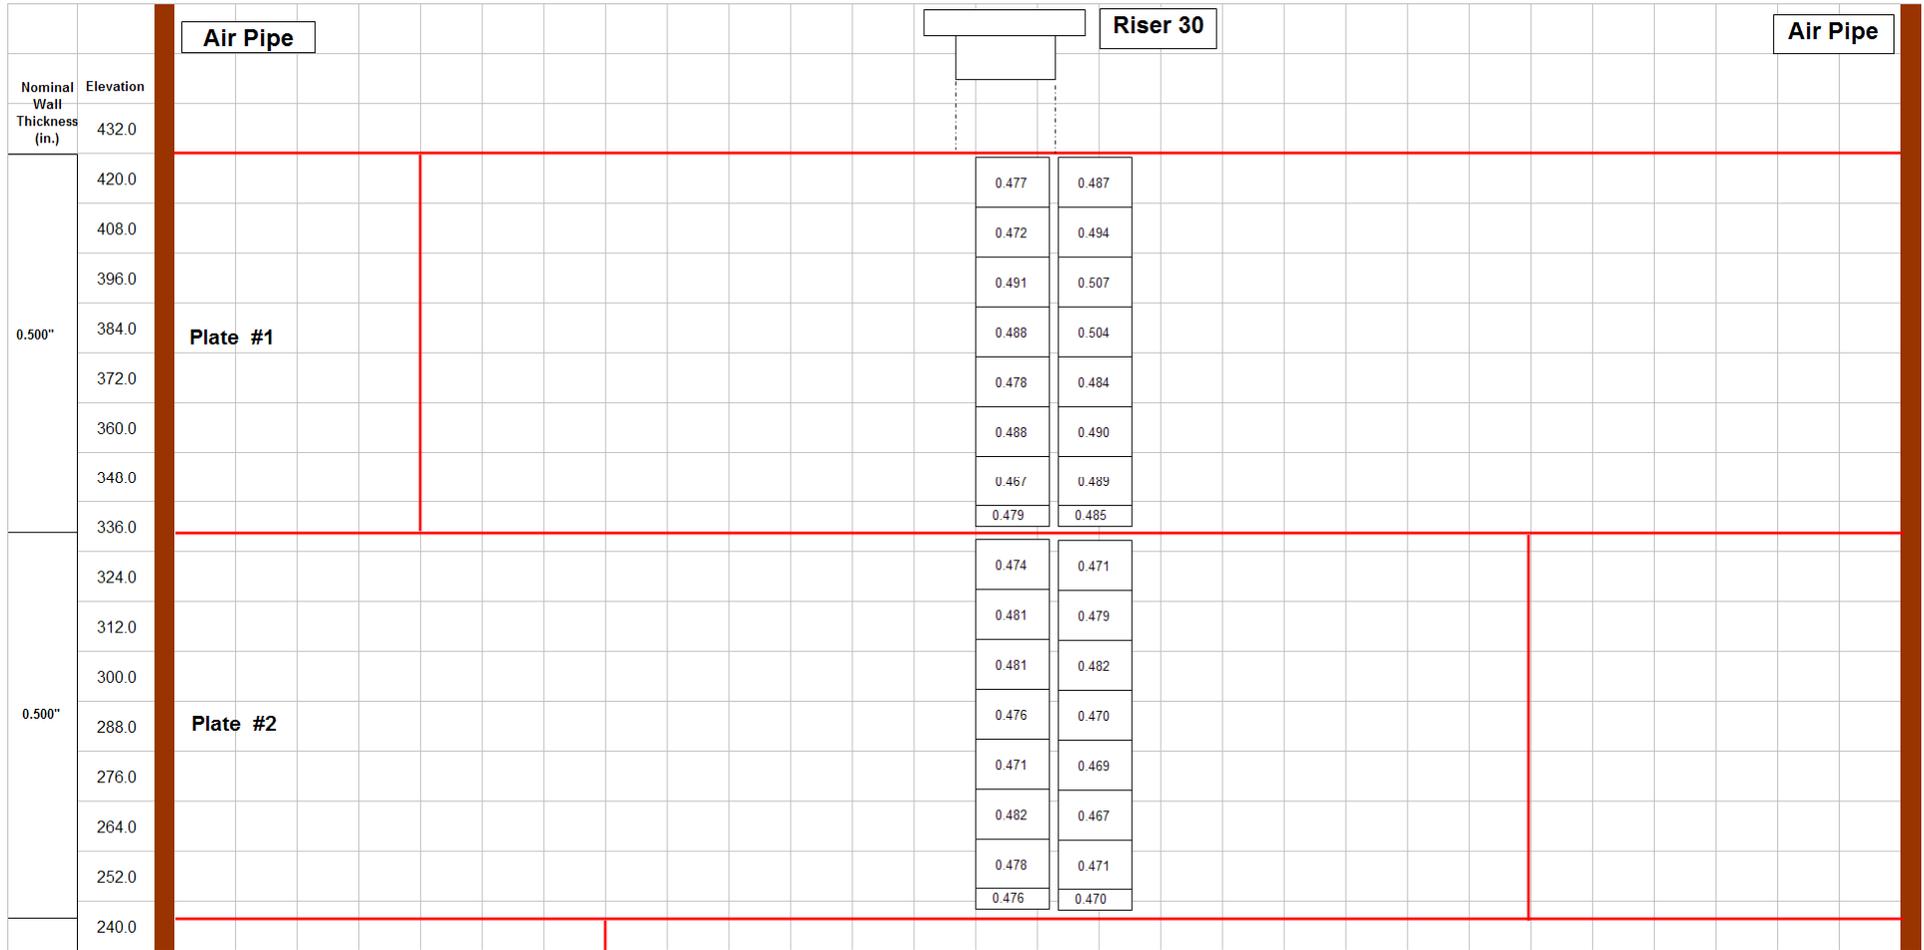
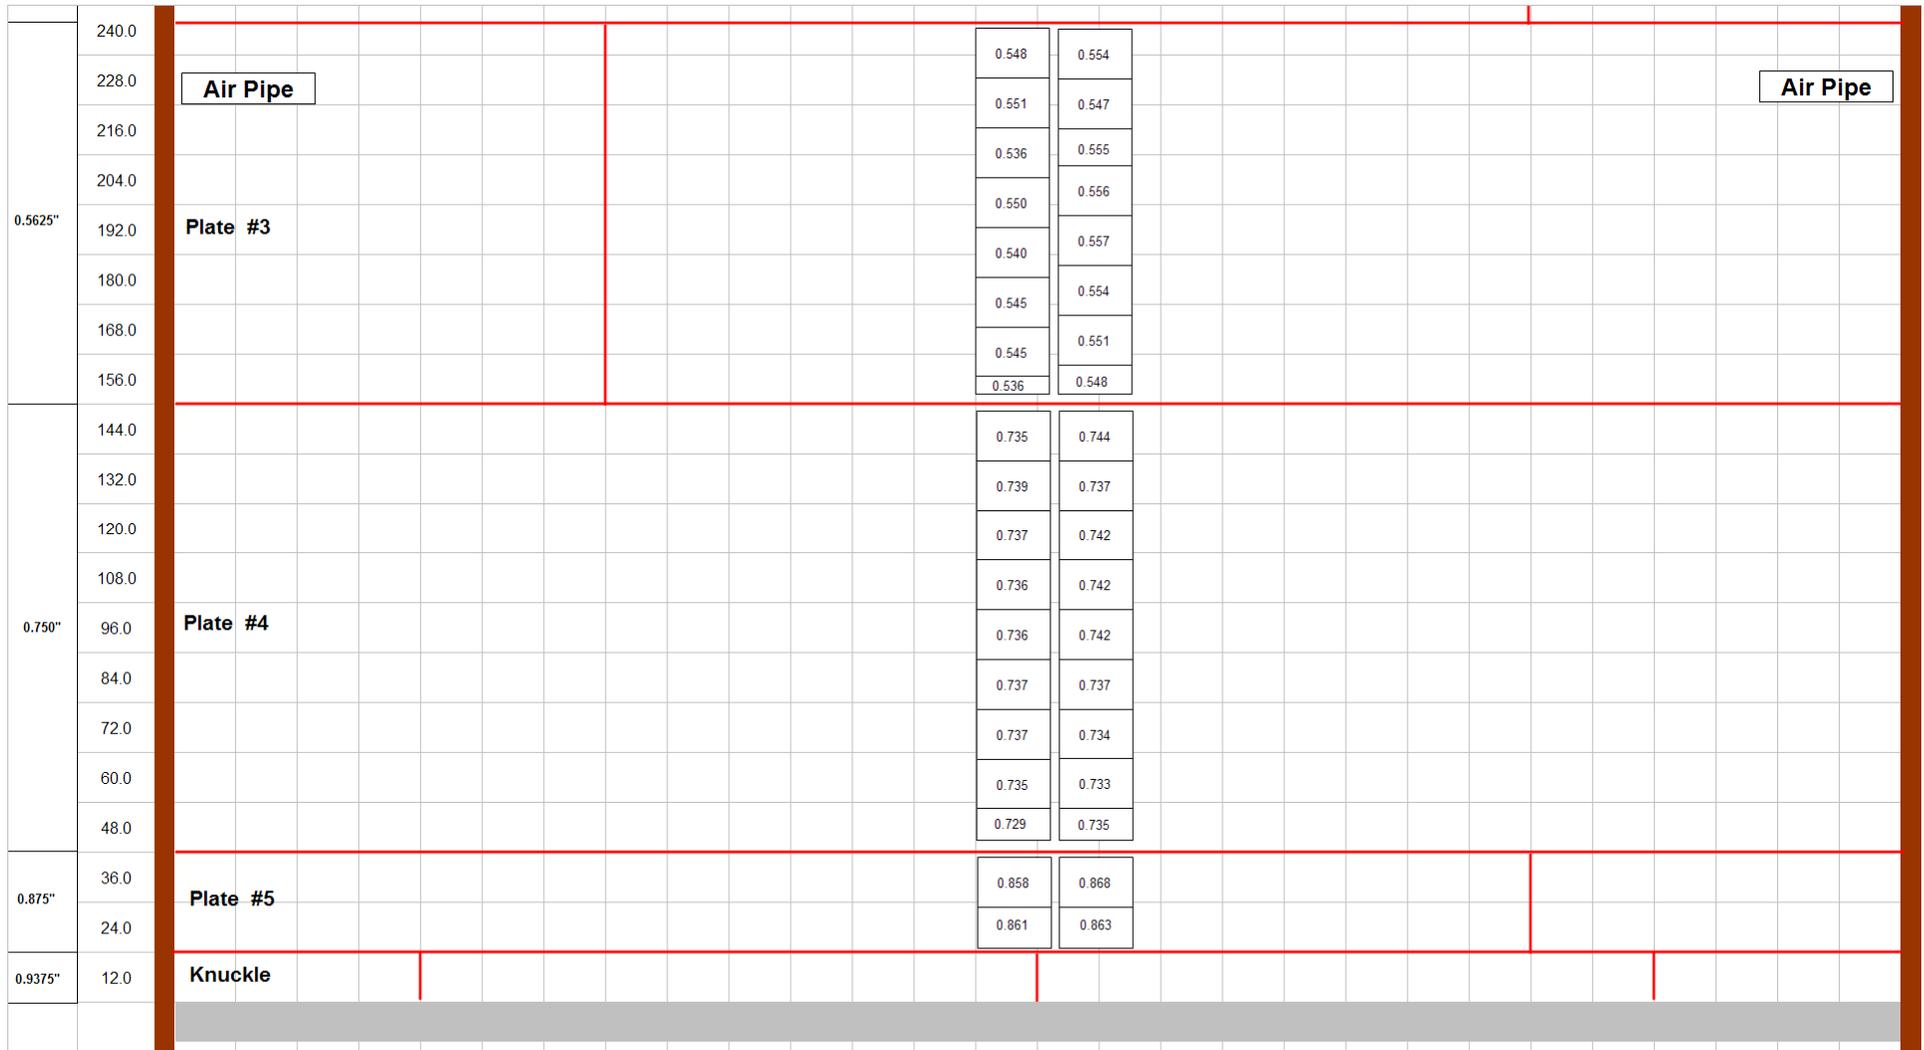
Figures 5.1 and 5.2 show the wall thickness examination results for the primary tank wall taken below Riser 30. The examination consisted of two vertical paths beneath the 24-in. diameter riser. Vertical scan #1 was 15-in.-wide on Plate #1, #2, #3, #4, and #5 near the centerline of the 24-in. riser. Vertical scan #2 was adjacent to vertical scan #1 and was also 15-in.-wide on Plates #1, #2, #3, #4, and #5. Vertical scans were conducted in the downward direction. Figures 5.1 and 5.2 display the minimum readings taken in each 15-in.-wide by 12-in.-long area of the scan.

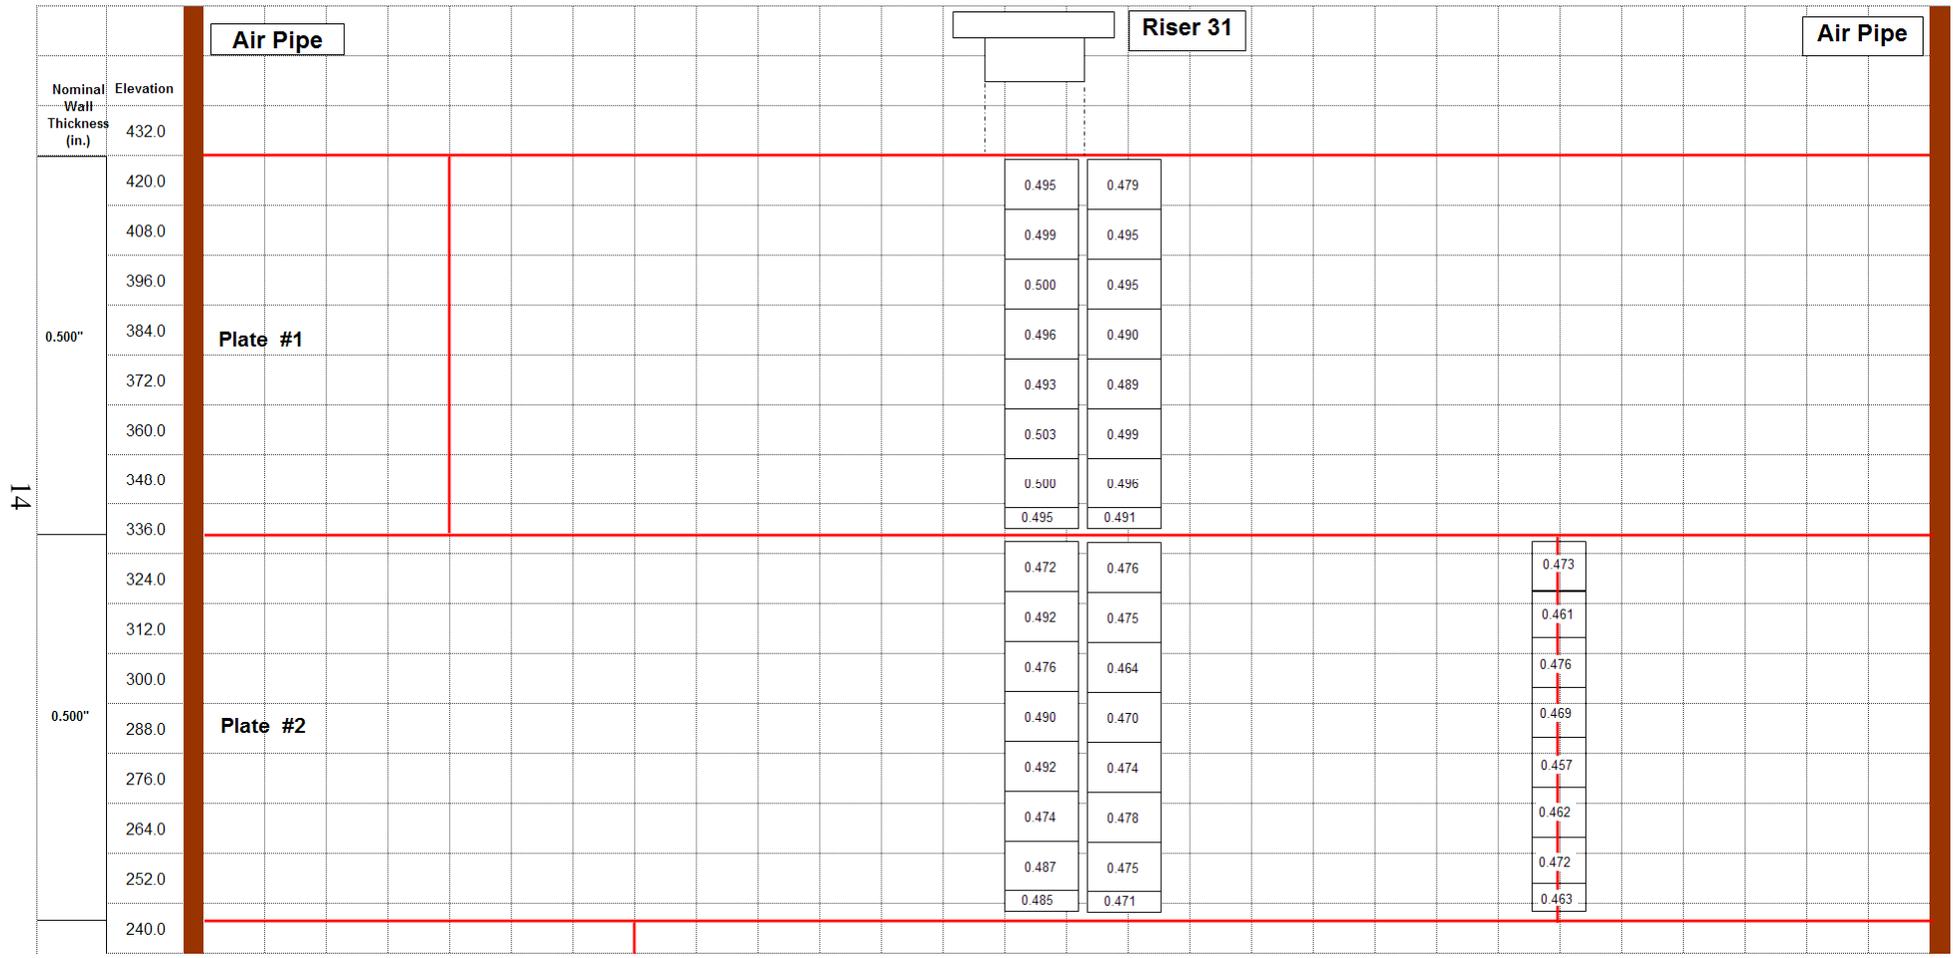
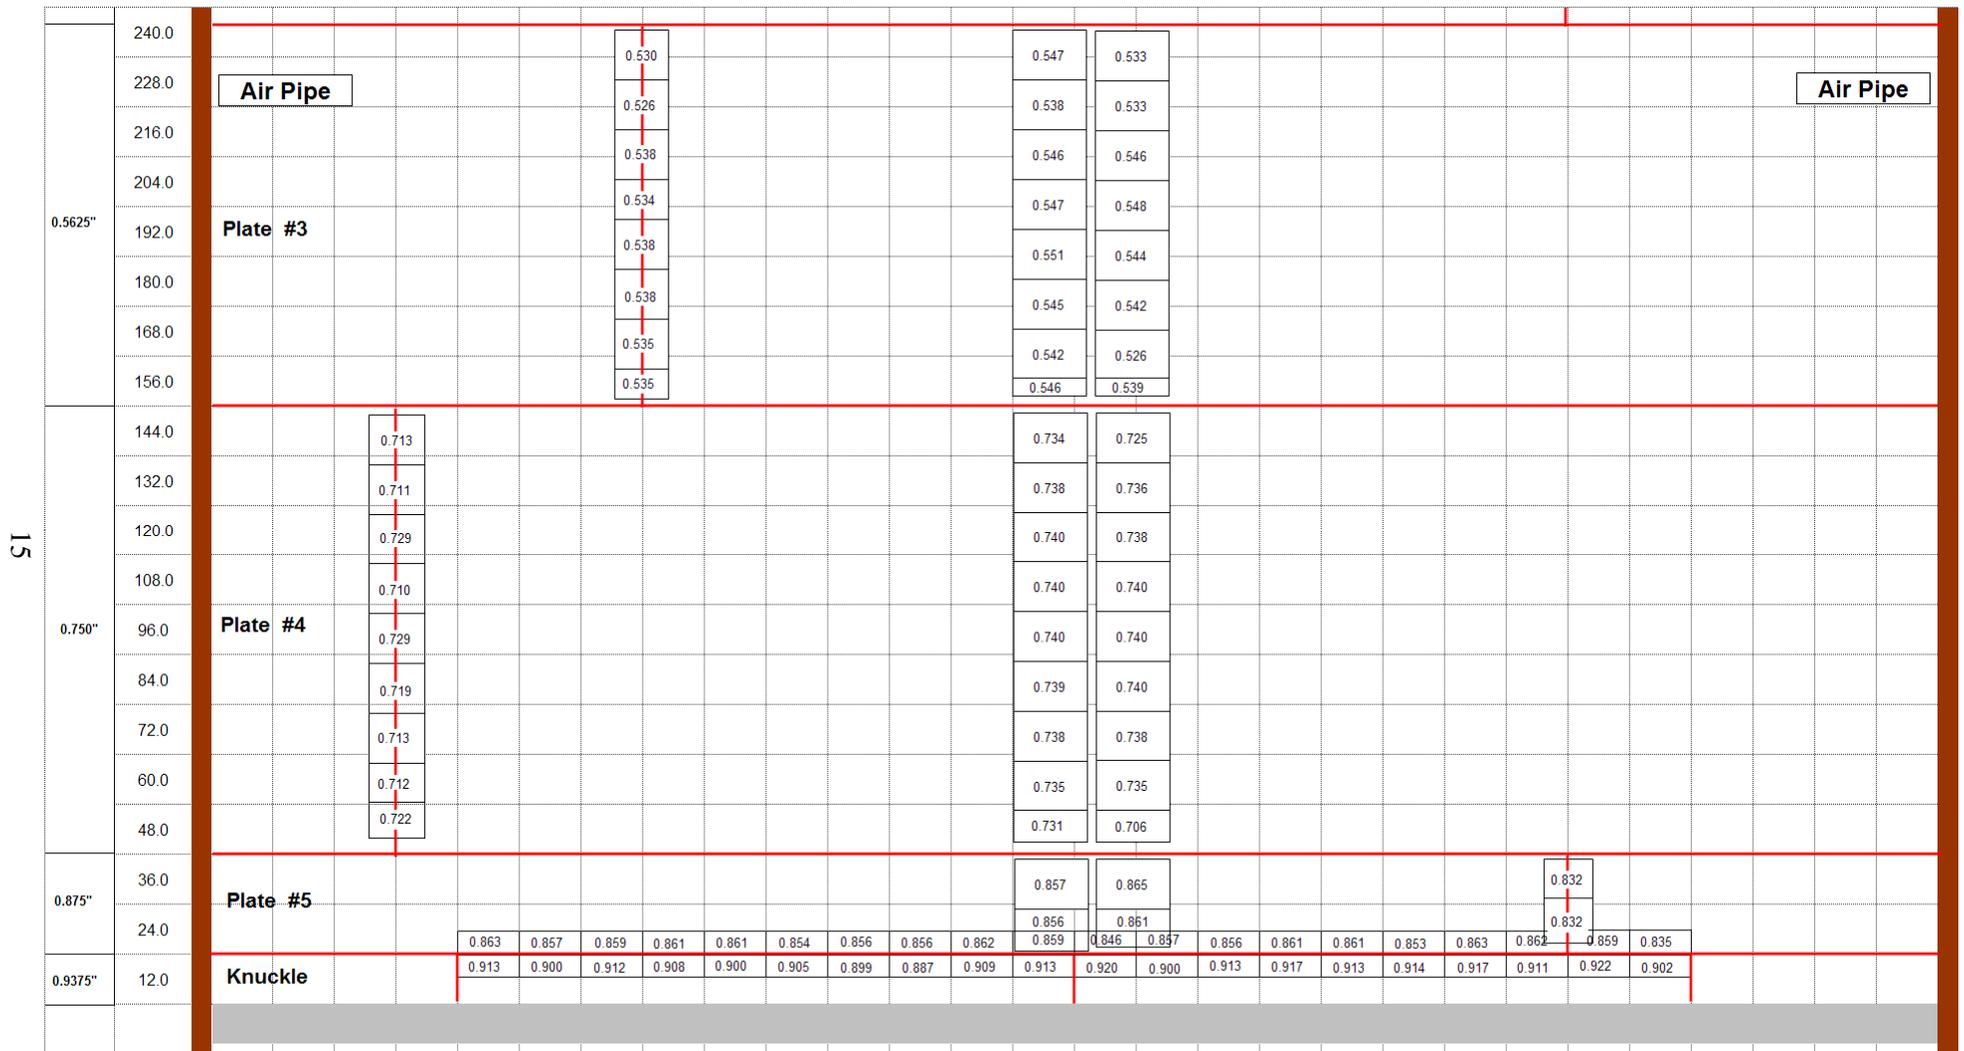
Figures 5.3 and 5.4 show the wall thickness examination results for the primary tank wall and the HAZs of both vertical and horizontal welds taken below Riser 31. The examination consisted of two vertical paths beneath the 24-in. diameter riser. Vertical scan #1 was 15-in.-wide on Plate #1, #2, #3, #4, and #5 near the centerline of the 24-in. riser. Vertical scan #2 was adjacent to vertical scan #1 and was also 15-in.-wide on Plates #1, #2, #3, #4, and #5. Vertical scans were conducted in the downward direction. Figures 5.3 and 5.4 display the minimum readings taken in each 15-in.-wide by 12-in.-long area of the scan. The HAZs of vertical welds in Plates #2, #3, #4, and #5 were examined and the HAZ in the horizontal weld between Plate #5 and the knuckle section was also examined. Weld area exams include approximately 5-in. on each side of the weld and figures 5.3 and 5.4 display the minimum readings taken in each 5-in.-wide by 12-in.-long area of the scan. Areas in the figures that show two measurements in the same box are the result of the vertical scan paths overlapping the horizontal scan paths. In the overlapping areas, both minimum readings from each vertical and horizontal scan paths are given.

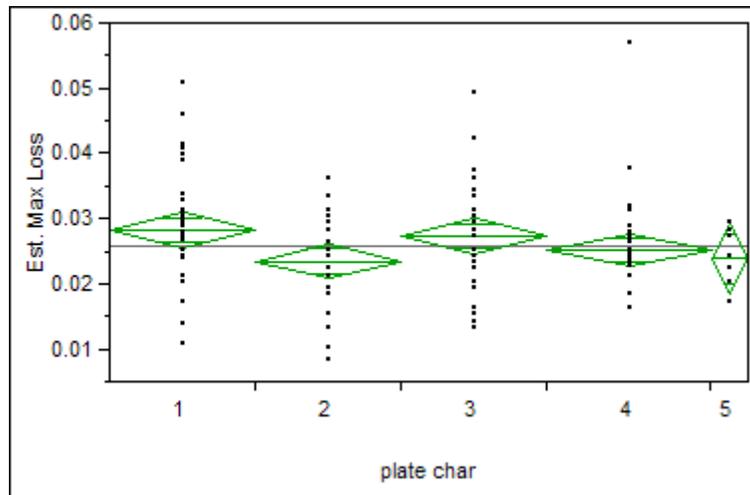
**Figure 6.2.** Estimated Maximum Loss by Plate

The estimated wall thickness maximum losses for Tank 241-AP-107 are shown across plates in Figure 6.2. The vertical extent of the green diamonds represents confidence intervals for the means within each plate (the widths of the diamonds reflect the number of UT measurements per plate). Statistically these means are at most only very marginally different, so for this reason it could be deemed appropriate to combine the measurements across all plates, and that is indeed done in the following for extreme value analysis, in addition to giving results for the individual plates. But the extreme value results actually depend more on the large values in the upper tails of plates' distributions than on the plate means. For this reason alternative groupings are considered; plates 1, 3, and 4 are combined since they have all the outlying larger values, and plates 2 and 5 are combined since they do not. Thus extreme value results are given for these latter groupings as well.

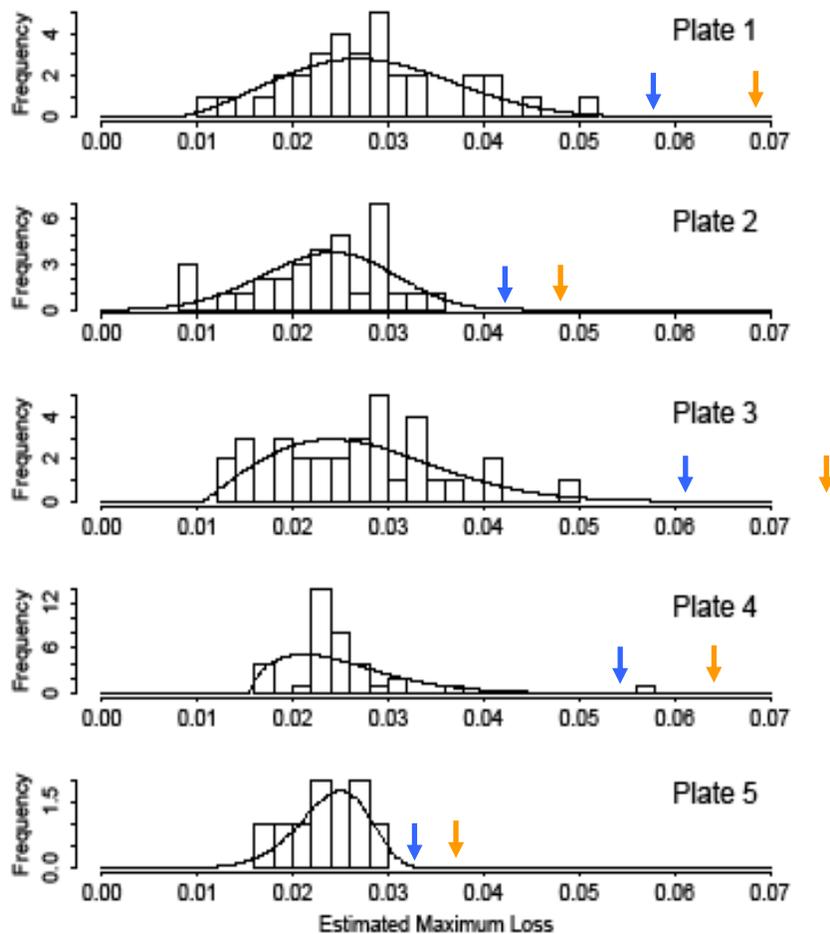
**Figure 6.3.** Weibull Distribution Fits to UT Maximum Wall Thickness Loss by Plate Course

The histograms in Figure 6.3 show estimated maximum wall thickness loss data for the individual plate courses. Three-parameter Weibull distributions are fit to these histograms and are shown as the smooth curves. The total surface area of a plate course, and thus the number of 15-in. by 12-in. UT images needed to 100% inspect the entire plate course is computed. The percentile of the distribution that then corresponds to the maximum expected loss among this many UT images, based on the distribution fit

The values indicated by the arrows on the histograms are the estimated worst case losses per plate course (blue, to the left) and their associated 95% confidence bounds (orange, to the right). The corresponding values are given in the table shown in Figure 6.4. Included in the table are: 1) the number of measurements, 2) the estimated extreme value loss expected for the plate course around the entire circumference of the tank, and 3) the 95% confidence bound for the extreme value loss.

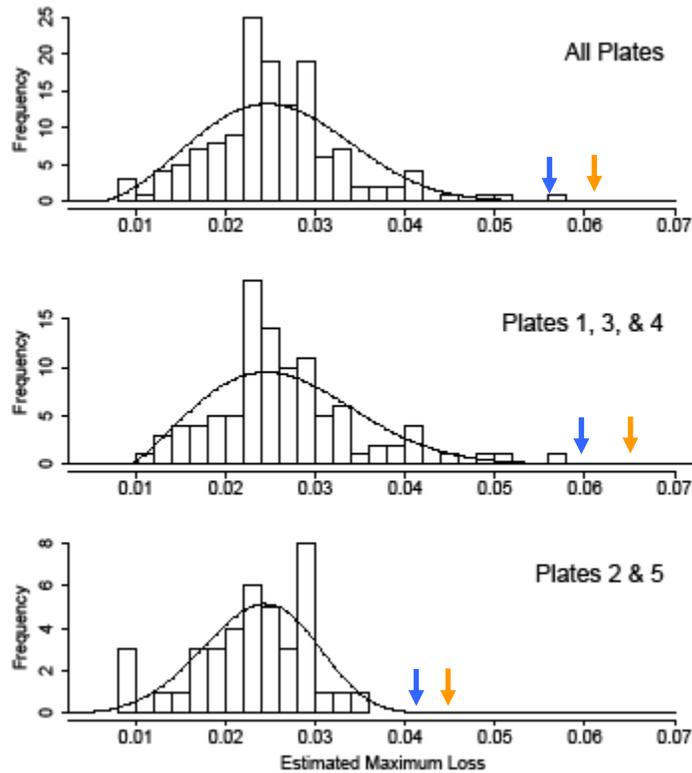
**Figure 6.5.** Weibull Distribution Fit to Combined UT Maximum Wall Thickness Loss

To obtain more measurements, and thereby reduce the uncertainty due to minimal number of measurements for distribution fitting, combinations of plate courses were used as well. The resulting Weibull fit to the combined measurements over all plates is shown as the top histogram in Figure 6.5. The other two histograms in that figure are the Plate 1,3,4 and Plate 2,5 cases; corresponding estimates and bounds for these cases are given in the final columns of Figure 6.4. The larger numbers of measurements in these combined cases will generally result in the tighter upper bounds, but the uncertainties in the estimates are still impacted by the quality of the Weibull fit. It can be seen in the histograms that the quality of the Weibull fit is hampered by clusters of measurements that occur too frequently, that is, as indicated by the tall bars relative to the smooth curve fits. Little can be done about these distributional anomalies however.

Since there is little reason to expect differences in the Plate 1,3,4 and Plate 2,5 groupings, and since little difference is shown between the individual plate distributions as well, the best estimate for this tank is probably the all plates combined case with worst case estimate 0.057-in. loss and 0.061-in bound. Recall these describe the expected worst case “measured loss” that reflects both actual wall thickness variability and measurement uncertainty. In addition recall that these losses should not be considered relative to the tank drawing nominal values, but rather relative to the estimated plate maximum values given in the table of Figure 6.1.

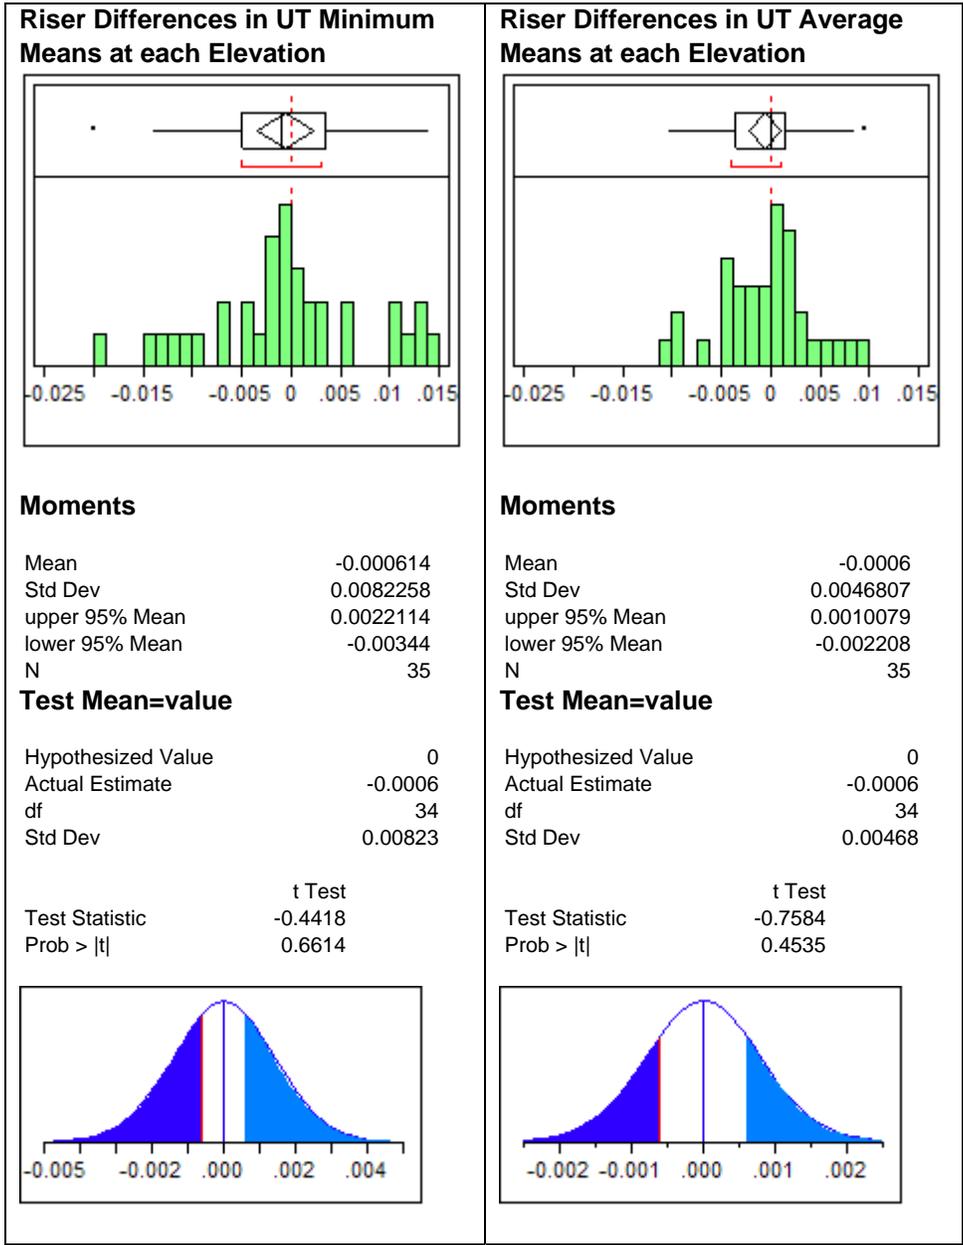
**Figure 6.6.** Riser Differences in UT Measured Wall Thickness

For both the UT minimum values and the UT average values no differences are indicated between risers on the average. Histograms centered at zero at the top of the figure indicate this. Note however the

greater variability in the riser differences in UT image minima than in UT image averages. Information below the histograms gives the t-test results for the differences. The blue shading in the bottom figures show how no statistical differences were observed. If statistically significant riser differences had been found, there would be very little blue area showing in those bottom figures (this will be observed in the next section on old versus new inspection results).

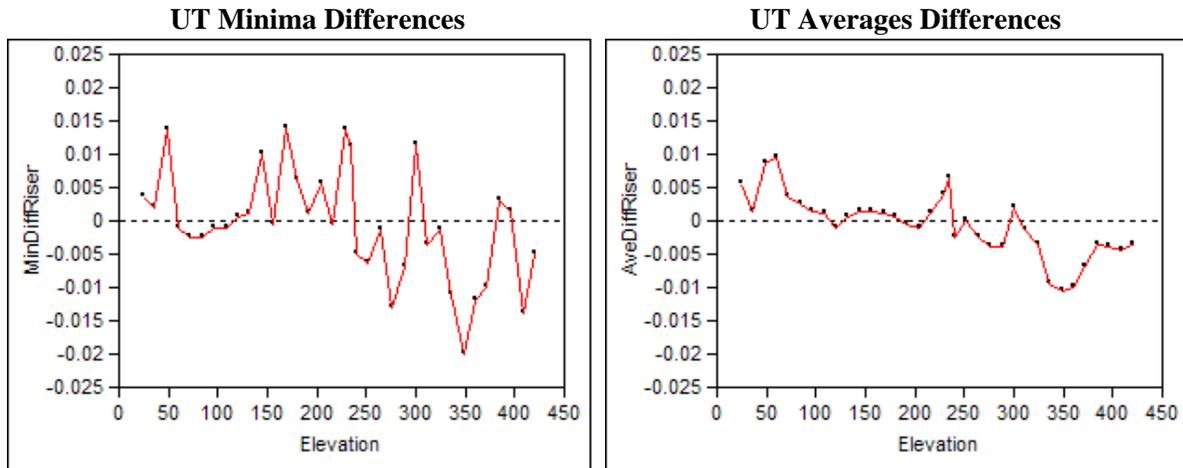
**Figure 6.7.** Riser 30 minus Riser 31 Differences

This riser difference result continues to suggest that UT inspections using single risers may prove sufficient. However, an interesting comparison is shown in Figure 6.7. Here the riser differences (Riser 30 minus Riser 31) are plotted by elevation. What is shown is that the measured Riser 30 wall thicknesses tended to exceed those of Riser 31 at the lower tank elevations while the opposite result held at the higher elevations. Thus on the average, as in Figure 6.6, no overall difference was indicated. No explanation for this pattern has been sought.

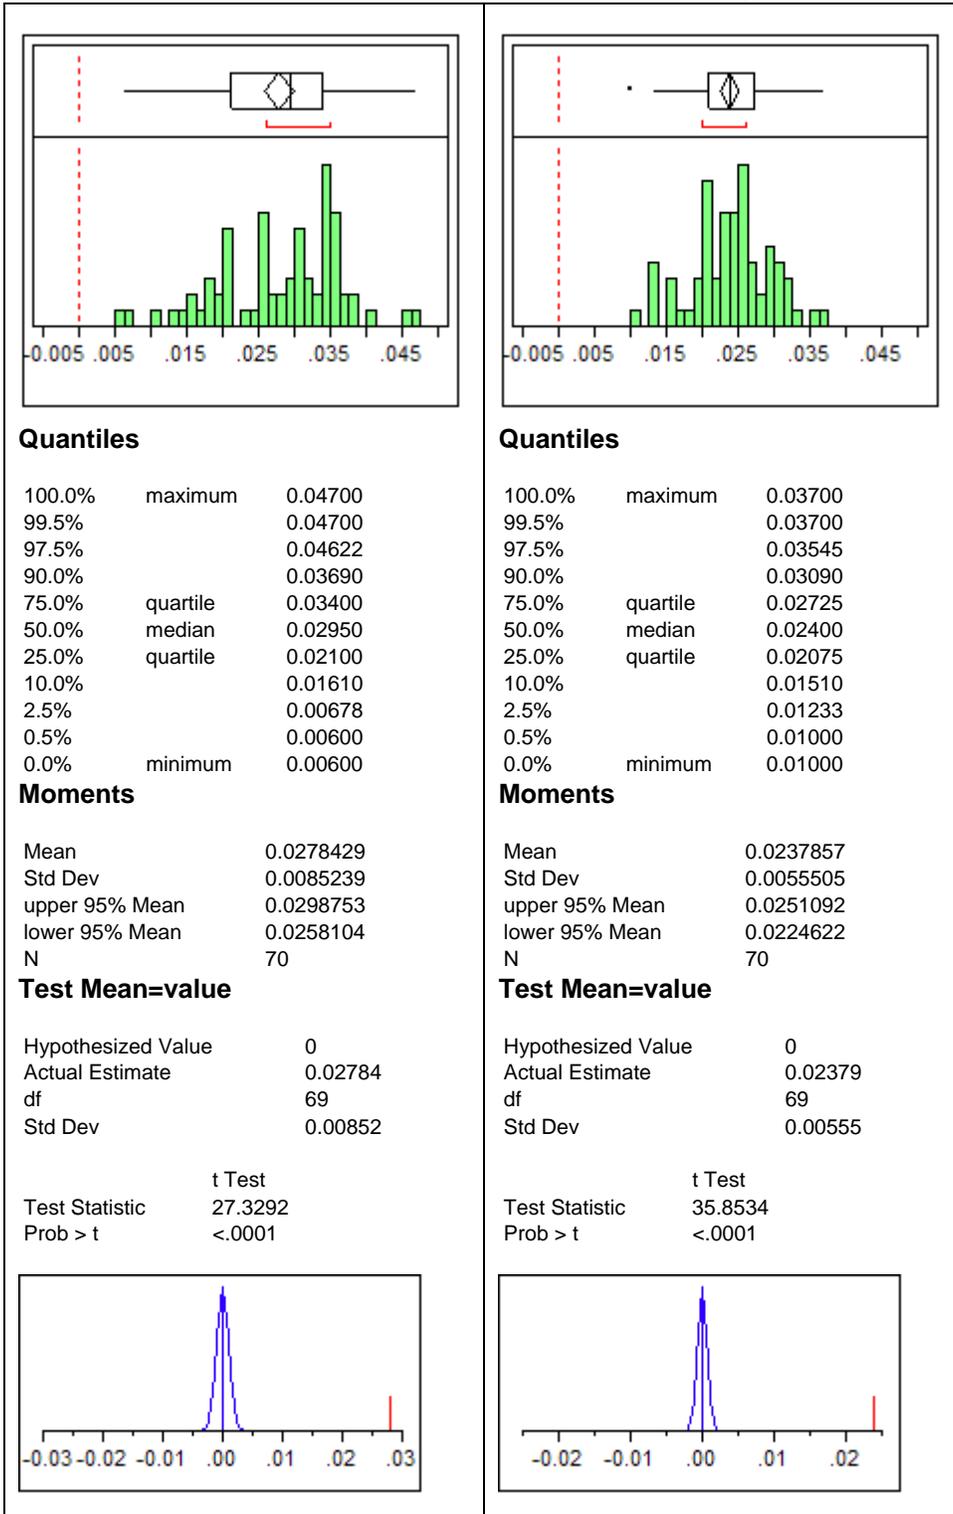
**Figure 6.8.** Year 2000 minus Year 2008 Differences

- 1) A very uniform corrosion rate over all tank wall surfaces that were inspected.

2) A systematic difference in the way measurements were generated in 2000 and in 2008.

Intuitively it would seem that such consistent differences make the second reason seem the more reasonable. Special studies of UT wall thickness measurement capability have been proposed that seek to identify the source of such systematic measurement error so that it can be better controlled. This will better support comparisons of today's measurements with those taken in the future so that these UT inspections can be used to make meaningful studies of wall thickness corrosion.
