FY 2003 VISUAL EXAMINATION OF IN-TANK AND TANK ANNULI AT 241-SY TANK FARM

Key Words: 241-SY-101, 241-SY-102, 241-SY-103, Annulus inspection, In-Tank Inspection

Abstract: This report documents the completion of the fy 2003 in-tank and annulus Video Inspections for the 241-SY tank farms. Representative photos of observed anomalies, water-streaks, corrosion deposits, pitting, and in-tank stains on the 241-SY-101, 241-SY-102, and 241-SY-103 in-tank and annulus primary walls have been included as appendices.

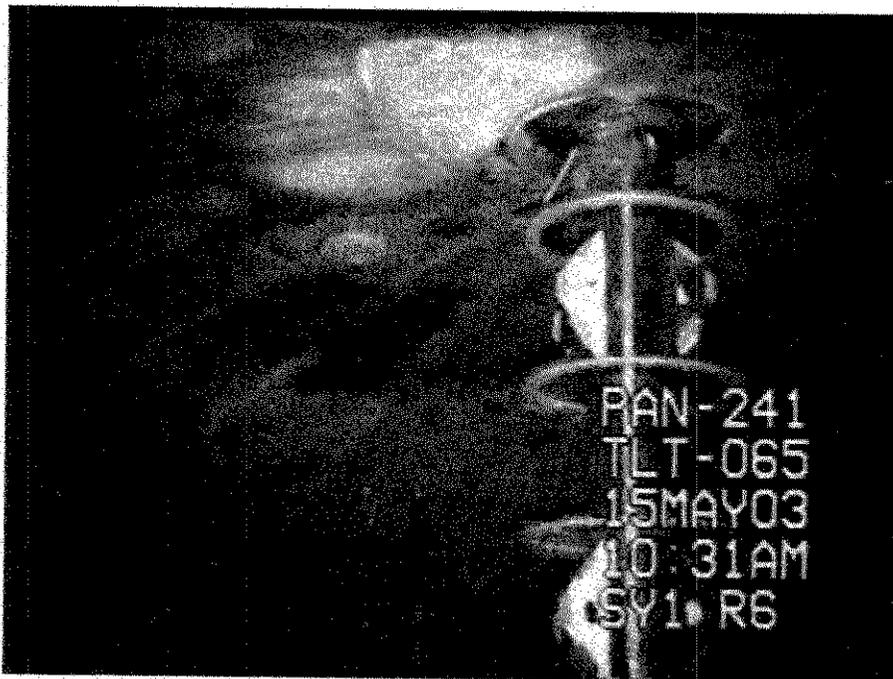
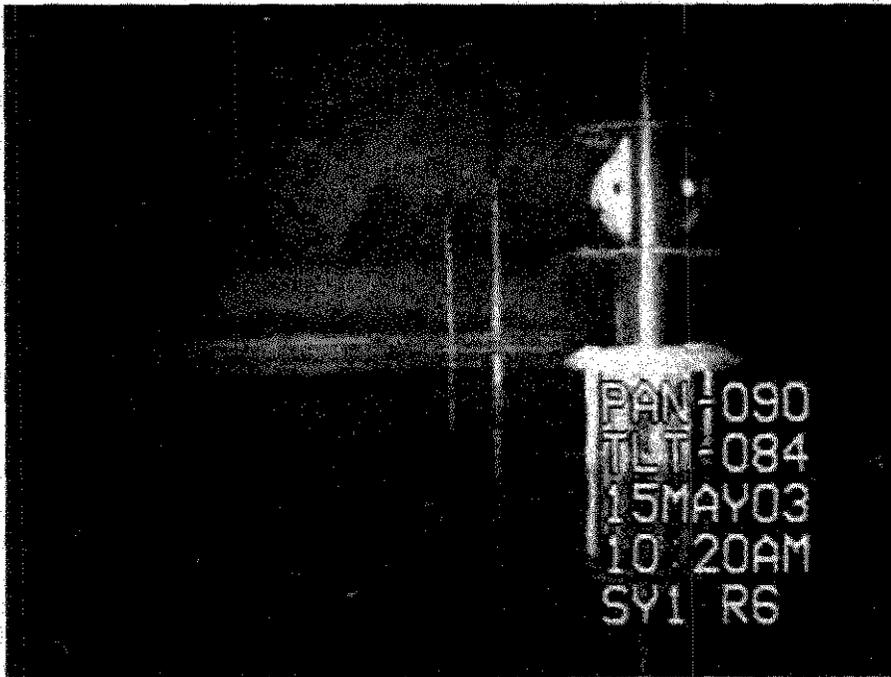
The in-tank video examination of 241-SY-101 performed through Riser 6 shows only light pitting on the interior dome with no evident cracks or leaks. Staining (Figures 13-16) is observed directly in the center of the dome beneath the Central Pump Pit and at one dome riser. No crust has formed on the waste. A thick white crystal waste ring has formed on the interior tank wall at waste level. The waste level is fairly high and covers the interior tank wall to the haunch. All older in-tank piping and instrumentation appears to be lightly corroded, with no significant cracking or pitting evident. White crystalline waste has accumulated on the mixer pump, clearly visible during the inspection, but there appears to be no signs of corrosion on the pump.

Figure 14 - SY-101 Riser 6, Primary Tank Interior, Stains at Central Pump Pit Riser (2003)

Figure 15 - SY-101 Riser 6, Primary Tank Interior, Dome Risers/Central Pump Pit Stains (2003)

Figure 16 - SY-101 Riser 6, Primary Tank Interior, Stain at Dome Riser (2003)

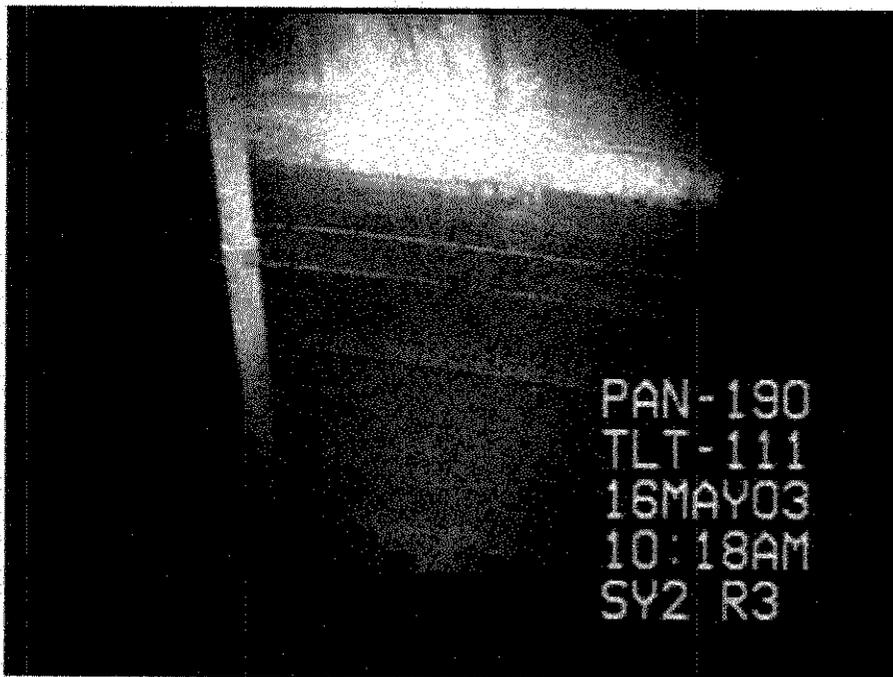
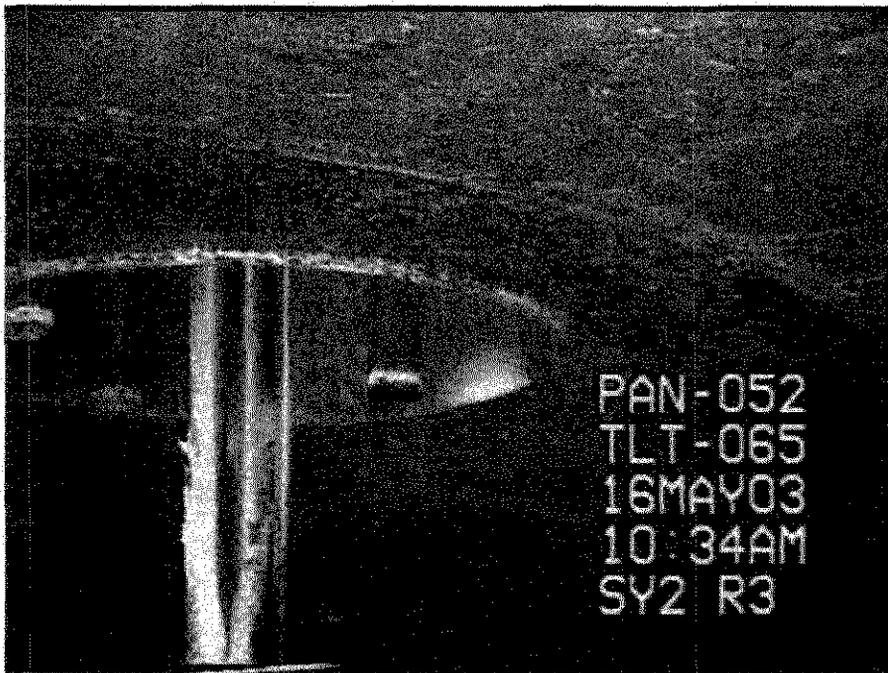
The in-tank video examination of 241-SY-102 performed through Riser 3 shows only light pitting on the interior dome with no evident cracks or leaks. Staining (Figures 81-88) is observed on the dome beneath the Central Pump Pit and at dome risers. No crust has formed on the waste. The waste level is fairly low, and waste rings formed on the interior tank wall are clearly visible. All older in-tank piping and instrumentation appears to be lightly corroded, with no significant cracking or pitting evident. Transfer pumping of the waste was in progress during the course of the video inspection.

Figure 81 - SY-102 Riser 3, Primary Tank Interior, Stain on Interior Wall at Riser (2003)

Figure 85 - SY-102 Riser 3, Primary Tank Interior, Stains at Central Pump Pit Risers (2003)

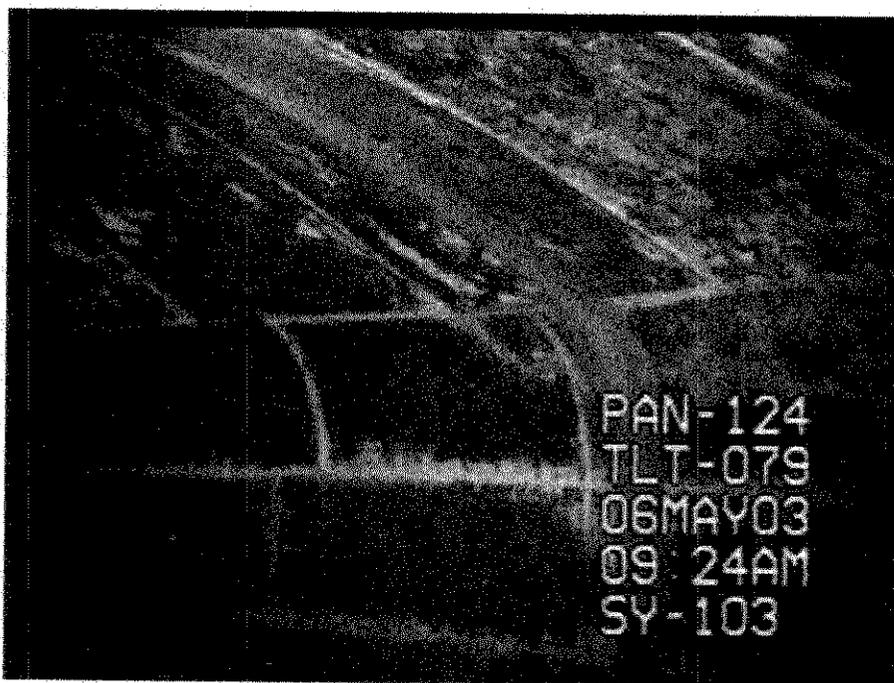
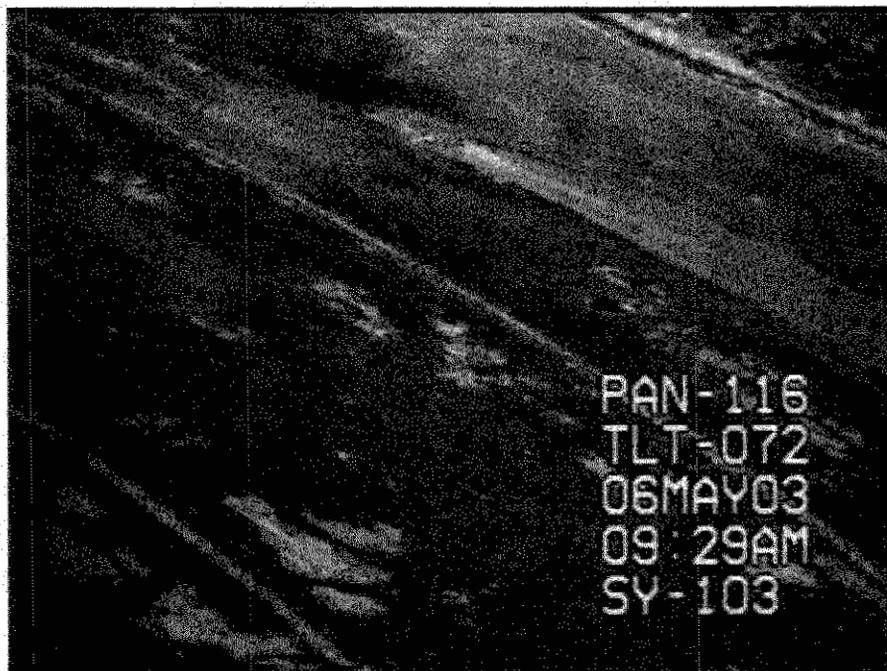
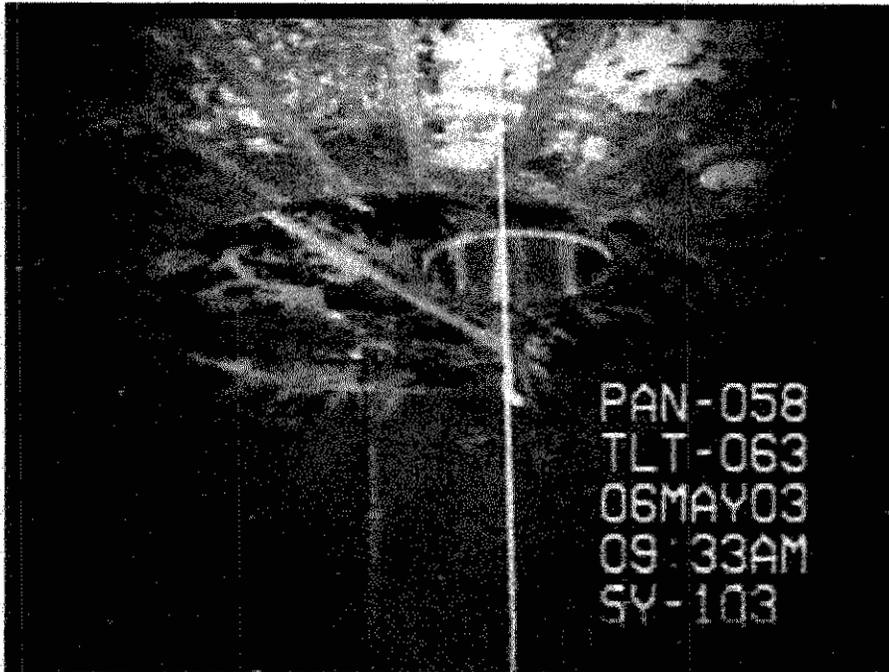
The in-tank video examination of 241-SY-103 performed through Riser 15 shows only light pitting on the interior dome with no evident cracks or leaks. Staining (Figures 157-158, 161-163) is observed directly in the center of the dome beneath the Central Pump Pit and at dome risers. A white rough crystalline crust has formed on the waste and a thick white crystalline ledge has formed around the perimeter of the tank at waste level. A white deposit has formed on the interior tank wall above the waste surface, signifying a previous waste level. All older in-tank piping and instrumentation appears to be lightly corroded, with no significant cracking or pitting evident.

Figure 158 - SY-103 Riser 15, Primary Tank Interior, Dome Welds/Stain on Wall (2003)

Figure 162 - SY-103 Riser 15, Primary Tank Interior, Stain at Dome Riser (2003)

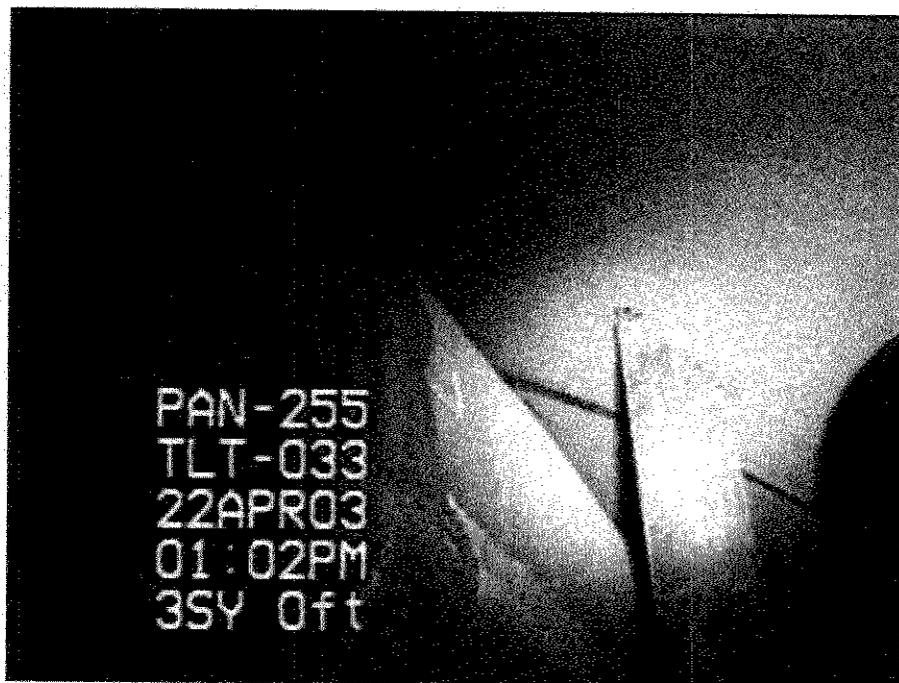
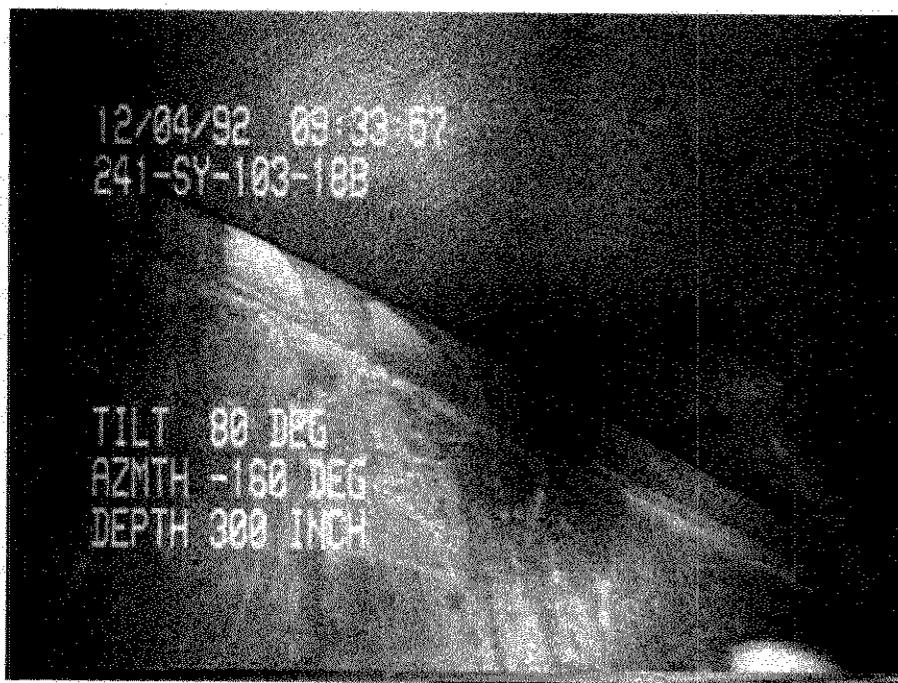
There is evidence of liquid draining down the primary and the secondary tank walls at Riser 43 (Figures 195-196, 199-200) and Riser 46 (Figures 211-214, 217-218, and 221-222). The liquid streaks originate at the top of the dome, flow down over the secondary and primary domes, and continue down the primary tank wall. These stains appear to have occurred before 1992, and are clearly evident on both the 1992 and 2003 videos. The stains appear dry and the "before" and "after" photos of Riser 46 show the surface condition of the primary and secondary tanks has not significantly changed.
