RPP-18399, Rev. 0

# Electrochemical Corrosion Studies, Core 308, Segments 14R1 and 14R2, Tank 241-AY-102

J. B. Duncan, ChemMet, Ltd. PC  
G. A. Cooke, CH2M HILL  
Richland, WA 99352  
U.S. Department of Energy Contract DE-AC27-99RL14047

Key Words: Tank 241-AY-102, Sludge, Corrosion Potential

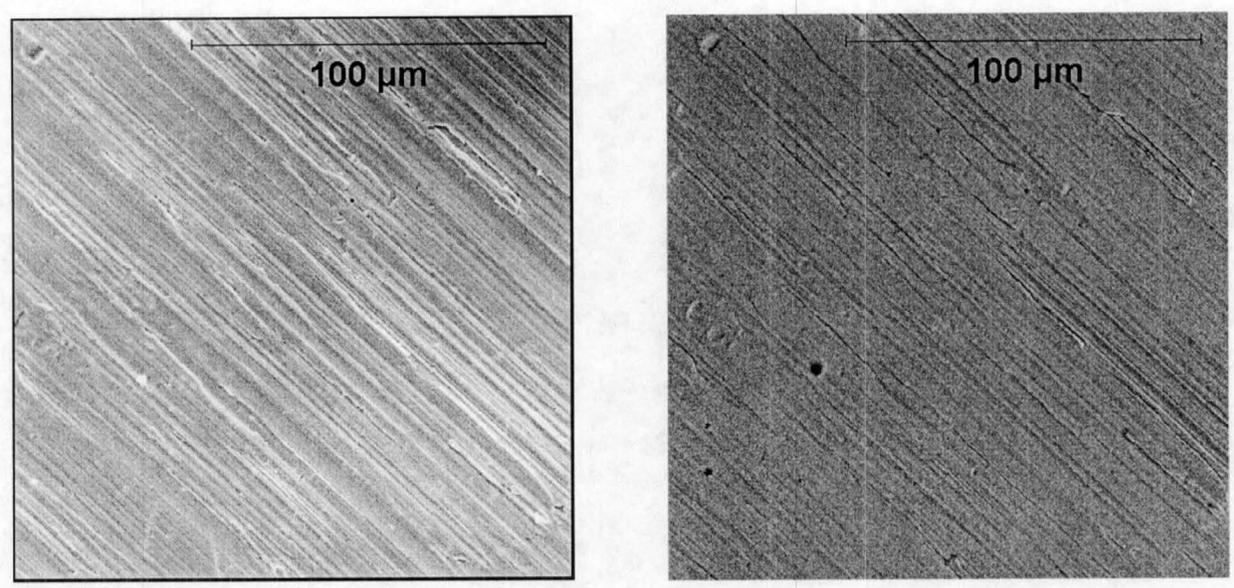
Figure B-3. SEI (left) and BEI (right) SEM images of Sample S03T001868 (Coupon 1M).

The SEM interrogation of Coupon S03T001868 did not indicate evidence of corrosion (Figure B-3).

Samples S03T001868 (Coupon 1M, mixed in air) and S03T001869 (Coupon 2MOH, mixed with tank 241-AY-102 supernatant), also showed little or no evidence for corrosion. No obvious patches of corrosion were observed visually, so the portion of the surface that was examined in the SEM was random. SEM examination of the entire length of these two coupons revealed no obvious corrosion (Figures B-3 and B-4)

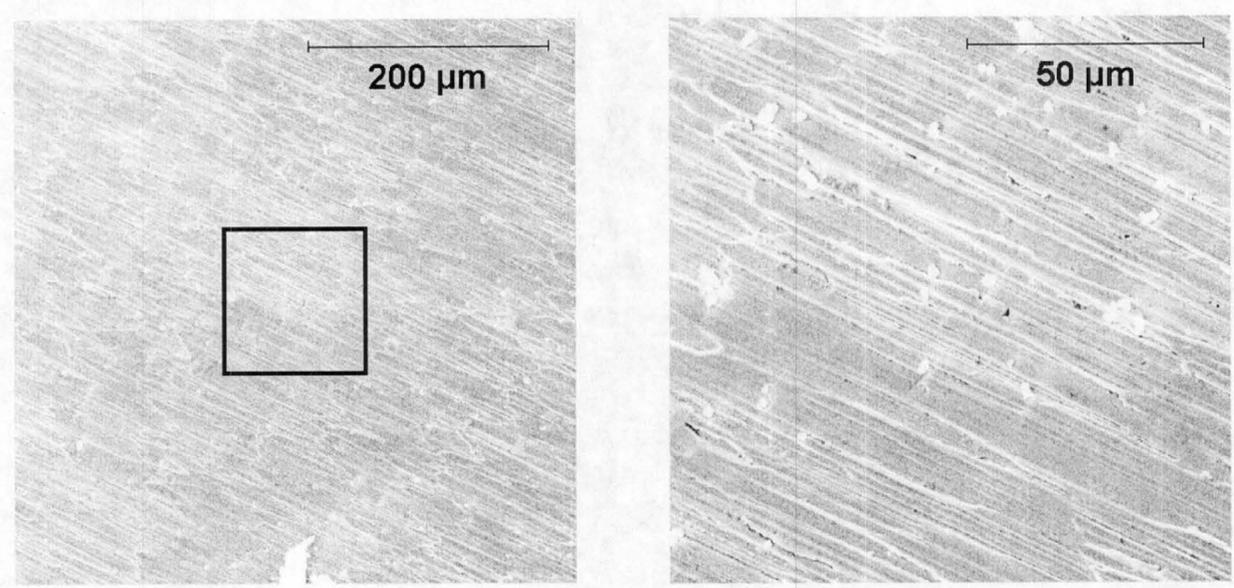
Figure B-4. Low Magnification SEI (left) SEM image of Sample S03T001869 (Coupon 2MOH). Area outlined in box is expanded in the SEI image to the right.

The SEM interrogation of Coupon S03T001869 did not indicate evidence of corrosion (Figure B-4).

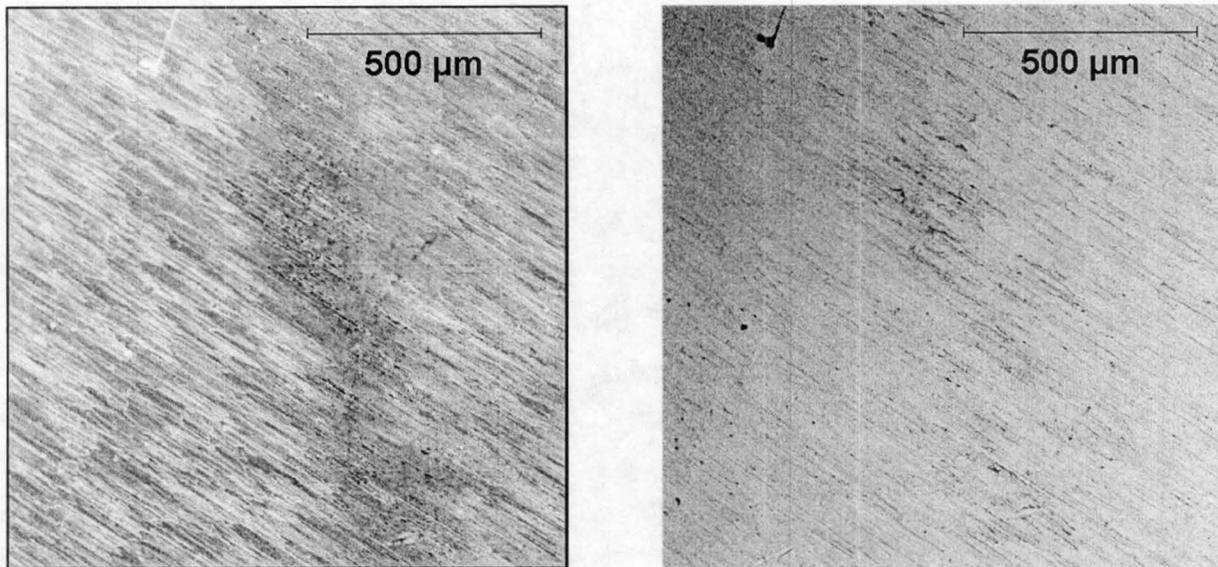
Figure B-5. SEI (left) and BEI (right) SEM images of Sample S03T001860 (Coupon 3B).

The coupon exhibited on small patch of yellow-orange corrosion (visual examination). As shown in Figure B-5, indicated a corroded region characterized by a “deeping” effect of low areas between the striations.

Sample coupon S03T001860 (Coupon 3B, room temperature scan) showed one small patch of yellow-orange corrosion during the visual examination. This was on the surface that was mounted for SEM examination. The SEM revealed no other patches along the length of the coupon and the patch that had been observed visually was difficult to discern using the SEM (Figure B-5). In this figure, a thin, irregular streak extending from the top to the bottom of the images. The normal surface striations seem to continue, for the most part, through the corrosion feature.

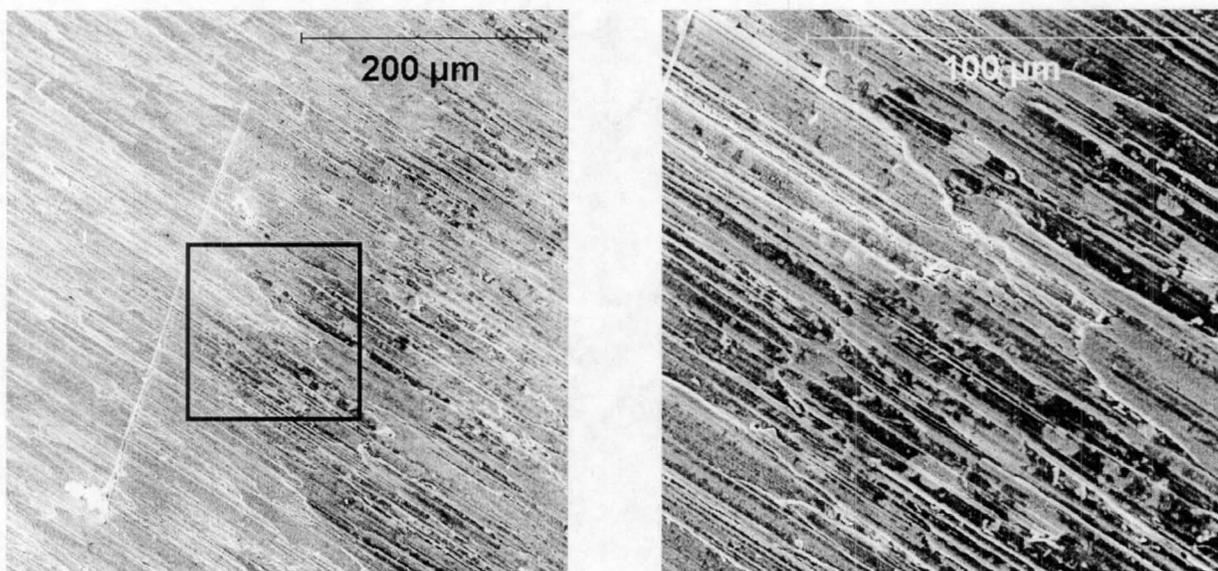
Figure B-6. Low Magnification SEI (left) SEM image of Sample S03T001860 (Coupon 3B). Area outlined in box is expanded in the SEI image to the right.

Higher magnification images from this patch show that this corroded region is characterized by a deepening of the low spots between the striations (Figure B-6). The gaps between the striations in the corroded region (right-hand portion of each image in Figure B-6) are also darker on the SEI images. This is probably due to an increase in surface roughness in these regions.

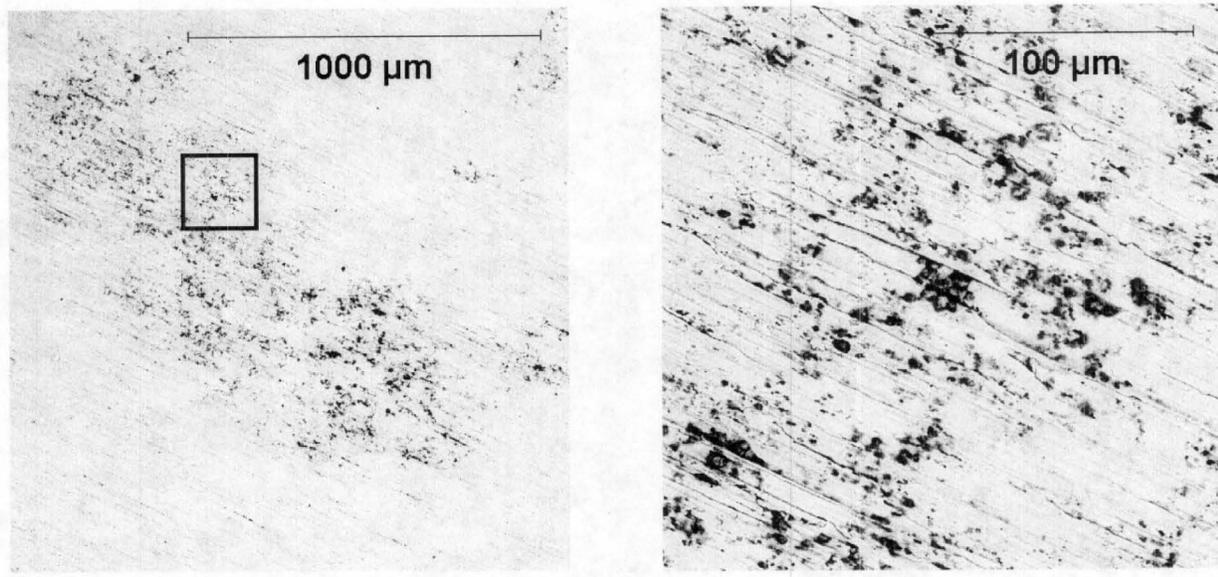
Figure B-7. Low Magnification BEI (left) SEM image of Sample S03T001727 (Coupon 2A). Area outlined in box is expanded in the BEI image to the right.

Figures B-7 indicates a single large patch of corrosion with obvious pitting occurring within the patch boundary.

Sample S03T001727 (Coupon 2A, chronoamperometry) showed a had single large patch in the surface examined on the SEM. The pitting in this patch was obvious, in part because they were partially filled with corrosion products (iron oxides and hydroxides) and they partially obliterated the surface striations.

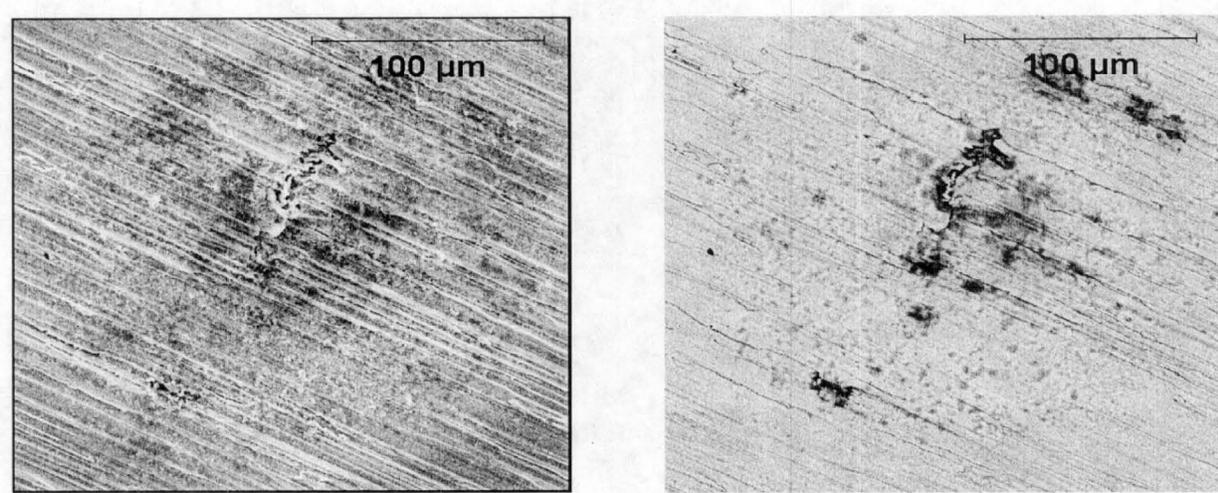
Figure B-8. SEI (left) and BEI (right) SEM images of Sample S03T001859 (Coupon 3A).

Sample coupon S03T001859 (Coupon 3A room temperature scan) was characterized by very small corroded regions that were barely visible as dark, rough patches. The side that was mounted up in the SEM had four of these patches. Two of these are shown in Figures B-8 and B-9. The first (Figure B-8) shows a larger area of “staining” with the striations continuing through the darker area in the SEI (left) image similar to Coupon 3B. However, it also shows a smaller region characterized by deep pits. The BEI (right) image in Figure B-7 shows that these pits are partially filled with corrosion product (iron oxides/hydroxides).

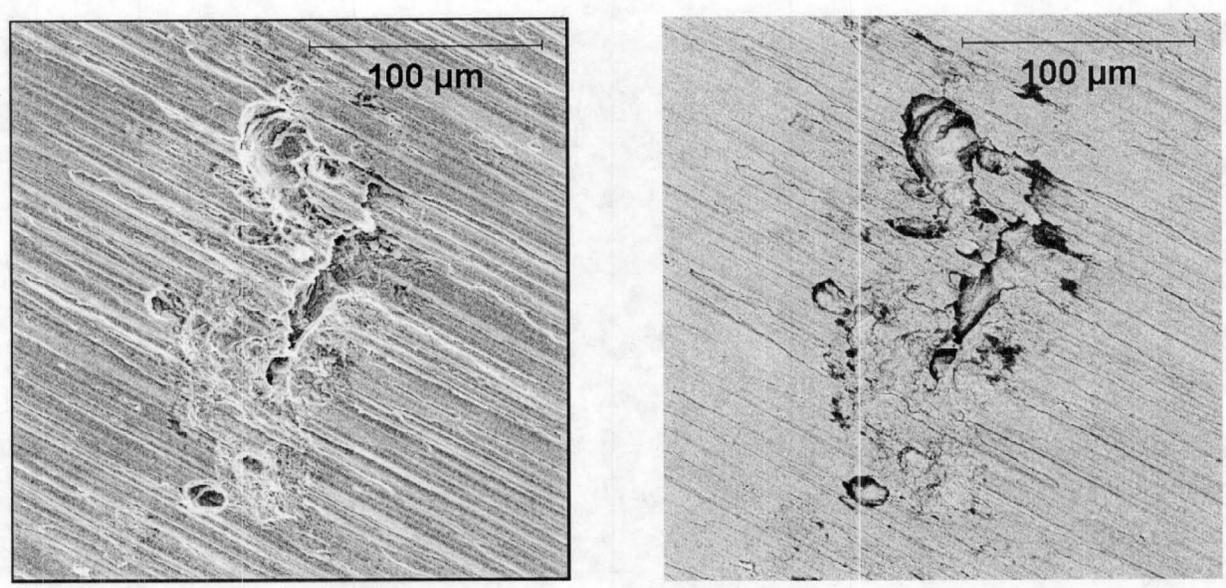
Figure B-9. SEI (left) and BEI (right) SEM images of Sample S03T001859 (Coupon 3A).

The other three pitted areas are similar to the one illustrated in Figure B-9, a small patch of deep, coalescing pits.

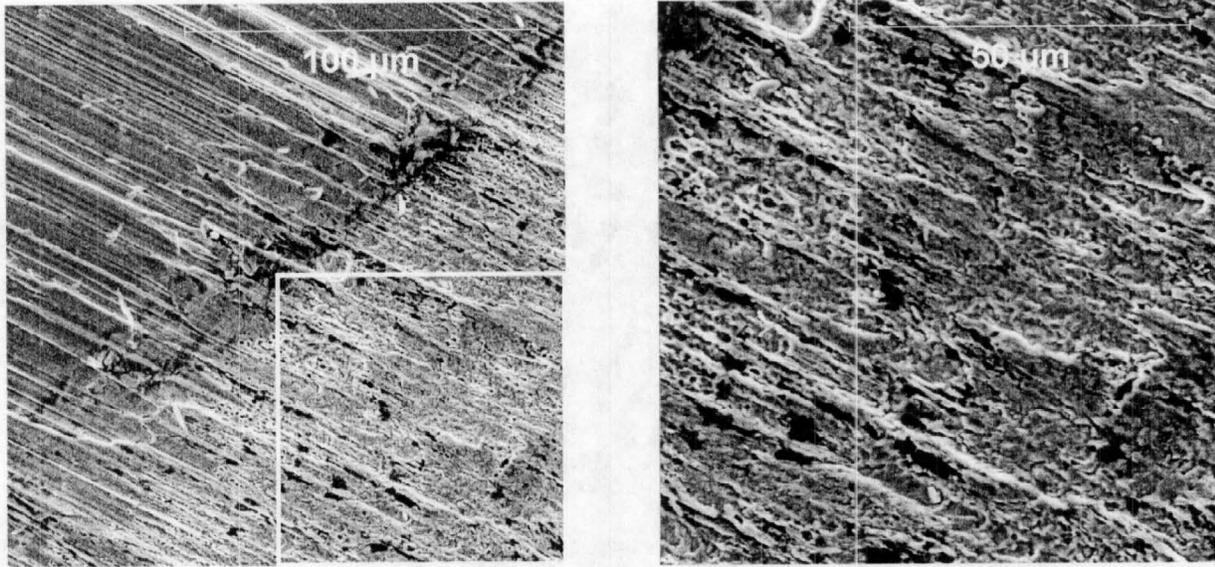
Figure B-10. Medium Magnification SEI (left) SEM image of Sample S03T001560 (Coupon 1B). Area outlined in box is expanded in the SEI image to the right.

Sample S03T001560 (Coupon 1B high temperature scan, segment 14R2) and Sample S03T001559 (Coupon 1A high temperature scan, segment 14R2) both showed several very large patches that were severely affected by corrosion. These patches were one or more millimeters across (greater than 1000 microns).

Figure B-10 shows the edge of one of these patches on sample S03T001560 (Coupon 1B). Here the surface striations are still visible, but they are etched below the depth of the original sample surface.

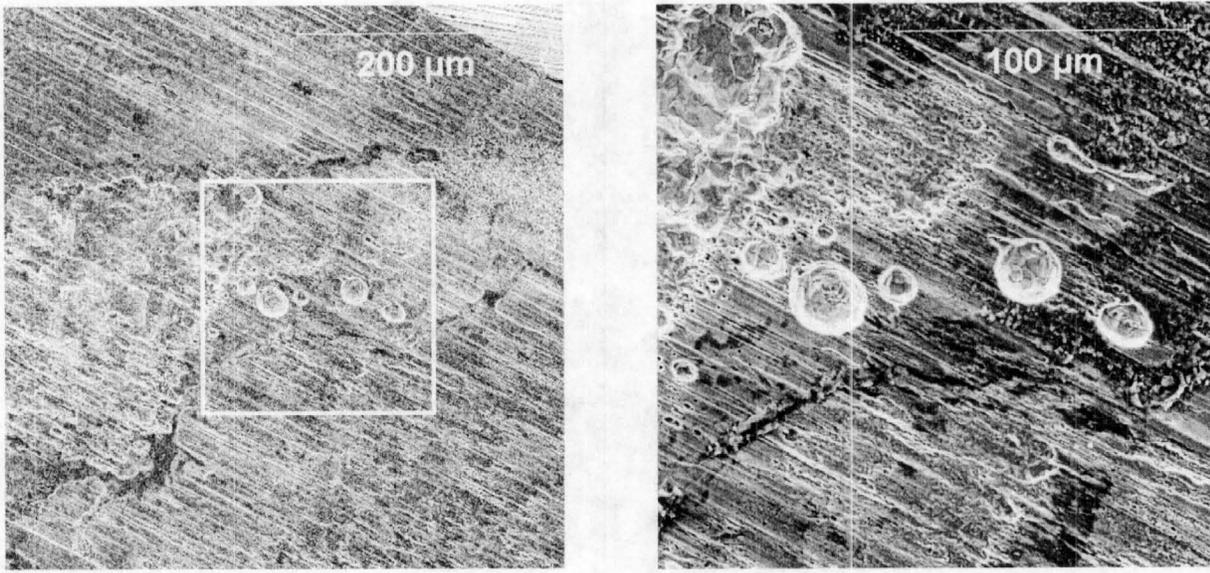
Figure B-11. Medium Magnification SEI (left) SEM image of Sample S03T001560 (Coupon 1B). Area outlined in box is expanded in the SEI image to the right.

In another portion of the same large patch, the etching and pitting has completely eaten away any evidence of the original surface features (Figure B-11).

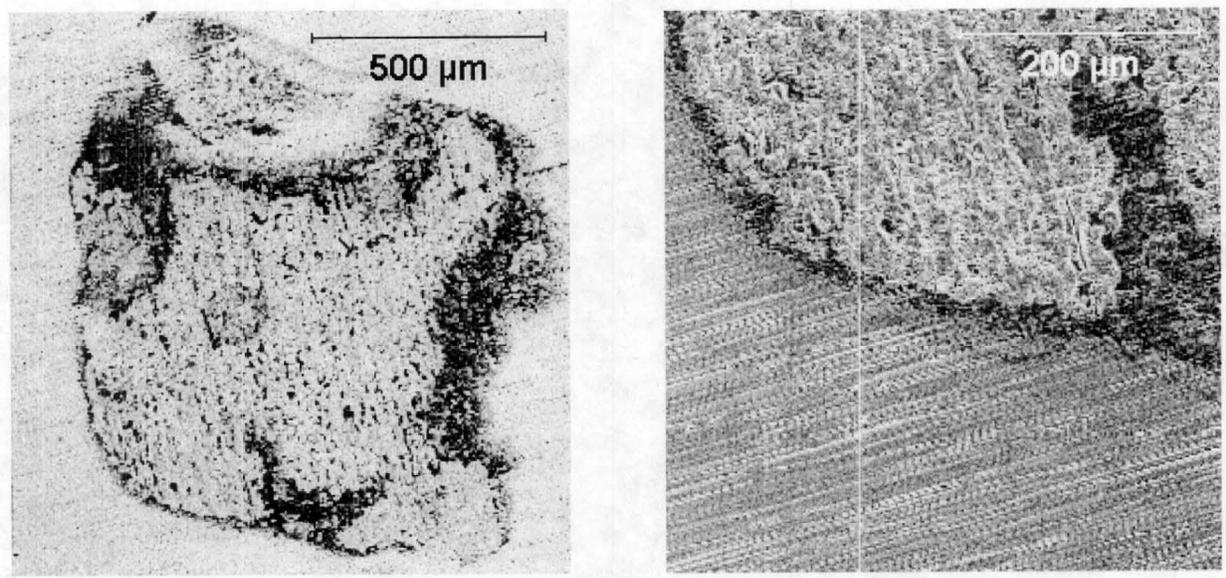
Figure B-12. BEI SEM images of sample S03T001559 (Coupon 1A). Right image is close up of lower left corner of left image.

Images of Coupon S03T001559 are shown in Appendix B, Figures B-12 through B-16. As noted in the narrative in Appendix B, this coupon showed several patches of corrosion up to several millimeters. Overall the pitting corrosion on this coupon was rather spectacular. The figures indicate pitting corrosion from shallow to more aggressive pitting that exposed individual metal grains (Figure B-16).

Sample S03T001559 (Coupon 1A) showed several patches of corrosion up to several millimeters in size. Figure B-12 is a BEI image of one of these, with a close-up of the lower left corner to

the right. The dark patches are corrosion that was not removed during cleaning. The pit is deeply etched into the coupon and no evidence of the surface striations remaining.

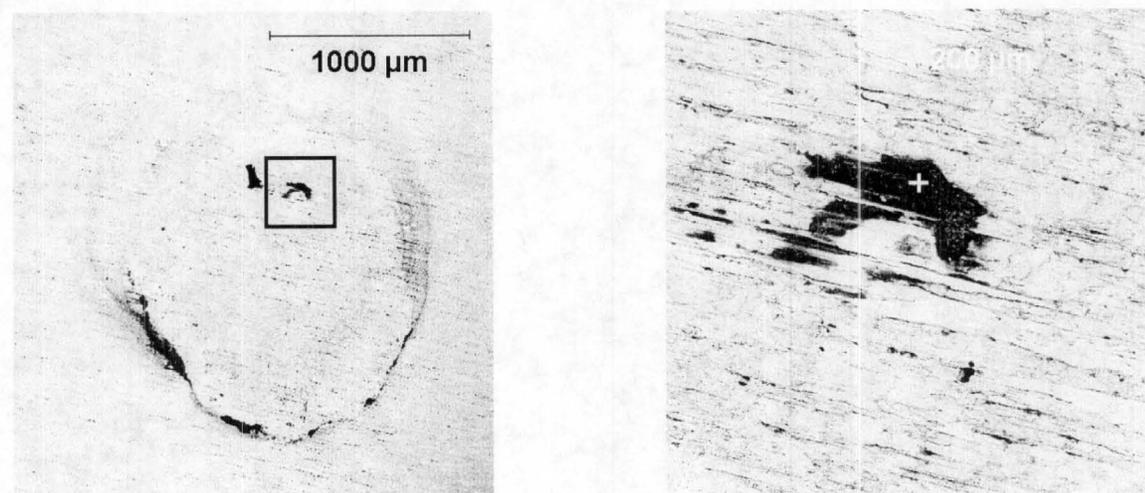
Figure B-13. BEI SEM images of sample S03T001559 (Coupon 1A), shallow pit.

Other patches of corrosion show a lesser degree of metal attack (Figure B-13). Here, the close up image at the right shows that the striations of the original surface still continue into the corroded patch.

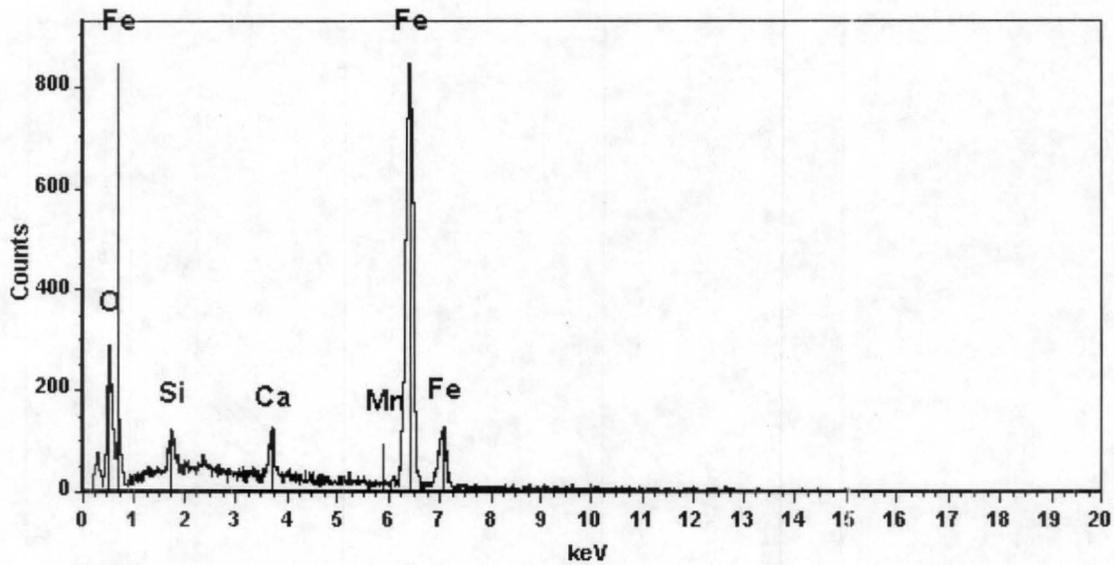
Figure B-14. EDS Spectrum of corrosion from sample S03T001559 (Coupon 1A), shallow pit.

Figure B-14 is an EDS spectrum of the patch of corrosion in the middle of the right image in Figure B-13 (marked with a cross). Note that the corrosion is primarily composed of iron and oxygen with lesser amounts of calcium and silicon.

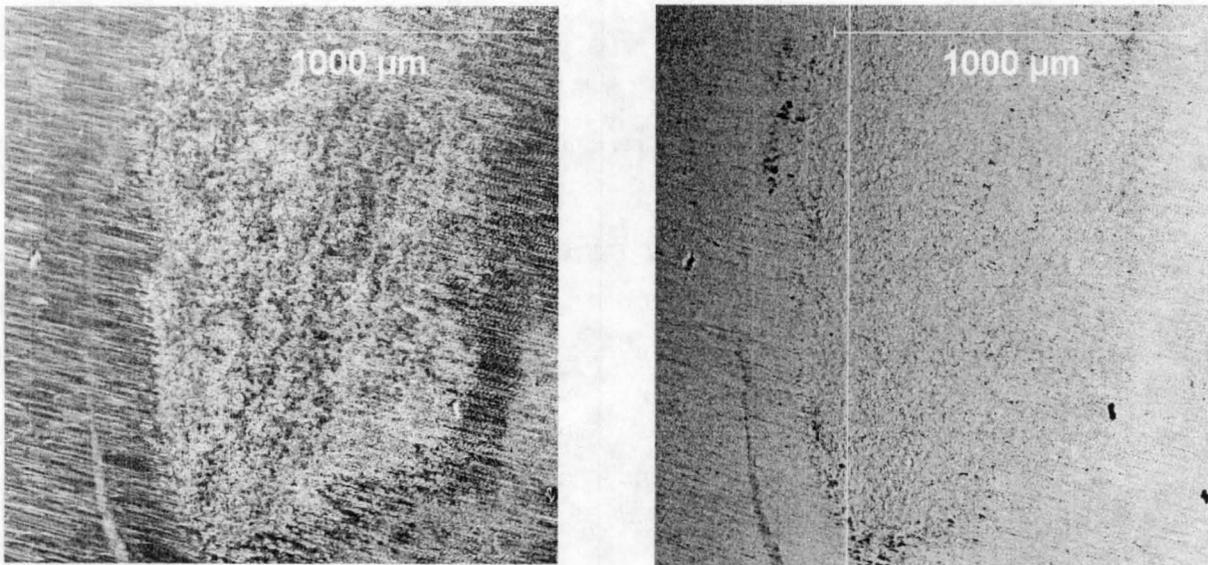
Figure B-15. SEI (left) and BEI (right) SEM images of sample S03T001559 (Coupon 1A), large patch.

Figure B-15 shows yet another patch on S03T001559 that is heavily corroded. This patch is about 1 millimeter wide and several millimeters long. It is less visible in BEI mode, since the corrosion has been largely cleared away.

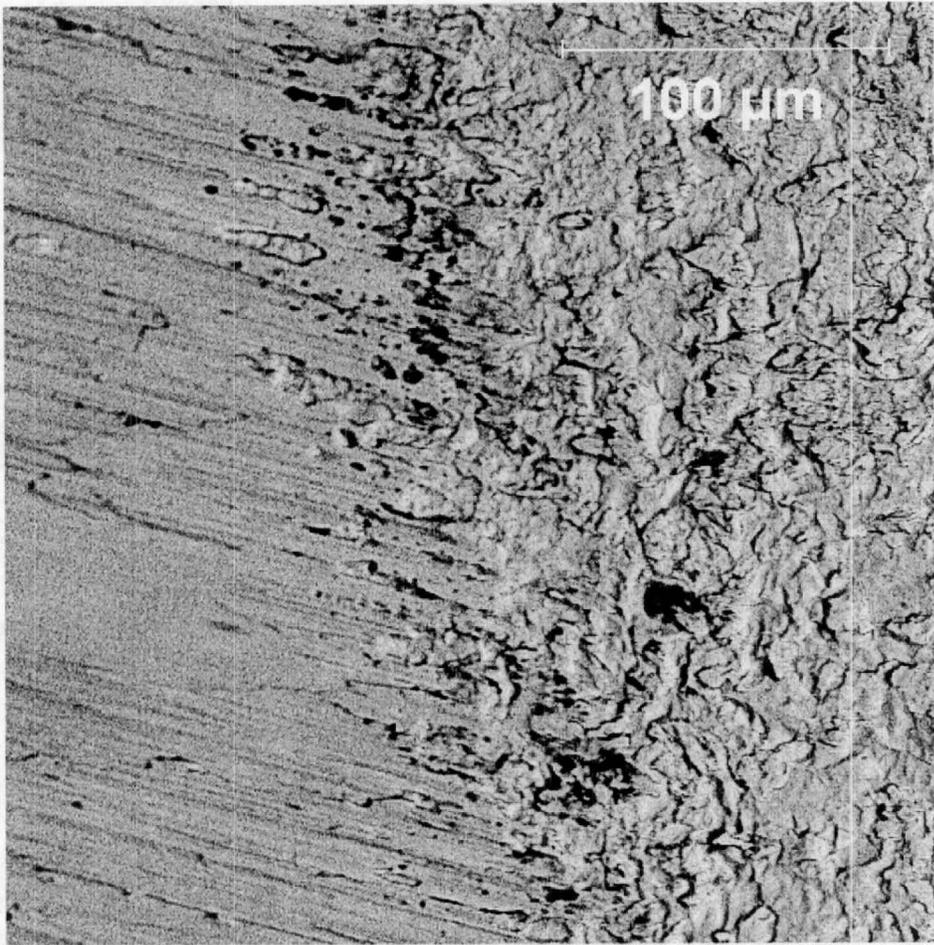
Figure B-16. BEI SEM image of boundary between uncorroded metal (left) and corroded metal (right) on Sample S03T001559 (Coupon 1A).

Note in the close up of this lower left portion of this patch (Figure B-16) that the corroded area is deeply etched. The etch pattern appears to outline individual metal grains. The metal crystal boundaries are apparently zones of weakness.
