# EVALUATION OF 3" SN-219 FAILURE AND S/SX TANK FARM SALTWELL PIPING

RPP-5825, Rev. 0

**TECHNICAL EVALUATION OF 3" SN-219 FAILURE AND S/SX  
TANK FARM SALTWELL PIPING**

**FEBRUARY 2000**

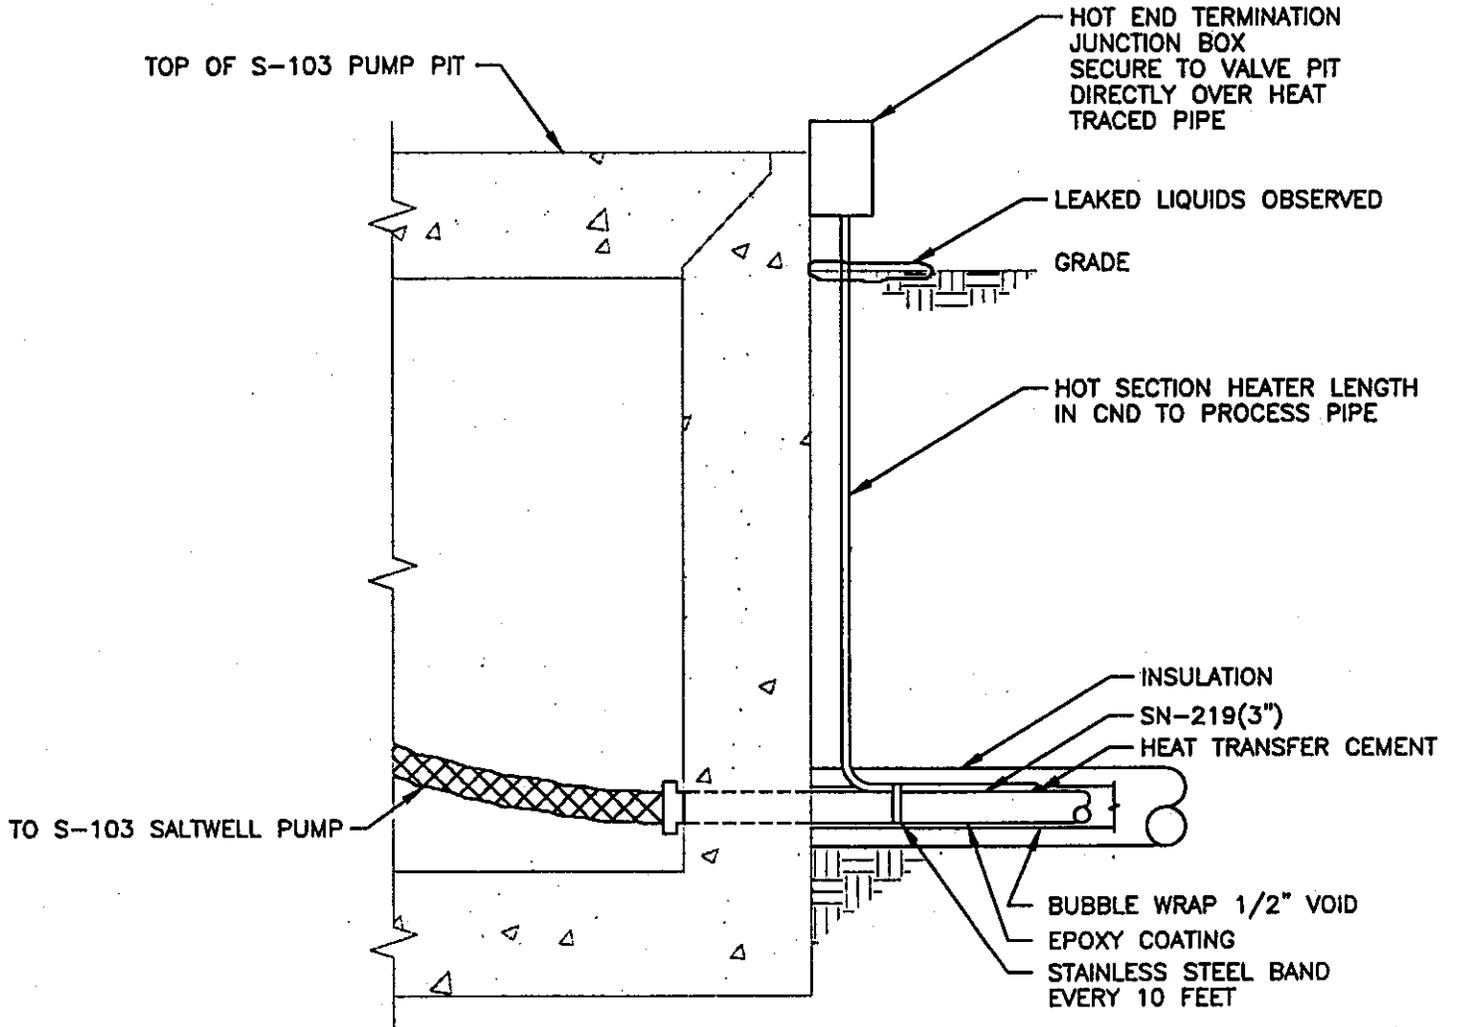
**FIGURE 2**  
**LEAK AREA PROFILE**

Saltwell system S-103 is pumped uphill directly to SY-102. The static head difference due to elevation between the two locations is approximately 8 psig. After complete corrosion through the heat trace conduit and final failure of the pipe under saltwell transfer pressure, the leakage from the transfer piping entered the annulus created by the bubble wrap and polyurethane foam insulation and followed the path of least resistance through the heat trace conduit. The required pressure to push the waste to SY-102 is approximately 8 psig, while the pressure to overcome the elevation between the transfer line and junction box (three feet) is approximately 2 psig. Once the waste entered the annulus between the pipe and insulation it entered the corroded heat trace conduit and finally the junction box at ground level. The junction boxes in S and SX farm are not

leak tight and the waste exited out through the junction box seams. Figure 2, Leak Area Profile is included to show an illustration of the heat trace installation and leak path.
