EVALUATION OF FAILED CRANE CHEMPUMPS USED DURING SALT WELL PUMPING

John J. Elsen

CH2M Hill Hanford Group

Abstract: Evaluation of failed Crane Chempumps used for saltwell pumping of single shell tank waste. Document is intended to capture recent failure mechanism associated with specific single shell tanks in S/SX, U, A and AX tank farms.

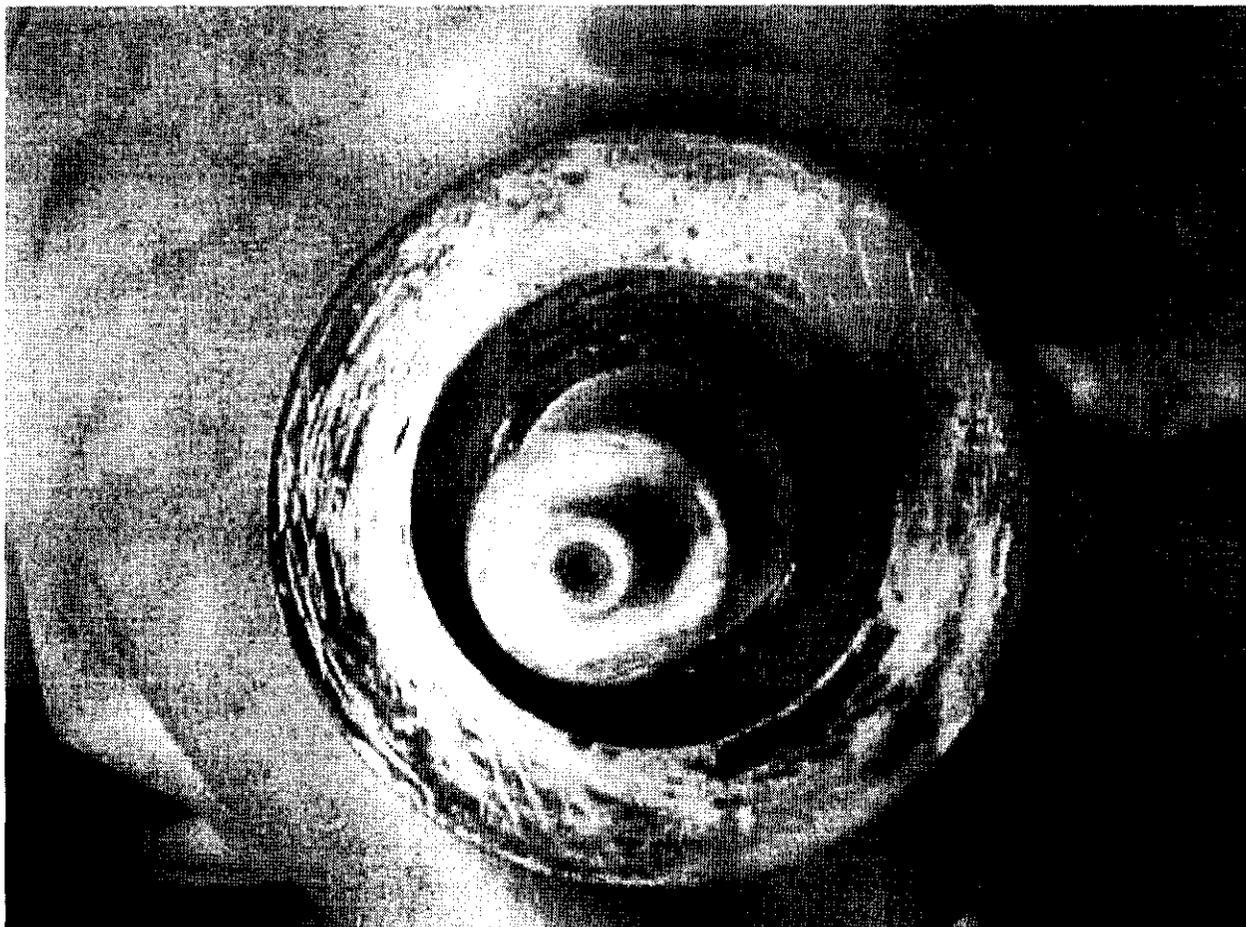
Figure 1 - Crane Chempump Front Rotor Model GB-3K

The first failed Crane Chempump model GB-3K used at A-101 was recently taken apart and analyzed in a glove bag. The results of the analysis showed that there was no pluggage of the impeller or pump casing due to temperature variations. Figure 1, shows evidence of excessive wear on the front face of the rotor assembly due to contact wear with the rear face of the front bearing. Figure 2, shows the unscarred front face of a new rotor assembly for comparison. Figures 3 and 4, show the interface between the front bearing and rotor of the failed pump and a new pump. According to the manufacturer, this excessive forward thrust was the result of cavitation or a restricted recirculation flow. Cavitation is not considered to be a contributing cause due to the closed loop nature of saltwell system and known operating parameters (suction pressure between 10 psig and 40 psig) during initial A-101 saltwell pumping campaign, refer to Appendix A, A-101 Saltwell System Operation.

Description: Photograph shows excessive forward thrust on the rotor assembly from the Crane Chempump model GB-3K used in tank A-101. Forward thrust caused the front face of the rotor can to rub against the rear face of the front ceramic bearing. The bearing acted as a cutting tool removing protective stainless steel metal from front of rotor assembly. Removal of stainless steel exposed the front cavity of the rotors aluminum bars and end caps to caustic tank waste. Fine scratch marks on the front face of the rotor can are the result of scrapping during waste sample collection. Photograph was taken of assembly while inside glove bag used to perform pump autopsy. The blackened residue on the front half of the rotor assembly indicates excessive heat generation and likely waste boiling and vaporization.

Following disassembly of the Crane Chempump model GB-3K on 8/11/00 and discussions with the pump manufacturer, it was revealed that extensive damage had occurred to the pumps rotor assembly. The damage to the rotor assembly was caused by excessive forward thrust and the inability of the automatic thrust balance to occur properly within the motor. The two possible causes of forward thrust are cavitation and restricted recirculation flow. Cavitation is not considered to be a credible cause due to positive suction pressure being maintained between 10 psi and 40 psi during pump operation. Restricted recirculation flow is the likely cause of the poor thrust balance. The cause of restricted recirculation flow is attributed to partial blockage of the recirculation passage by solid particles. Once the recirculation flow was restricted to below the required flow of 1 ½ to 2 gpm the thrust balancing is effected. One possible scenario based upon damage discovered during pump autopsy is that due to the low recirculation flow and extra heat caused by friction between the ceramic bearing and rotor. The process fluid passing through the pump internal recirculation passage was boiling and therefore adding vaporization to the already out of balance thrust condition. The results of the poor thrust balance are clearly seen in the attached figures, the actual cause may be indeterminate.

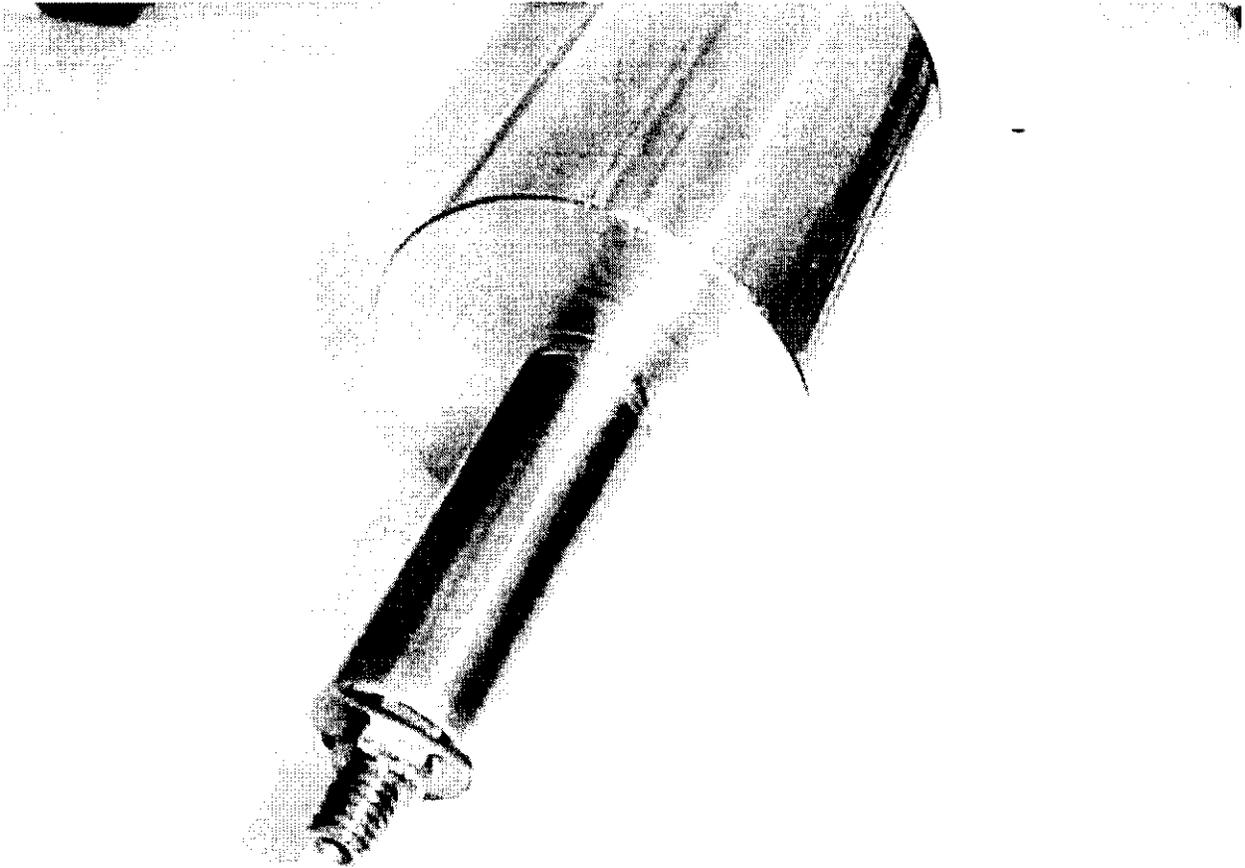
Figure 2 – New Rotor Assembly From Crane Chempump Model GA-1 ½ K

Description: Photograph shows a new rotor assembly taken from a Crane Chempump model GA-1 ½ K. Rotor assemblies for the model GA- 1 ½ K and the model GB-3K are similar in design. Note the front face of the rotor can and solid surface of stainless steel end plate.

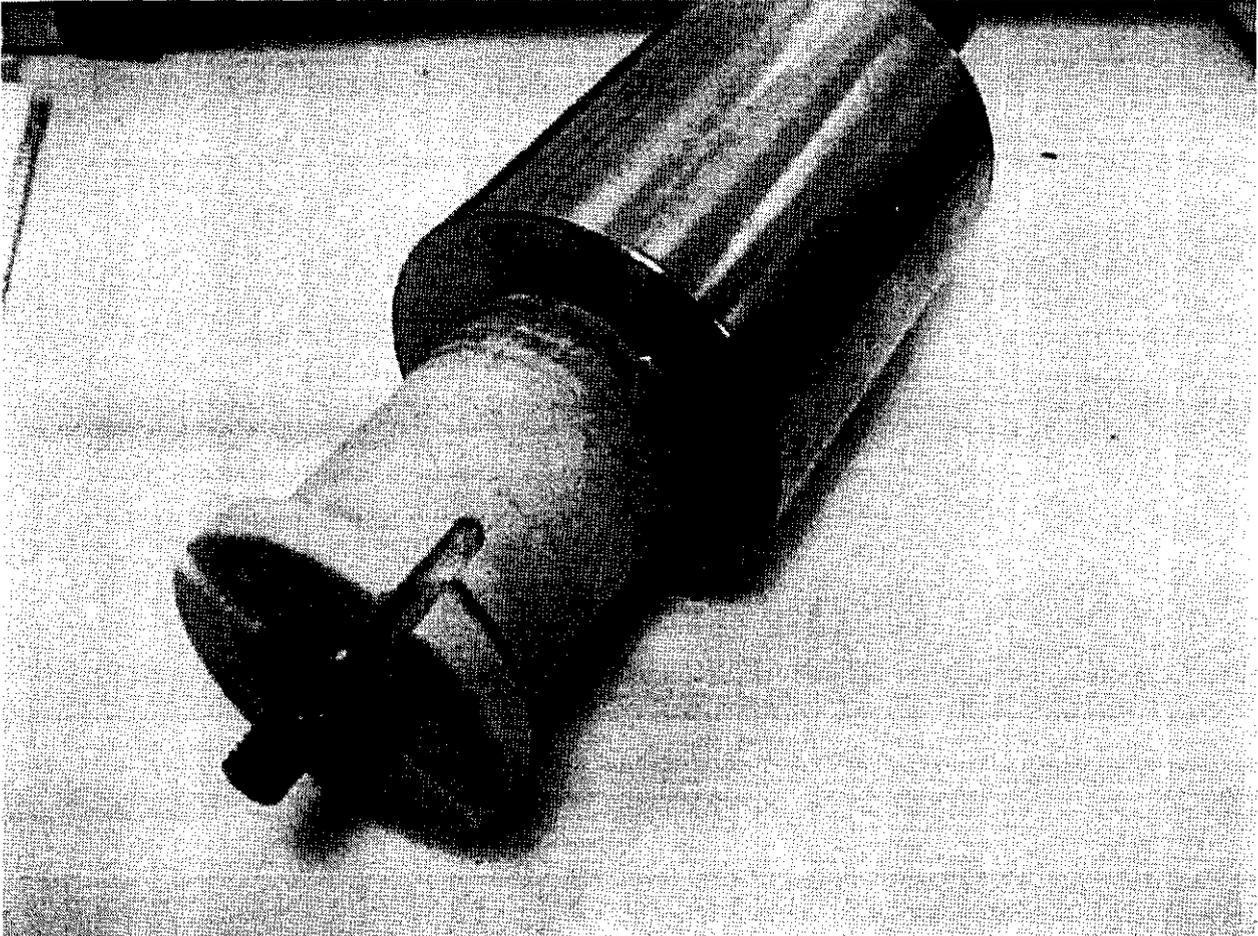
Figure 3 - Rotor/Bearing Interface

Description: Photograph shows the interface location of a new bearing and rotor assembly from a Crane Chempump model GA- 1 ½ K. The front bearing housing, which captures the front bearing is not shown for clarity. With proper thrust balance the rotor rides on a *thin wall of recirculation fluid*, which prevents bearing to rotor assembly contact.

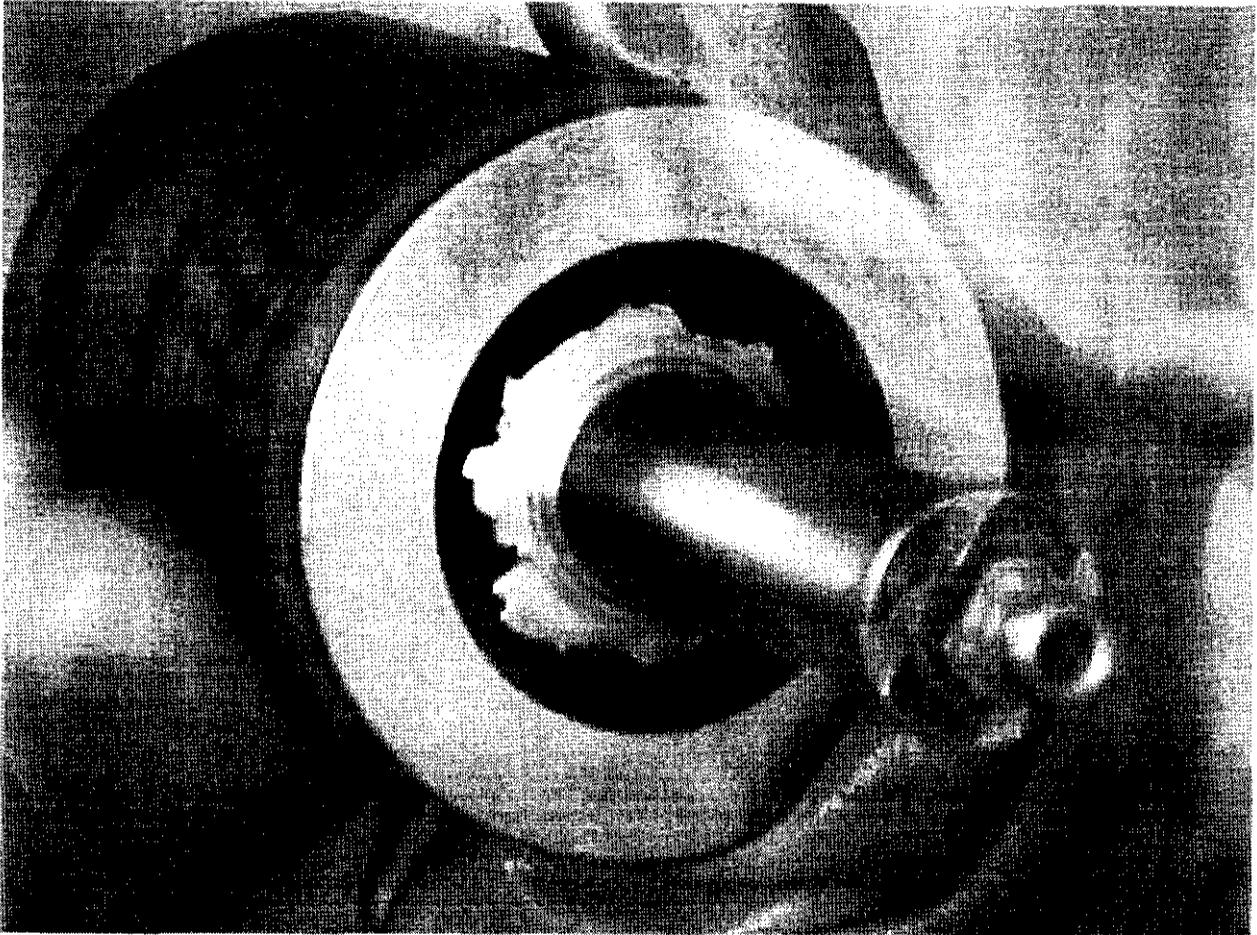
Figure 5 -- Crane Chempump Front Rotor Assembly GA-1 ½ K (U-102)

Description: Photograph of front face of rotor assembly of Crane Chempump GA-1 ½ K from U-102, shows wear caused by contact with rear face of front bearing. Pump operated for approximately 1400 hours. Front shaft shows signs of significant wear, reducing overall cross sectional diameter of shaft.

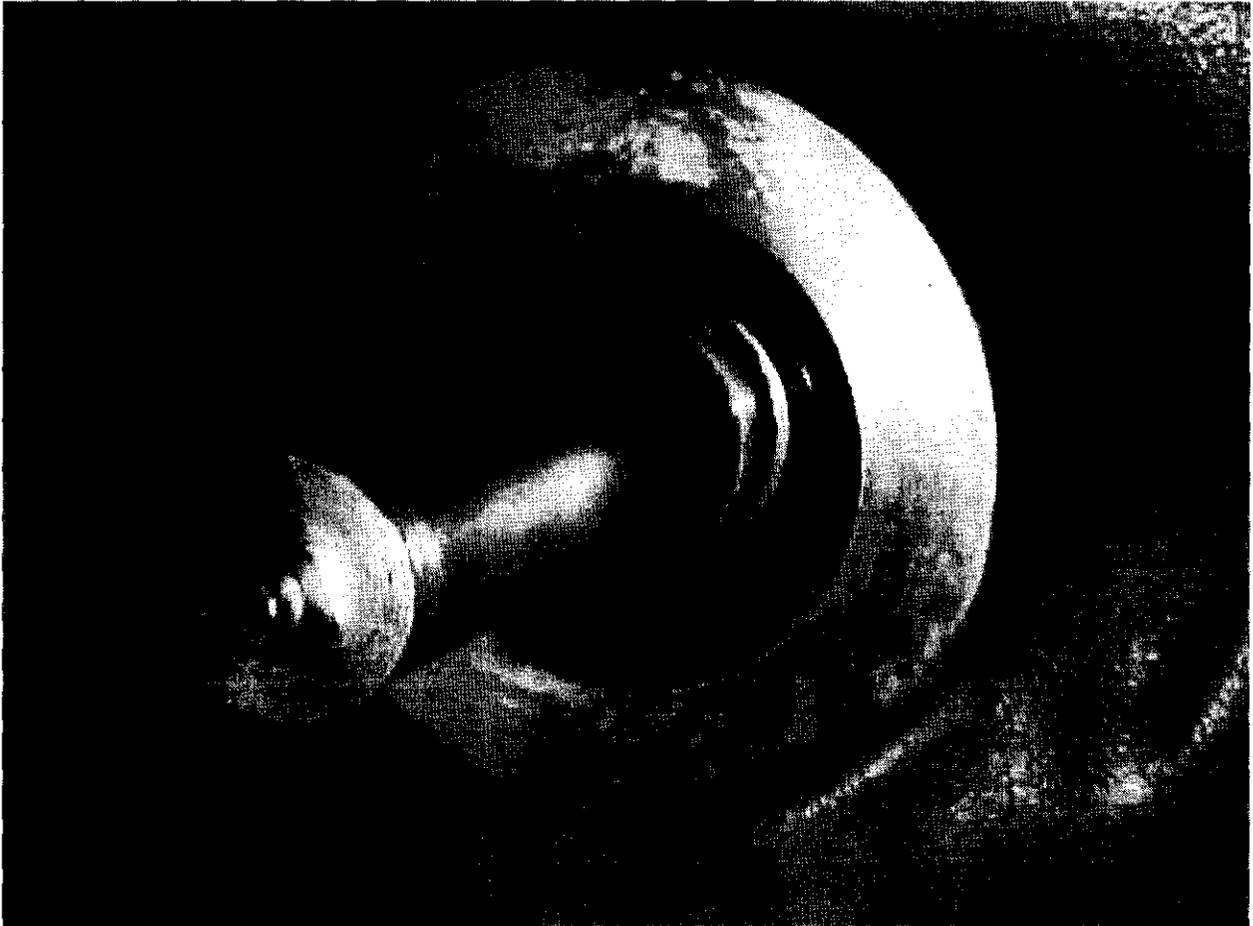
Figure 7 - Crane Chempump Front Rotor Assembly GA-1 ½ K (U-109)

Description: Photograph of front face of rotor assembly of Crane Chempump GA-1 ½ K from U-102, shows wear caused by contact with rear face of front bearing. Pump operated for approximately 1400 hours. Front and rear shafts shows signs of significant wear, reducing overall cross sectional diameter of shaft. Increased spacing between shaft and bearing sleeve results in an eccentric rotation pattern of the rotor assembly and impeller. Rear face of rotor can shows signs of wear caused by contact with front face of rear bearing. Complete rotor face wear away had note yet been caused. Note impeller nut thread section is sheared off.
