Document Number: WHC-SD-WM-ETP-119, REV. 0

Document Title: Engineering Task Plan and Status of 241-S-106 Enraf Level Gauge Wire Break

WHC-SD-WM-ETP-119

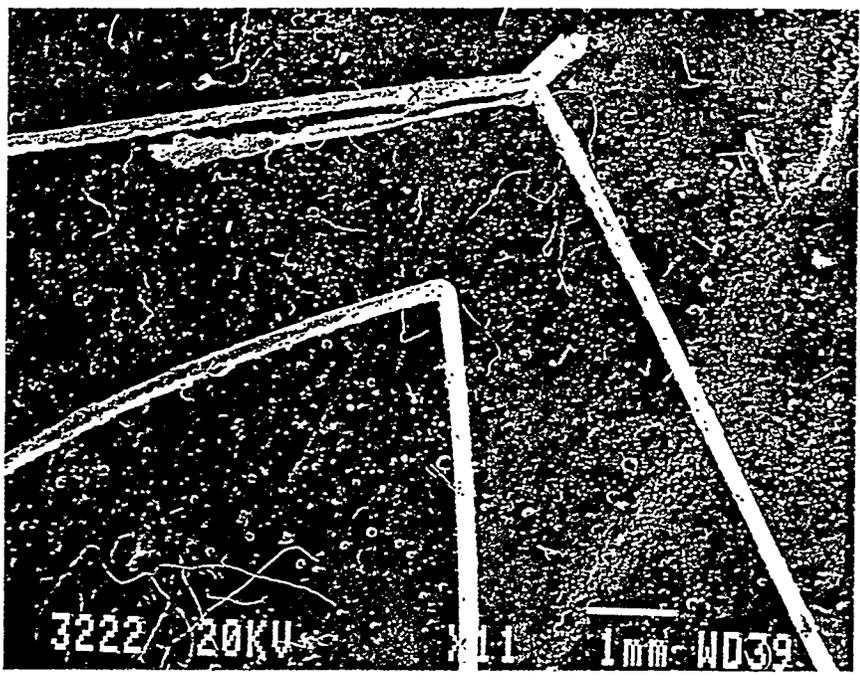
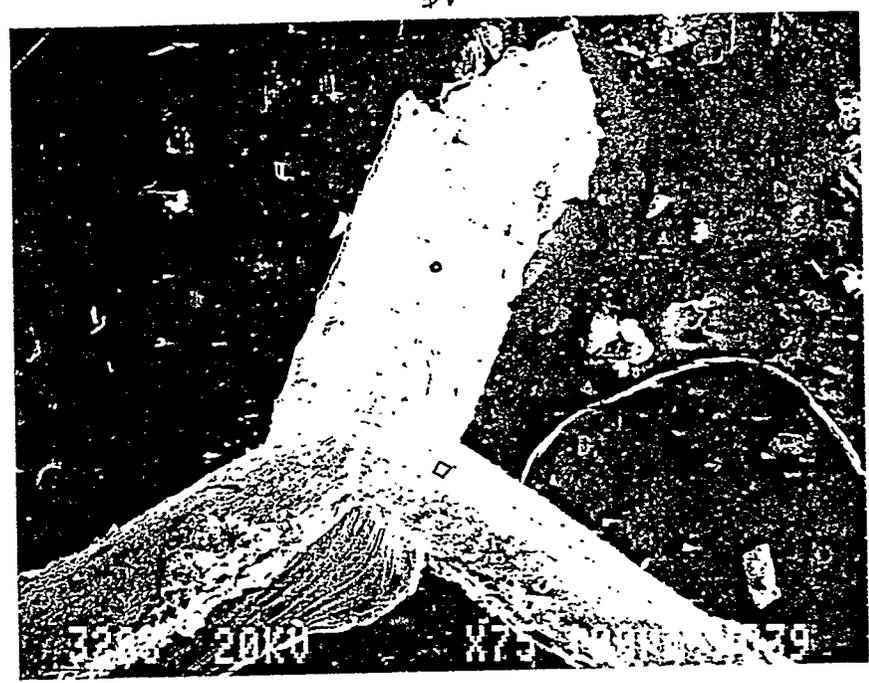
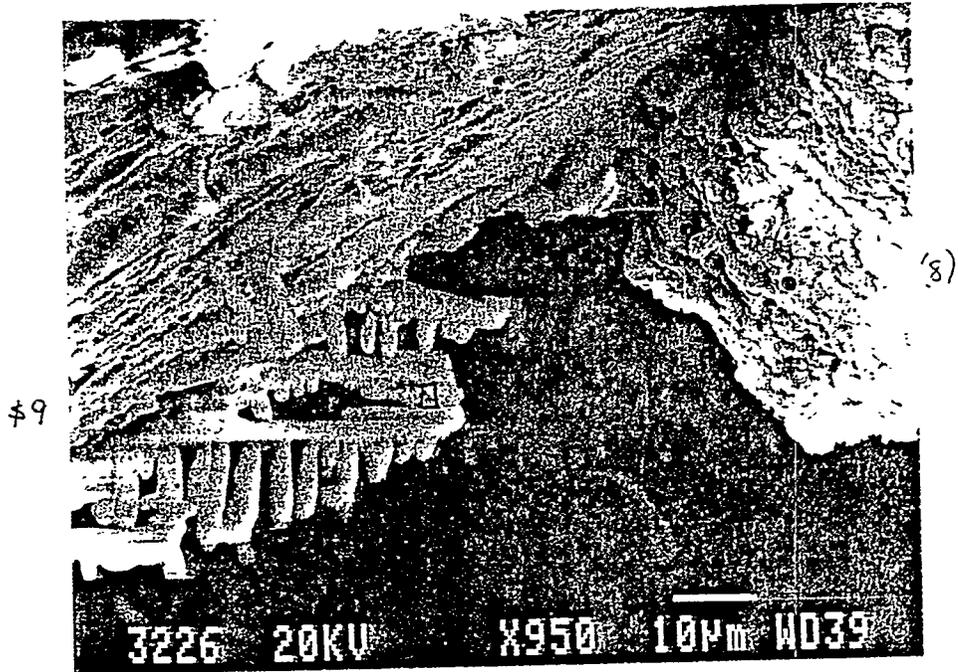
EDX ANALYSIS

5. Chemical Analysis of Wire Surface. The wire was analyzed for contaminants using X-Ray fluorescence. The corrosion product on the broken fragments was found to be very high in chlorine, in accordance with the SEM results. After this observation was made, the other samples (A,B, and C) were analyzed to determine the relative amounts of chlorine. Sample A (nearest the waste level) was found to have a relatively high amount; sample B a lower amount, and no chlorine was detected on sample C (nearest the drum). Additional analyses are underway to determine the actual compounds that are present.

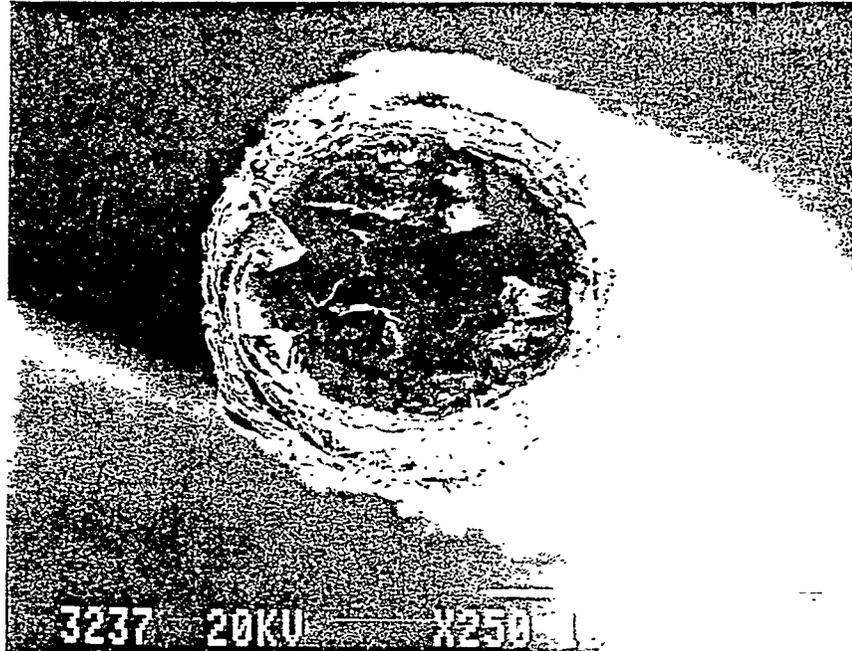
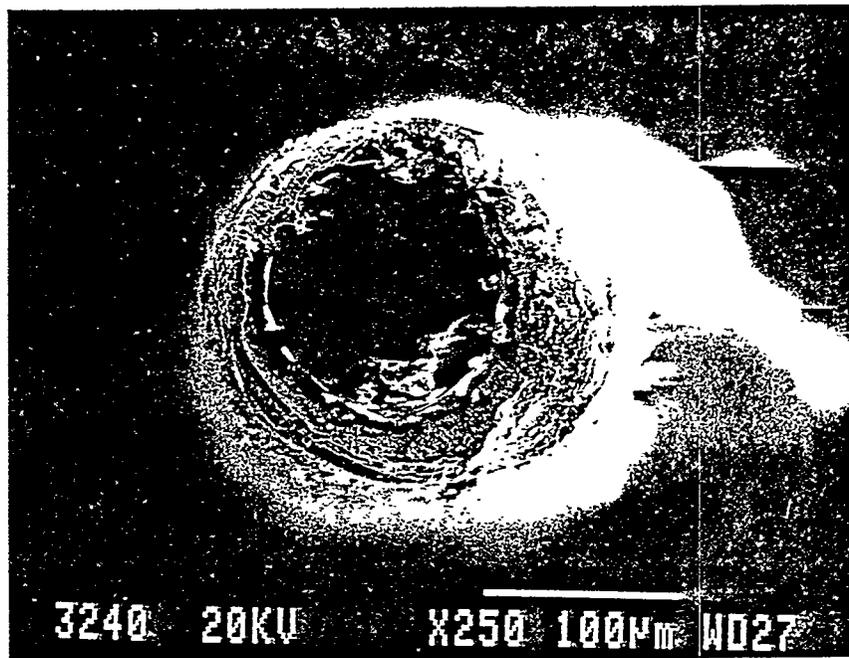
SEM MICROGRAPHS

4. Scanning Electron Microscope Examination. Two broken fragments were examined in the scanning electron microscope (SEM) to determine the morphology of the fractures and to evaluate the deposits or corrosion products that were present. A detailed description of the results cannot be presented here due to time constraints, but the results can be summarized as follows:

- a. The fragments failed in a brittle manner, without appreciable ductility. This indicates that failure did not occur due to a simple overload.
 - b. The fragments were covered with a relatively thick corrosion product. This corrosion product was determined to be very high in chlorine, and a smaller amount of sulfur was found to be present.

- c. Examination of the ends of the broken wire fragments showed that the wire was hollow; most of the inside had apparently been corroded away in the embrittled regions. To verify that this was not due to corrosion following a brittle failure, a section was bent until it broke, and the fresh surface was examined. It was also found to be hollow.

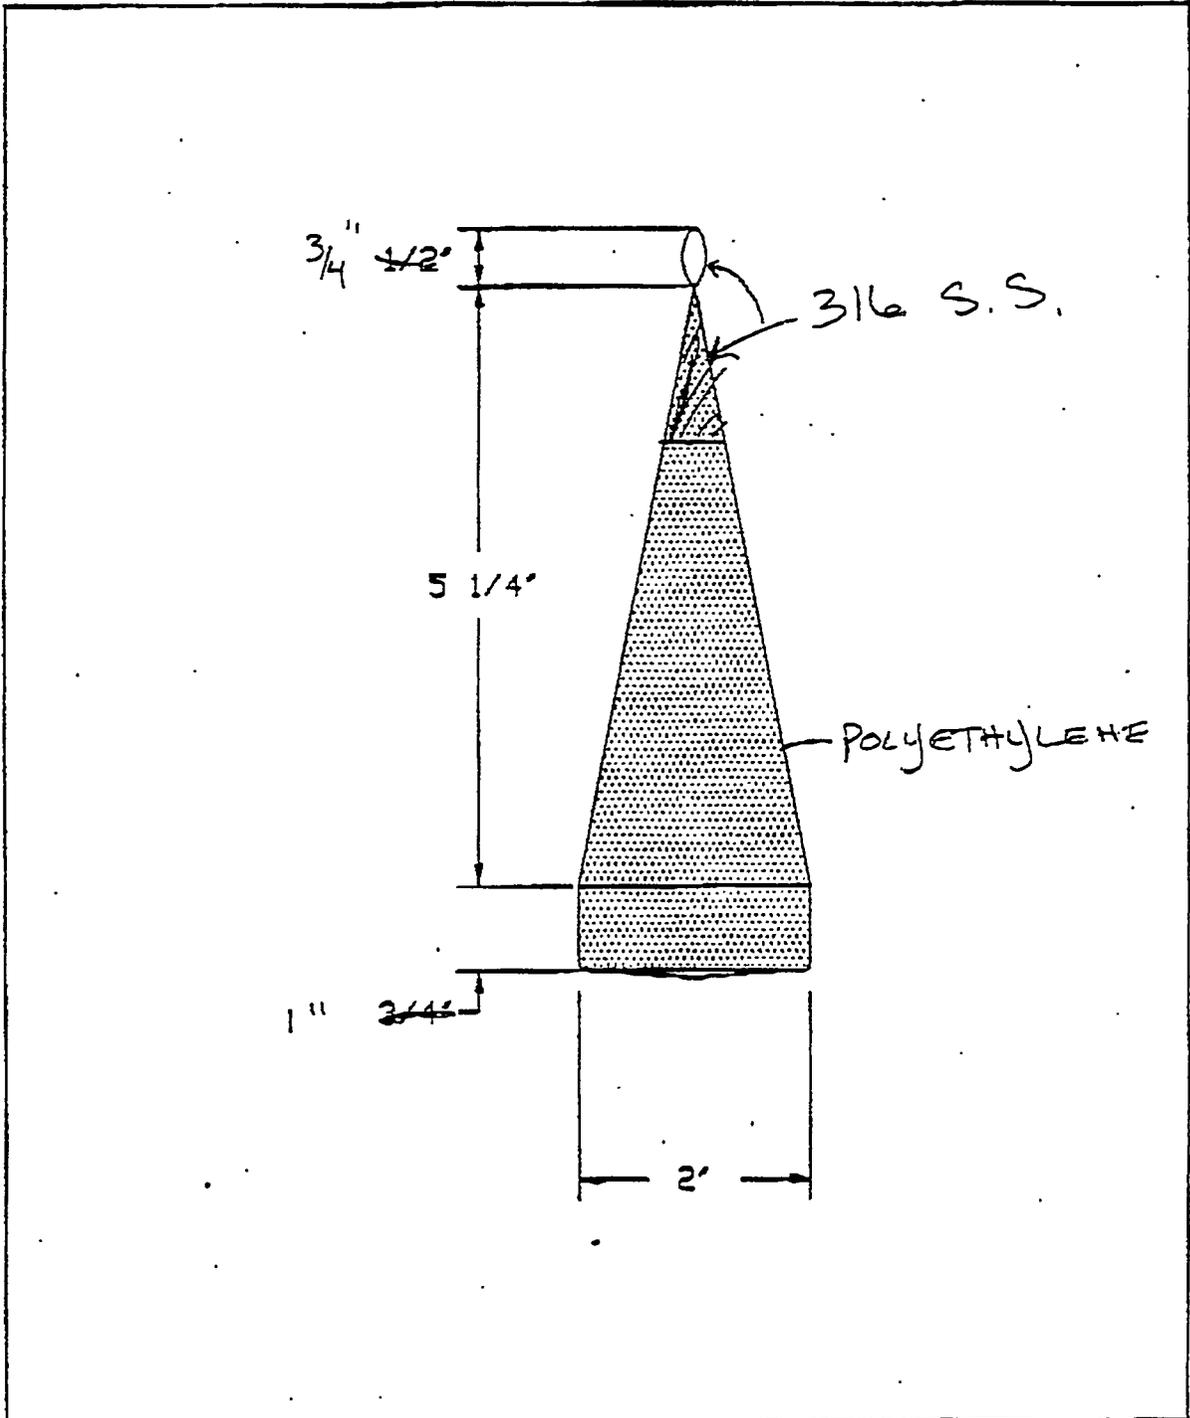
Figure 1 - LEVEL SENSOR PROBE

The new Enraf level displacement gauge in tank 241-S-106 has been found to be non-functional. The plummet and a portion of the 316 stainless steel wire is missing (see Figure 1). The cause of the failure has not been determined conclusively. However, it is thought that the polyvinyl chloride riser liner is degrading and forming hydrochloric acid that runs down the 316 stainless steel wire and this caused the failure. The question at hand is does the loss of the plummet and the potential for another loss in the future cause hazards that are not addressed in the existing safety basis.
