Document #: SD-WM-RPT-227

CHARACTERIZATION SAMPLING EQUIPMENT STATUS REPORT
01/1996 THRU 03/1996

CHARACTERIZATION SAMPLING EQUIPMENT STATUS REPORT - JANUARY THROUGH MARCH 1996

WHC-SD-WM-RPT-227

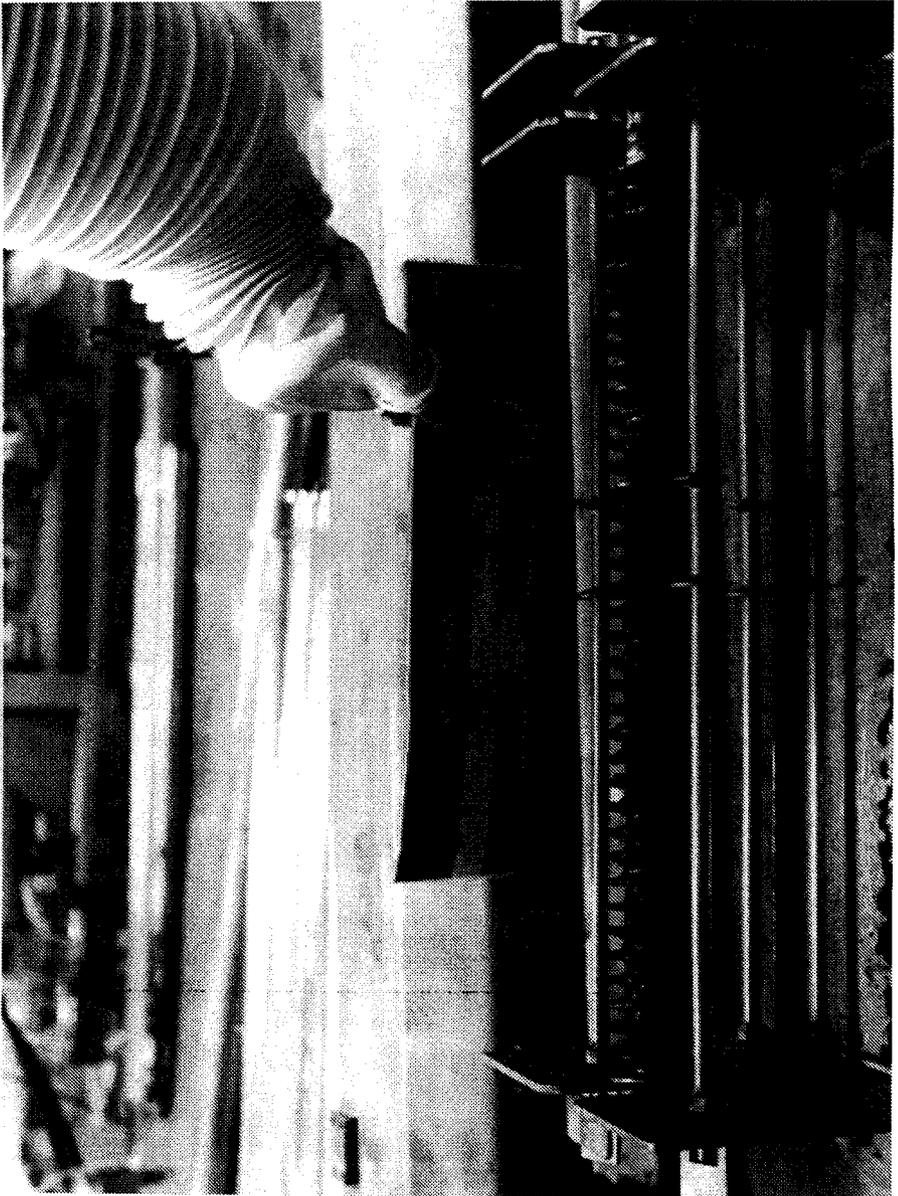
TX-107 96-AUG-001

Field testing of the new auger, noted in the last report, were completed with fairly good results. The auger, which incorporated the shallow pitch, small shaft features obtained high recovery, but on tank 241-TX-107 (riser 9A) a "tape" that was left in the tank wound around the auger shaft and the majority of the sample was lost untangling the recovered tape. The other tank auger sampled was 241-A-102 with excellent results.

Auger sampling with the improved "shallow pitch fluted bit" was completed in two tanks, 241-TX-107 and 241-A-102. The results were very good with, but the recovery from 241-TX-107 was partially lost due to the fact that the auger, during sampling, captured a discarded manual tape (zip cord) in the auger flutes, and during the tape removal exercise, a large portion of the captured sample was lost (see Figure A01). The recovery in 241-A-102, was excellent, the first 26 flutes had sample medium (see Figure A02). As a comparison of the differences between the improved sampler configuration and the old design photo Figure A03 (old configuration) is included.

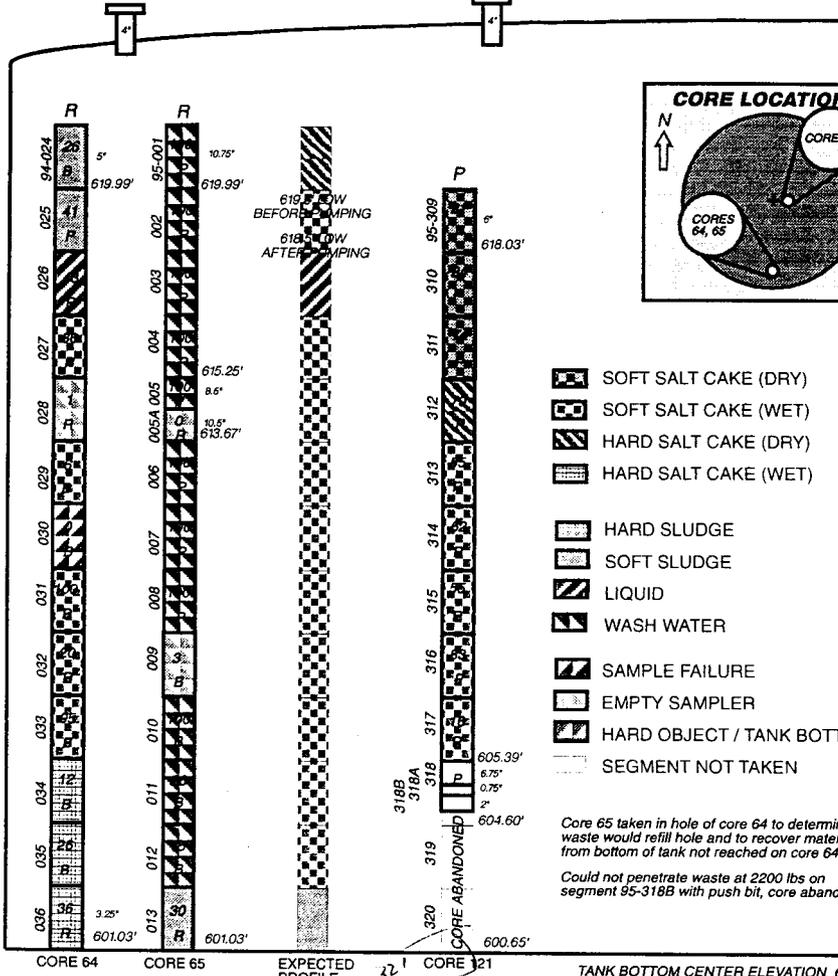
BY-106 RMCS CORE PROFILE

32' CORE 121
None exists

Core 65 taken in hole of core 64 to determine if waste would refill hole and to recover material from bottom of tank not reached on core 64.

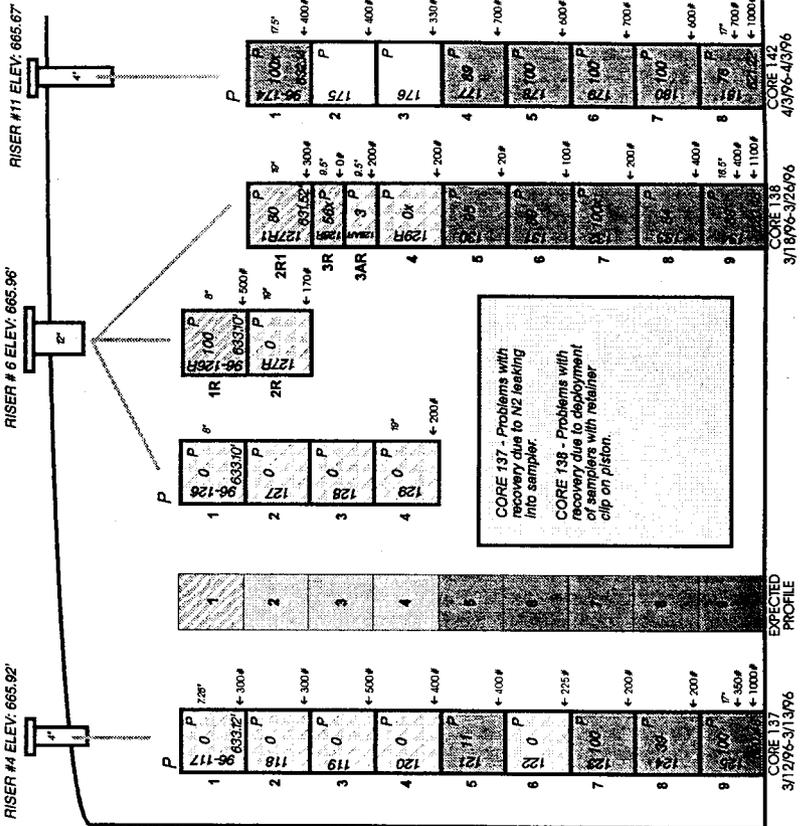
FILE: S101 CRD
DATE: 04/28/96

CORE 137 - Problems with recovery due to M2 leaking into sampler.

CORE 138 - Problems with recovery due to deployment of samplers with retainer clip on piston.

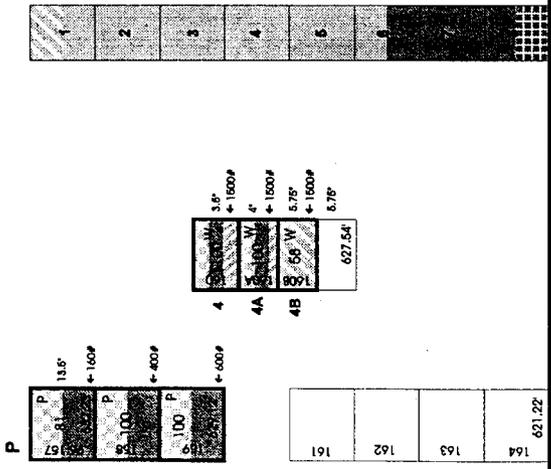
S-110 RMCS CORE PROFILE

96-160B Could not penetrate waste with 1500 lbs and riser sleeve installed.

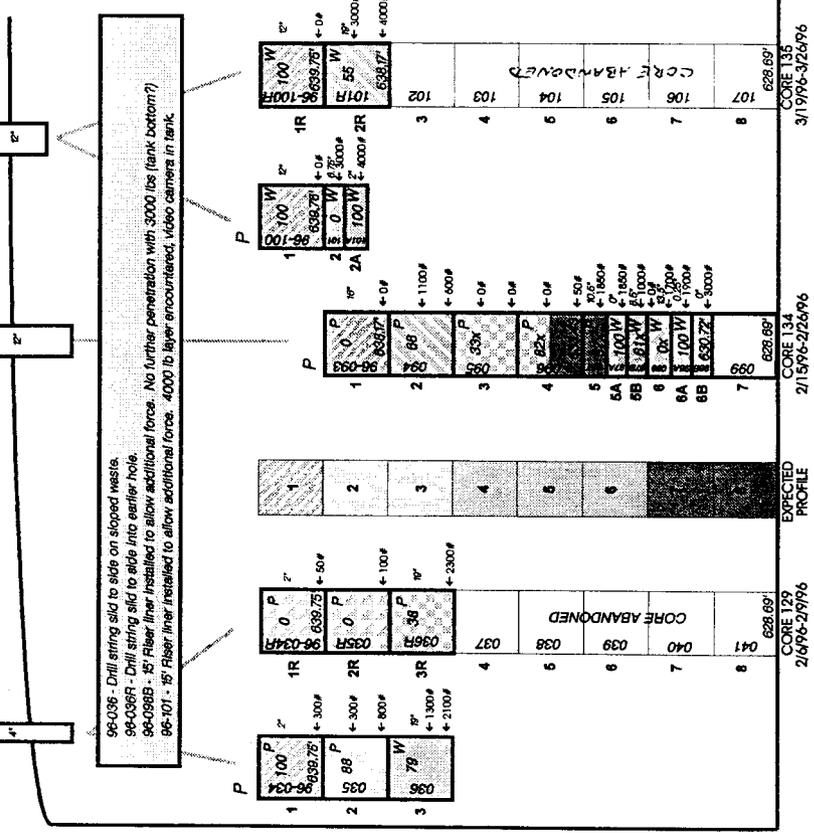
U-107 RMCS CORE PROFILE

96-036 - Drill string slid to side on sloped waste.
96-036R - Drill string slid to side into earlier hole.
96-098B - 1" Riser liner installed to allow additional force.
96-101 - 1/2" Riser liner installed to allow additional force. 4000 lb. layer encountered. Video camera in tank.

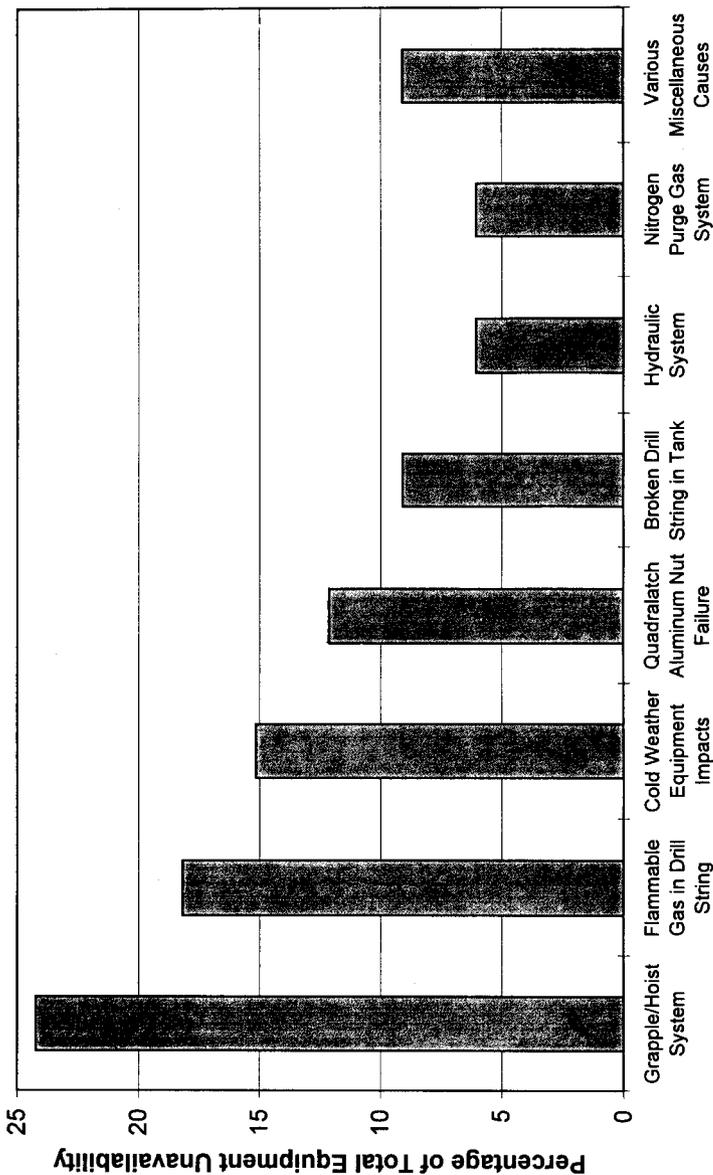
Distribution of Causes for Sampling Equipment Unavailability

The problems which are cause for high sampling equipment unavailability are given the highest priority for resolution by design engineering. Figure A25 depicts the percentage distribution of causes for sampling equipment unavailability during the first half of FY96. Seven specific and one miscellaneous grouping from all other causes are depicted. The number one cause of sampling equipment downtime is associated with the grapple hoist system and in particular the tendency of the hoist cable to jump off of its spooling drum and become entangled on its drive system inside its "confinement" box. Figure A26 lists the equipment modifications planned or implemented during this period to address each of these high profile equipment unavailability causes.

- Revise material to stainless steel for new samplers (complete)
- Revamp existing samplers to stainless steel (in progress)
