# A STRUCTURAL INTEGRITY ASSESSMENT OF UNDERGROUND PIPING ASSOCIATED WITH THE TRANSFER OF RADIOACTIVE WASTE

**A STRUCTURAL INTEGRITY ASSESSMENT OF UNDERGROUND PIPING  
ASSOCIATED WITH THE TRANSFER OF RADIOACTIVE WASTE**

**Bruce J. Wiersma**

Savannah River National Laboratory  
Washington Savannah River Company  
Savannah River Site  
Aiken, SC, 29808  
USA

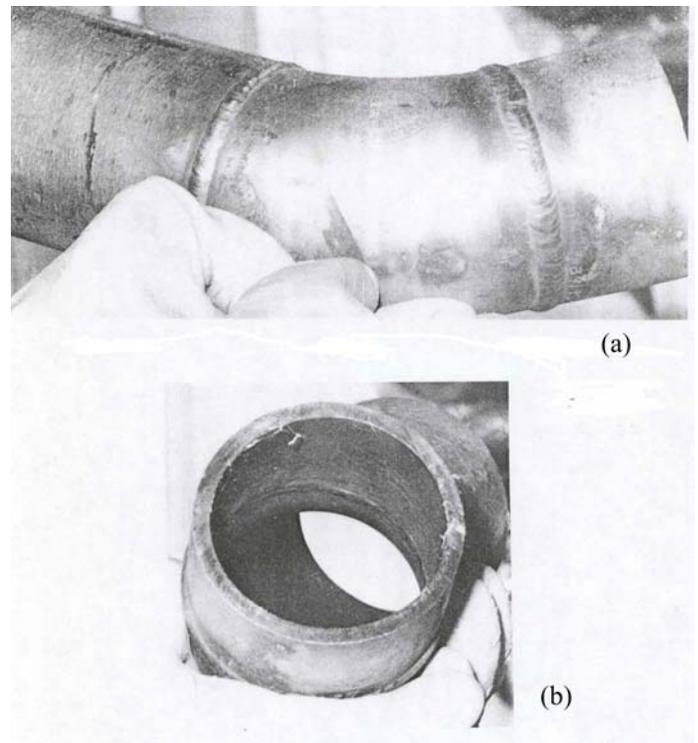
The waste solutions that are normally transferred through the core pipe are compatible with the stainless steel core pipe. The high concentrations of nitrate and hydroxide present in the waste combined with the relatively low concentrations of chloride would maintain the passive oxide film. Laboratory tests performed with 304L stainless steel in simulated high level waste solutions predicted a general corrosion rate of less than 0.1 mils per year (mpy), and no pitting susceptibility [2]. These results are confirmed by field observations. Figure 3

shows a stainless steel core pipe that was removed after 15 years of service. No evidence of pitting or general corrosion was observed.

**Figure 3. Stainless steel elbow from core pipe: (a) exterior and (b) interior.**

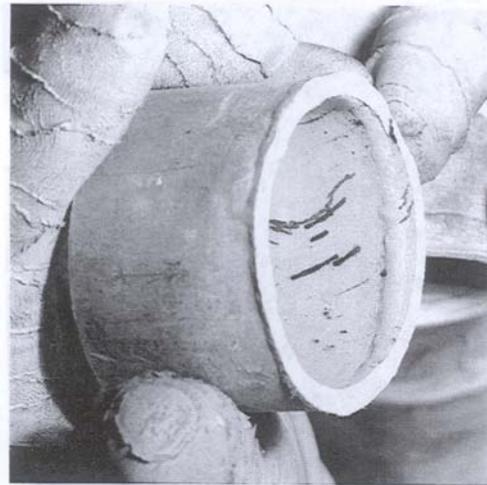
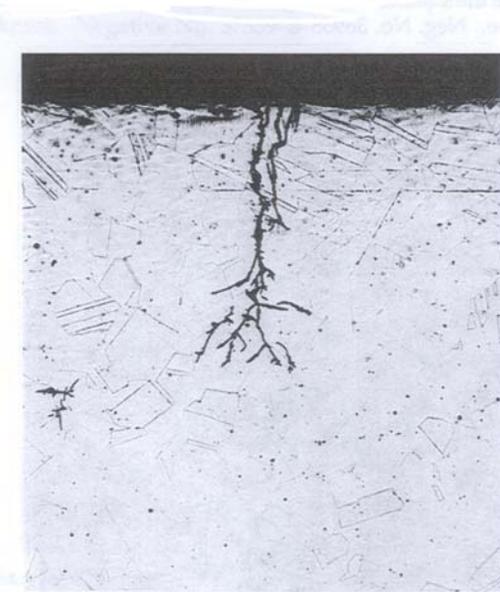
Stress corrosion cracking is also not anticipated under normal service conditions. Laboratory tests indicated that 304L stainless steel is not susceptible to stress corrosion cracking (SCC) in high level waste environments [3]. However, a case of transgranular chloride stress corrosion cracking (CSCC) of a core pipe has been observed (see Figure 4). A leak was detected from the pipe some time between hydro-testing of the system and placing the pipe in radioactive service. Neutral well water was utilized for the hydro-test and was a likely source of the chloride ions. Concurrent with the hydro-test, a leak in an underground steam line in close proximity to the pipe was discovered. The steam leakage provided a heat source which produced the elevated temperatures that resulted in evaporation of the water. Although the SRS well water is typically low in chlorides (less than 5 ppm), evaporation likely increased the chloride concentration beyond a critical level. A time/temperature combination is also required for cracks to initiate and propagate. It was observed that both the extended period of steam leakage and the extended period before the line was placed in service were likely contributors to the failure. It was therefore recommended that the repair time for leaks in buried steam lines be minimized and that new pipe lines should not be held out of service for extended periods of time. Administrative controls are currently utilized to minimize the potential for well water to be left in the lines for extended periods of time.

**Figure 4. Section of core pipe from clean-out-port #3: (a) Dye penetrant test showing cracks on the interior of the pipe, Magnification 1X (b) Micrograph showing transgranular SCC, Magnification 50X.**

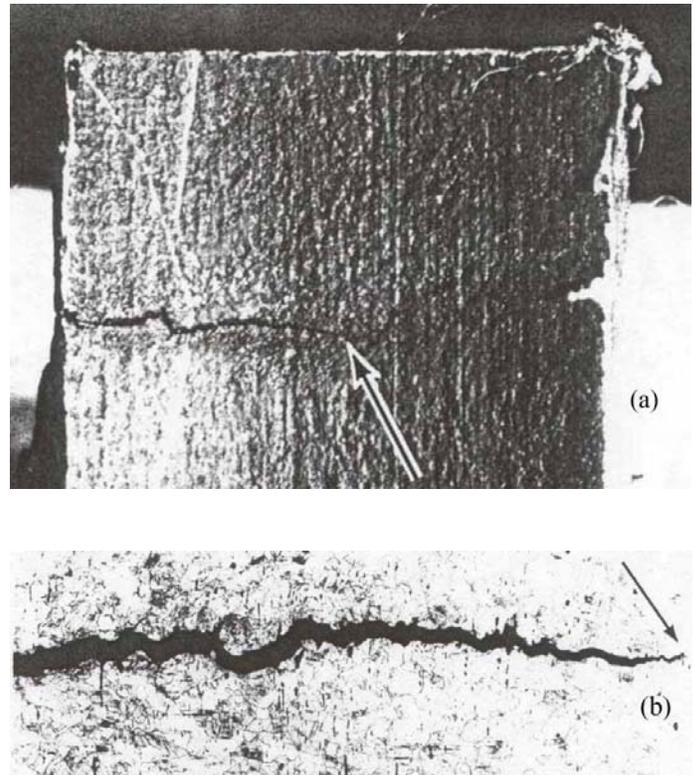
Thermal fatigue was identified as the cause of leakage from one stainless steel core pipe (see Figure 5). The pipe failed in a straight, anchored section. The combination of anchoring the internal pipe to the carbon steel jacket, restricting the space for expansion, and having multiple lines within the same jacket intensified the stresses on the transfer line. The line had been in service for approximately 4.5 years and had experienced approximately 5500 thermal cycles. The cycles resulted from transfer of concentrated waste at a temperature of 115-135 °C alternated with desalination back flushes with water at 20-50 °C. A second pipe, adjacent to this pipe in the same carbon steel jacket, also showed indications of cracks at the anchor plate between the jacket and the core pipe. This second line had been in service for only six months and had experienced approximately 100 thermal cycles.

**Figure 5. Fatigue crack in pipe: (a) View of interior surface of pipe, (b) Micrograph showing the fatigue crack.**

To reduce the likelihood of failure it was recommended that the projected total usage cycles be reduced by increasing the flush water temperature from 20 °C to 120-135 °C. Increased monitoring of these lines and remedial actions were implemented where practical (e.g., modifications to reduce thermal stresses).

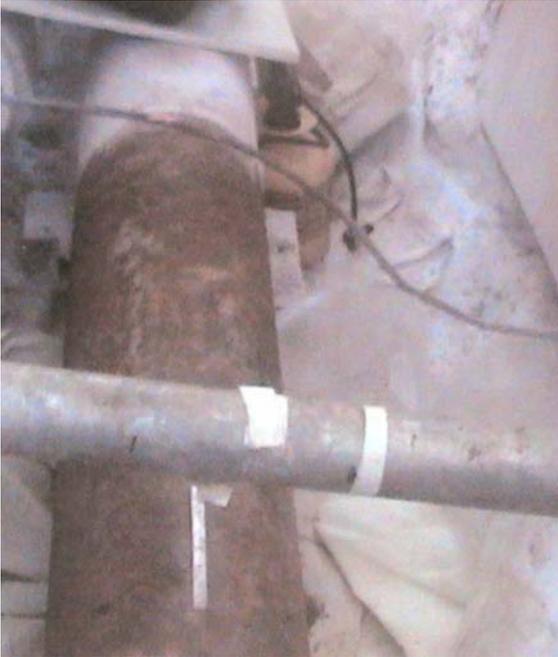
There have been examples of degradation of carbon steel piping that was buried in the insulation. Poor placement of the insulation such that water is allowed to penetrate to the jacket surface is usually the cause of corrosion. This jacket pipe shown in Figure 6 had been in service for approximately 20 years. During excavation of a nearby line, broad shallow pitting with isolated areas having deeper pits was observed in a 30" segment of this jacket. The attack was determined to be pitting within a locally thinned region. The corrosion was greater (more frequent and deeper pitting) along the bottom half of the jacket. The isolated nature of this attack was also observable as a majority of the line remained un-attacked.

**Figure 6. View of jacket pipe that shows corrosion beneath the thermal insulation.**

- Ultrasonic measurements taken on the pipe shown in Figure 6 were used to estimate the remaining useful life of carbon steel jackets. Ultrasonic line scans were performed every 45 degrees around the jacket circumference to determine the wall thickness profile. The average wall thickness was approximately 0.24” or 10 mils less than the installed nominal thickness of the pipe. The minimum wall thickness at the deepest pit was 0.127”. Twelve pit-couples were measured in order to perform the assessment.

Assuming that the depth of general corrosion was 10 mils, P is determined to be 11.3. If T is the nominal thickness of 0.25", the time to through-wall penetration is estimated to be approximately 80 years. Given that the pipe had already experienced 20 years of service, 60 years of remaining life was projected. However, this estimate assumes the jacket continues to corrode at the present rate. If the thermal insulation was properly placed around the jacket when this line was returned to service, the corrosion rate may slow significantly and the jacket would remain in essentially the present condition. Therefore, this calculation may be more applicable to a similar pipe that remained buried and therefore the corrosion went undetected.

The carbon steel jackets are likely to continue to suffer further pitting attack at local thin areas beneath insulation or at holidays in a coating due to improper placement of thermal insulation or poor coating application at isolated areas along the transfer line system. The 80 year lifetime estimation is supported by the observation that relatively few failures of transfer line jackets have occurred to date. Thus, the 80 year life expectancy can be utilized to estimate approximately when the transfer line system jackets as a whole may begin to see a significant increase in failure rate. Most of the transfer lines have been in-service for approximately 20 to 50 years. Thus, the remaining life of the jackets is estimated to be 30 to 60 years (2035 to 2065). Due to the statistical nature of pitting some jackets may fail earlier, but it is expected that a significant increase in the number of jacket pressure test failures will be observed after this time. The two year frequency for testing the jacket is sufficient to monitor for these failures for the next 30 years. However, after that time, a shorter testing frequency should be considered.
