WSRC-TR-98-00373 (U)

*Structural Dimensions, Fabrication, Materials and
Operational History for Types I and II Waste Tanks*
(U)

Publication Date: October, 1998

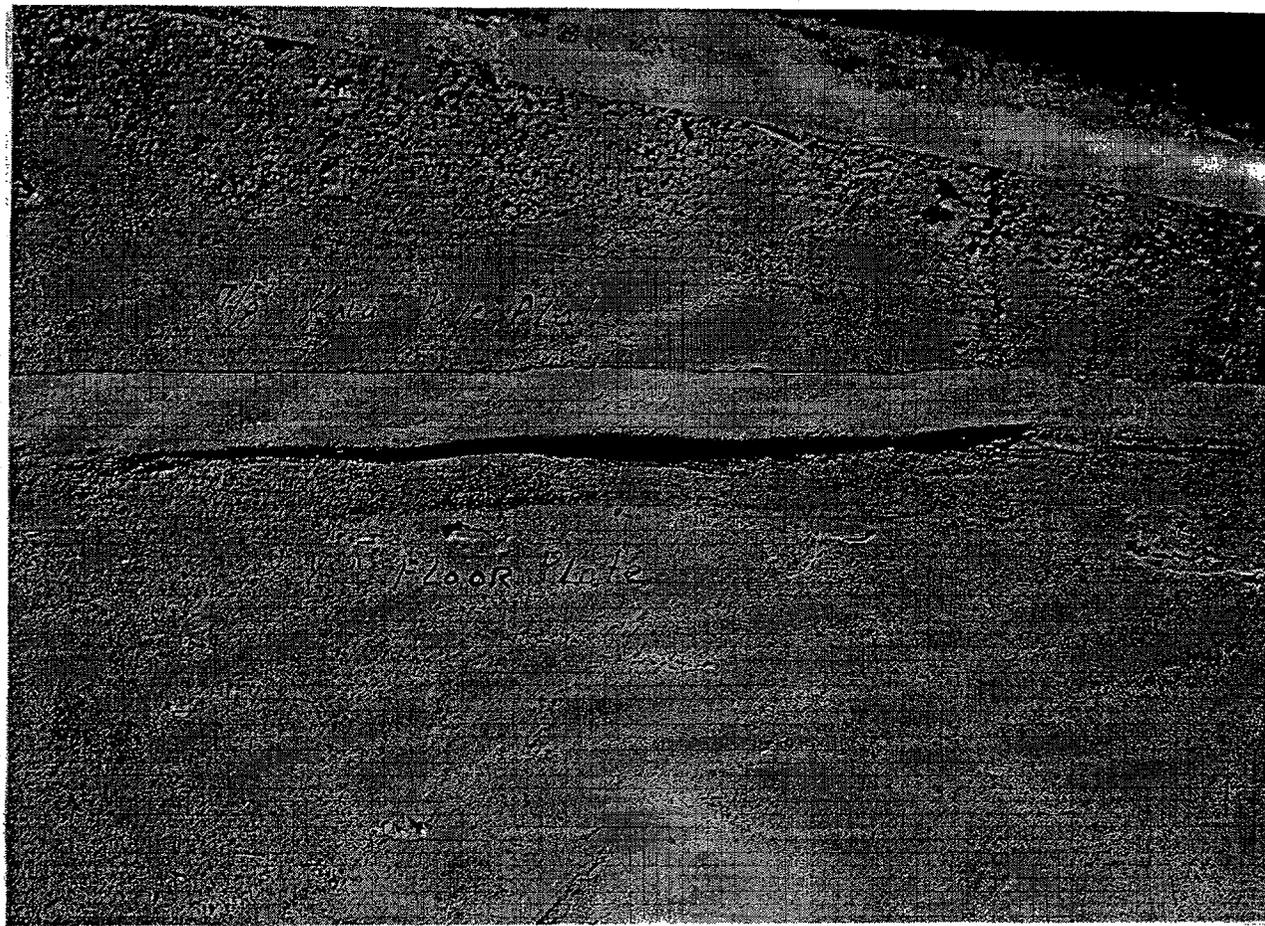
5. The resulting groove from the partially ground-out seam weld was approximately 0.02 inch deep and 18 inches long. (See Figure 6)
6. Welds were inspected utilizing the magnetic particle technique that was designed to detect fine cracks that would be undetected by radiography. This type of inspection was used on 20% of the butt welds on the bottom of the tank and 25% of the butt welds on the side of the tank to a height of 6 feet. Dye penetrant testing was performed on 30 patch welds. No flaws were detected by either of these methods.

Figure 6. Partially ground out seam weld in Tank 15 (Mag. 1/3X).

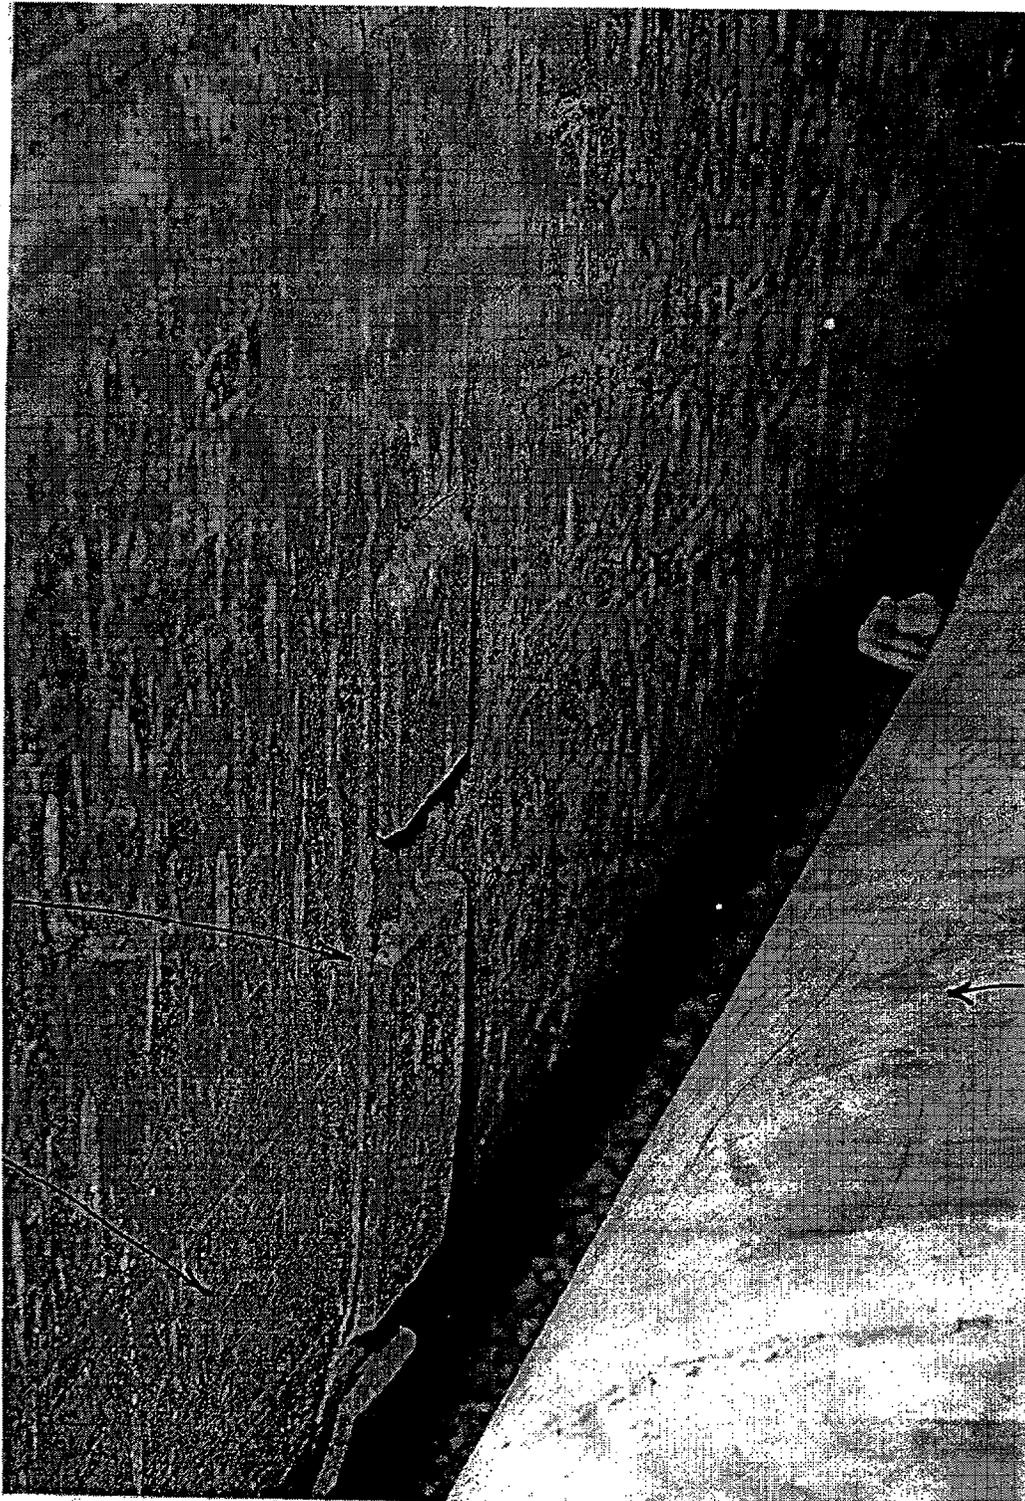
Figure 7. Back-up plates placed over vertical seam welds in Tank 15 (Mag. ¼ X)

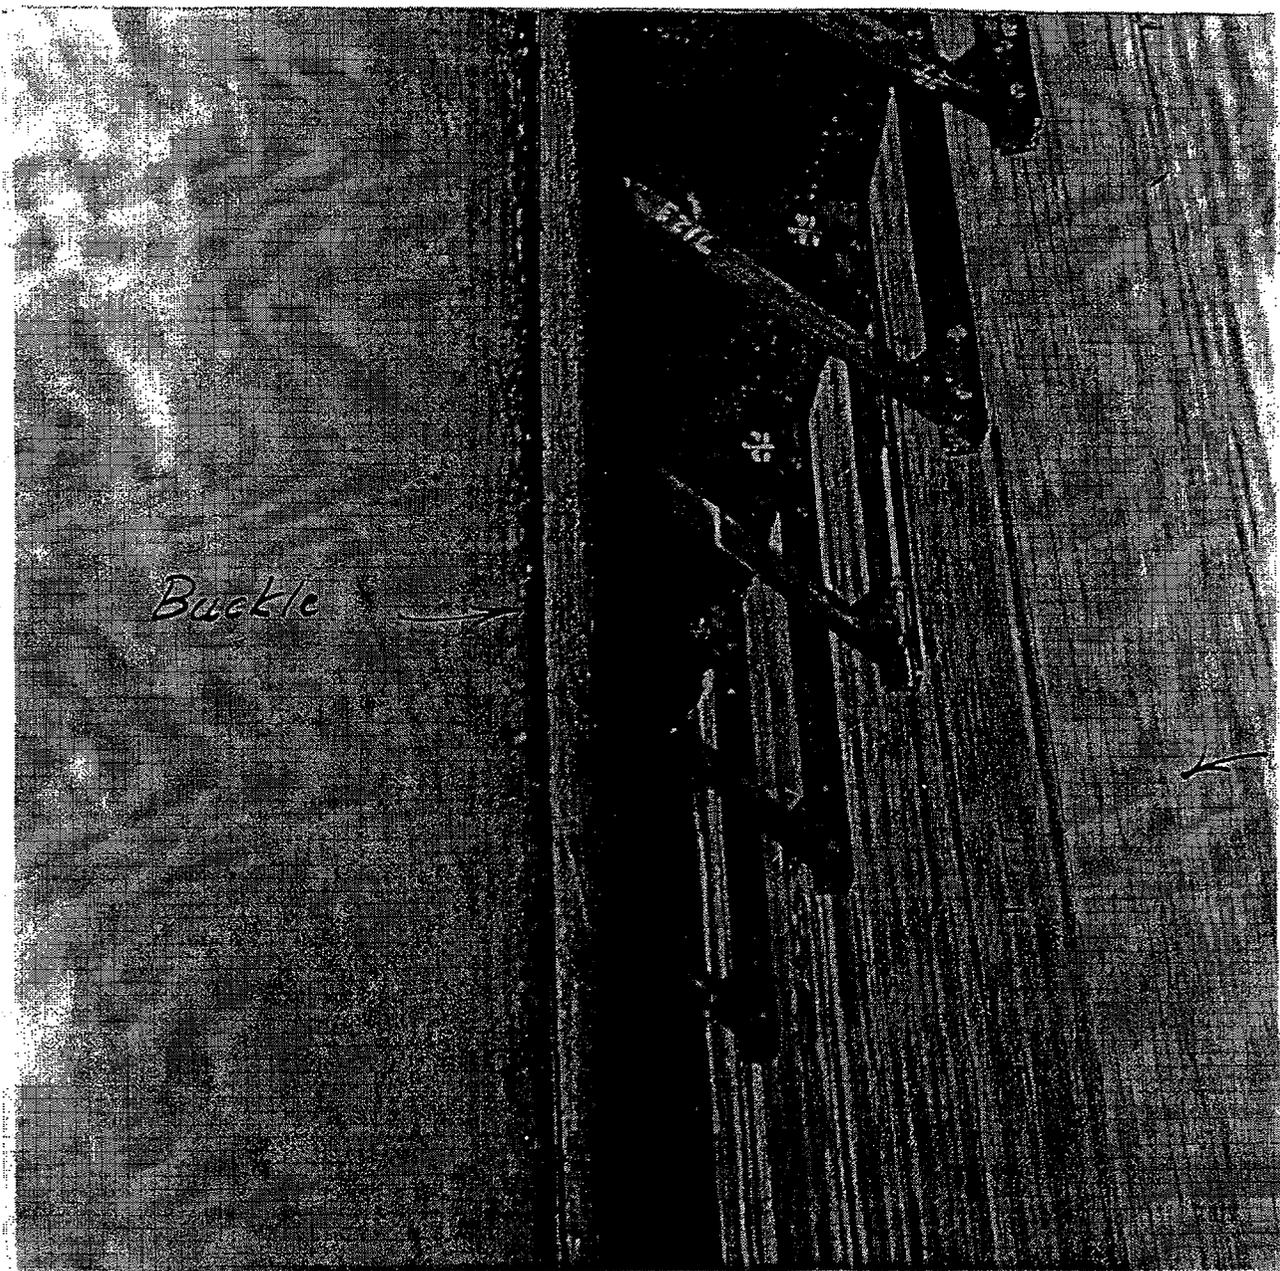
Figure 9. Severe buckle in seam weld in Tank 15 (Mag 0.1 X).

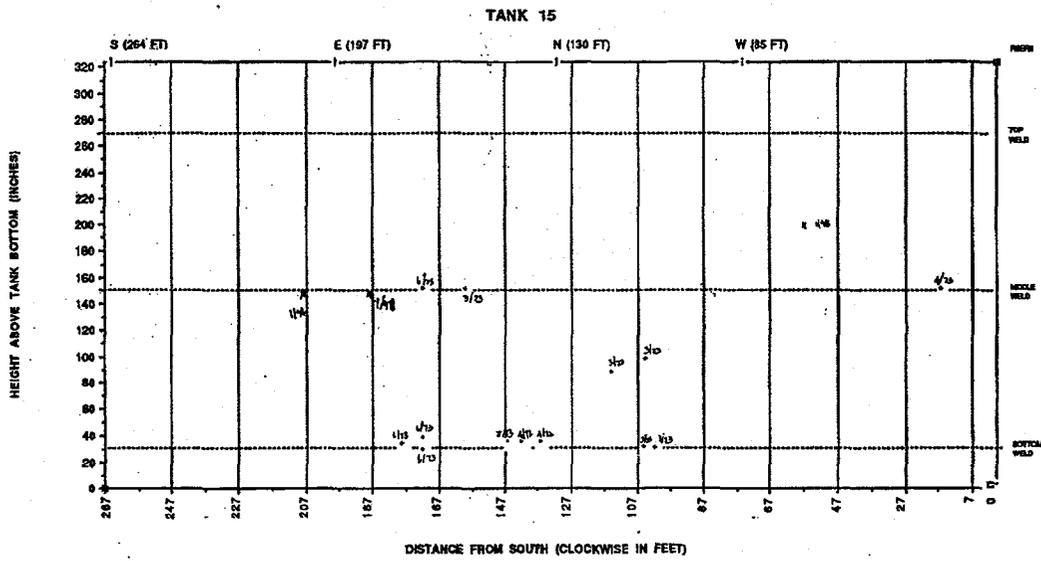
During a visual inspection of Tank 15 in 1972 two leaksites were discovered below one of the four risers providing access to the annulus near the bottom circumferential weld about 2.5 feet above the tank bottom [13]. Twelve additional risers were installed, increasing the observable portion of the primary steel wall from 25% to 96%. Inspections in 1973, via the additional risers, revealed eleven other leaksites. Figure 12 is a map of the primary tank wall showing the location of the leaksites.

Figure 12. Wall map of Tank 15 showing the locations of leak sites.
