**Status Of Chemical Cleaning Of Waste Tanks At The Savannah River Site –
F-Tank Farm Closure Project – 9114**

G. Donald Thaxton IV, G.B. Clendenen and W.E. Gordon
Washington Savannah River Company
Savannah River Site, Aiken, SC 29808

ABSTRACT

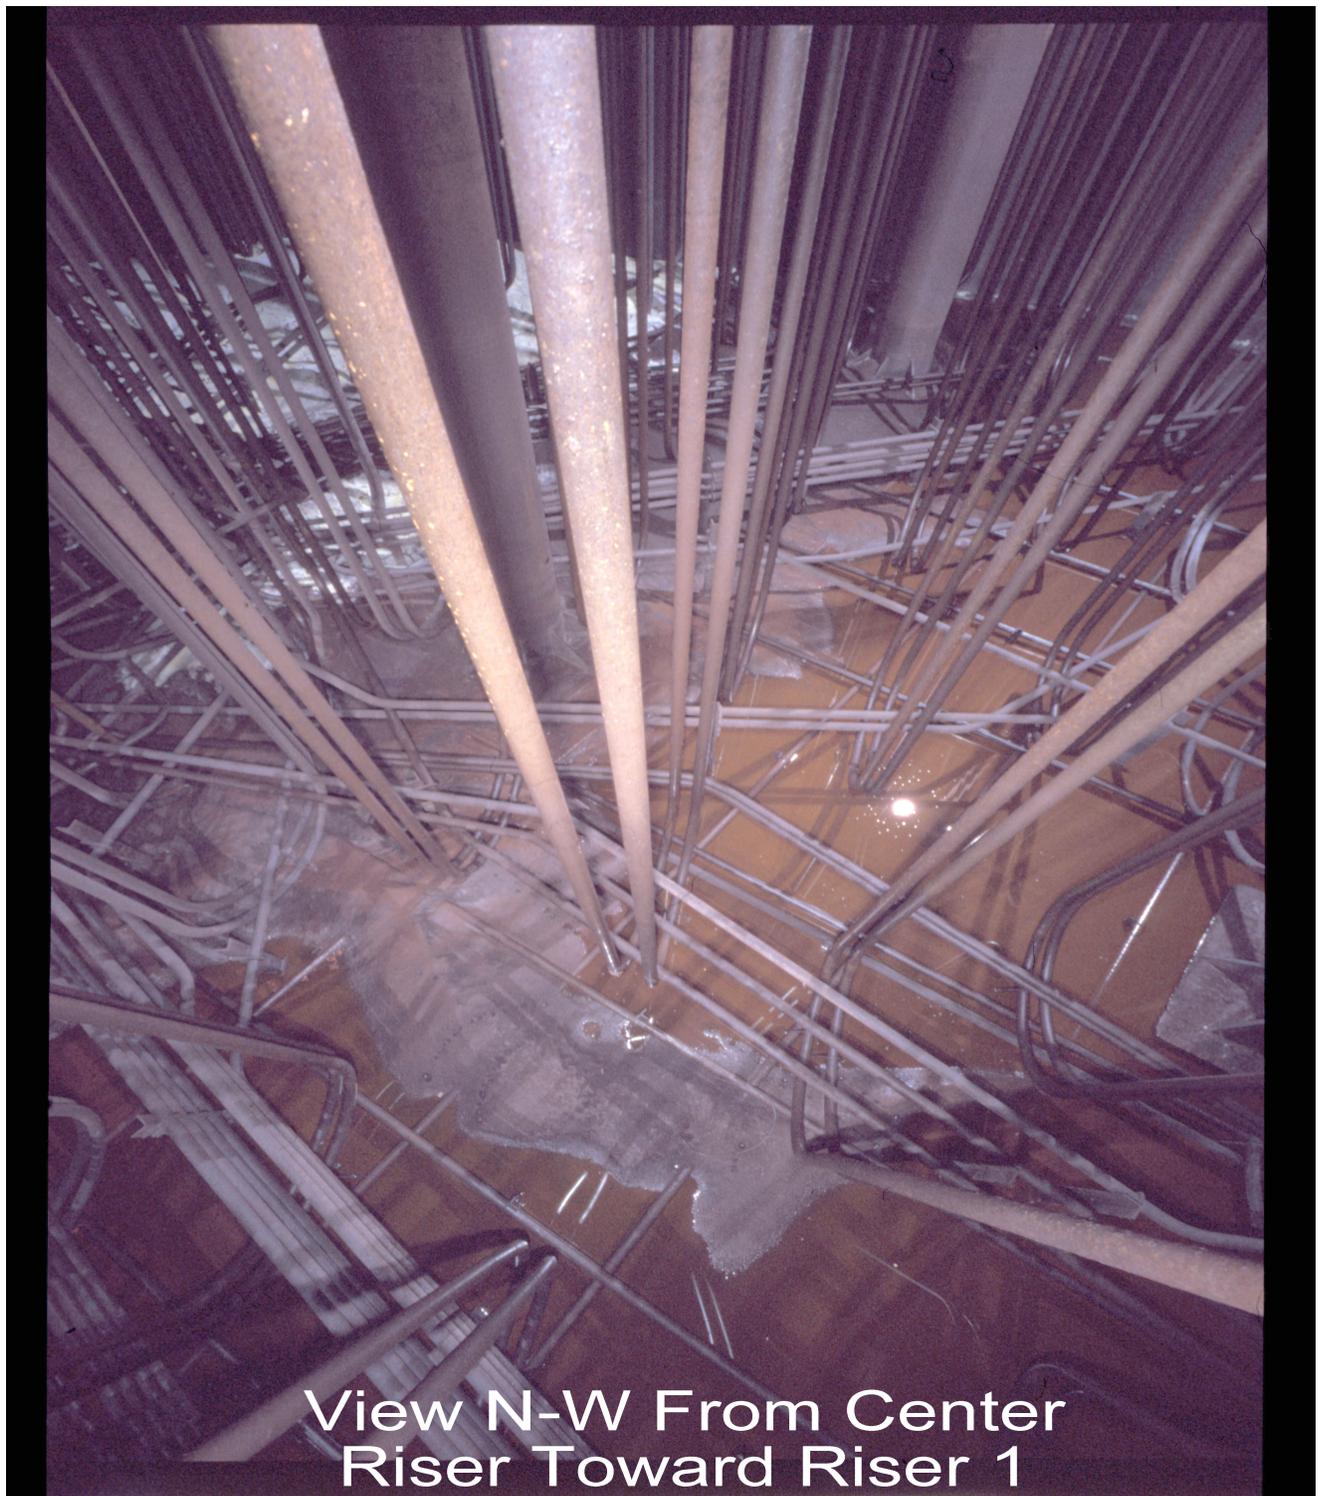
Figure 3. Tank 5 prior to completion of mechanical cleaning.

Visual inspections of the tank interiors have been performed during the cleaning process. Figure 3 is a photograph of Tank 5 prior to the fourth cycle of mechanical cleaning and is provided as an example of tank cleanliness prior to Chemical Cleaning. Inspections during Chemical Cleaning have not revealed evidence of severe corrosion since no large accumulations of corrosion products on tank walls and components have been observed (See Figure 4). These inspections have also shown that the majority of the tank is in a clean condition. Ultrasonic testing of the waste tank side walls was performed prior to Chemical Cleaning to measure wall thickness. This testing will be repeated at the completion of Chemical Cleaning to determine actual corrosion rates for the carbon steel walls in contact with the oxalic acid.

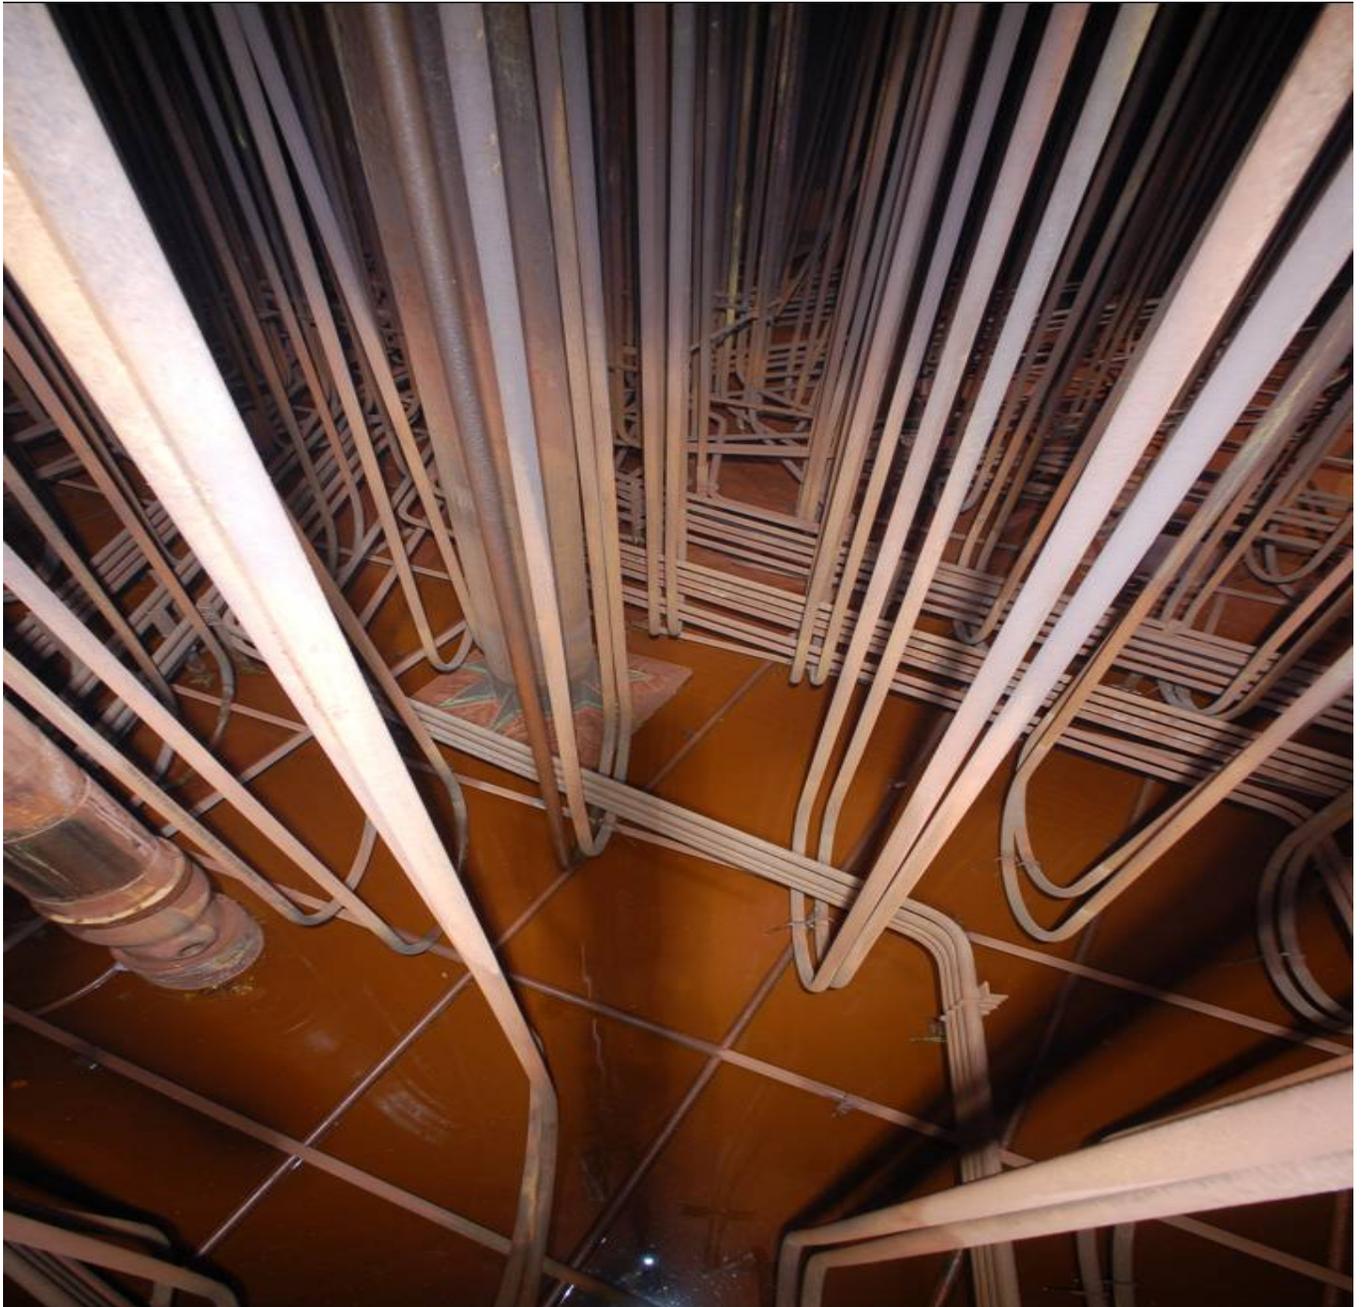
Figure 4. Tank 5 after the second Chemical Cleaning acid strike.

The formation of new solids in the treatment tanks has proven to be a significant issue during the Chemical Cleaning process. This phenomenon was observed in the bench-scale process testing at SRNL. Inspections and solids mapping confirmed that new solids formed in Tanks 5 and 6 during the Chemical Cleaning process. However, it will not be possible to determine if the remaining solids in the tanks are new oxalate precipitates, un-reacted sludge, or a combination of the two until solids samples are obtained and analyzed.
