# **The Gunitite and Associated Tanks Remediation Project Tank Waste Retrieval Performance and Lessons Learned**

**September 2003**

**B. E Lewis  
P. D. Lloyd  
B. B. Spencer  
S. D. Van Hoesen  
Oak Ridge National Laboratory**

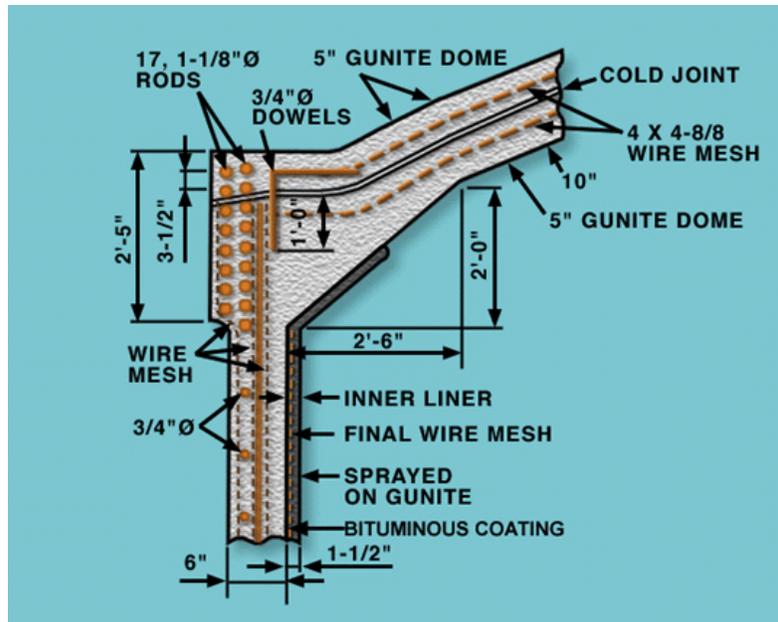
**Fig. 1-4. Schematic of the cross section of a typical gunite tank wall and dome junction.**

walls were constructed and construction of the tank domes followed. Each tank has an associated dry box connected to its footer that drains the base of the tank. The dry boxes were used for leak detection. All tank domes were covered with ~5 to 6 ft of soil and seeded with grass to prevent erosion.

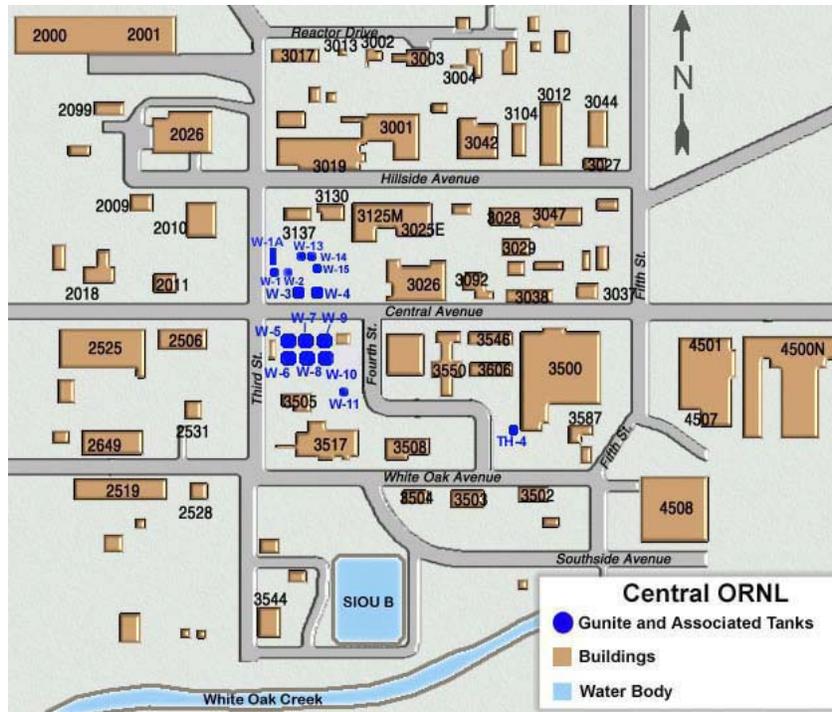
Fig. 1-6. Diagram of the 16 tanks in the GAAT OU.

The GAAT OU includes eight tanks in the North Tank Farm (NTF), six tanks in the STF, and tanks W-11 and TH-4. Each area was roped off and posted as a restricted-access area prior to and during remediation. Figure 1-6 shows the location of the tanks included in the GAAT OU. The tank farms are located near the ORNL cafeteria, on the north and south sides of ORNL's Central Avenue, which serves as the main east-west thoroughfare for ORNL (Fig. 1-7).

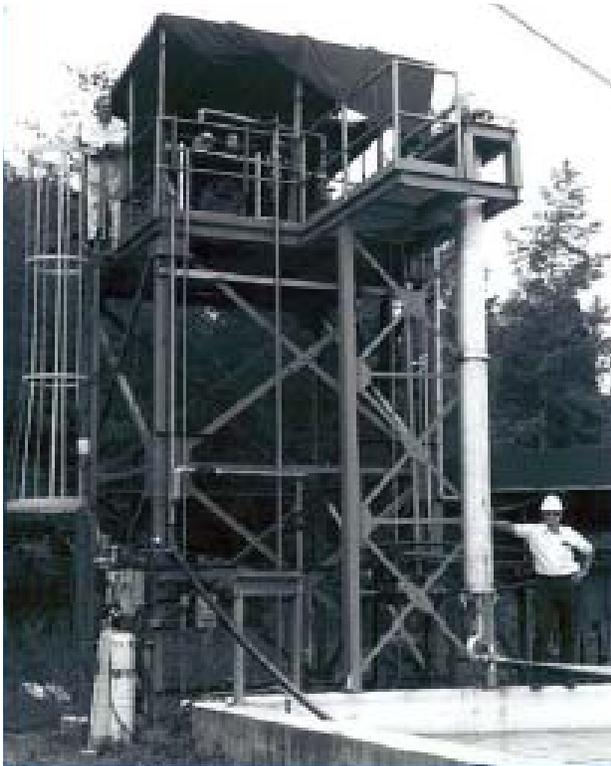
**Fig. 1-8. Single point sluicing cold test at ORNL prior to bulk sludge removal in the early 1980s.**

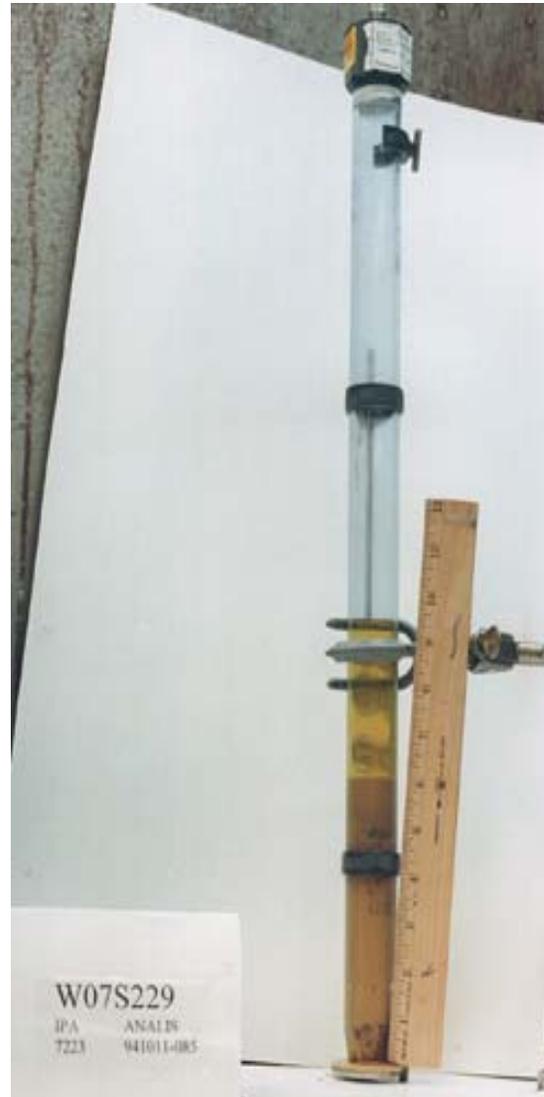
**Fig. 2-2. Push tube sample taken from tank W-7 in 1994.**

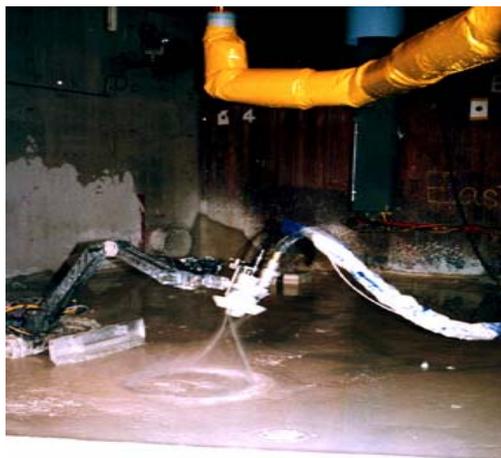
**Fig. 2-4. Houdini I ROV manipulating the CSEE, with the MLDUA positioned overhead at ORNL's TTCTF.**

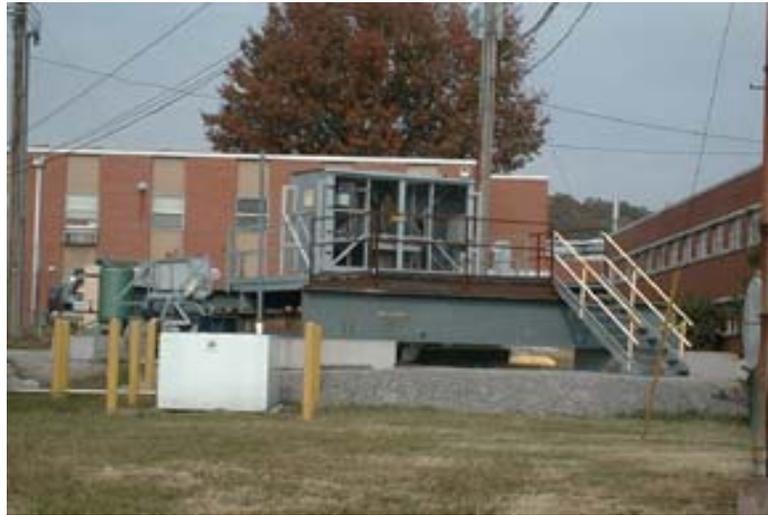
**Fig. 2-8. Russian PMP installed at tank TH-4.**

Waste retrieval from tank TH-4 was completed in early 2001. Operations in this tank were conducted separately from the STF operations. A Russian-fabricated Pulsating Mixer Pump (PMP) was used to mobilize the sludge waste. During the preparation for waste retrieval operations in tank TH-4 in October 2000, the PMP Tank Riser Interface Containment (TRIC) structure was positioned on top of the equipment platform at the TH-4 remediation site (Fig. 2-8). A diaphragm pump transferred the waste slurry out of the tank. The slurry was pumped through the WCS in the STF and then on to BVEST W-23. Tank W-23 served as the batch tank for all waste retrieved from tank W-9 before waste slurry transfers were made to the MVSTs. In April 2001, after waste retrieval and equipment demobilization activities were completed, the ORNL Inactive Tanks Program stabilized tank TH-4 in-place by filling it with a low-strength grout as part of a separate project.

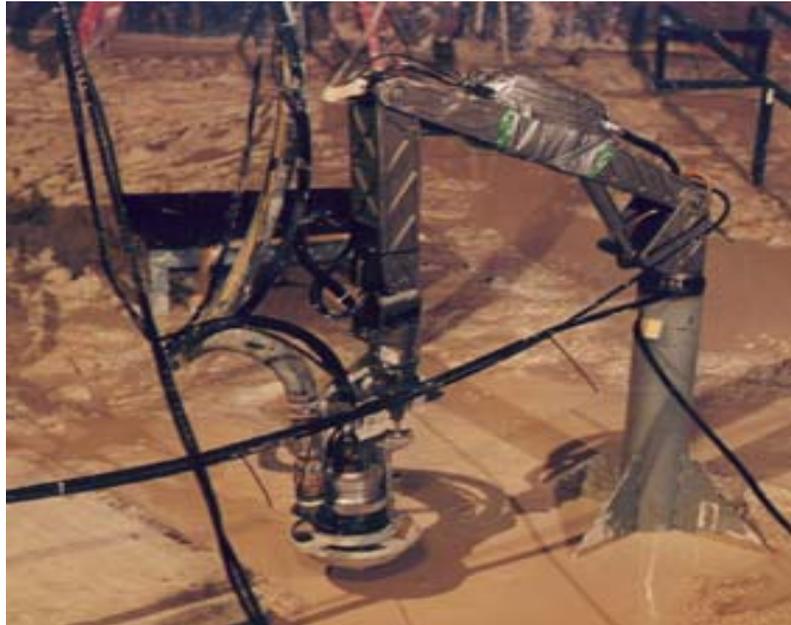
**Fig. 3-1. CSEE during tests with a surrogate waste slurry in the ORNL TTCTF.**

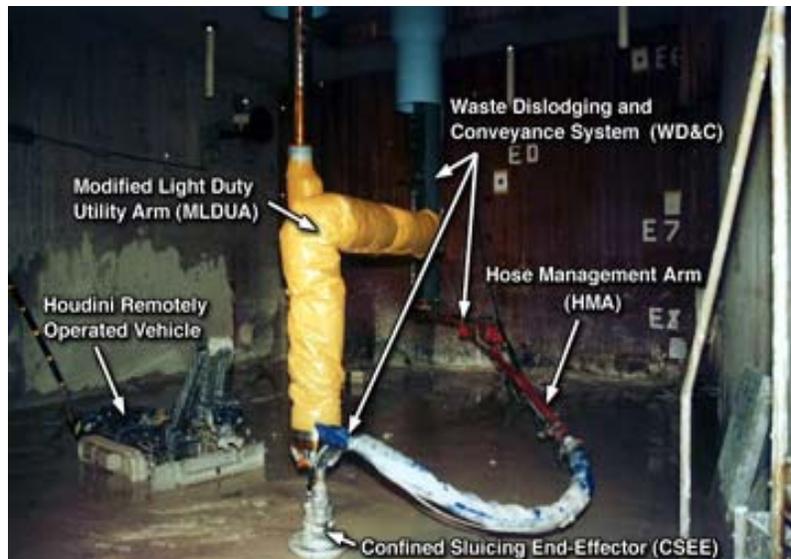
**Fig. 3-2. Main components of the RTCS during tests with a surrogate waste slurry at the ORNL TTCTF.**

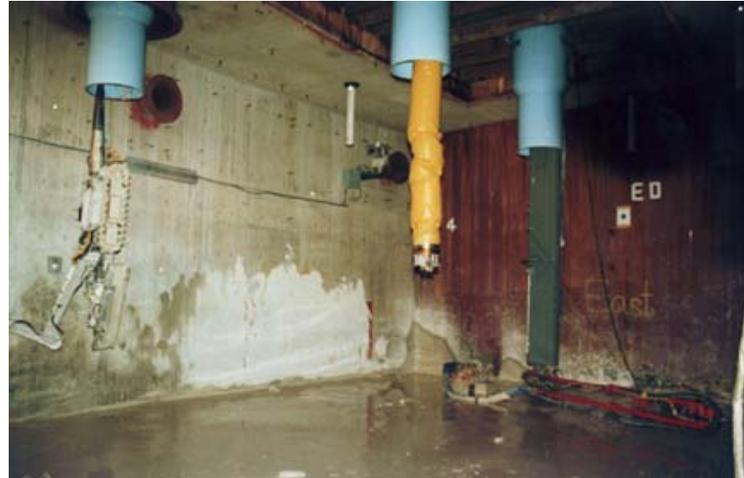
**Fig. 3-3. Cold testing of the Houdini ROV (left), MLDUA (center), and HMA (right) using mock 24-in.-diam tank risers.**

Major in-tank components of the RTCS were designed to deploy through 24-in.-diam tank access risers, which were duplicated at the cold test facility. Figure 3-3 shows the Houdini ROV (left), MLDUA (center), and HMA (right) inserted through mock 24-in.-diam tank risers at the TTCTF. Workers controlled the RTCS equipment and subsystems from a remotely situated control room.

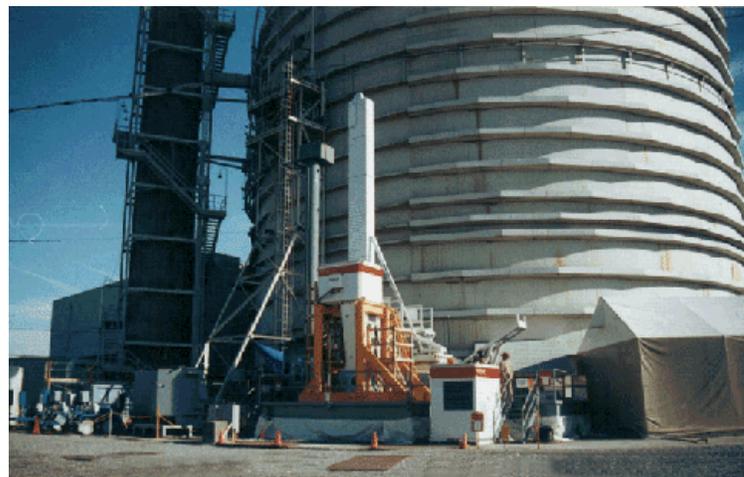
**Fig. 3-4. RTCS components set up on a work platform installed at the ORNL TTCTF.**

The RTCS subsystems were designed for deployment on and around an equipment platform placed over the tank undergoing waste removal operations. This feature was created for the cold tests, as shown in Fig. 3-4. This photograph shows equipment containment and support structures setup on the platform constructed over the TTCTF pit. The tent shown on the right covered the test pit's entrance and viewing area. The platform is a steel structure with removable floor grids, which allowed access to the tank risers. The platform provided a stable area for placement of the equipment containment structures and for performing maintenance and decontamination activities.

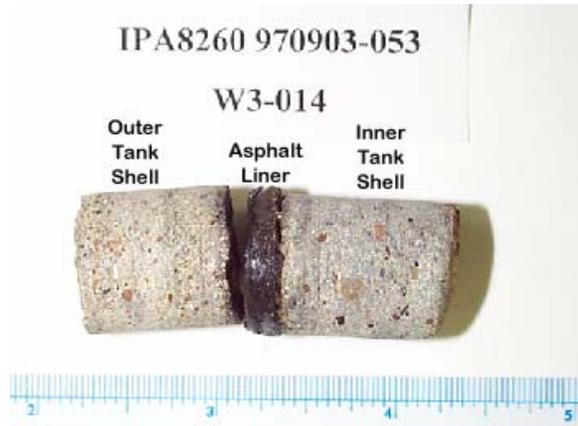
**Fig. 4-13. Core sample taken from the inner wall in tank W-3.**

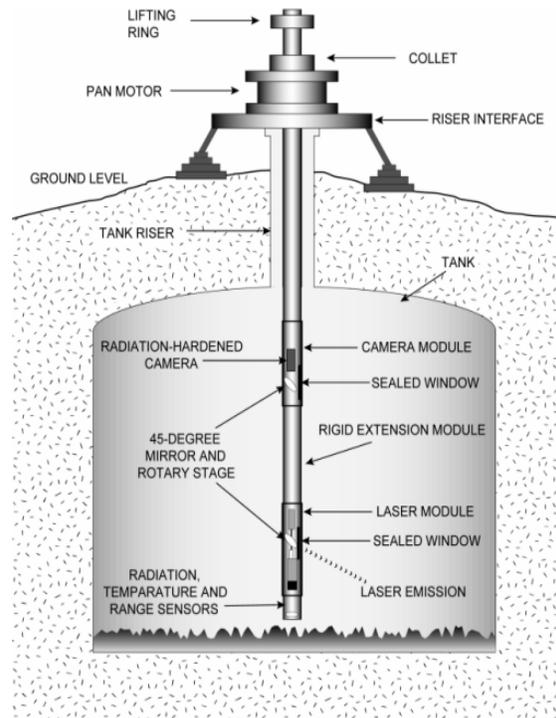
**Fig. 4-14. Graphical representation of the TMS deployed in a UST.**

The TMS is a laser-based measurement system designed to provide three-dimensional mapping of the interior of the USTs (Fig. 4-14). It was designed and developed to operate in hazardous and radioactive environments. The TMS is a self-contained, reconfigurable system capable of providing rapid, variable-resolution mapping information in poorly characterized workspaces with a minimum of operator intervention. Such topographical information was useful for providing operators with the location and depth of sludge deposits and for estimating the volume of sludge within a tank.<sup>8</sup>

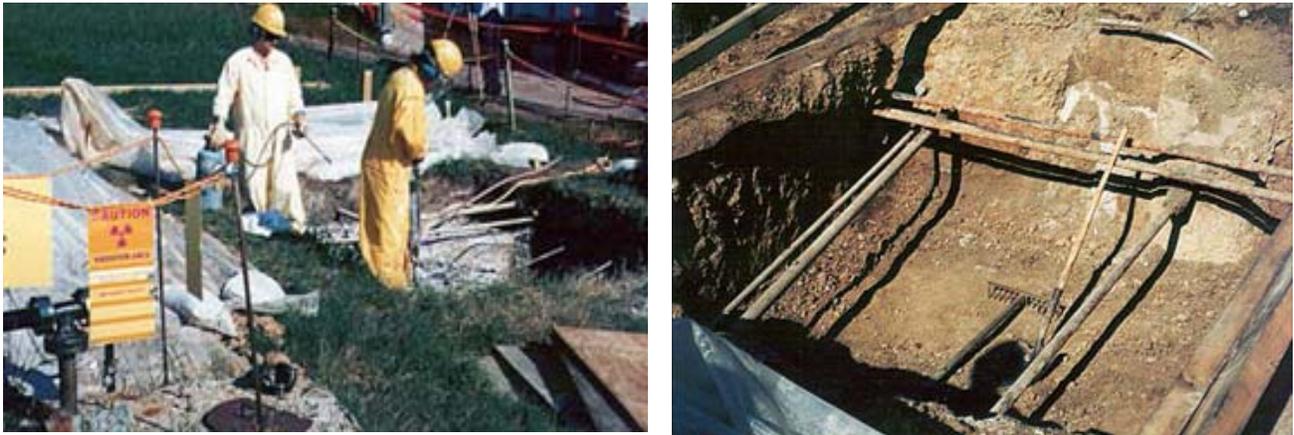
**Fig. 5-3. Workers (left) excavate underground piping (right) in the NTF for either removal or relocation to prepare the site for additional modifications to the tanks and the tank farm.**

Some of the underground piping located in the tank farms was excavated (Fig. 5-3) and removed or relocated so that it would not interfere with tank modifications and facility upgrade activities. All

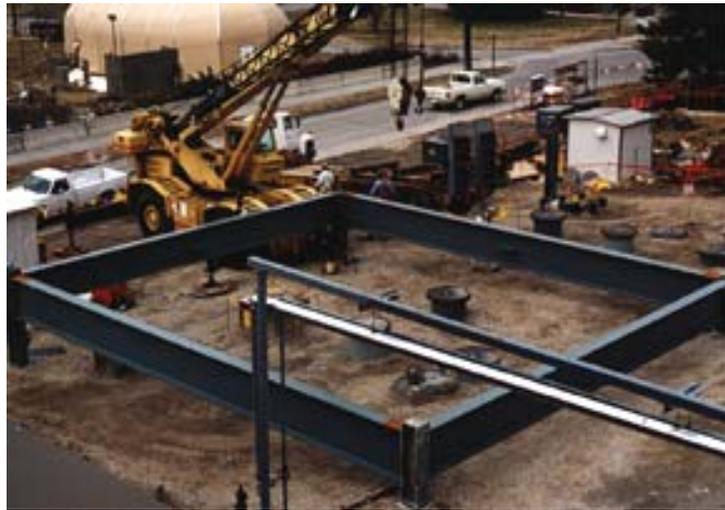
**Fig. 5-5. Installation of the steel beams for the work platform constructed over tanks W-3 and W-4.**

Modifications in the NTF included the construction of a large work platform over tanks W-3 and W-4 that was used to support the waste retrieval equipment. The platform was constructed with steel beams (Fig. 5-5) and removable steel grating panels, which allowed access to the tank risers. Additional utilities and lighting were added to the NTF to support waste retrieval operations. Modular buildings (trailers) were brought to the site to serve as the equipment control room and offices for support services. After waste retrieval activities in tanks W-3 and W-4 were completed in 1998, the utility buildings (prefabricated wood-frame and plywood construction) were relocated to the STF and used as a frisking station, storage for RP personnel, and general parts/equipment storage. The platform materials were cleaned, broken down, and recycled. The modular buildings that served as offices and the control room were left at the site for an upcoming project (Tank W-1A and Corehole 8 Plume Source Remediation Project).

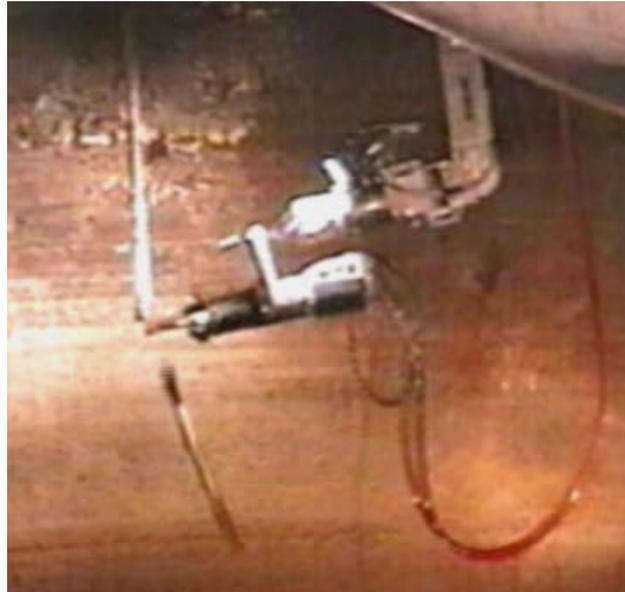
**Fig. 5-7. Modifications in tank W-6 using the hydraulic shear deployed by the Houdini ROV.**

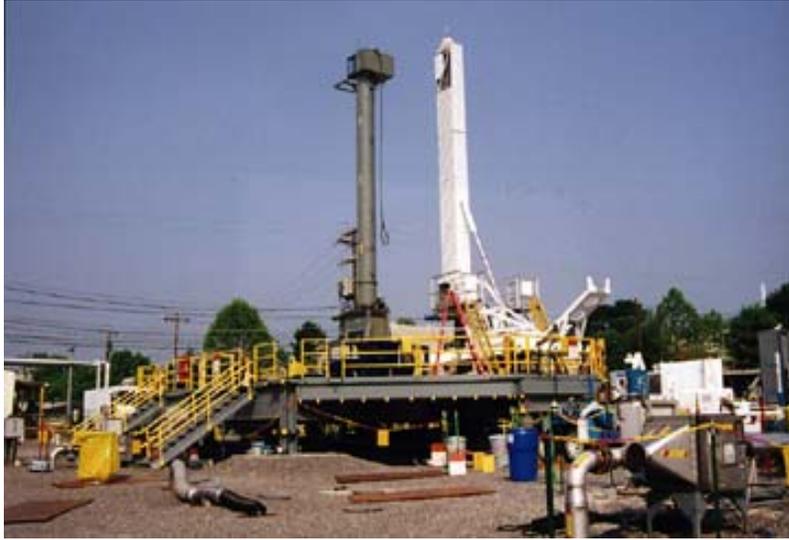
**Fig. 6-1. RTCS components installed on the tank W-6 equipment platform during waste retrieval operations.**

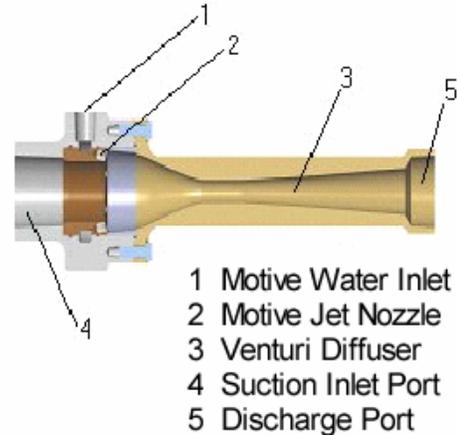
**Fig. 6-2. Schematic of the axial-flow jet pump.**

A commercial jet pump was modified with a hardened stainless venturi nozzle after cold testing revealed that the standard aluminum bronze nozzle was prone to rapid erosion. Figure 6-2 is an illustration of the components of the axial-flow jet pump.

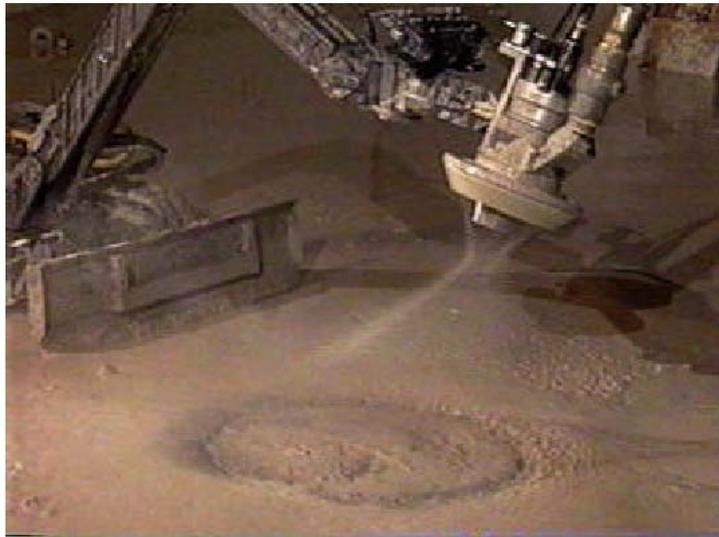
**Fig. 6-3. View of the CSEE held by Houdini I and showing the operation of the rotating cutting jets used to mobilize waste material from the GAATs.**

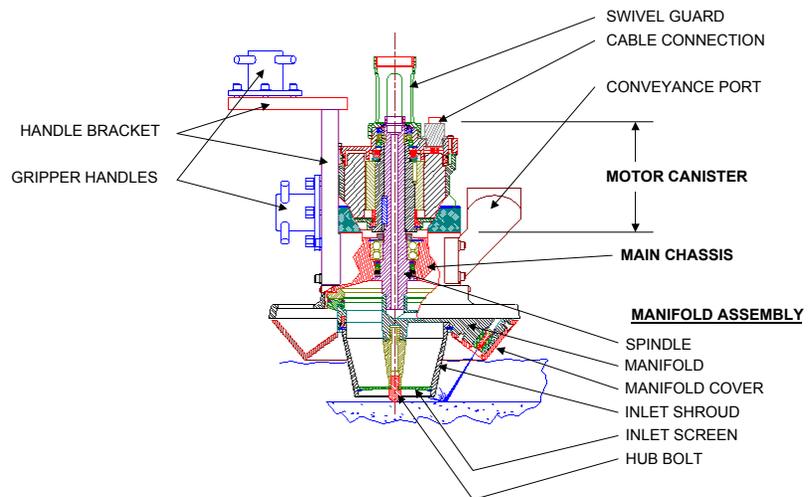
**Fig. 6-4. Schematic cross section of the CSEE assembly.**

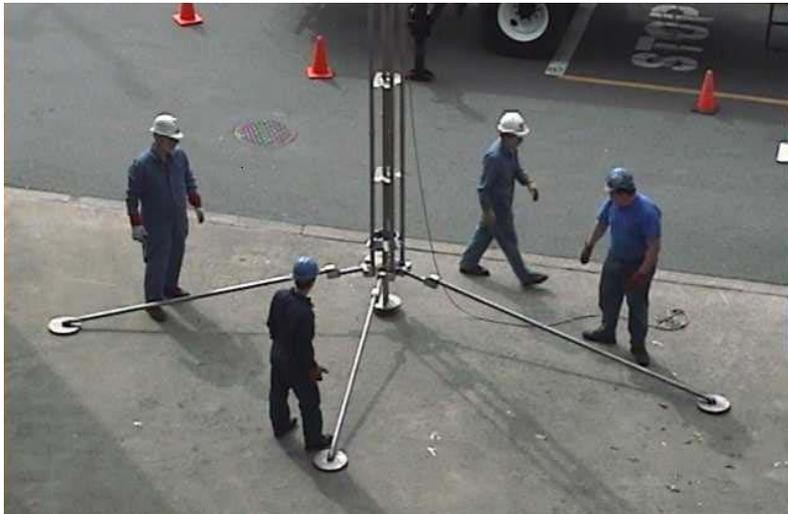
**Fig. 7-2. PAM assembly with arms unfolded.**

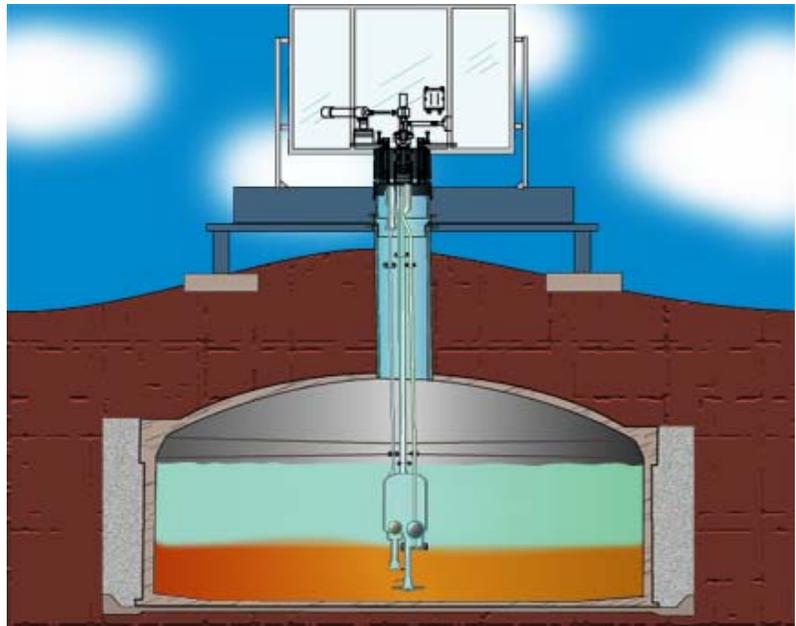
**Fig. 7-5. Schematic cross section of the PMP installed in a tank and its containment structure on an equipment platform positioned over an underground storage tank.**

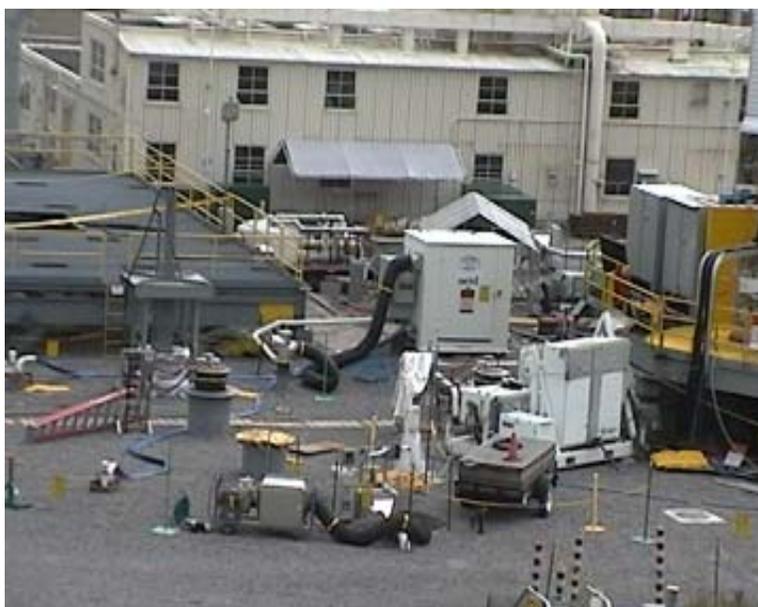
**Fig. 8-1. Components of the WCS, as positioned in the STF near tank W-9 during waste retrieval operations.**

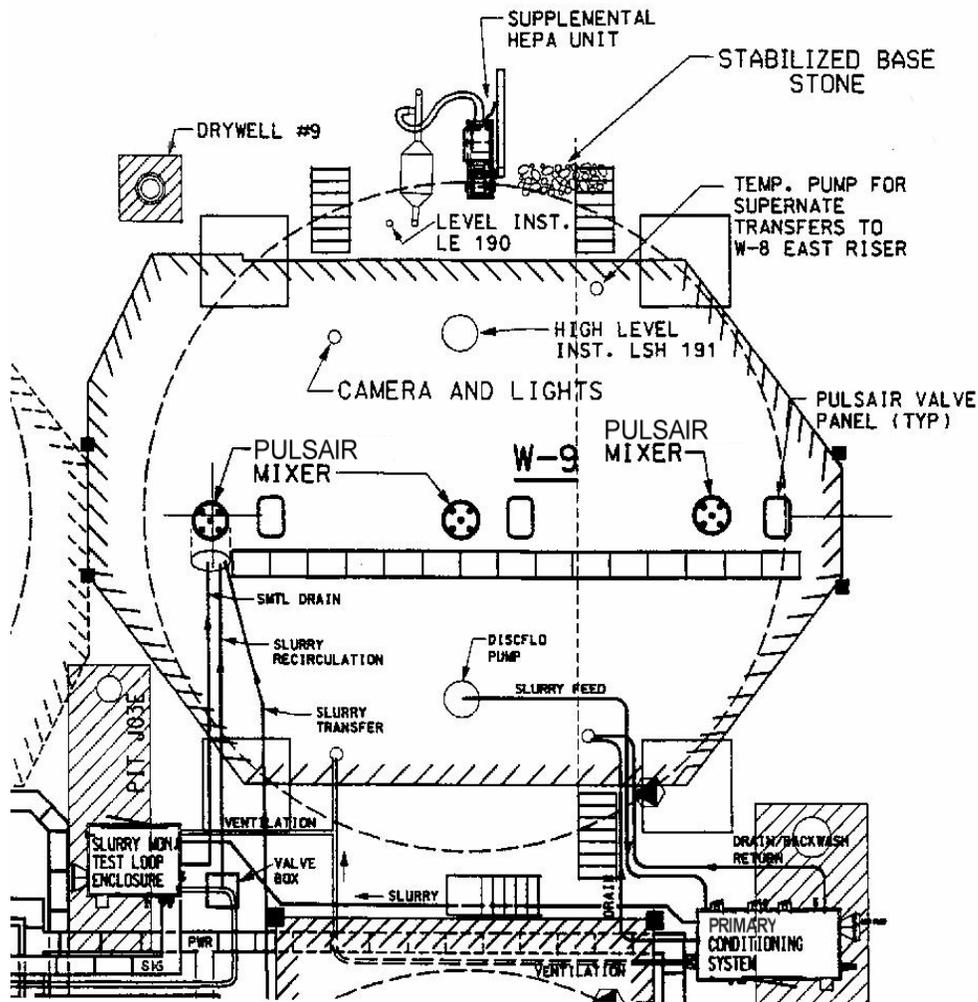
Fig. 8-2. Sketch of the WCS layout at tank W-9.

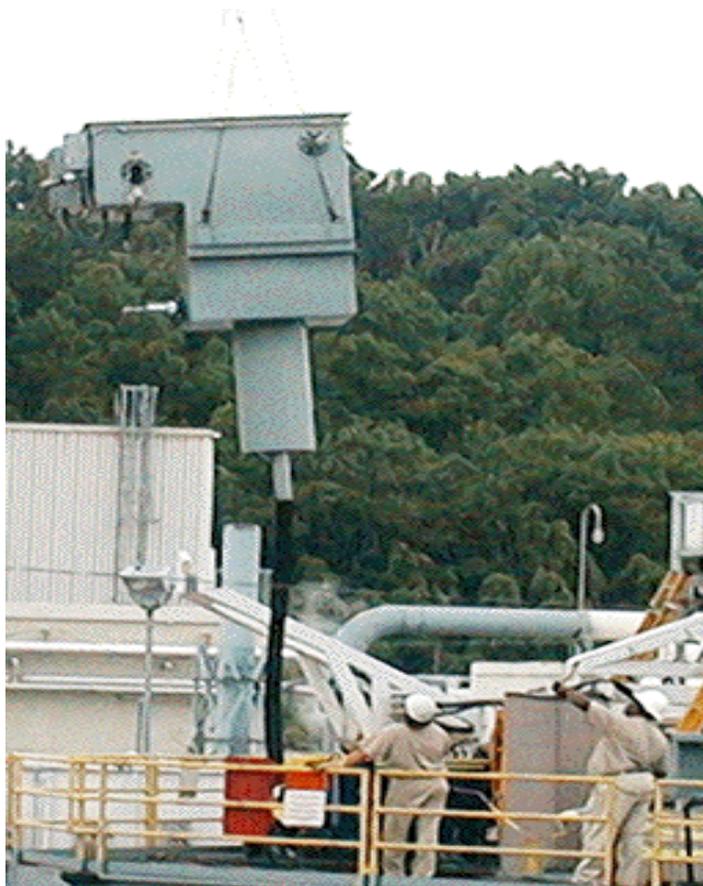
**Fig. 8-5. WaRTS accumulation tank and confinement box assembly as it is lifted onto a riser of tank W-9.**

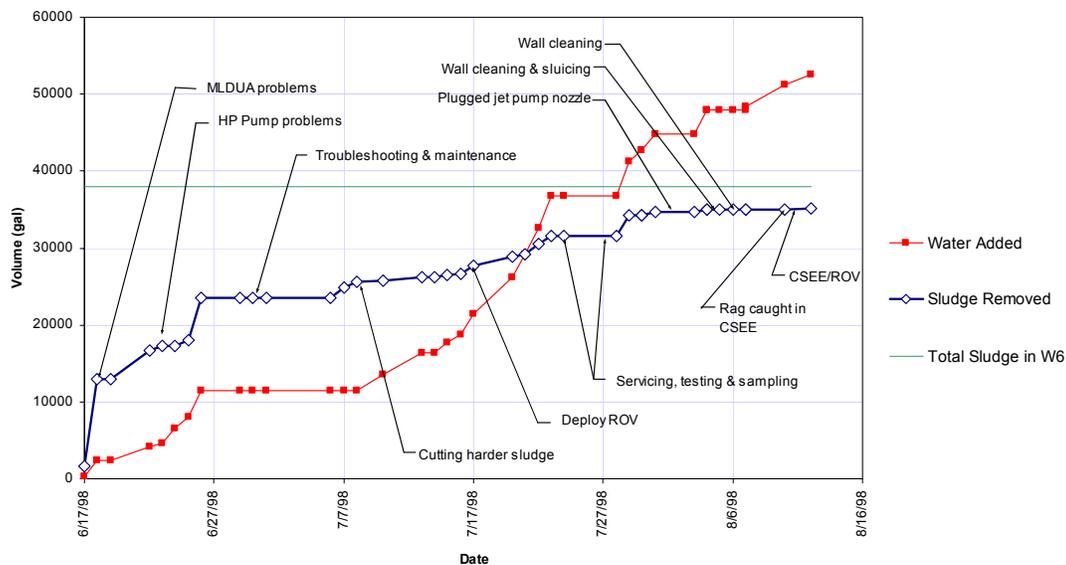
**Fig. 10-1. Chronological plot of W-6 retrieval operations.**

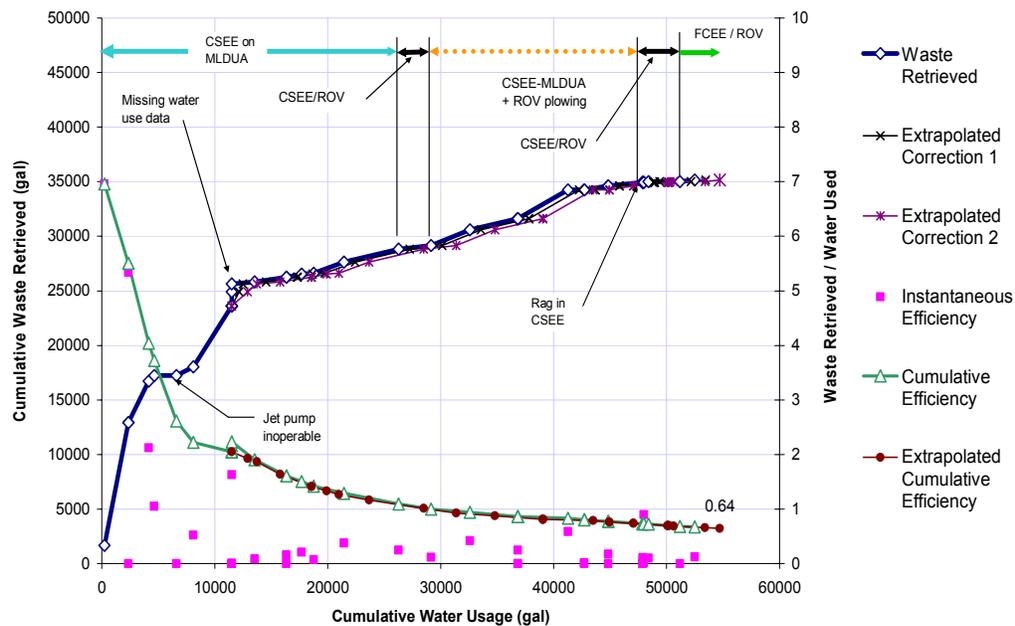
**Fig. 10-2. Waste retrieval efficiency for operations in tank W-6.**

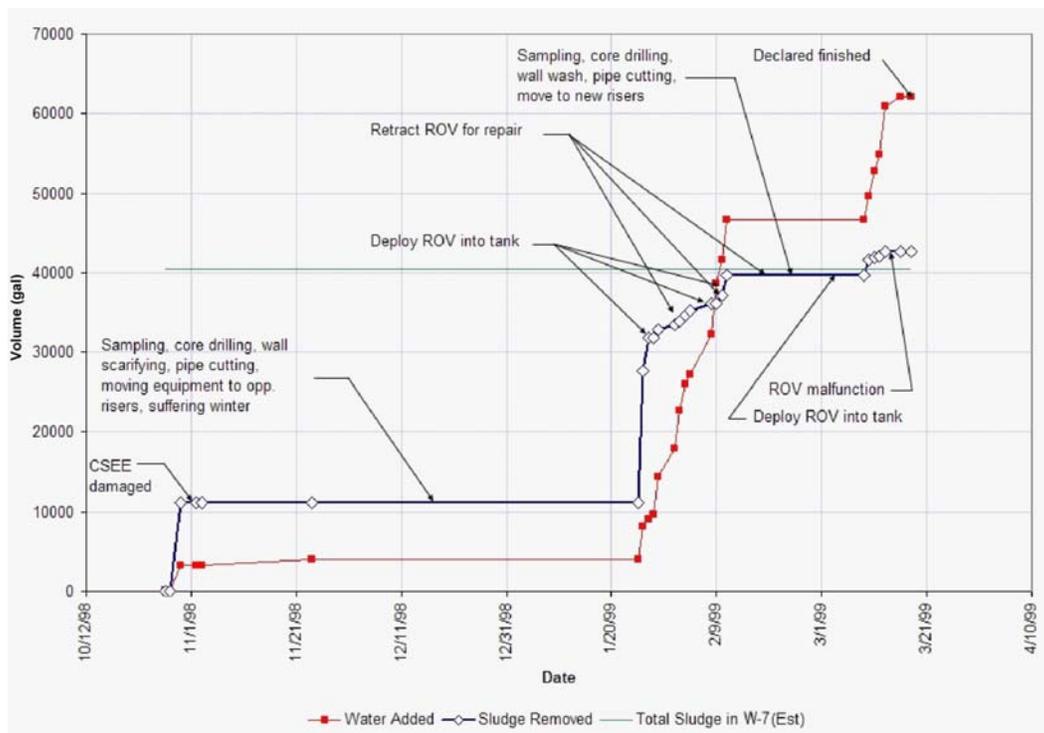
**Fig. 10-3. Chronological plot of tank W-7 waste retrieval operations.**

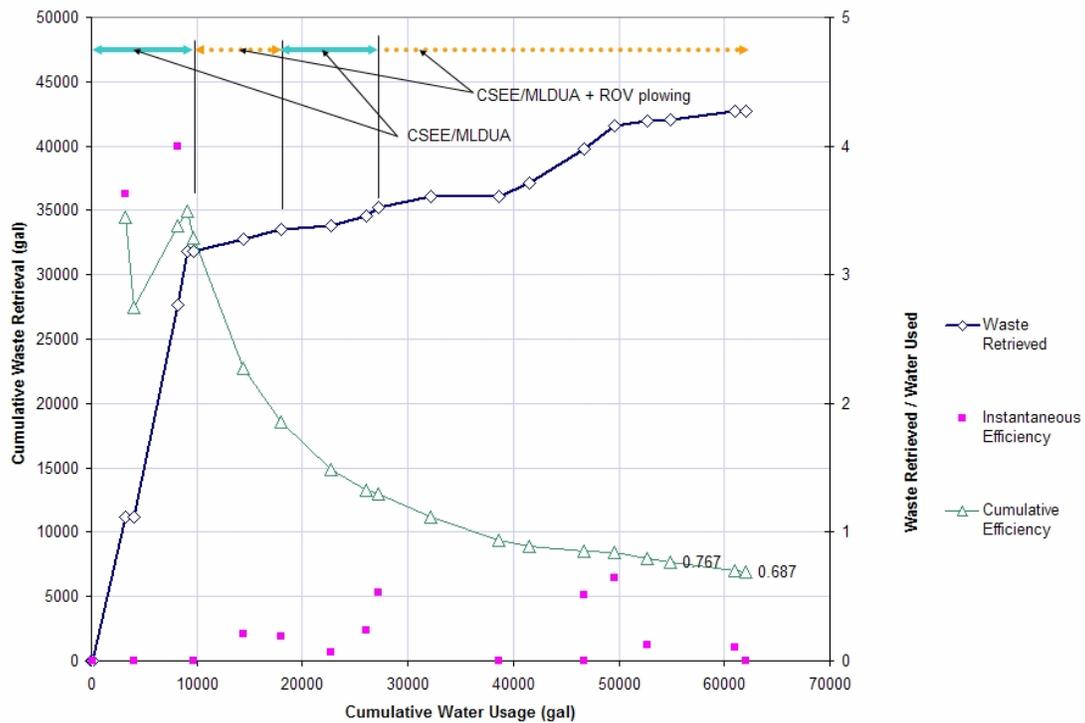
**Fig. 10-4. Waste retrieval efficiency for operations in tank W-7.**

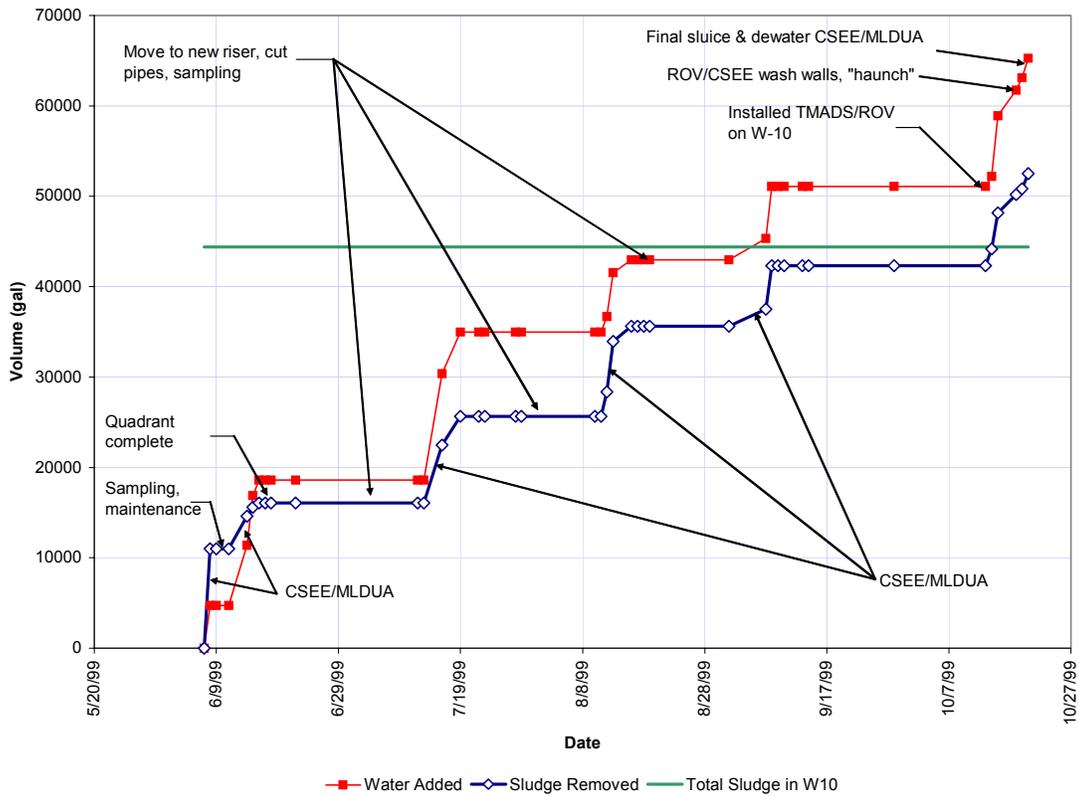
**Fig. 10-5. Chronological plot of tank W-10 waste retrieval operations.**

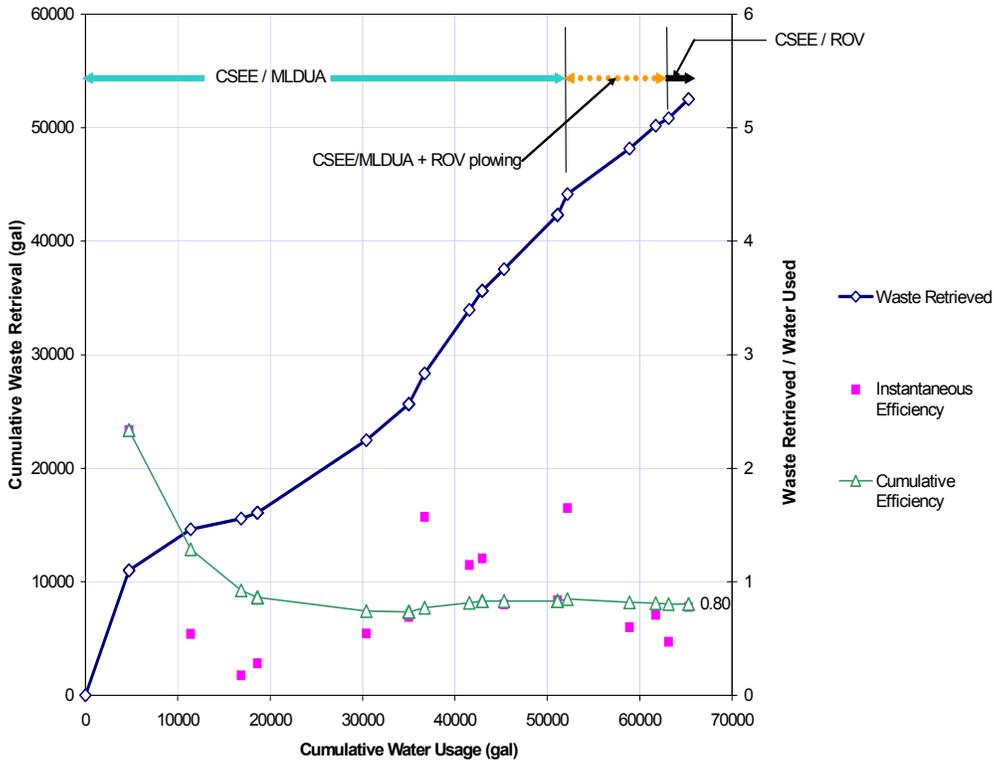
**Fig. 10-6. Waste retrieval efficiency for operations in tank W-10.**

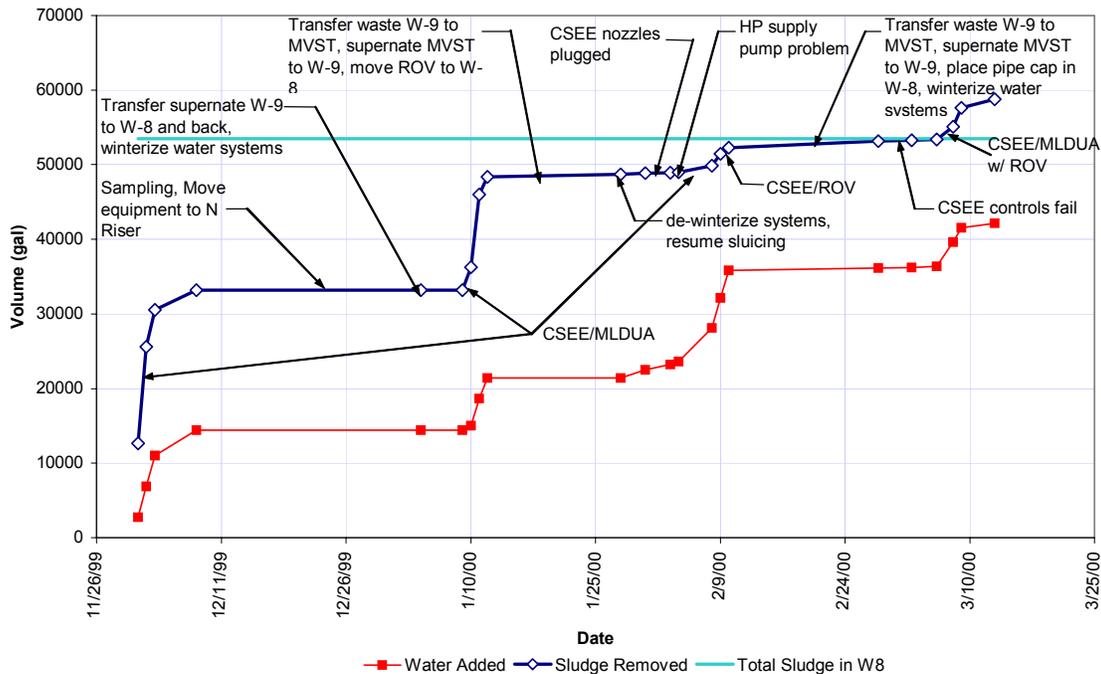
**Fig. 10-7. Chronological plot of tank W-8 waste retrieval operations.**

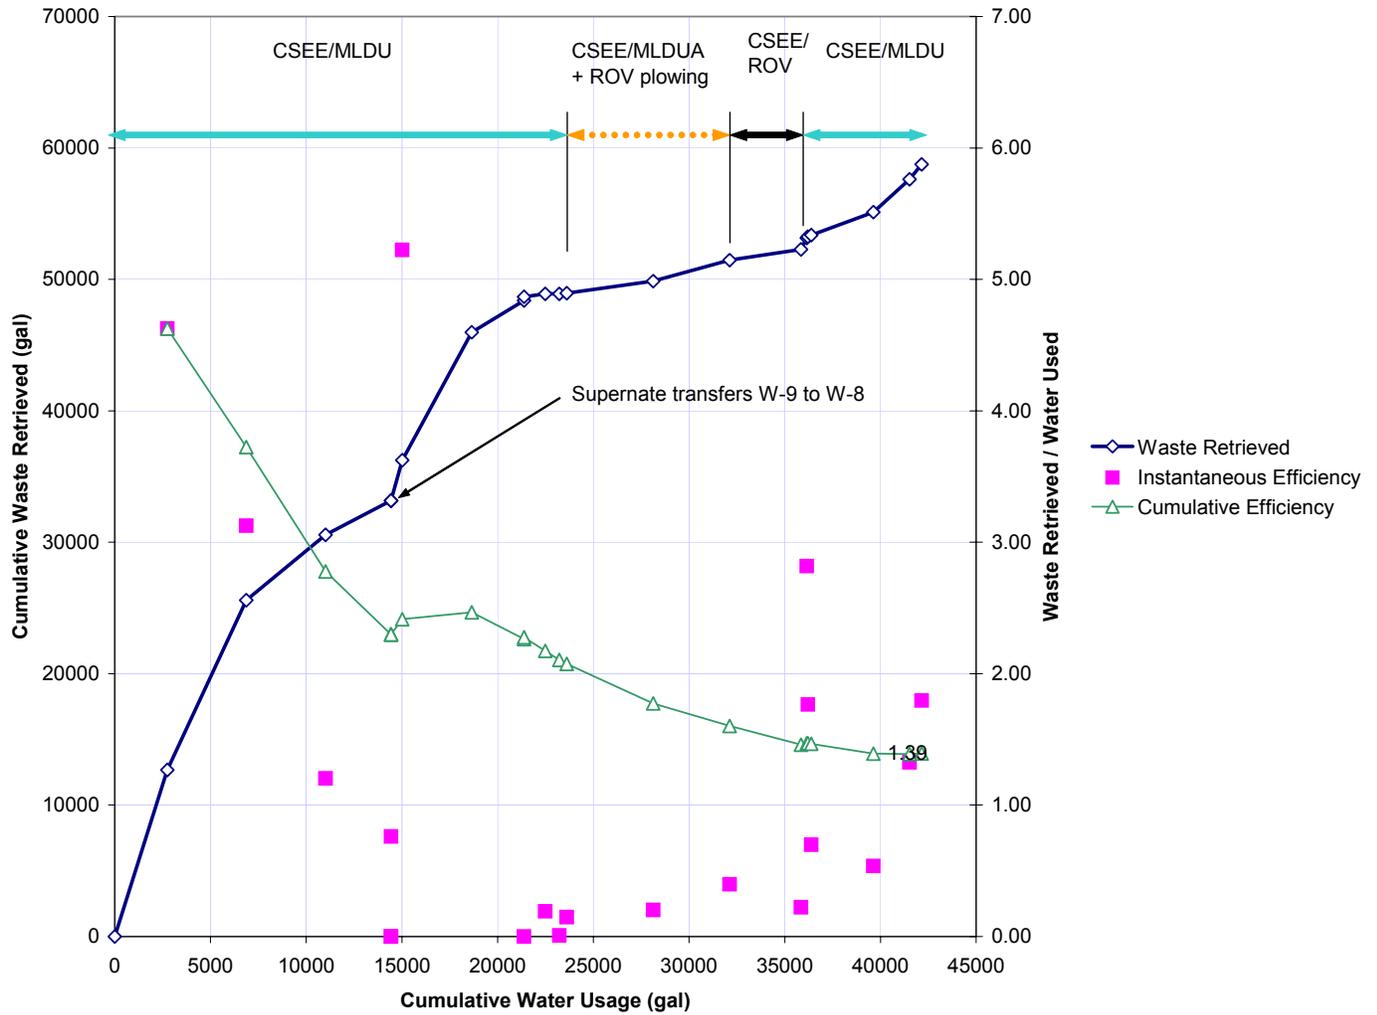
Fig. 10-8. Specific efficiency of W-8 retrieval operations.

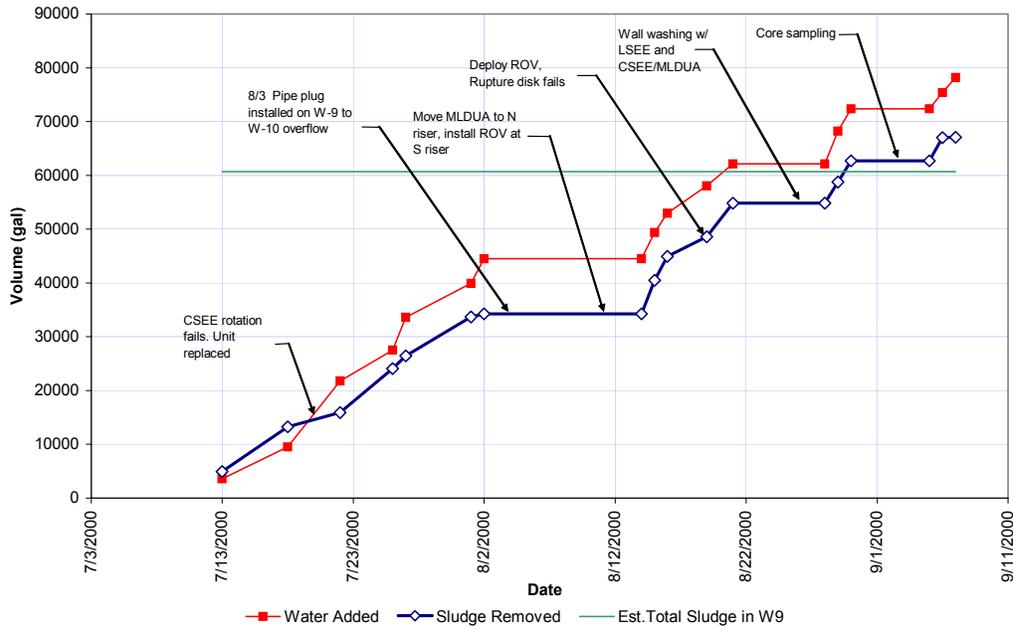
**Fig. 10-9. Chronological plot of tank W-9 waste retrieval operations.**

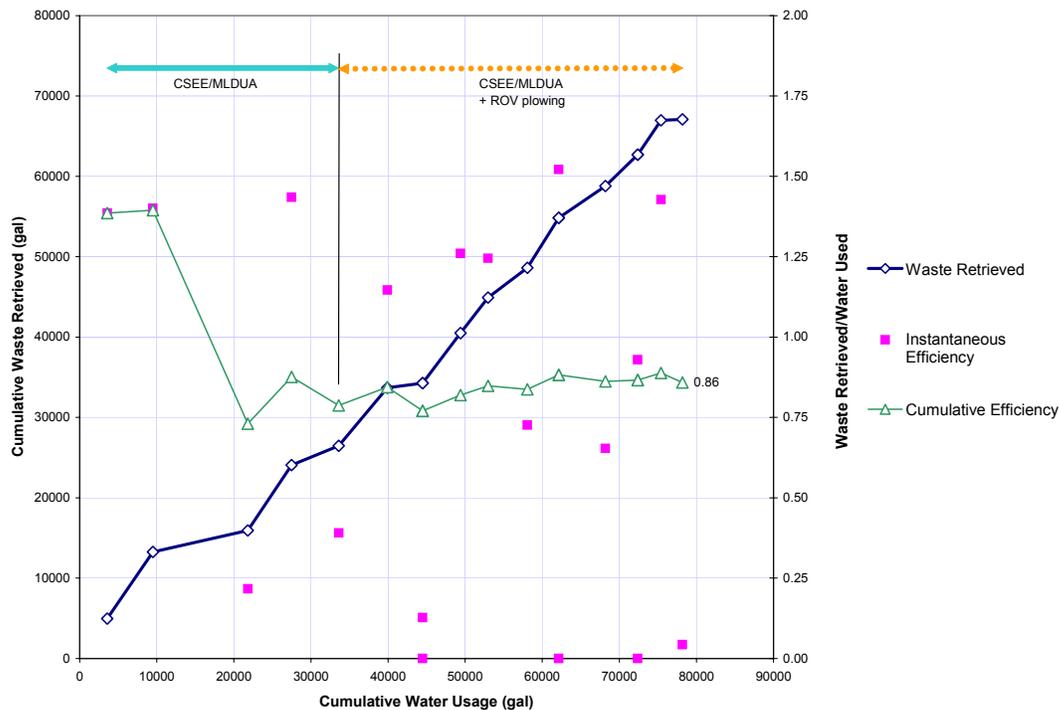
Fig. 10-10. Specific efficiency of W-9 retrieval operations.

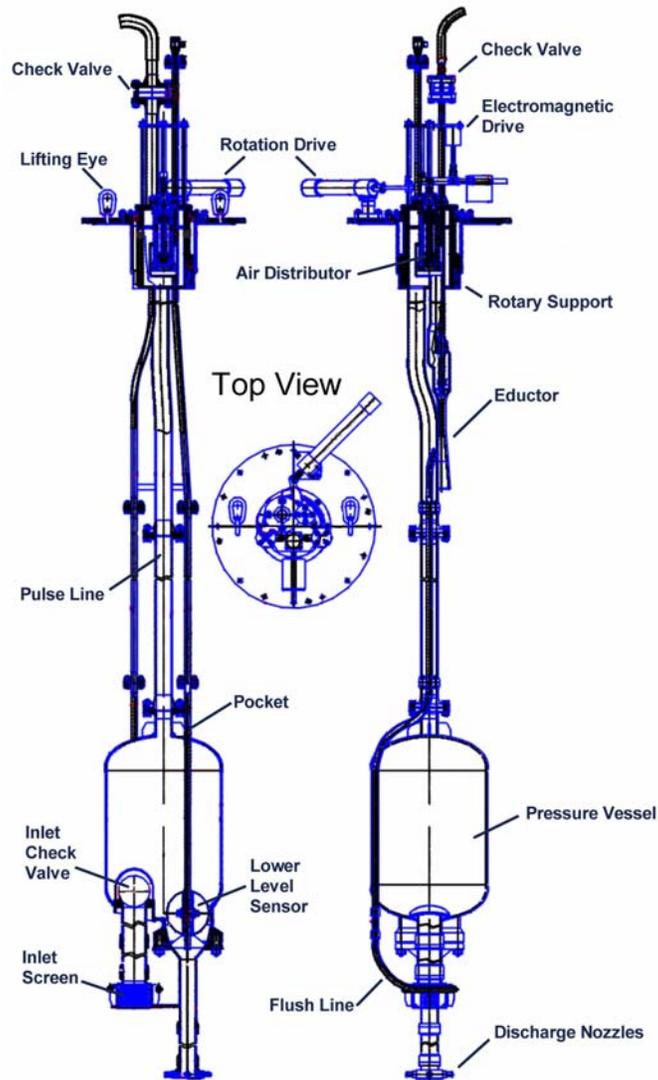
Fig. 11-1. Schematic of the PMP.

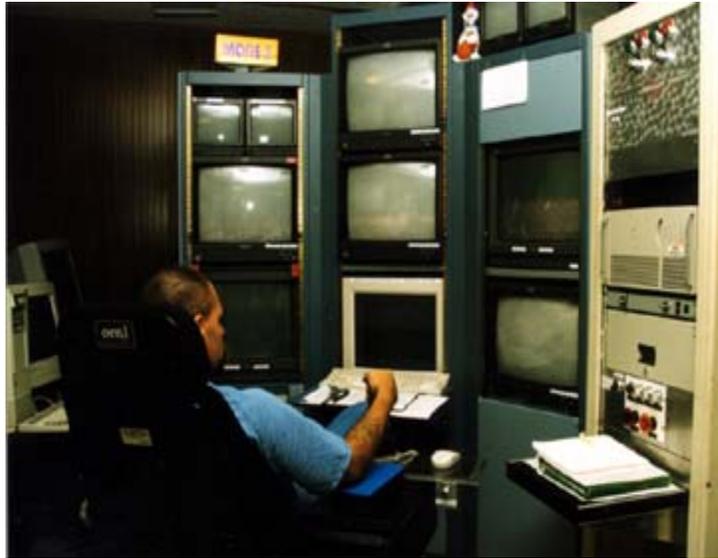
**Fig. 13-2. MLDUA user interface.**
