WVNS Tank Farm Process Support

Corrosion Evaluation of Waste Storage Tank 8D-2 Under Simulated Sludge Washing Conditions

M. R. Elmore

January 1996

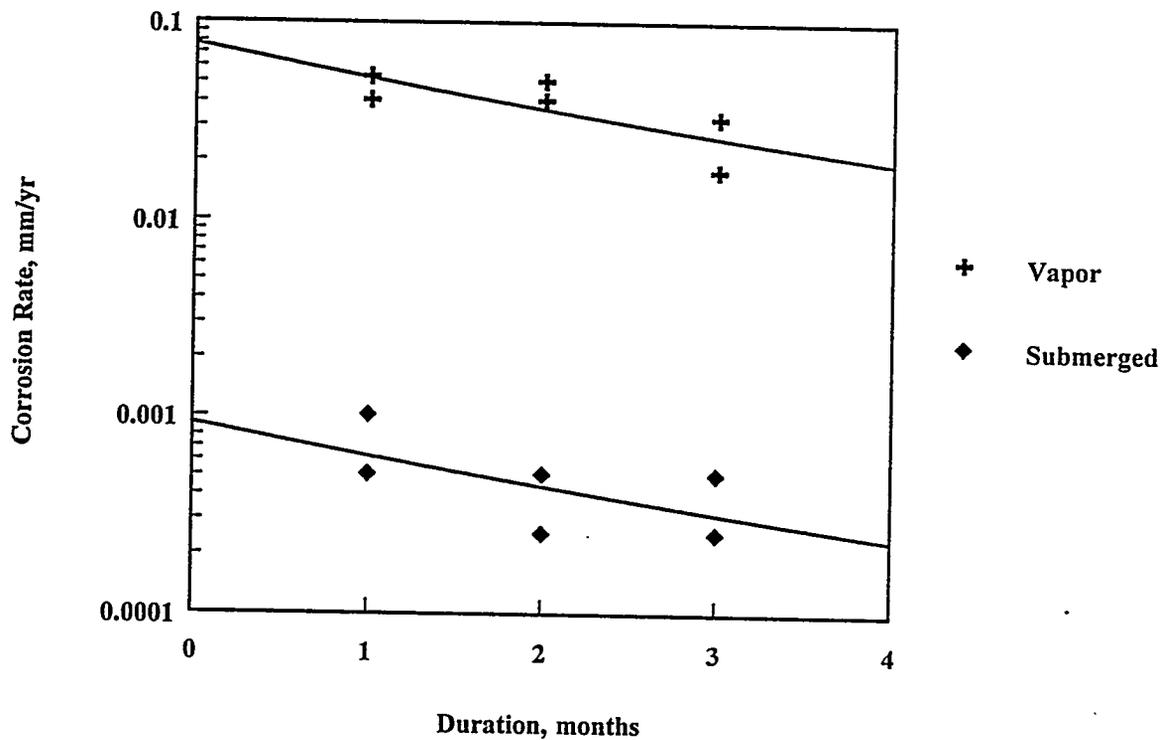
Figure 3.1. Plot of Corrosion Results from “Unwashed” Waste Test. The semi-log plot shows calculated uniform corrosion rates (determined after 1-, 2-, and 3-month exposures) for vapor space and submerged specimens.

The highest corrosion rates were found after a 1-month exposure of specimens to the vapor-phase environment (~0.05 mm/yr), decreasing to ~0.025 mm/yr by the end of the 3-month test. Pitting was noted on both the standard specimens and on the crevice specimens taken from the vapor space. Most of the pits ranged in depth from 0.05 to 0.15 mm, as measured with an optical micrometer. Similar pits were observed after 3 months of exposure, although none were deeper than ~0.15 mm (Table 3.2). Conditions tested with the unwashed waste simulant were apparently not suitable to sustain the pitting corrosion reactions.

For the submerged specimens, calculated uniform corrosion rates ranged from near zero to less than 0.0025 mm/yr after 1 month of exposure. By the end of 3 months, submerged uniform corrosion rates were still very low, indicating long-term uniform corrosion rates significantly less than 0.0025 mm/yr (Figure 3.1). No pitting was observed on these specimens at the 1-, 2-, or 3-month intervals.

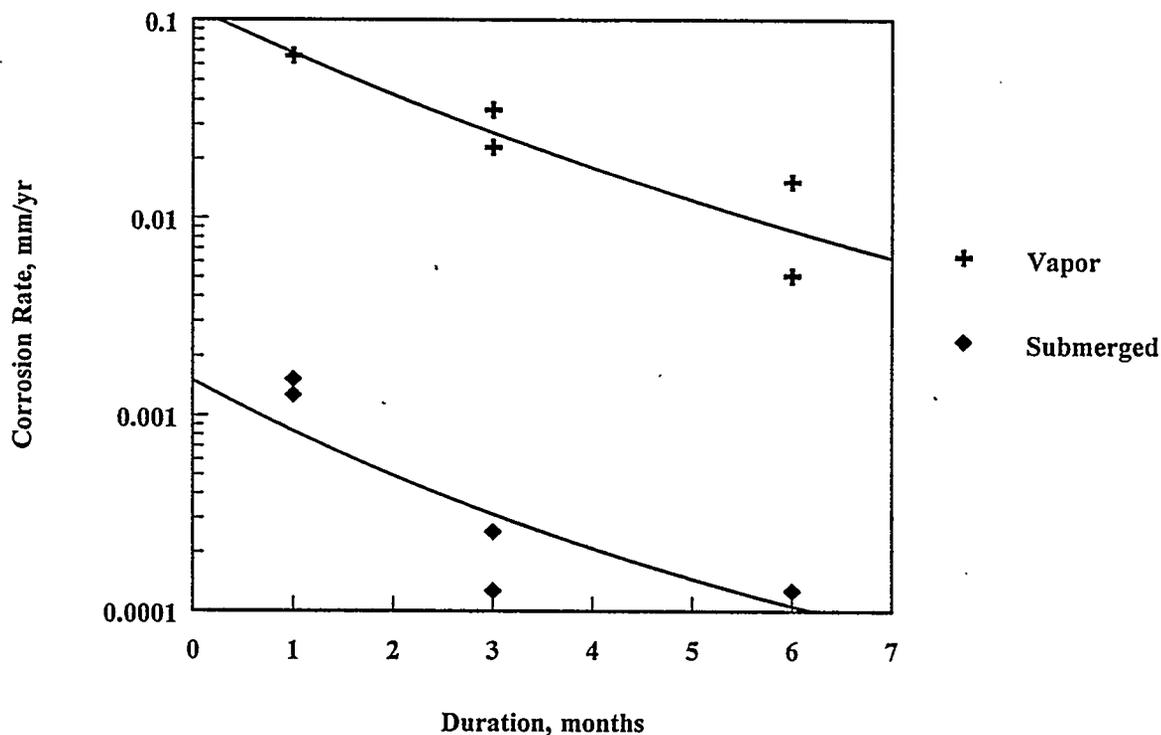
Figure 3.2. Plot of Corrosion Results from 1st-Stage Wash Test. The semi-log plot shows calculated uniform corrosion rates (determined after 1-, 3-, and 6-month exposures) for vapor space and submerged specimens.

Results of the 1st-stage wash tests were similar to results of the unwashed waste test. The most severe corrosion (in terms of weight loss) occurred on the vapor space specimens (Figure 3.2). Pitting

was also observed on the vapor space specimens (Table 3.2) with pits ranging to ~ 0.15 mm deep after 6 months. No pitting was noted on submerged specimens at either test temperature, 66°C and 88°C. No SCC was observed on the submerged U-bend specimens. Long-term uniform corrosion rates for submerged specimens were low (<0.0025 mm/yr) by the end of the 6-month tests (Figure 3.2). No significant difference in calculated uniform corrosion rate for the submerged specimens was apparent between the 66°C and 88°C tests.

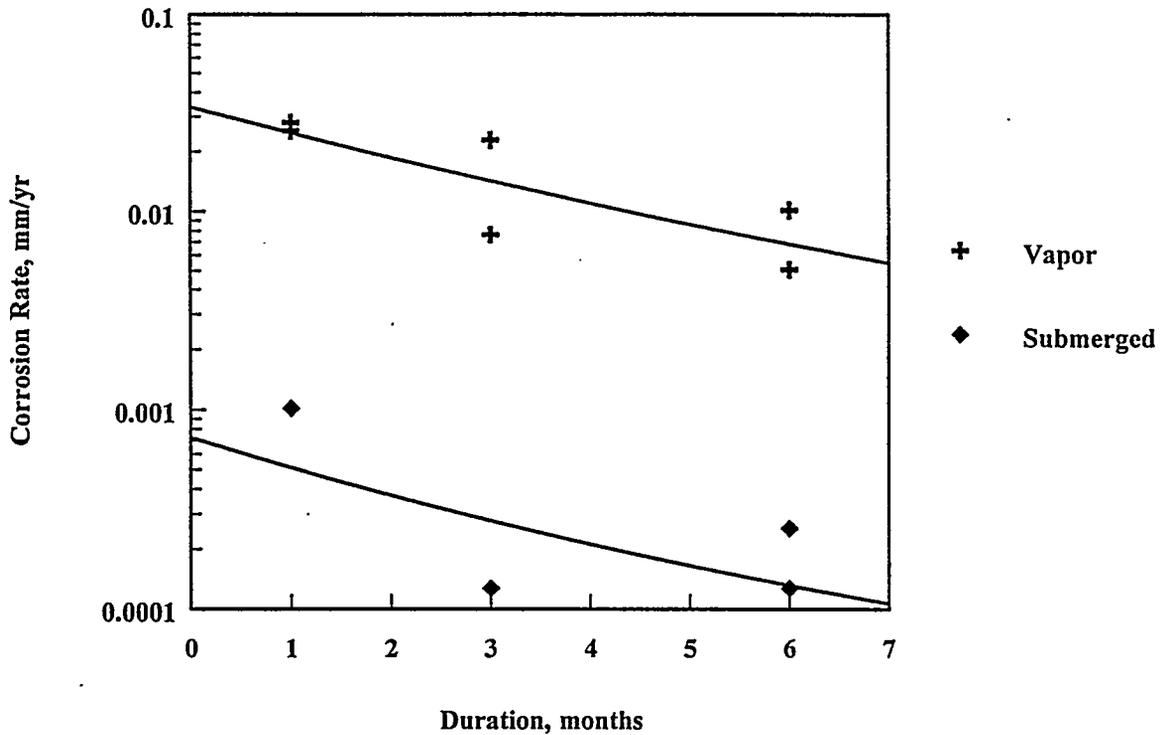
Figure 3.3. Plot of Corrosion Results from 2nd-Stage Wash Test. The semi-log plot shows calculated uniform corrosion rates (determined 1-, 3-, and 6-month exposures) for vapor space and submerged specimens.

Figure 3.3 shows a plot of uniform corrosion rate as a function of exposure time for the vapor space and submerged specimens. Data for 66°C and 88°C were combined on the same graph, since no significant difference was noted in corrosion rate between the two temperatures.

For the submerged specimens, calculated uniform corrosion rates ranged from near zero to ~0.0003 mm/yr after the 6-month exposures (see Table 3.1 and Figure 3.3). No pitting was observed on the submerged specimens from the 1-, 3-, or 6-month durations.

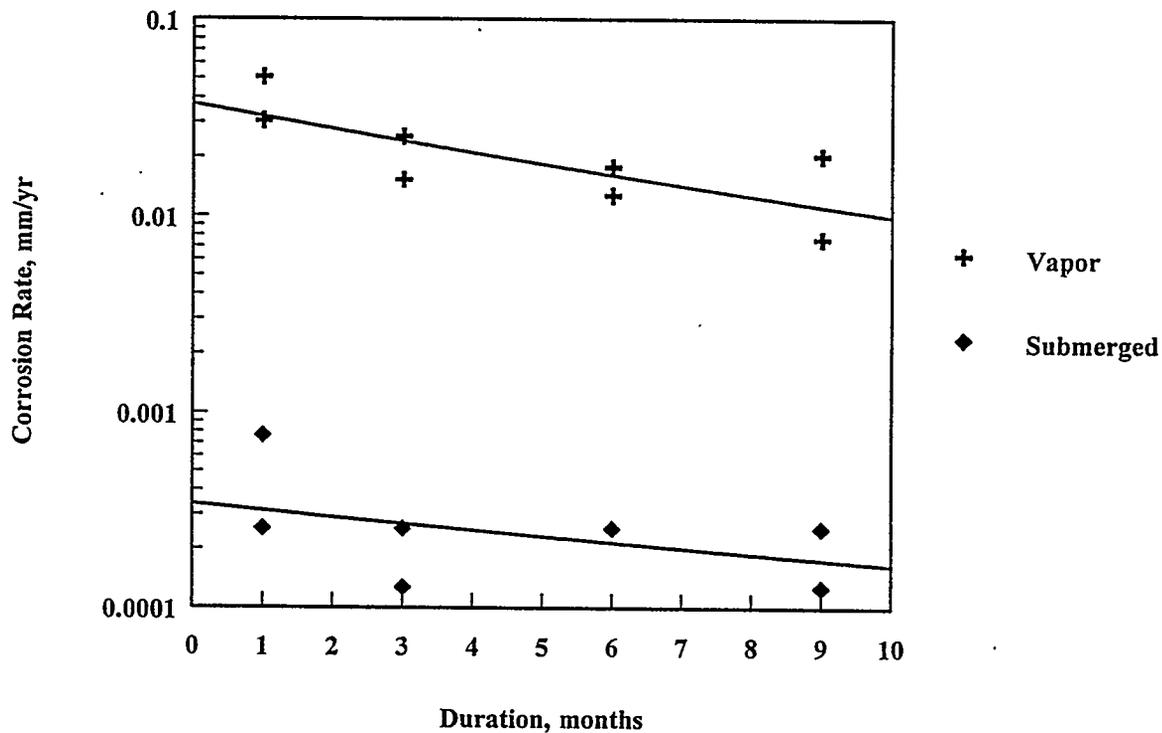
Figure 3.4. Plot of Corrosion Results from "Original" 3rd-Stage Wash Test. The semi-log plot shows calculated uniform corrosion rates (determined after 1-, 3-, 6-, and 9-month exposures) for vapor space and submerged specimens.

Table 3.1 gives the calculated uniform corrosion rates for the 1-, 3-, 6-, and 9-month exposures for specimens from the original 3rd-stage wash test, and the 1-, 3-, and 6-month exposure specimens from the revised 3rd-stage wash test. Figure 3.4 shows a plot of uniform corrosion rate as a function of exposure time for the submerged and vapor specimens from the original 3rd-stage wash test. No significant difference was noted in corrosion rate between the 66°C and 88°C test temperatures. Figure 3.5 shows a plot of uniform corrosion rate for the submerged and vapor specimens from the revised 3rd-stage wash test. Again, no significant difference was noted in corrosion rate between the 66°C and 88°C test temperatures.

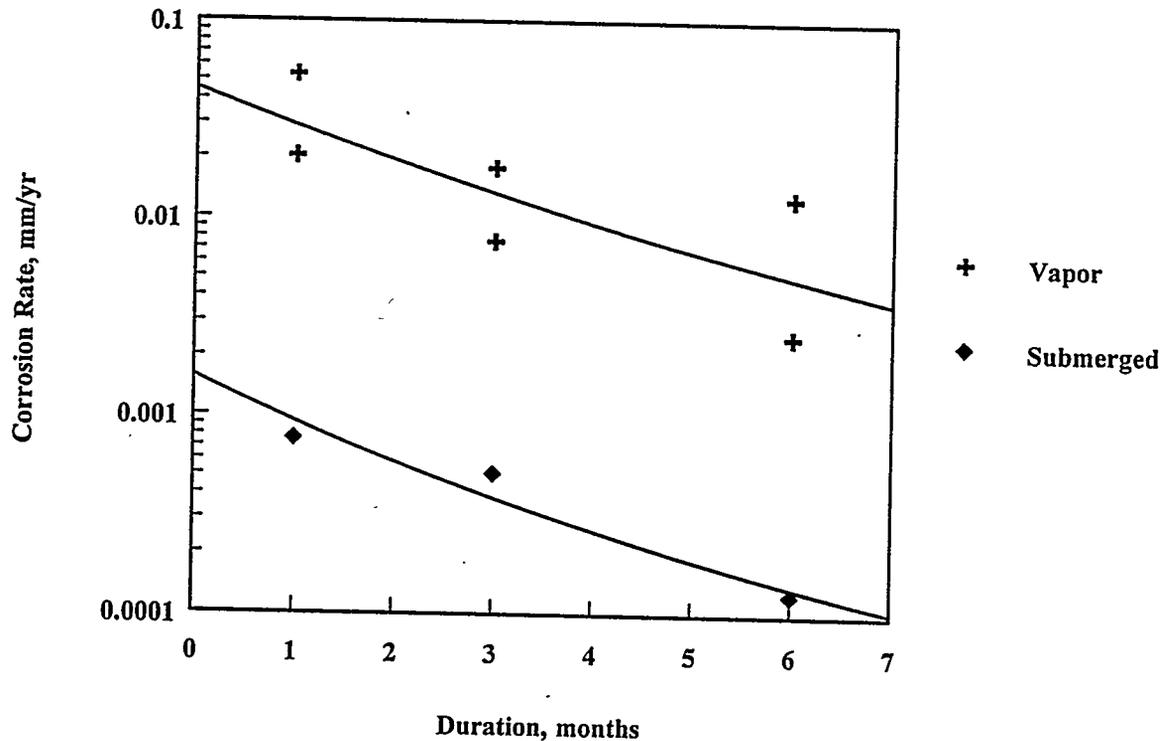
Figure 3.5. Plot of Corrosion Results from “Revised” 3rd-Stage Wash Test. The semi-log plot shows calculated uniform corrosion rates (determined after 1-, 3-, and 6-month exposures) for vapor space and submerged specimens.
