# Pacific Northwest National Laboratory

## Bench-Scale Feasibility Testing of Pulsed-Air Technology for In-Tank Mixing of Dry Cementitious Solids with Tank Liquids and Settled Solids

September 1997

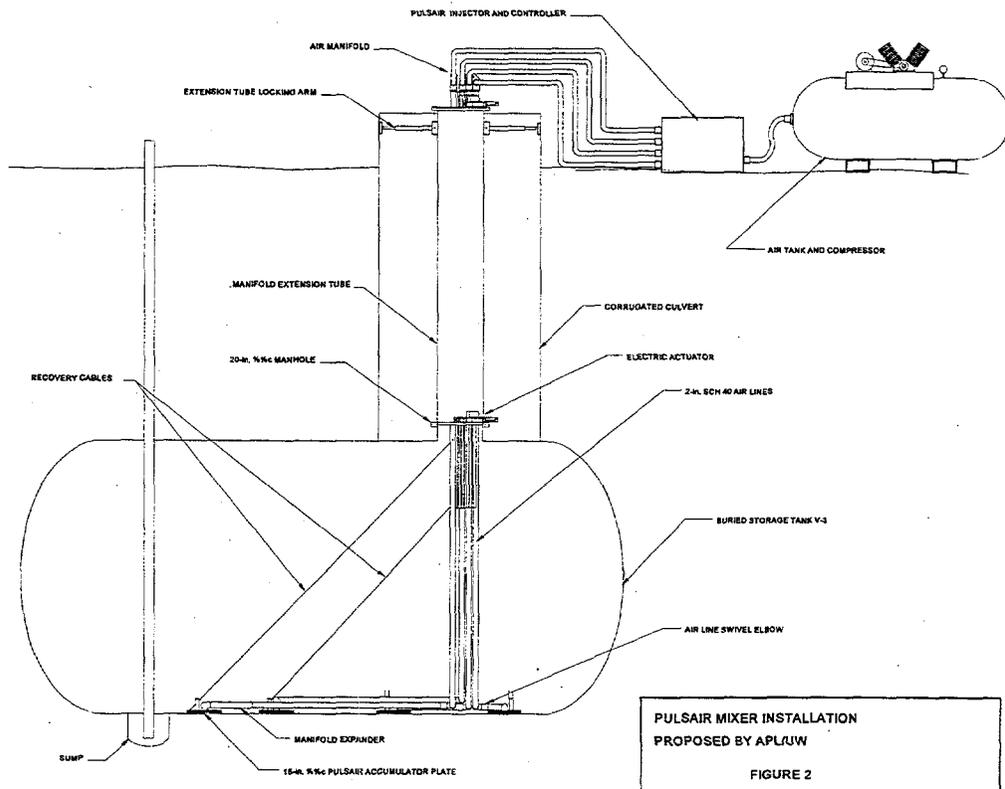
**Figure 2.1.** Installed Pulsed-Air Mixer in INEEL V-Tank (reproduced from Powell and Hymas 1996).

the manway and unfolding accumulator plates on extensions to provide agitation across the whole tank. After deployment, the accumulator plates are roughly evenly spaced with the manway between two plates at one end of the tank. The otherwise even spacing of accumulator plates is slightly disrupted by the presence of the sump.

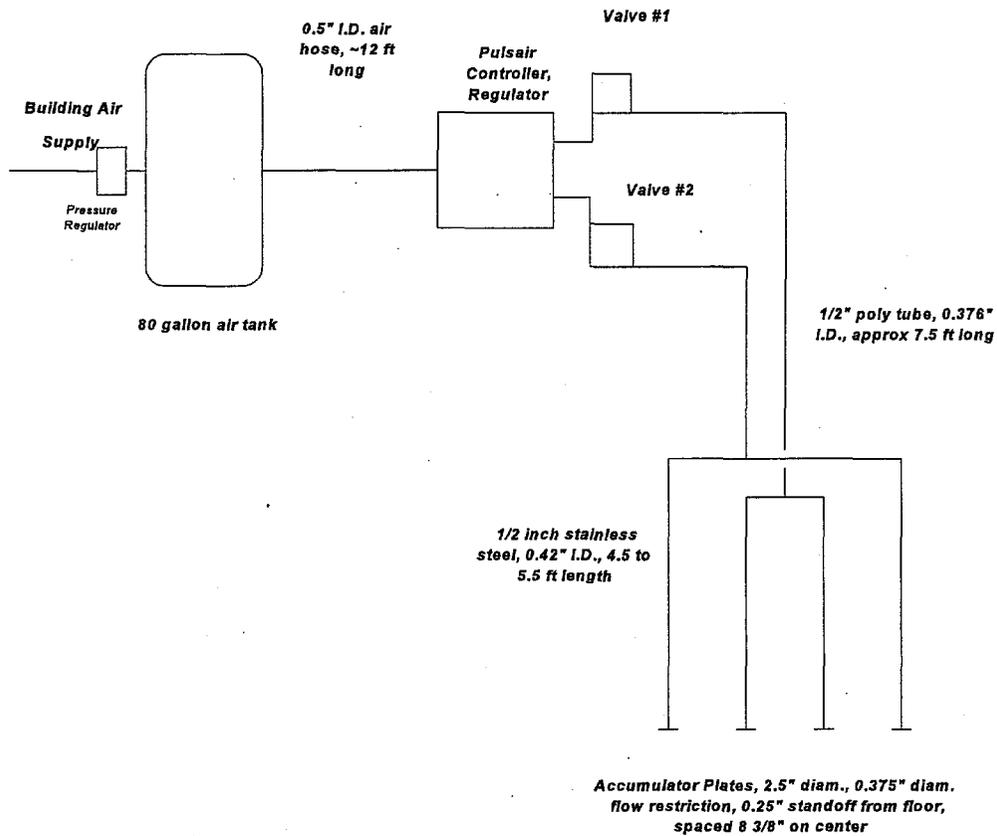
**Figure 5.1.** Schematic of Test 1 Air Delivery System

A schematic configuration of the pulsed-air control equipment is shown in Figure 5.1. Photographs showing the accumulator plates within the drum and the air supply test setup are provided in Figures 5.2 through 5.4. Prior to actual testing, water was placed in the drum and the air pulsing system tested. Operating in water, it appeared that the system had minimal effect on coarse sand particles on the bottom of the drum and it appeared unlikely that the soil would be suspended by the system. The system as configured could supply a much higher pulsing frequency than was used in this test.

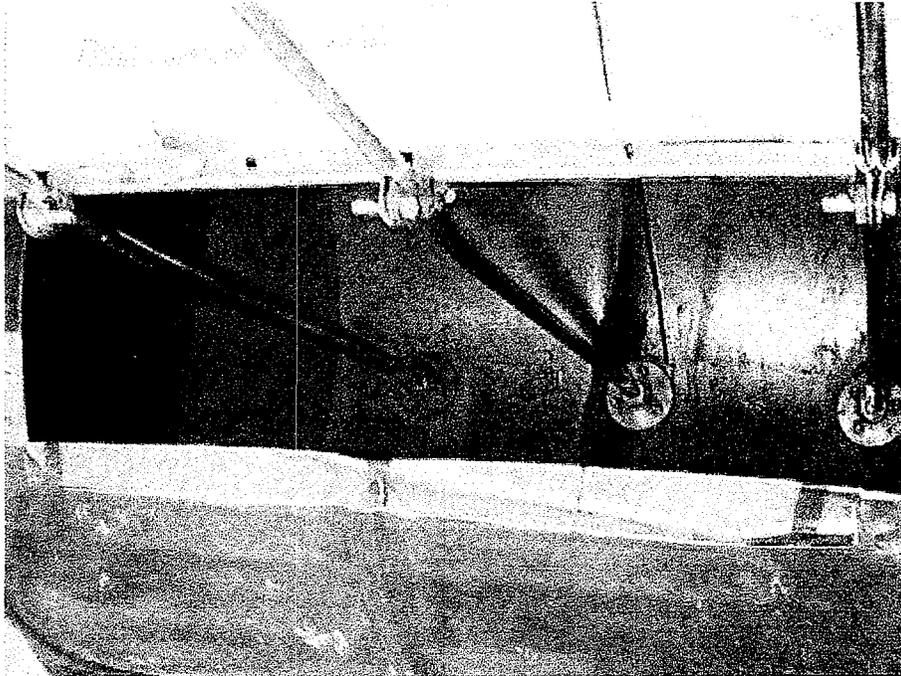
**Figure 5.2.** Test 1 Accumulator Plate Positioning. Dark area on drum floor is epoxy used to fill in the drum ribs. The thermocouple is also visible.

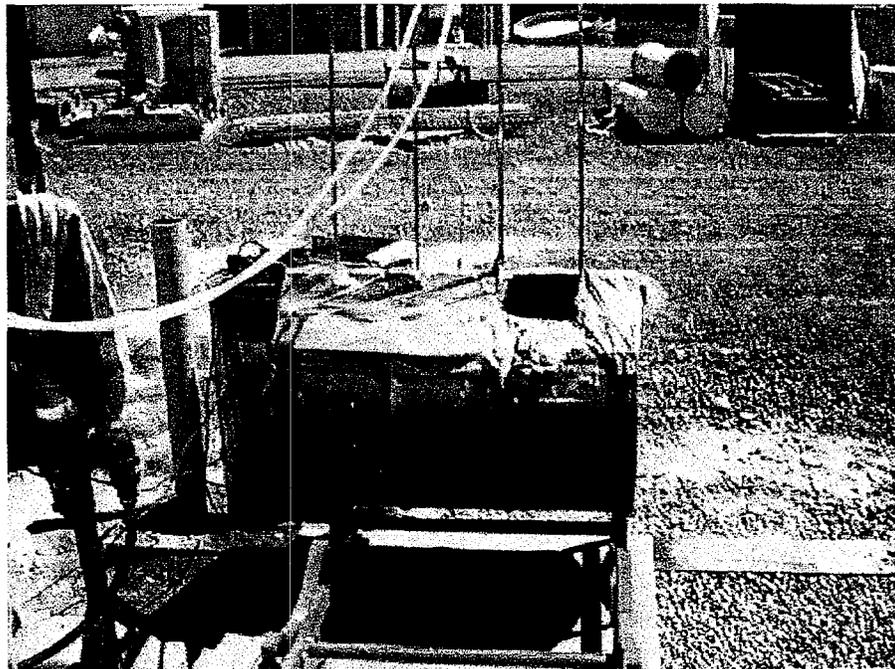
**Figure 5.3.** Test 1 Configuration. The polyethylene tubing that supplied air to each pair of accumulator plates was believed to be choking flow in this test.

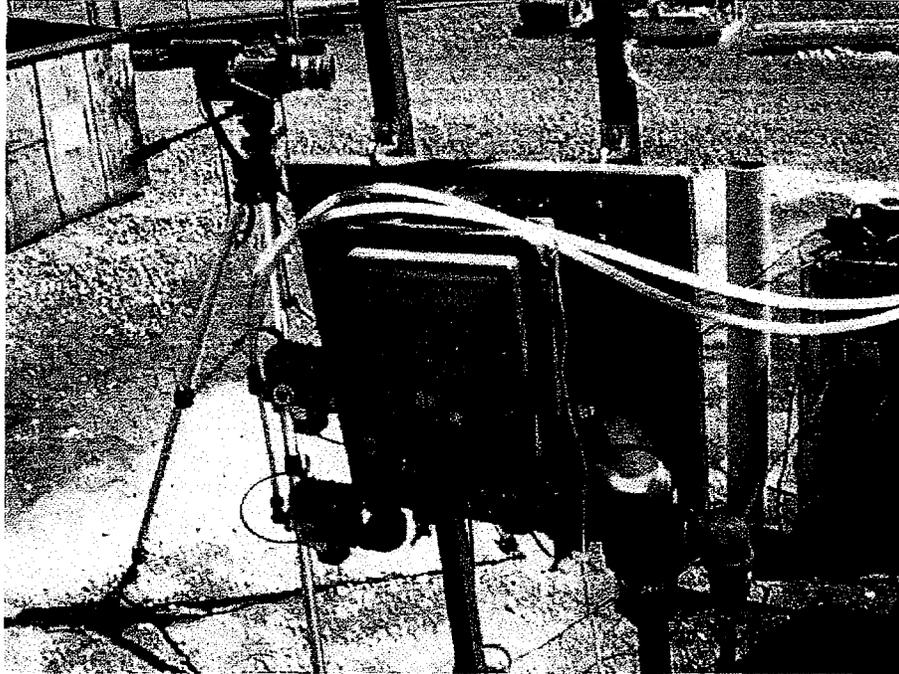
**Figure 5.4.** Position of Valves and Pulsair Controller in Test 1. Each polyethylene tube leads to a pair of accumulator plates. An air hose supplies the system at bottom right of photo.

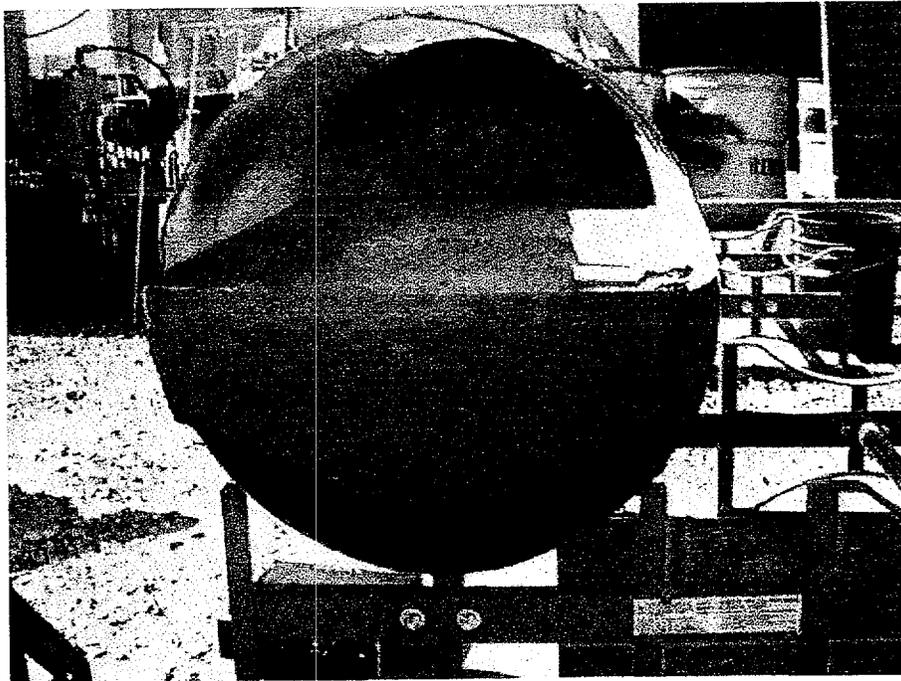
**Figure 5.6.** End View of Drum in Test 1. Dark area shows soil that is poorly mixed.

slurry. One end of the drum and the drum wall above the grout level was cut away. It was clear upon removal of the end of the drum that most of the soil did not mix into the grout product (Figures 5.6 and 5.7). Non-cemented soil was mounded between accumulator plates and piled along the sides of the drum. Mixing of cement to the floor of the drum occurred only within about a 5-in.-diam. circle surrounding each accumulator plate (Figures 5.8 and 5.9).

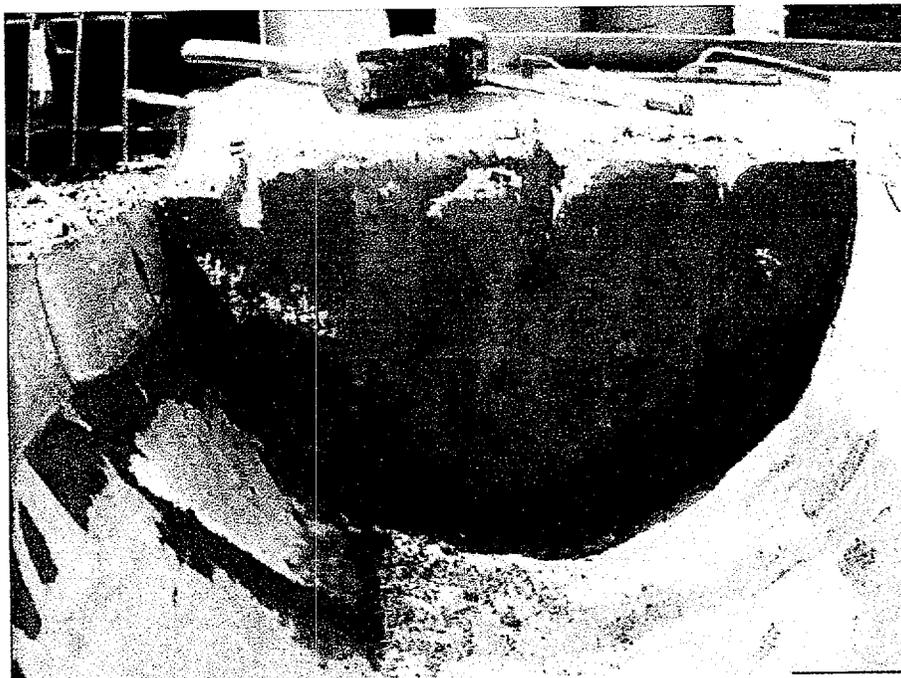
**Figure 5.7.** Profile along Drum Bottom in Test 1. Dark area shows soil that is poorly mixed.

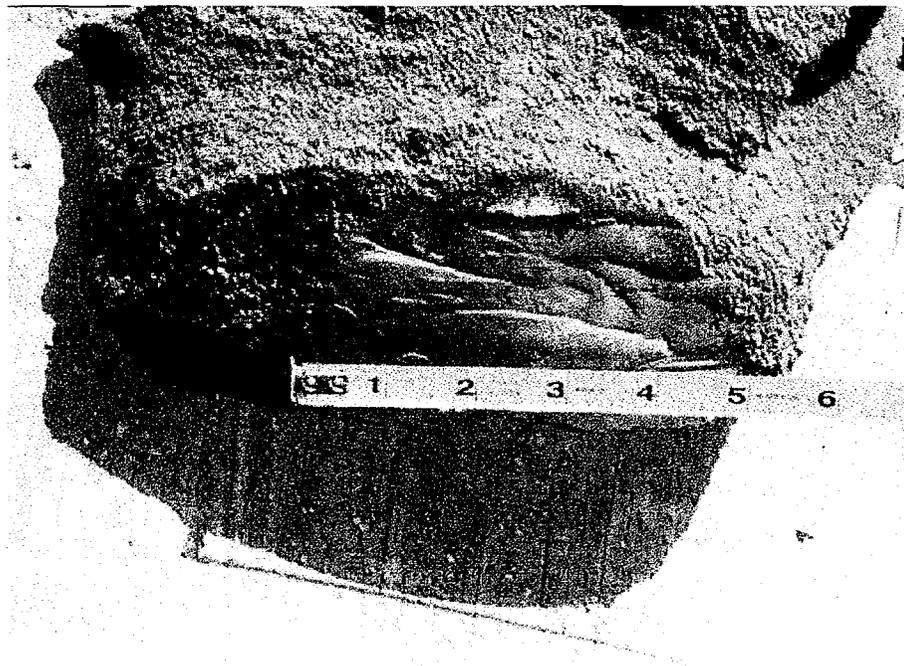
**Figure 5.9.** Test 1, Profile of Cemented Material at Accumulator Plate Position.

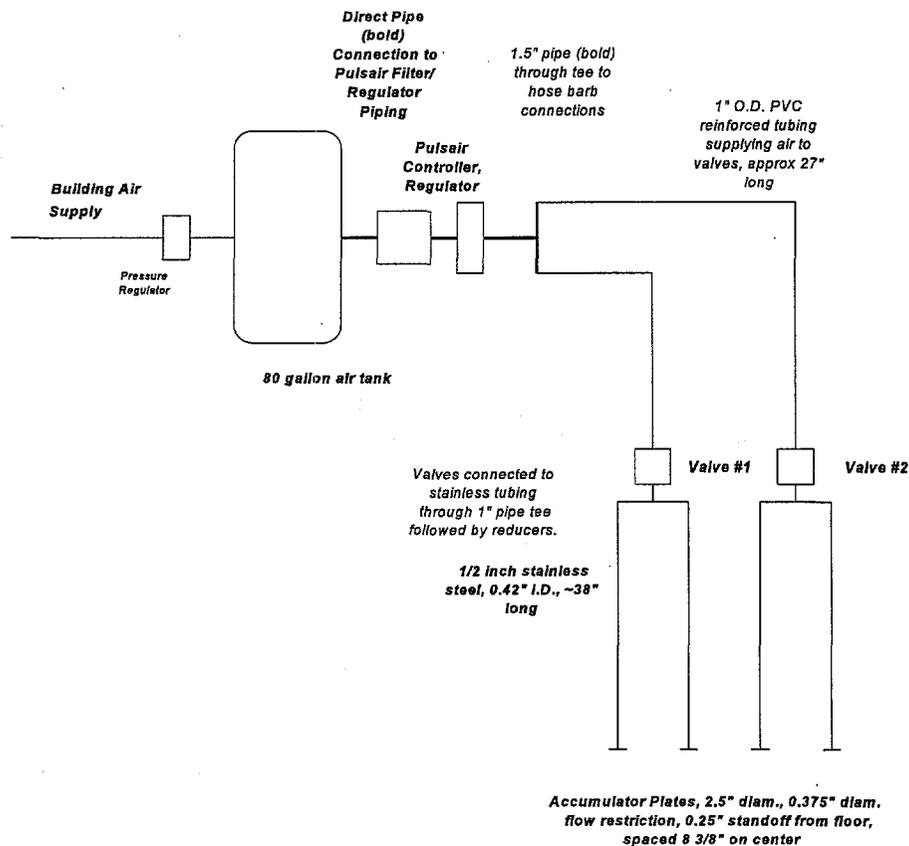
Figure 5.10. Revised Air Delivery System for Test 1B.

Because the soil failed to mix into the slurry, the air delivery system was reviewed. The cross sectional area available for flow in the tubes running between the pulsed-air valves and the tees which, in turn, supplied air to each pair of accumulator plates was determined to be insufficient. This resulted in a “choked-flow” situation which limited flow of air to the accumulator plates during each pulse. It was decided to repeat Test 1 with some modifications. The pulsed-air valves were mounted directly above the drum on larger tees to avoid flow restrictions and the air hose between the air tank and the pulsed-air controller/valves was eliminated. It was decided to simultaneously pulse both plates at one end of the drum in order to increase the mixing action at the addition point and to use a higher pressure (see Chapter 3) and frequency for the pulsing. A schematic of the revised pulsing system is shown in Figure 5.10.

The equipment setup for Test 3 was the same as for Test 2 and is accurately represented by Figures 5.10 through 5.12. Due to the extra scoping test performed (Test 1B), the soil initially collected was exhausted and additional soil was needed for Test 3. Because a second soil batch was collected, there are minor differences between the soil used in earlier tests and the soil for Test 3. The additional soil was collected from the same source and was analyzed for soil moisture and size distribution by sieving (see Section 5.1).

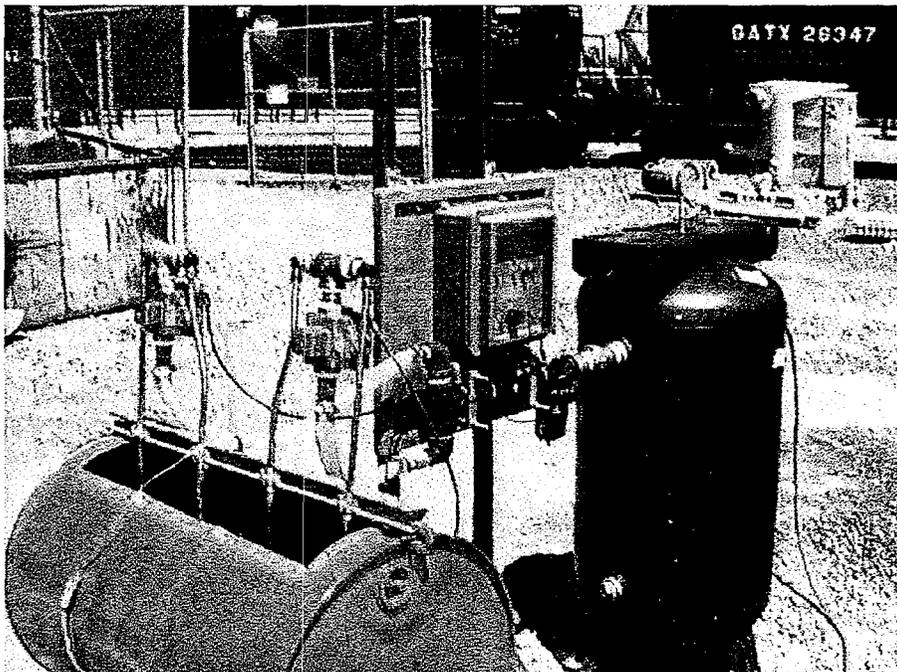
**Figure 5.12.** Setup for Tests 1B, 2, and 3. (Tests 2 and 3 included an additional air hose to supply tank)

Photographs of the test setup prior to testing are provided in Figures 5.11 and 5.12. The pulse frequency was set at 21/minute for each valve (42 pulses/minute total). The pressure was approximately 65 to 67 psi, the highest pressure that could be maintained during operation. To allow sustained operation at higher pressures, a second air supply hose was added in Tests 2 and 3.

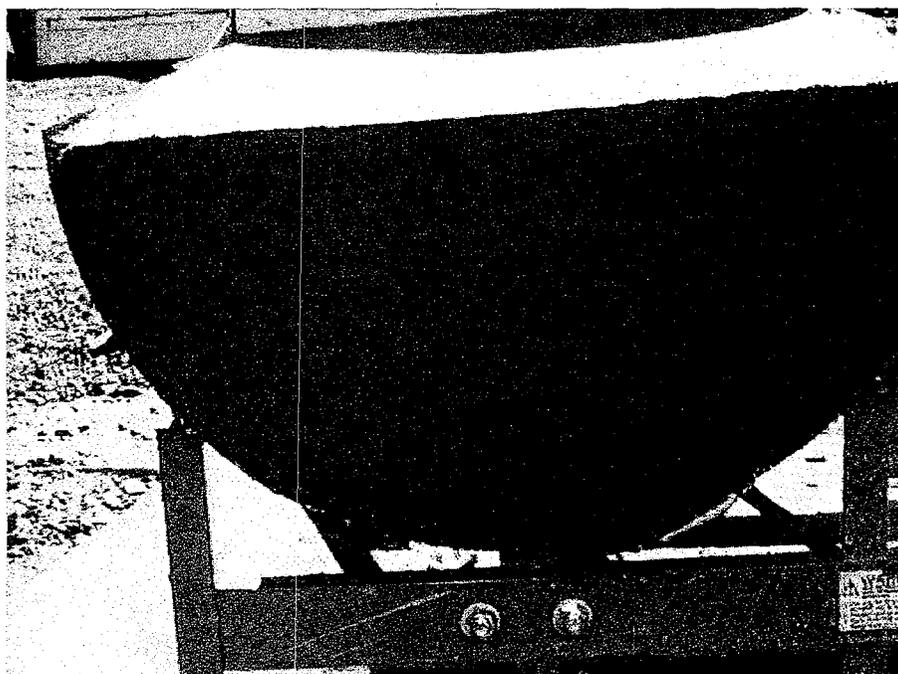
**Figure 5.13.** End View of Grout Block From Test 1B. The dark area is soil that is poorly mixed into the grout.

Disassembly of the grout was started approximately 65 hours after completing the mixing. As in Test 1, the top half of the horizontal drum and the end of the drum farthest from the addition point was removed first. The surface of the grout was smooth with no evidence of floating cement clumps that had been observed in Test 1. Next, the grout was chiseled away in about 6-in. increments down the length of the drum. Much less unmixed sand was observed in this test compared to Test 1. The deposits seemed to be biased towards the end farthest from the addition point and to one side of the line of accumulator plates. Small silvery specks were noted in several samples. Observation of bubbles within the cured grout indicate the specks may have a tendency to attach to air bubbles. It is postulated that the specks may be related to the stainless steel epoxy used to fill the ribs along the bottom of the drum. Photographs of the disassembly of the grout are shown in Figures 5.13 through 5.17.

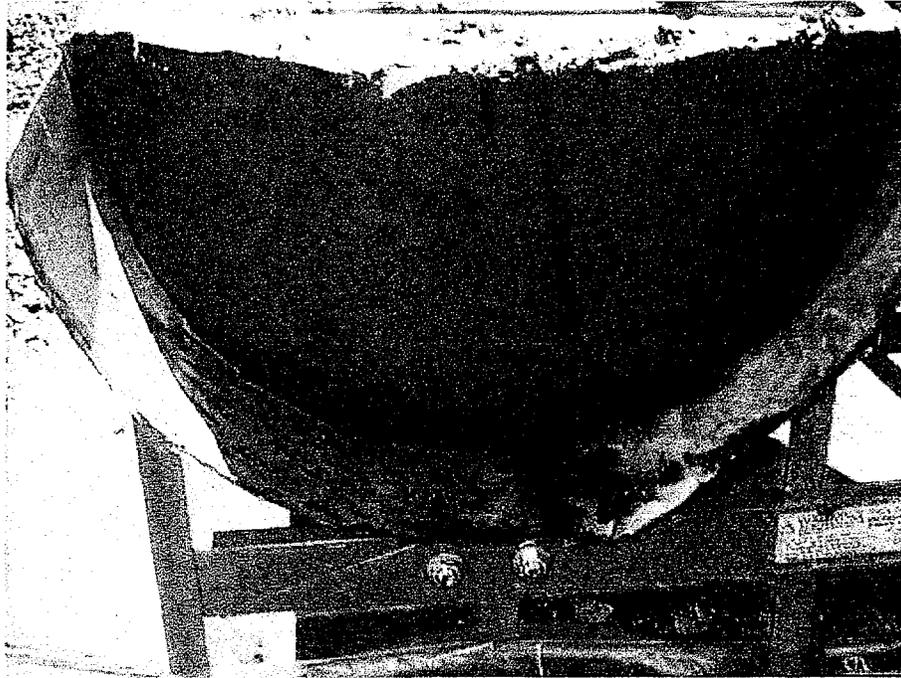
**Figure 5.14.** Test 1B Grout Block. Cross section with about 6 in. removed from end. Dark portion shows soil that is poorly mixed into the grout.

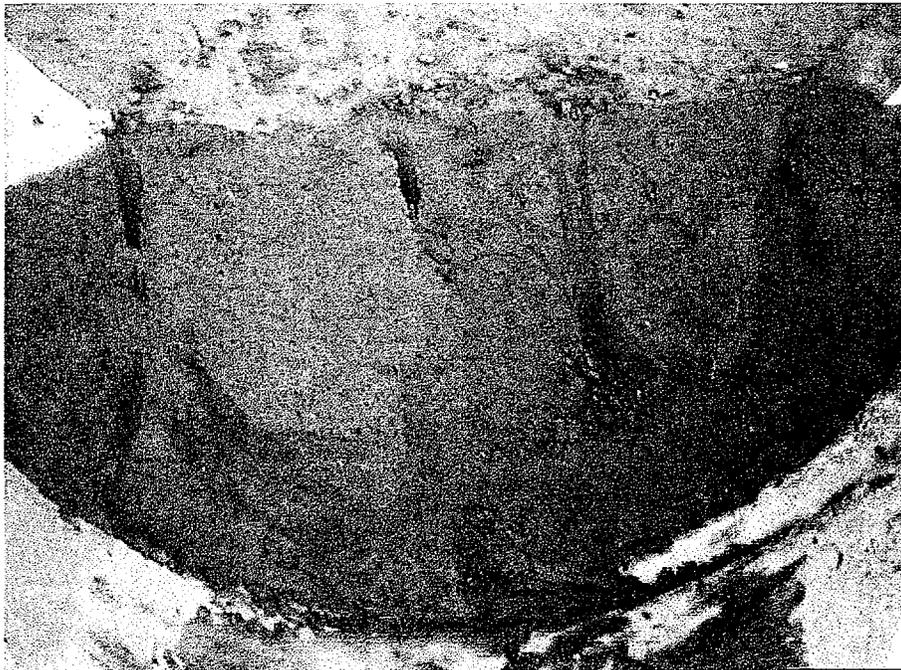
**Figure 5.15.** Test 1B Grout Block. Grout appears uniform. No soil deposits are visible.

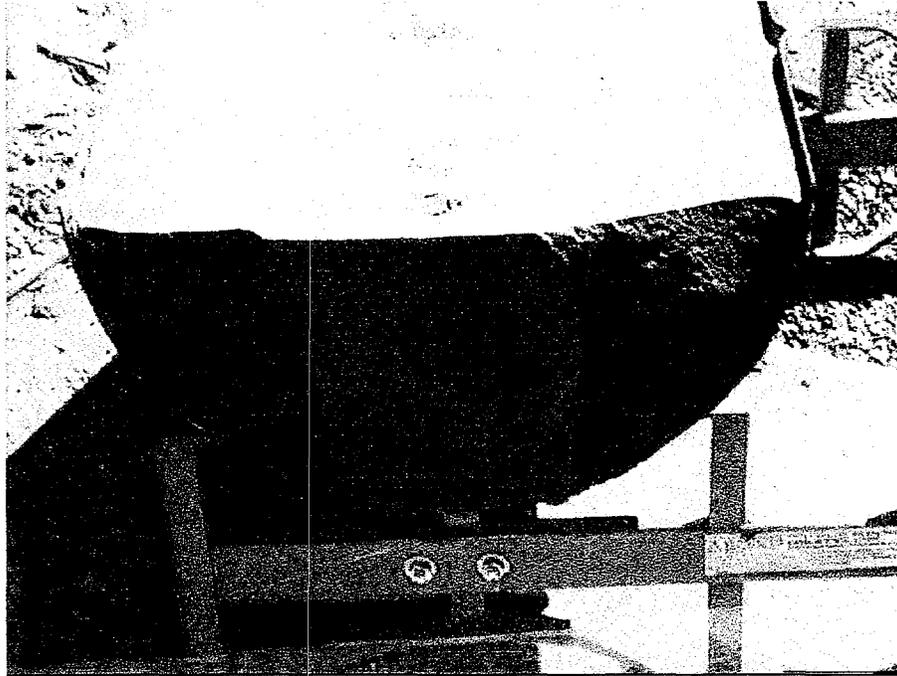
**Figure 5.18.** End of Grout Block in Test 2. Uniform appearance in grout. The different textures are a result of some of the grout being removed with the end of the drum.

During disassembly, the end of the grout farthest from the addition point appeared uniformly mixed. Near the top center of the end of the grout, a few inches into the block and beneath the surface, was a white ball of tracer material as seen in Figure 5.19. XRF analysis determined that this “ball” was formed by the  $\text{Ga}_2\text{O}_3$  tracer. Additional views of the grout disassembly are shown in Figures 5.18 through 5.25.

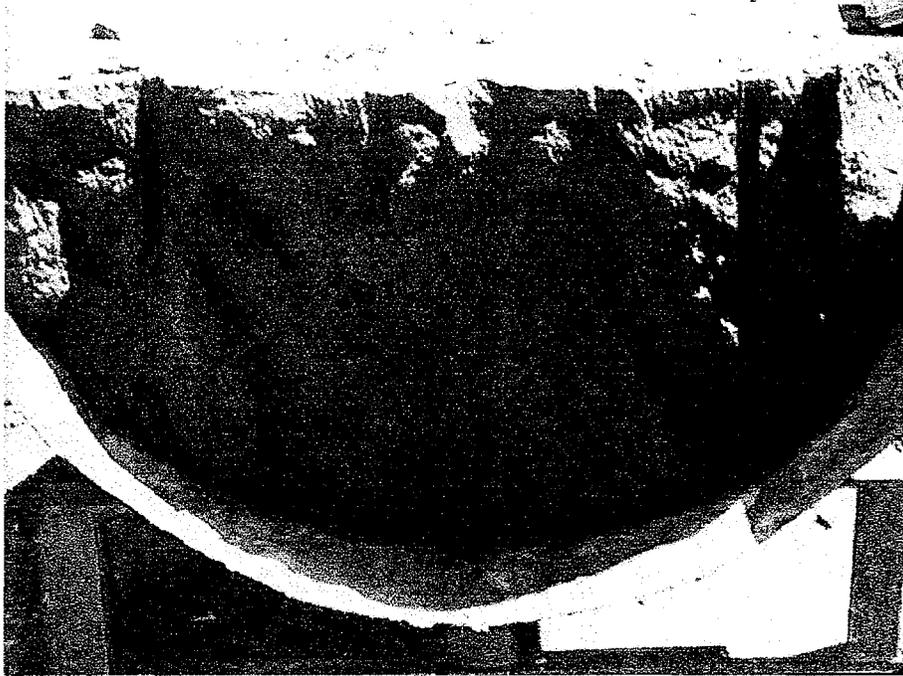
**Figure 5.20.** Grout Removed to ~ 6 in. from Drum End in Test 2. Grout appears uniform.

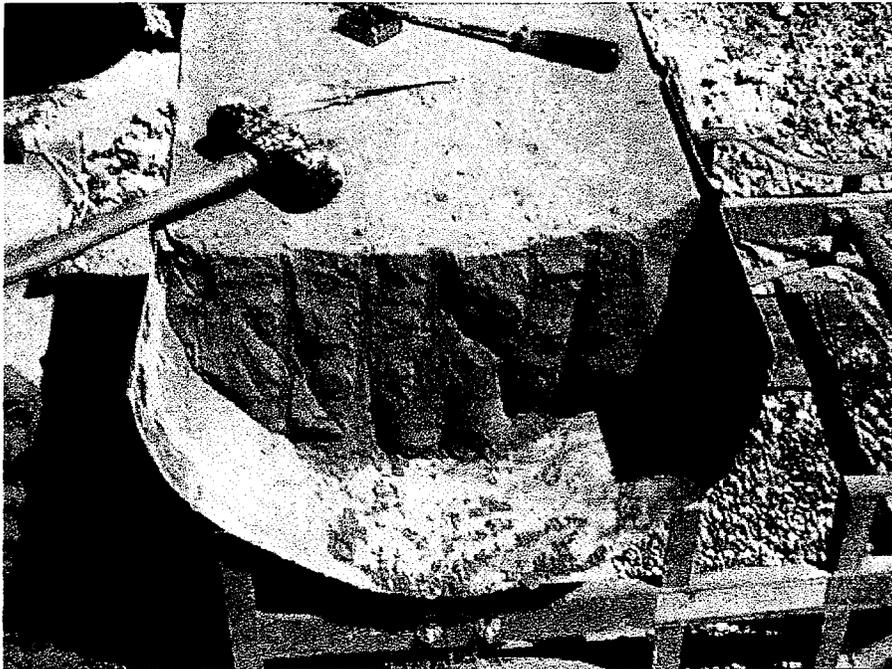
**Figure 5.21.** Grout Removed to ~12 in. from Drum End in Test 2. Grout appears uniform.

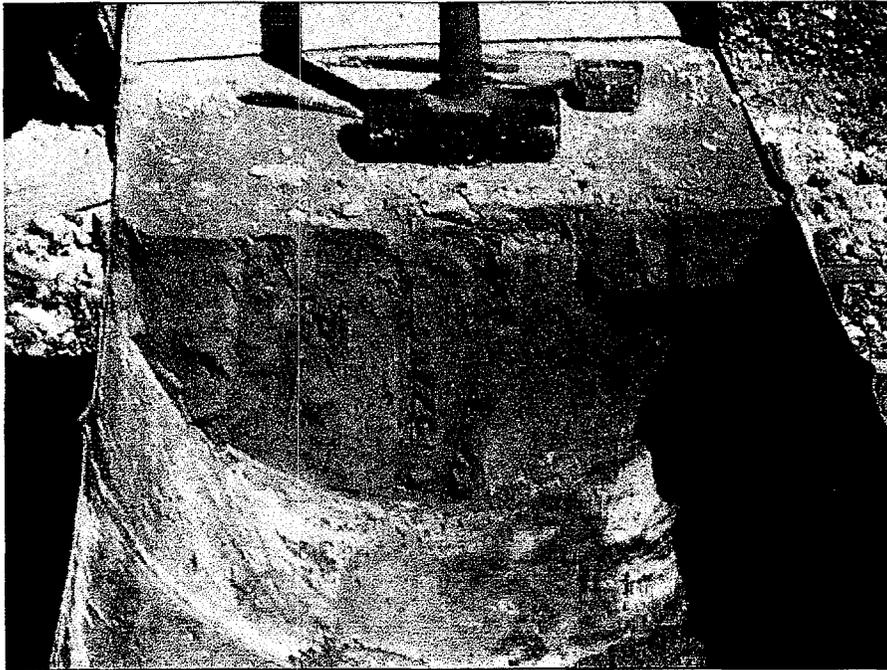
**Figure 5.23.** Test 2, Approximately 1 ft of Grout Remaining. Grout appears uniform.

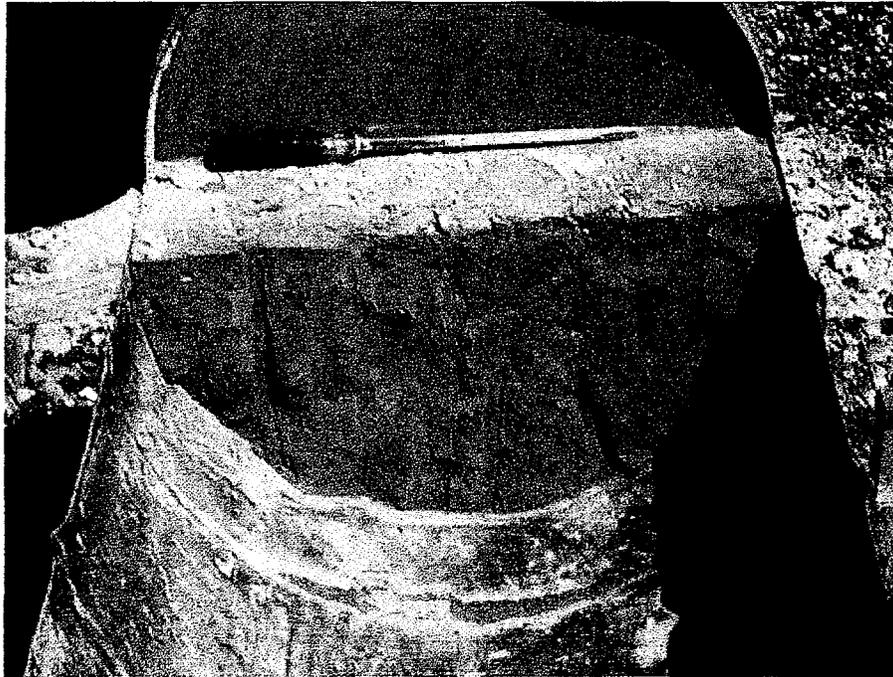
**Figure 5.24.** Test 2, Approximately 6 in. Grout Remaining in Drum. Appearance is uniform.

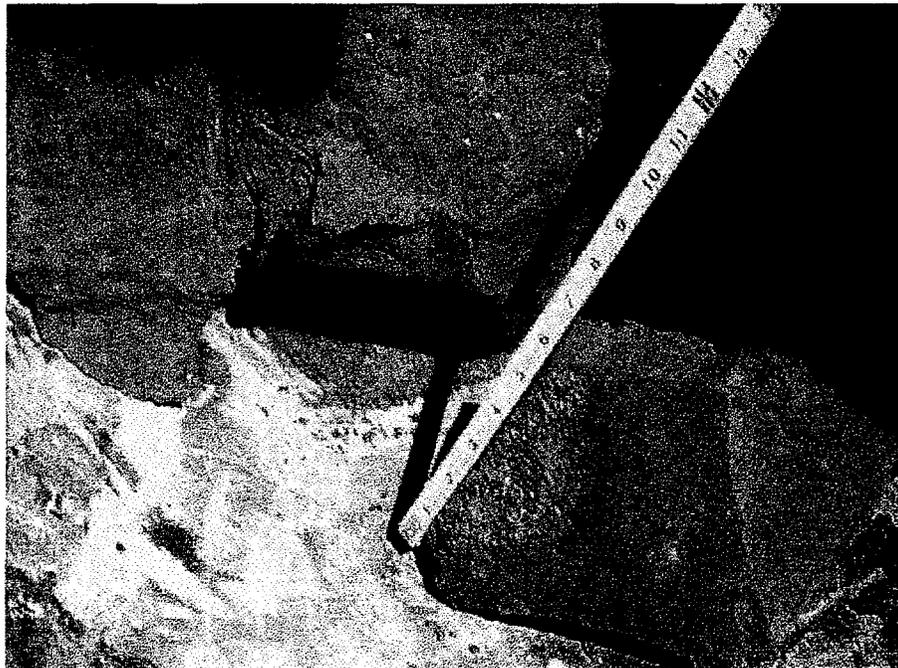
**Figure 5.25.** Test 2, Sand Deposit Found Near the Wall of Drum Nearer the Addition Point. This was the largest sand deposit found during disassembly of the material from this test.

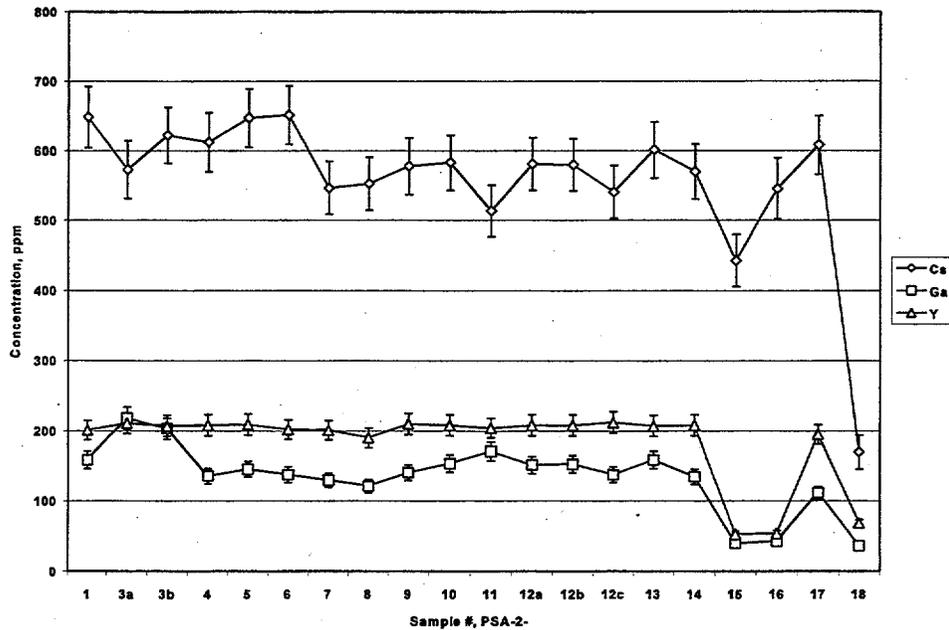
**Figure 5.26.** Tracer Concentrations of Samples Taken From Test 2.

Figure 5.26 shows the XRF analysis results for samples taken from the cured grout.

Significant deviations in Ga content are seen for samples 2, 15, 16 and 18. Sample 2 is not shown in Figure 5.26 because it consisted primarily of a portion of the Ga tracer that had formed a solid clump and was not dispersed. XRF analysis sufficient to determine that the clump was the Ga tracer was performed but detailed results were not pursued for this sample. Sample preparation consisted of grinding in a mortar and pestle followed by a “cone and quarter” procedure to obtain the subsample for XRF analysis. Samples 3a and 3b were reanalyses of the same sample. It is believed that sample 3 was contaminated by being processed through the sample preparation steps following the Ga tracer clump. Thus, its elevated Ga reading may be due to contamination. Samples 15 and 18 are from sand deposits where the gallium may not have been mixed, and sample 16 is believed to be a clump of cement or Aquaset-2H that formed a ball and did not mix.

Results for Y are much more uniform than those for Ga. The relatively large scatter in the Ga tracer results compared to Y results may be due to the Ga ball breaking down as the slurry continued to mix. The Y results for samples 15, 16, and 18 show the same significant deviation from the uniform concentration as the Ga. As noted above, samples 15 and 18 are primarily sand deposits and 16 is believed to be a cement clump that failed to break up.

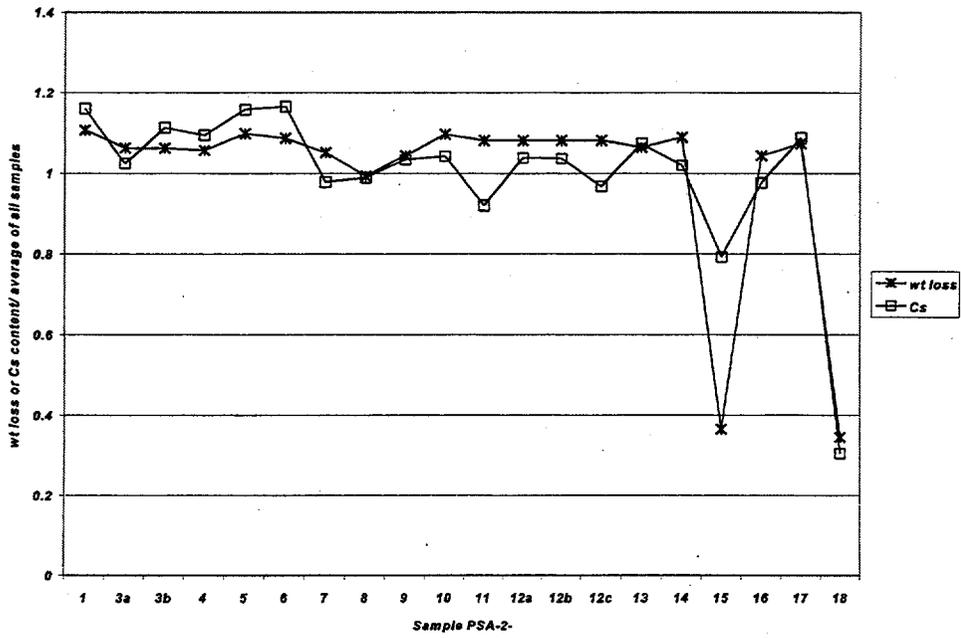
Figure 5.27. Comparison of Weight Loss on Drying and Cs Content for Test 2 Samples

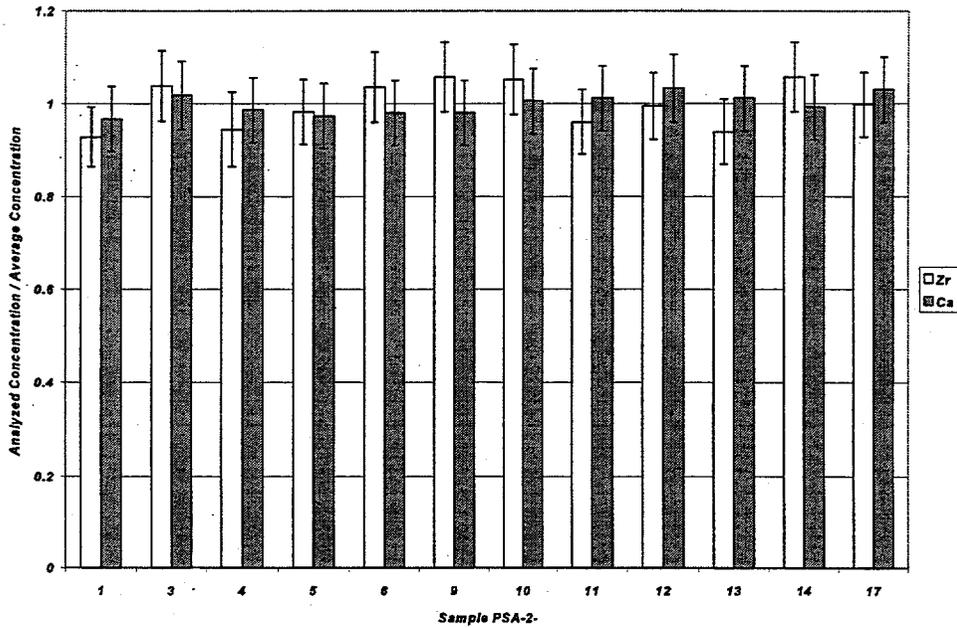
Figure 5.28. Comparison of Relative Ca and Zr Contents for Test 2 Samples Not Noted as Representing Inhomogeneous Locations

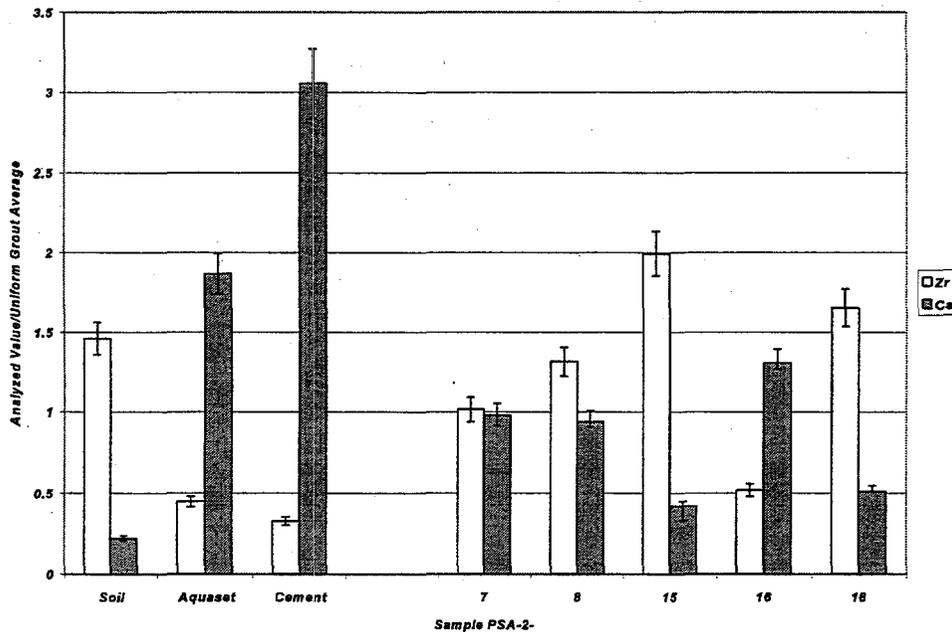
**Figure 5.29.** Test 2 Ca and Zr Analyses for Samples Directed at Inhomogeneities

Figure 5.29 shows the samples targeted at an inhomogeneous location in the cured grout. The data have been normalized by dividing by the average concentration of uniform samples as in Figure 5.28. The relative compositions of the raw materials are shown to the left of the plot for reference. Samples 7 and 8 were of very small sand deposits and included the immediately

adjacent material. Sample 7 is within analytical error of being the average composition while sample 8 shows a moderate excess of the sand. Samples 15 and 18 appear to be primarily sand deposits while sample 16 appears to be primarily cement or Aquaset-2H (Ca) with little soil (Zr).

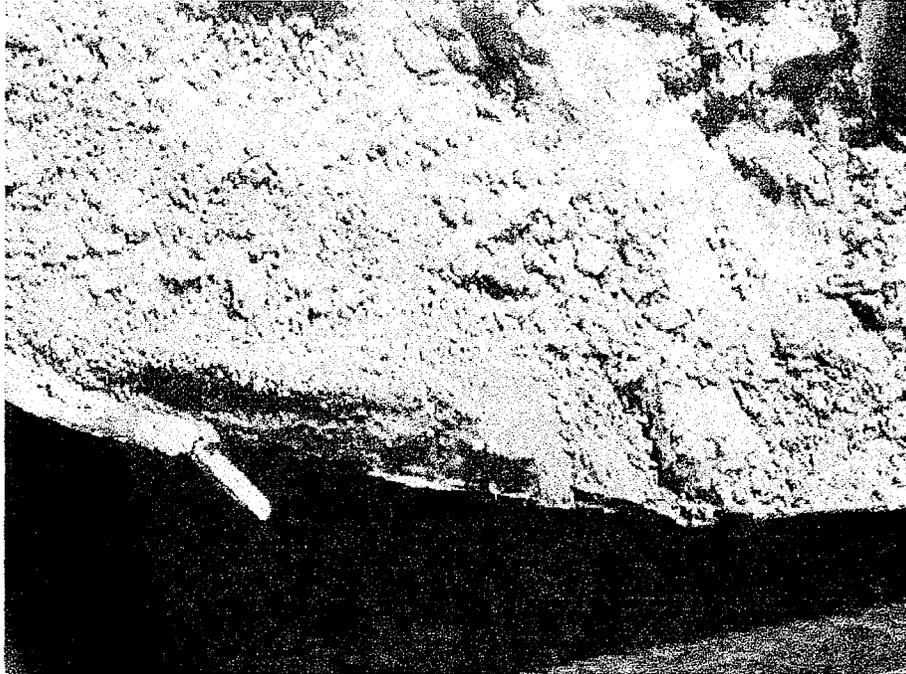
**Figure 5.30.** Soil Deposit Along Bottom of Drum at End Farthest From Addition Point. Soil can be seen by slightly different color and texture.

As was done previously, the grout was disassembled by cutting away the upper portion and the end of the drum farthest from the addition point. Samples were taken for analysis by XRF and pictures were taken. The pictures shown in figures 5.30 through 5.36 illustrate observations made during disassembly. Because the soil and Aquaset-2H have similar colors, the soil layers are more difficult to see for this test than was the case in Test 2.

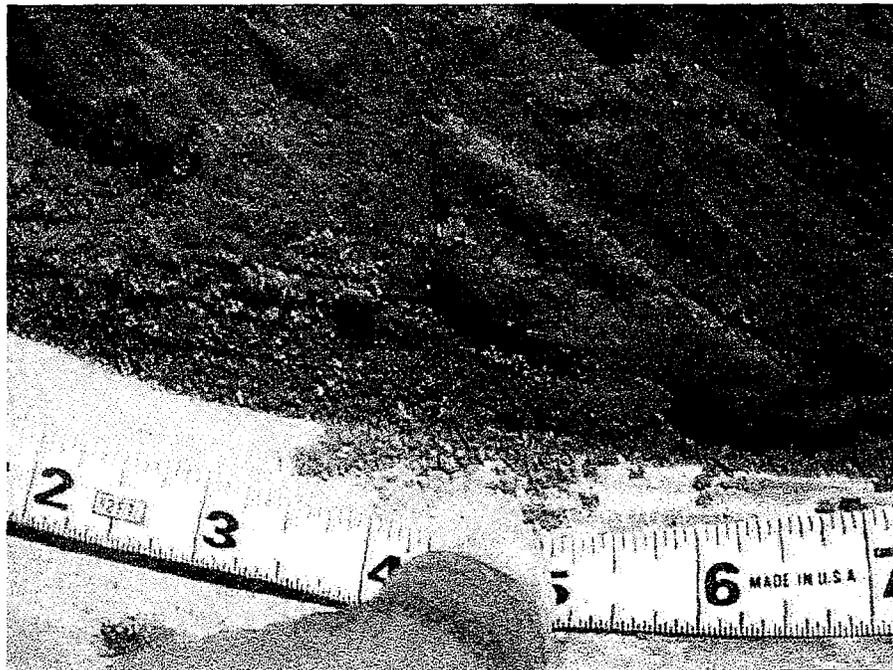
**Figure 5.31.** Test 3, Cross Section of Sand Layer ~ 4 in. From Drum End. Deposit exists from drum end (see Figure 5.30) to about 6 in. into the block. Dimensions are up to about 5 in. wide and a maximum of 1 in. thick. Deposition is off center to the east of the bottom drum centerline.

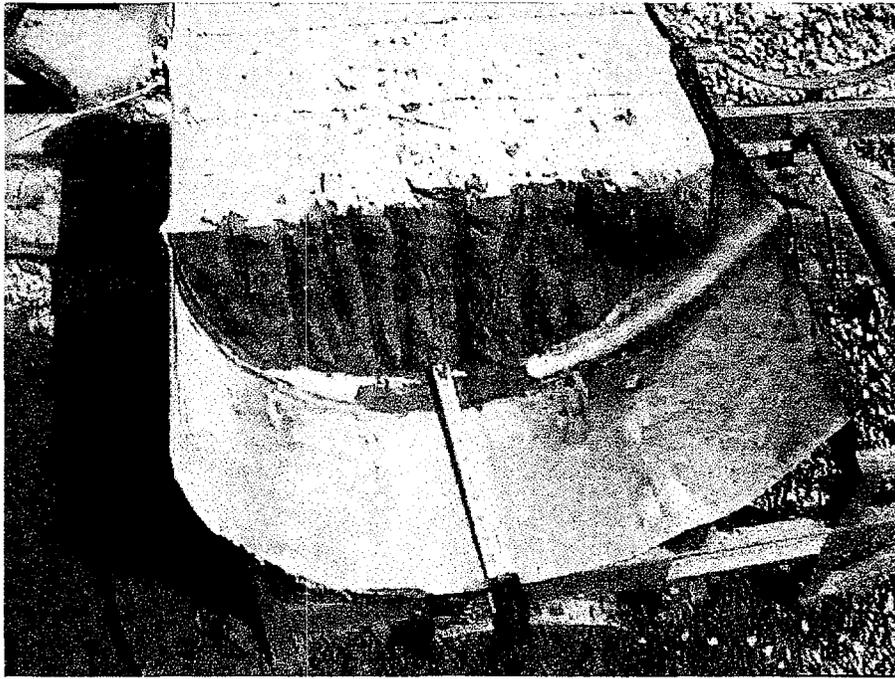
**Figure 5.32.** Test 3, Grout Removed to Between 11 in. and 12 in. From End. Approximate position of second accumulator plate from. No sand deposits apparent at this cross section.

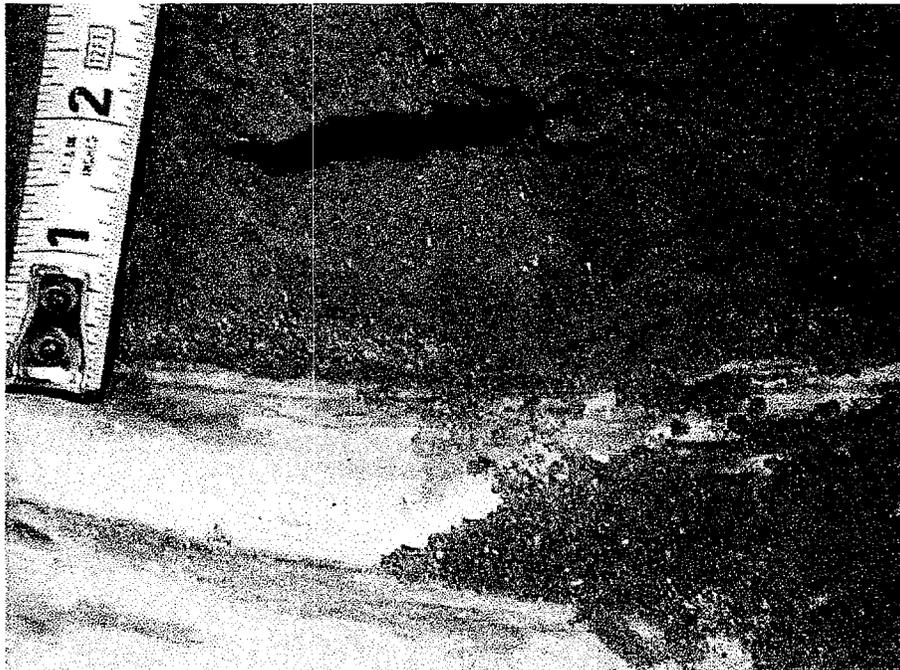
**Figure 5.33.** Test 3, Cross Section at ~10 in. From Addition End of Drum. Sand deposit runs from ~8 in. to ~12 in. from addition end of drum and is up to 1/2 in. thick.

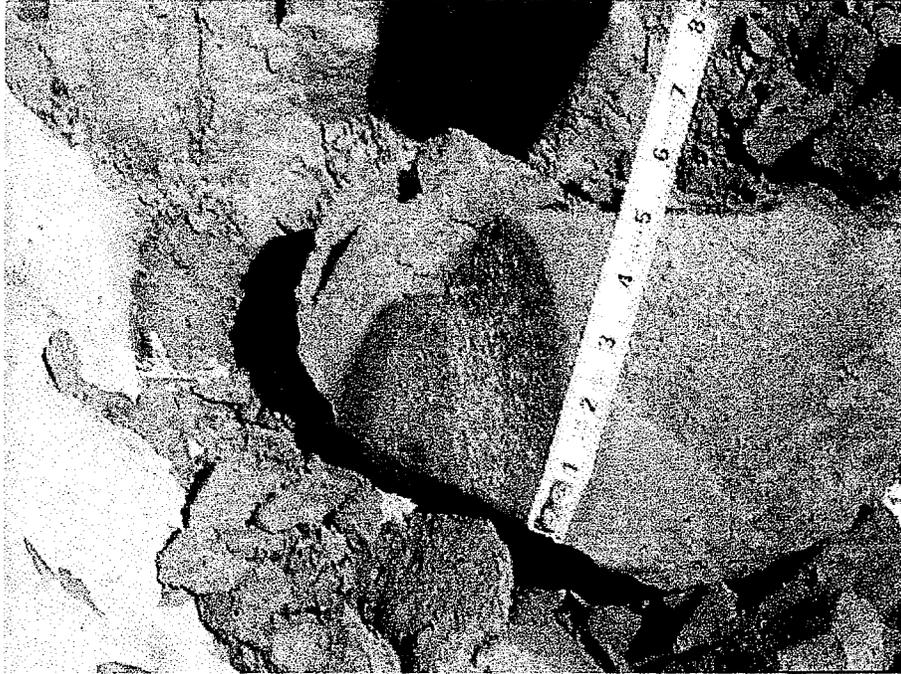
**Figure 5.34.** Test 3, Grout Piece Removed from Location Illustrated in Figure 5.33. The side facing down was facing the camera in Figure 5.33.

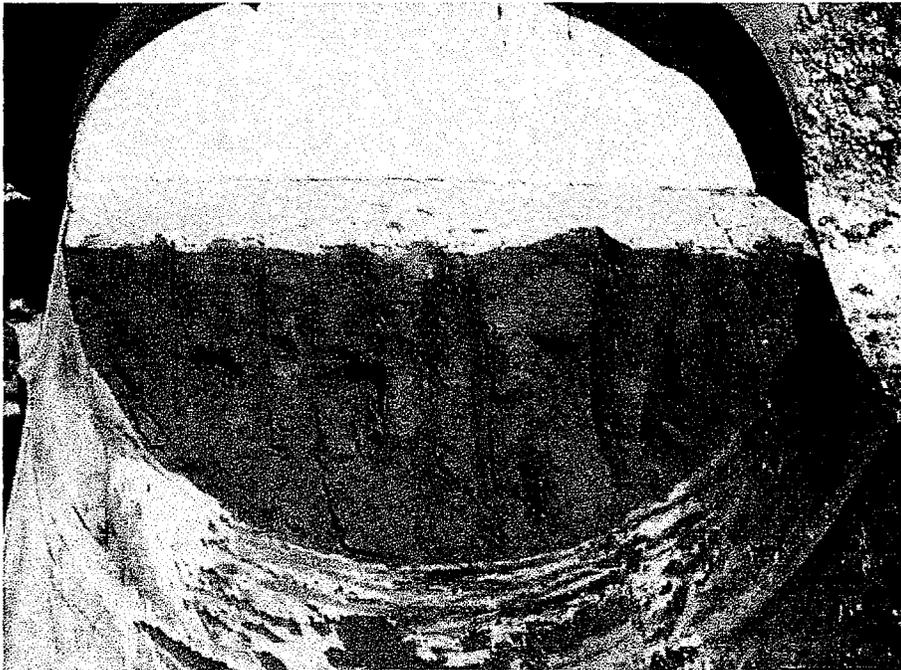
**Figure 5.35.** Test 3, Cross Section With ~ 4 in. of Grout Remaining in the Drum. Removing sample numbers PSA-3-14, 15 and 16 created divets in the wall.

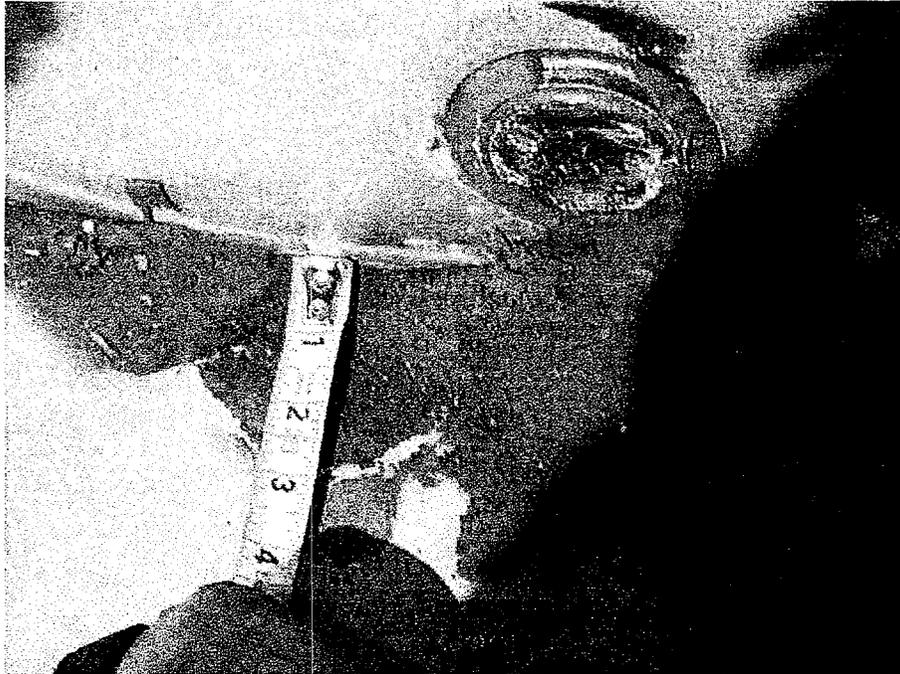
**Figure 5.36.** Test 3, Sand Deposit at End of Drum Following Removal of Last 4 in.

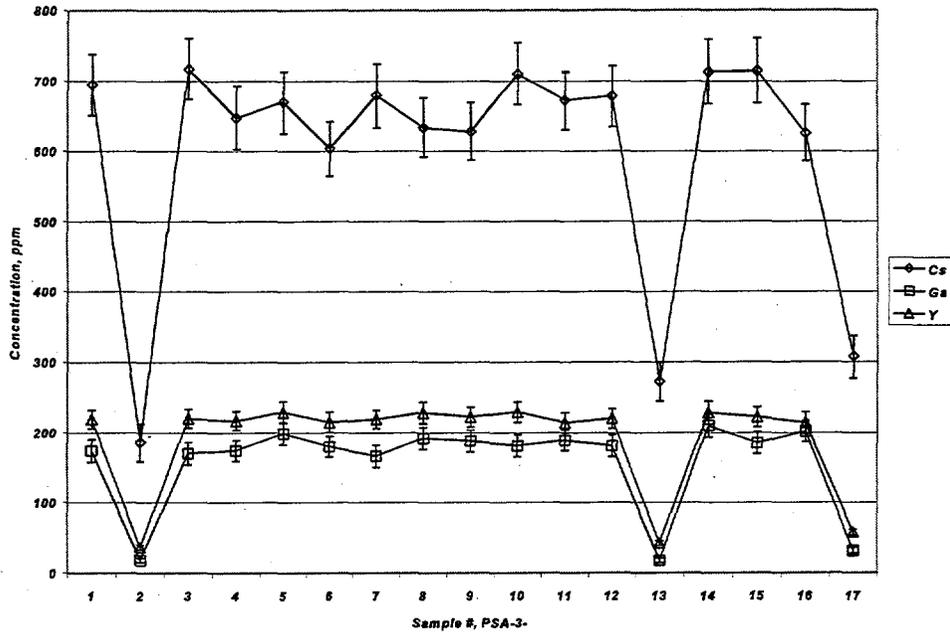
Figure 5.37. Test 3 Tracer Concentrations
