# Pacific Northwest National Laboratory

## Bench-Scale Feasibility Testing of Pulsed-Air Technology for In-Tank Mixing of Dry Cementitious Solids with Tank Liquids and Settled Solids

September 1997

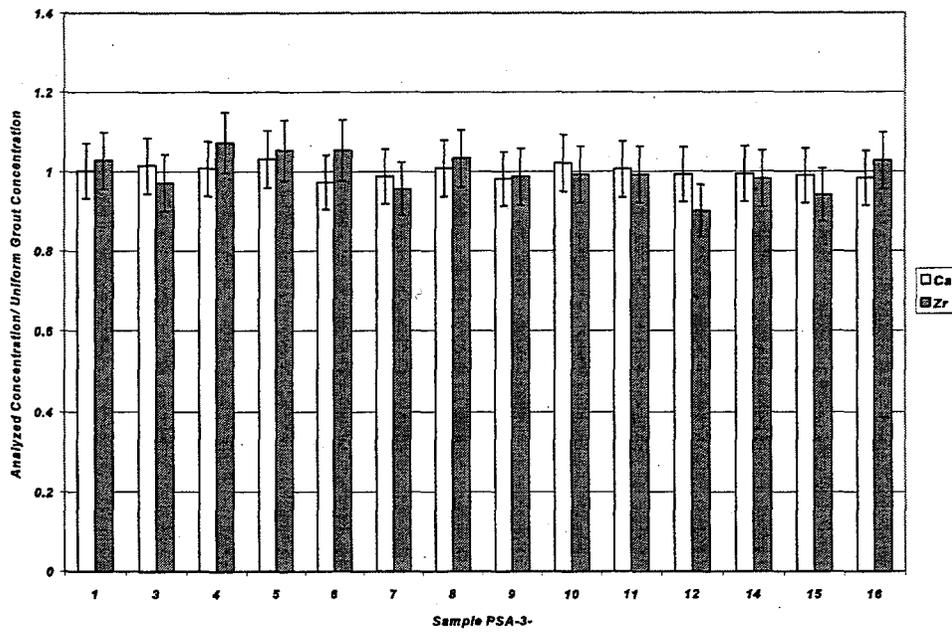
Figure 5.38. Test 3 Ca and Zr Concentrations of Samples Not Targeted at Inhomogeneities

<sup>(1)</sup>All samples except #12 encompass the value of 1.0 within the analytical error estimate. Sample 12 Zr value narrowly misses a value of 1.0. However, the Ca value is at the expected average and since this is a binary mixture of soil and Aquaset, the small Zr deviation is attributed to analytical error. For a 95% confidence interval one deviation per 20 samples would be expected, so a single deviation out of the 28 samples is not surprising.

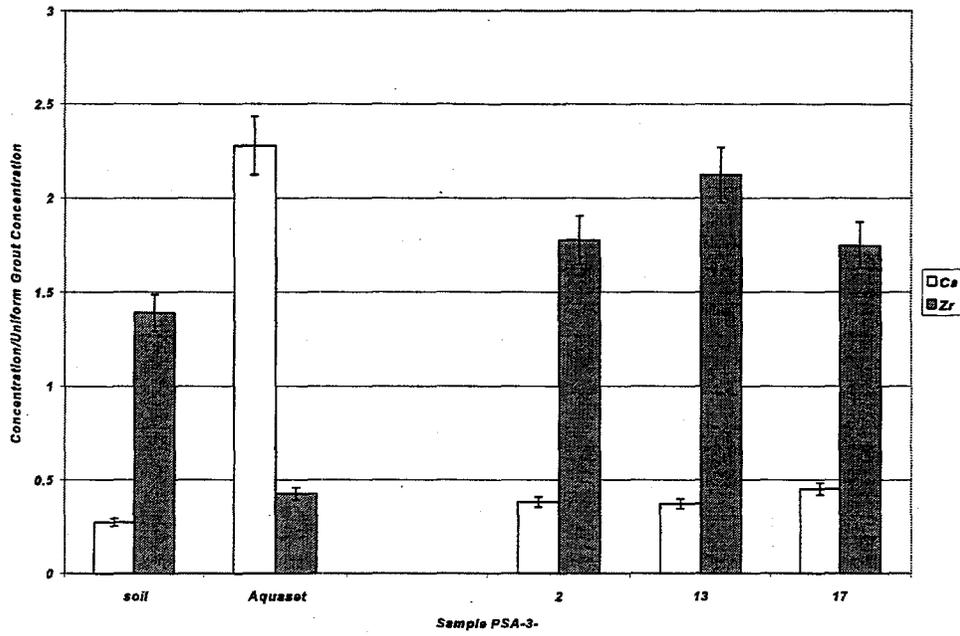
**Figure 5.39.** Ca and Zr Analyses of Test 3 Samples. All samples clearly have an excess soil component with very little Ca (Aquaset-2H) present.

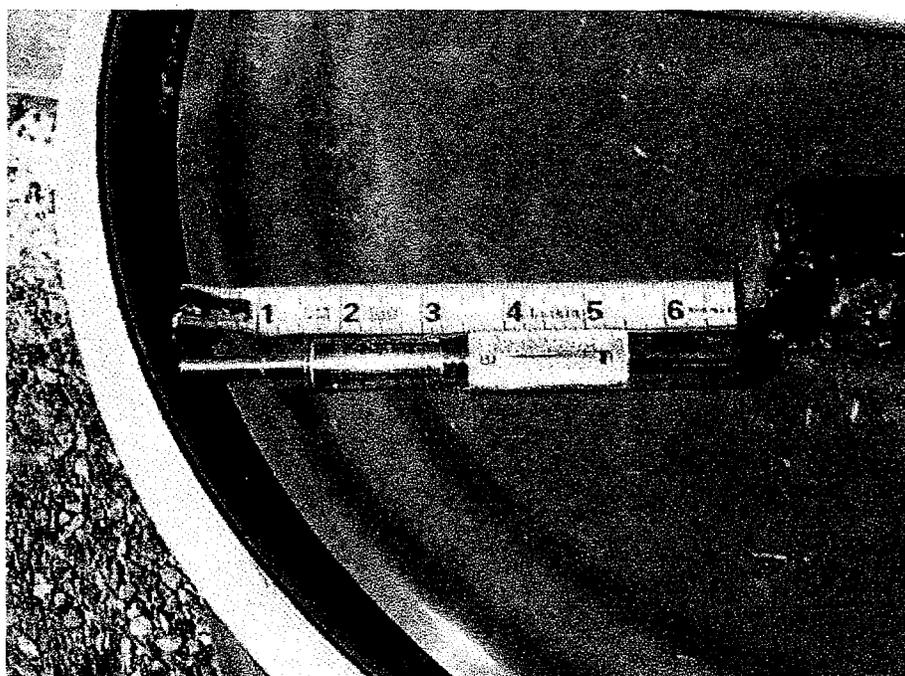
Figure A.1. Concrete Penetrometer Used to Obtain Penetration Resistance Measurements

A concrete penetrometer was used to test the cured grouts from Tests 1B and 3. All measurements in Test 1B exceeded the capacity of the penetrometer. A picture of the penetrometer is provided in Figure A.1. The penetrometer consists of a 0.25" diameter shaft, with a mark scribed 1" up the shaft. Pressing the shaft into the grout compresses a spring and a sliding ring records the maximum force required. The penetrometer was pushed into the cured grout until it penetrated into the grout at least 1" and the maximum reading taken. The test procedure used is very similar to ASTM C 403/C 403M-95 "*Standard Test Method for Time of Setting of Concrete Mixtures by Penetration Resistance*" using the spring-loaded device option described in section 6.3 of the test method<sup>1</sup>.

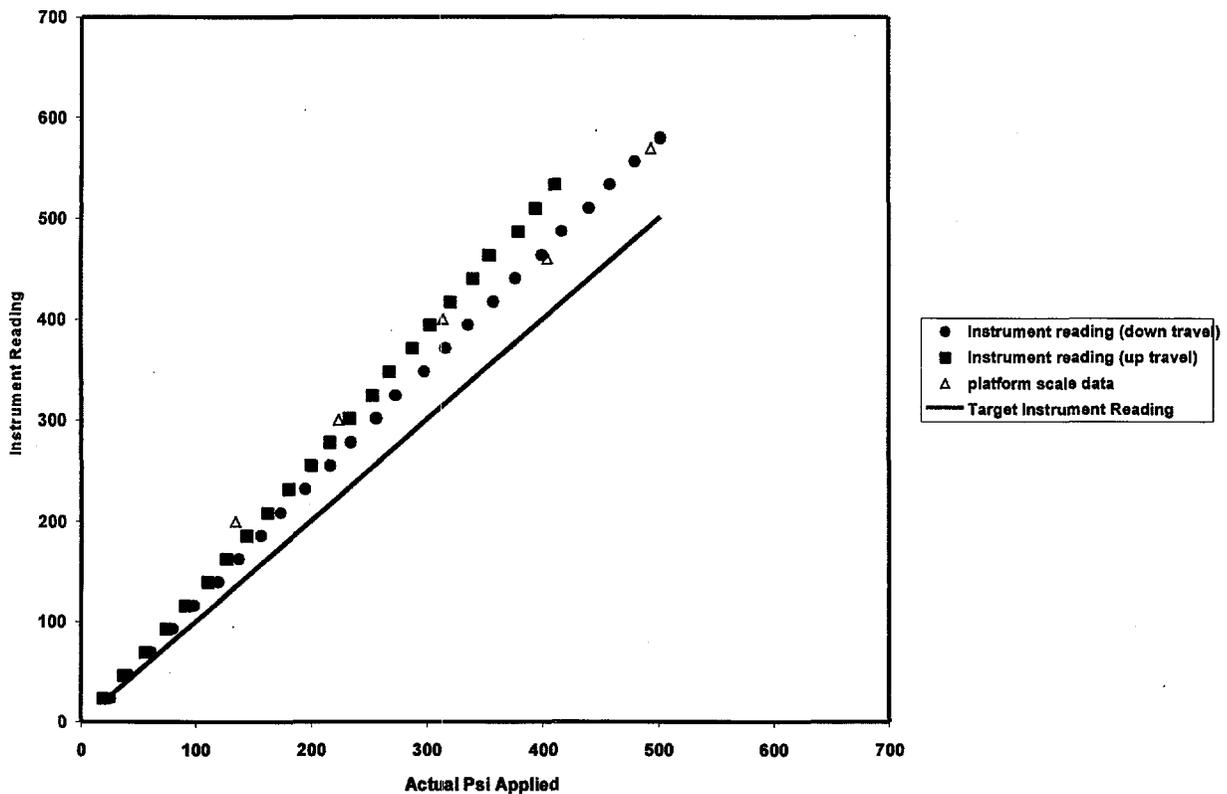
Figure A.2. Results of Penetrometer Calibration

To check the accuracy of the penetrometer, it was placed in a TA-XT2 Texture Analyzer (Manufactured by Stable Micro Systems Ltd., Surrey, England) and the force required to achieve displacement was measured at 1 mm intervals over a total of 25 mm displacement moving in both the compressing and decompressing directions. A few additional data points were taken by pressing the device onto a platform scale by hand. Based on the force exerted, the pressure on the penetrometer shaft was calculated and compared to the instrument readings. The results of the calibration effort are shown in Figure A.2. The readings from the penetrometer appear to be consistently about 17% higher than the actual pressure applied by the texture analyzer. The platform scale data were generally consistent with this trend although much more scattered due to the requirement to apply a steady load and catch the scale reading at the maximum force. The

data from the texture analyzer indicated that the applied force to obtain a given reading was lower while the instrument was being decompressed. Since the penetrometer readings are taken in the compression mode, only the compression data were used. Based on these calibration data, readings taken using the penetrometer were reduced by 17% to account for the discrepancy between actual psi and instrument indication.

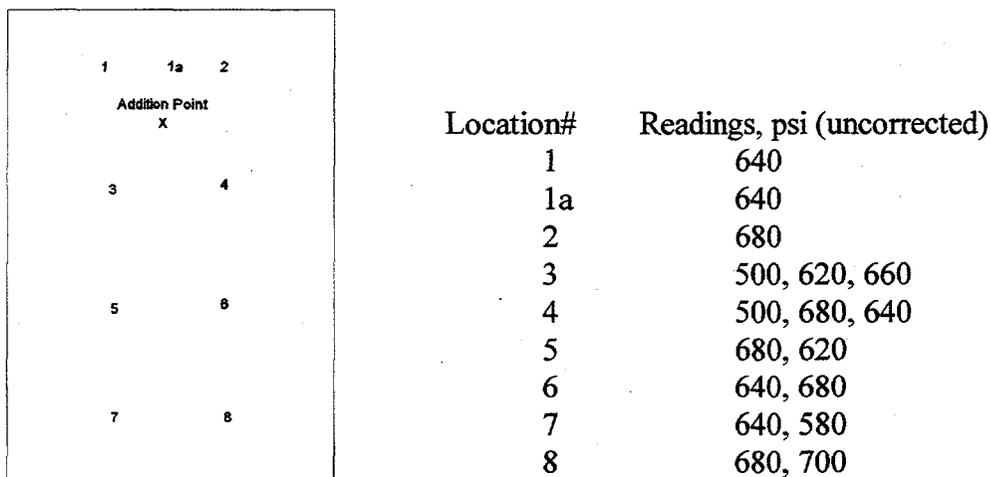
Figure A.3. Plan View of Drum Showing Penetrometer Measurement Locations and Readings

Data were collected using the penetrometer for Test 1B which used the INEEL suggested recipe containing both Portland cement and Aquaset. In 4 locations the penetration resistance after 2 days of curing exceeded the upper range on the penetrometer (700 psi uncorrected). The penetrometer penetrated only about 1/4" at the maximum spring reading so it is suspected that the penetration resistance exceeds 700 psi by some margin. No measurements of penetration resistance were made in Test 2 because this test used the recipe from Test 1B with twice the Portland cement addition and was qualitatively harder than Test 1B. Test 3 used the INEEL suggested recipe containing Aquaset-2H without any additional Portland cement. This material was not as hard as the previous tests. Penetration resistance measurements and the corresponding locations of the measurements are indicated in Figure A.3.

Taking an average of all 17 readings provides an average of 634 psi and correcting for the 17% calibration factor provides a penetration resistance of the grout of approximately 542 psi.
