**Oak Ridge National Laboratory  
Old Hydrofracture Facility Waste Remediation  
Using the Borehole-Miner Extendible-Nozzle  
Sluicer**

J. A. Bamberger  
G. F. Boris<sup>1)</sup>

June 1999

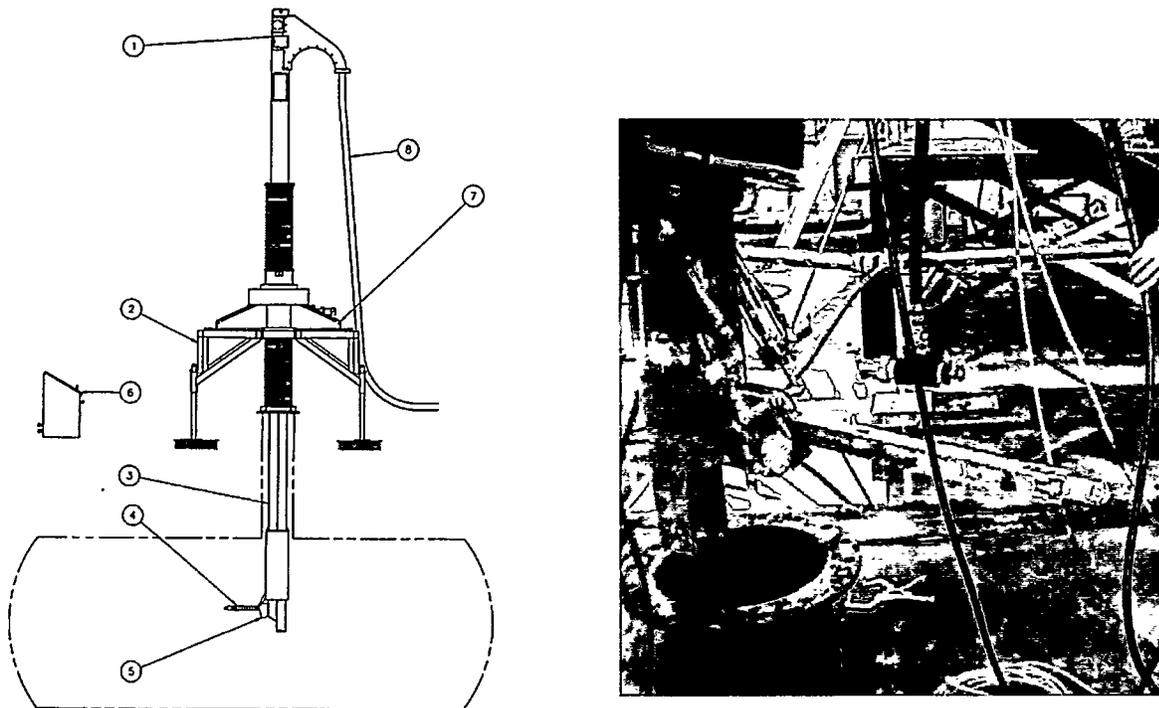
Figure 2.1 Borehole-miner extendible-nozzle sluicing system

An extendible-nozzle water-jetting system, shown in Figure 2.1, was designed, constructed, and deployed at Oak Ridge National Laboratory to remediate five horizontal underground storage tanks containing sludge and supernate at the ORNL Old Hydrofracture Facility site. The tanks were remediated in fiscal year 1998 to successfully remove ~98% of the waste. The tanks contained up to 18 in. of sludge covered by supernate. The 42,000 gal of low-level liquid waste were estimated to contain 30,000 Ci, with 97% of this total located in the sludge. At the completion of the remediation, the State of Tennessee Department of Environment and Conservation agreed that *the tanks were cleaned to the maximum extent practicable using pumping technology*. This deployment was the first radioactive demonstration of the borehole-miner extendible-nozzle water-jetting system.

The extendible-nozzle arm extends up to 10 ft from the center of the mast, extends downward at angles from the horizontal to nearly vertical, and rotates 360 degrees about the mast. The extendible nozzle can operate at water pressures up to 3000 psi; however, for deployment at Oak Ridge, the maximum operating pressure was limited by the high-pressure pump to ~1500 psi and most operations occurred at ~400 psi.<sup>1</sup> The extendible-nozzle design was improved during the design phase. The design moved the arm actuator from beneath the elbow to above the elbow, thereby shortening the lower mast length by ~2.5 ft. The new design simplifies construction and operation considerably. The current nozzle design 1) covers the entire area beneath the nozzle from vertically downward to horizontal and eliminates the need for separate spray nozzles to clean beneath the mast, 2) eliminates an additional line from the pump to the extendible nozzle and valves and controls associated with operation of these separate spray nozzles, and 3) allows the nozzle to operate along the horizontal tank centerline. The extendible nozzle, as configured during the acceptance tests, is shown in Figure 2.1.

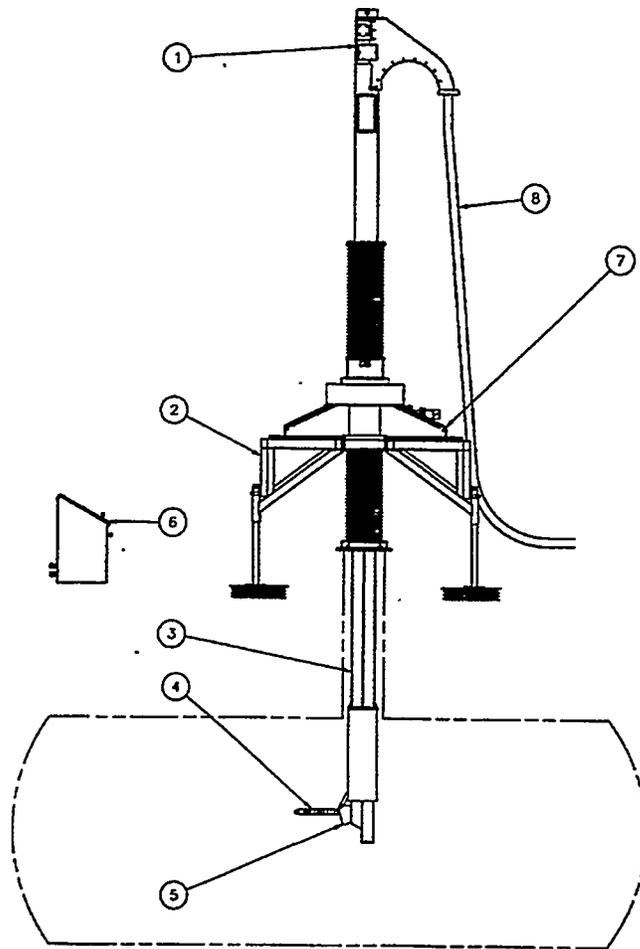
**Figure 3.3** Extendible nozzle components

The extendible-nozzle components are shown in Figure 3.3. The nozzle assembly consists of a support platform (2) and mast (1 and 3) that extends below grade into the tank. Inside the mast is a segmented, flexible arm through which the high-pressure hose passes. The exit nozzle is located on the distal end of the arm (4). The arm is made rigid by four tensioned steel cables passing through the segments. While tensioned, the arm can be deployed radially to a distance of 10 ft (3 m) from the mast centerline, and also from a horizontal position to vertically downward. In addition, the mast and nozzle assembly can be rotated ±180 degree to give complete coverage of the tank. Movement and tensioning of the arm are accomplished hydraulically, and the arm's position and extension are measured by potentiometer-type encoders.

Legend: 1) top mast assembly, 2) platform assembly, 3) lower mast assembly, 4) arm assembly, 5) launch assembly, 6) control console, 7) bridge mount, and 8) containment hose assembly

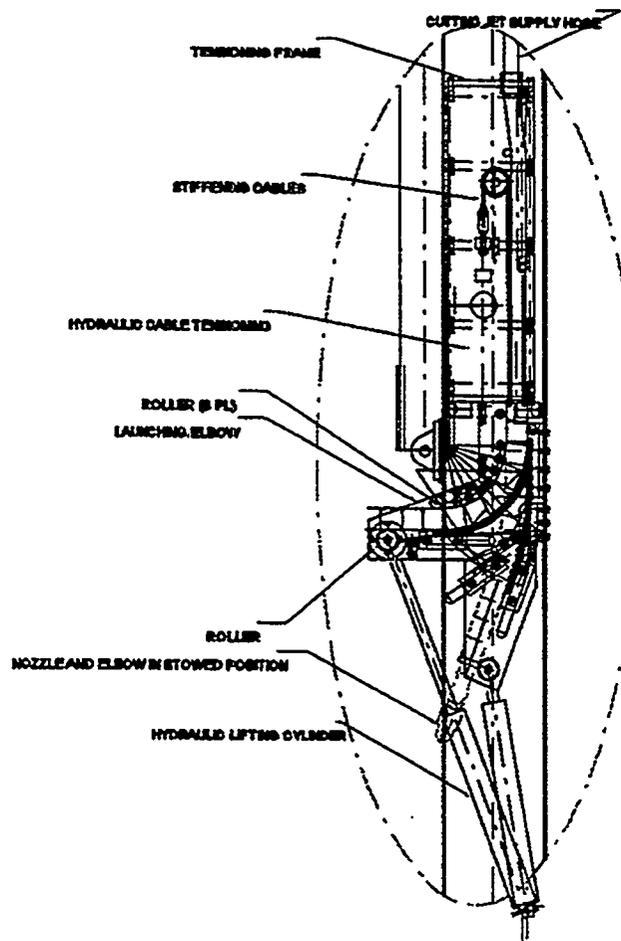
Figure 3.4 Details of the arm and launch assembly

The arm and tensioning mechanism are moved up and down in the bottom mast section by a length of rigid pipe. The hydraulic oil and high-pressure water hoses required to move with the arm tensioning assembly (as the arm is drawn in and out of the mast) run from the bottom mast section to the top mast section within this pipe. This pipe extends from the arm tensioner, through the mast, to the extension actuator, which is located inside the top mast section above the bridge. The arm extension actuator is a hydraulic motor.

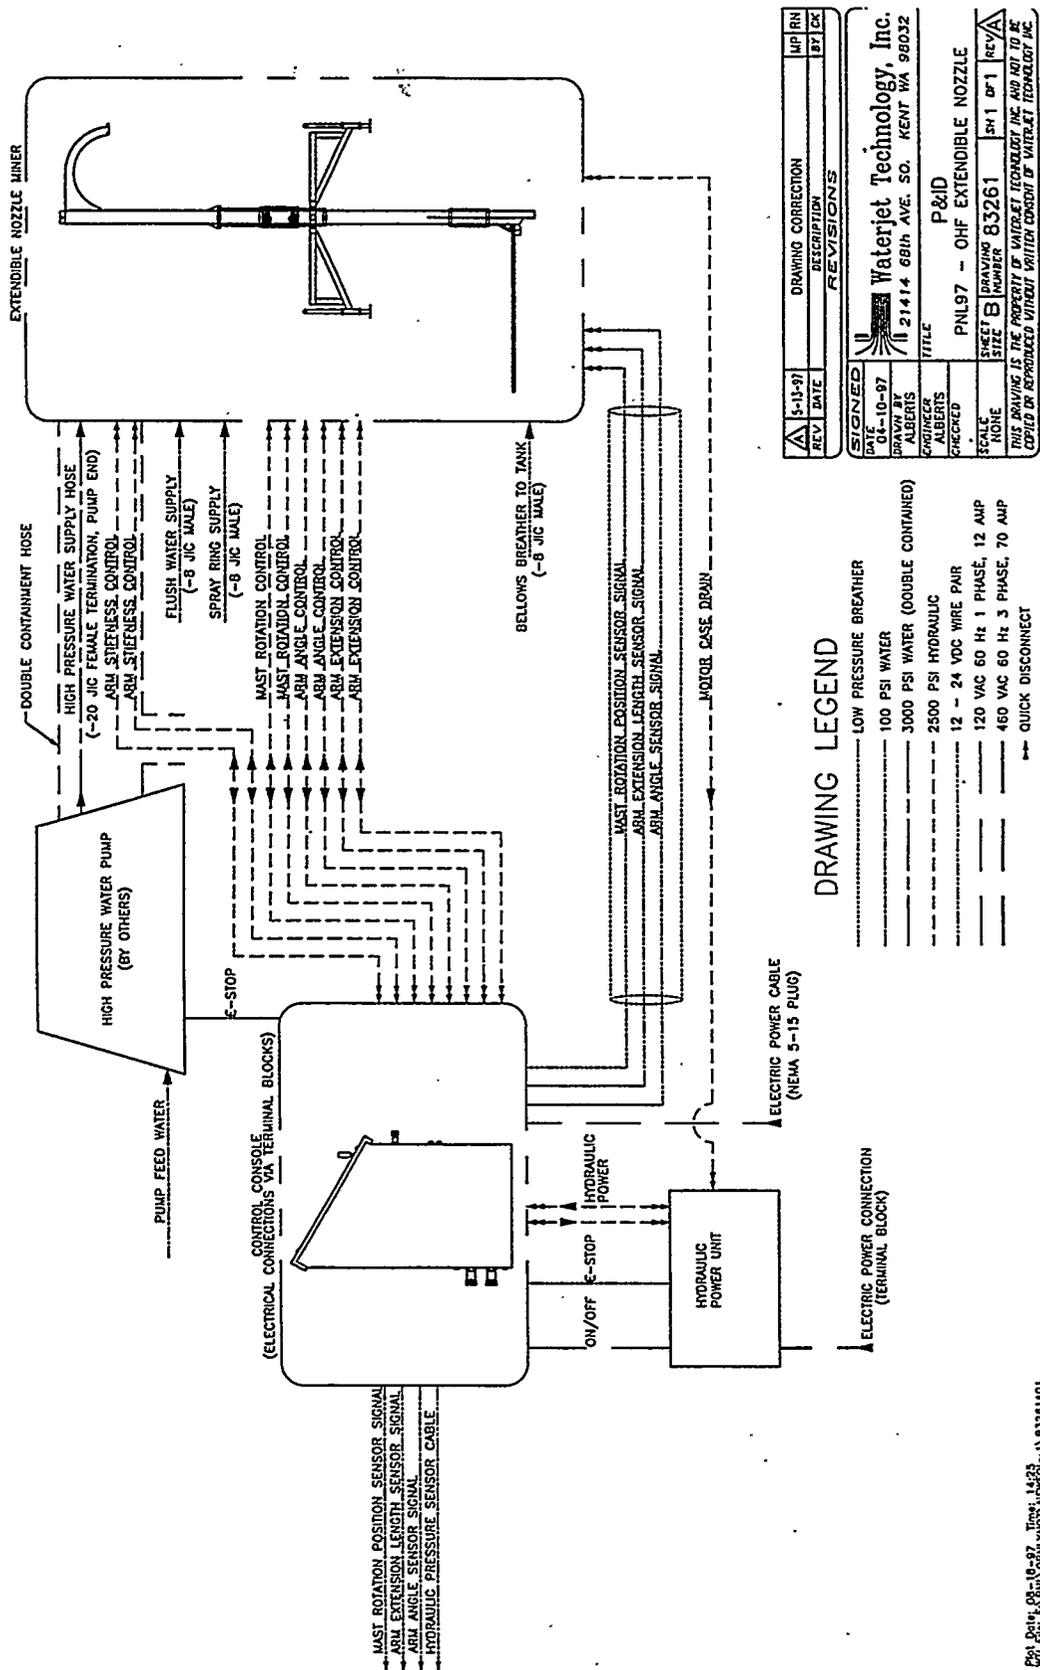
**Figure 3.8** Extendible-nozzle fluid, hydraulic, and electrical connections

---	LOW PRESSURE BREATHERS
---	100 PSI WATER
---	3000 PSI WATER (DOUBLE CONTAINED)
---	2500 PSI HYDRAULIC
---	12 - 24 VDC WIRE PAIR
---	120 VAC 60 Hz 1 PHASE, 12 AMP
---	460 VAC 60 Hz 3 PHASE, 70 AMP
---	QUICK DISCONNECT

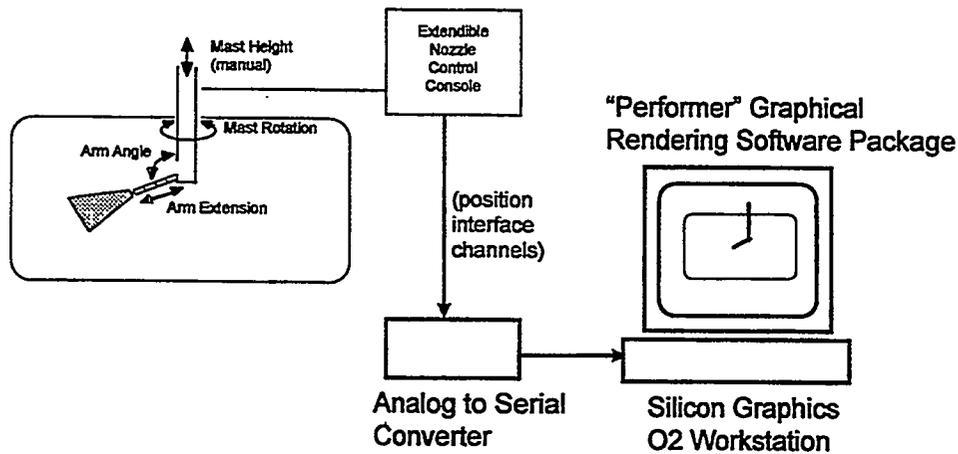
**Figure 3.9** Visualization system.

The extendible-nozzle visualization system consists of a Silicon Graphics O2 low-end work station, and I/O (input/output) module that connects to the extendible-nozzle control console and software (called Squirt). The system provides a three-dimensional animated model of the extendible nozzle and the tank in which it is working. Position and orientation information from the extendible nozzle is fed to Squirt via the I/O module so that the three-dimensional model accurately shows where the extendible nozzle and its spray stream are in relation to the tank. In addition, Squirt can warn of any impending collisions between the nozzle and the tank infrastructure or any modeled items in it. A schematic of the visualization system is shown in Figure 3.9.

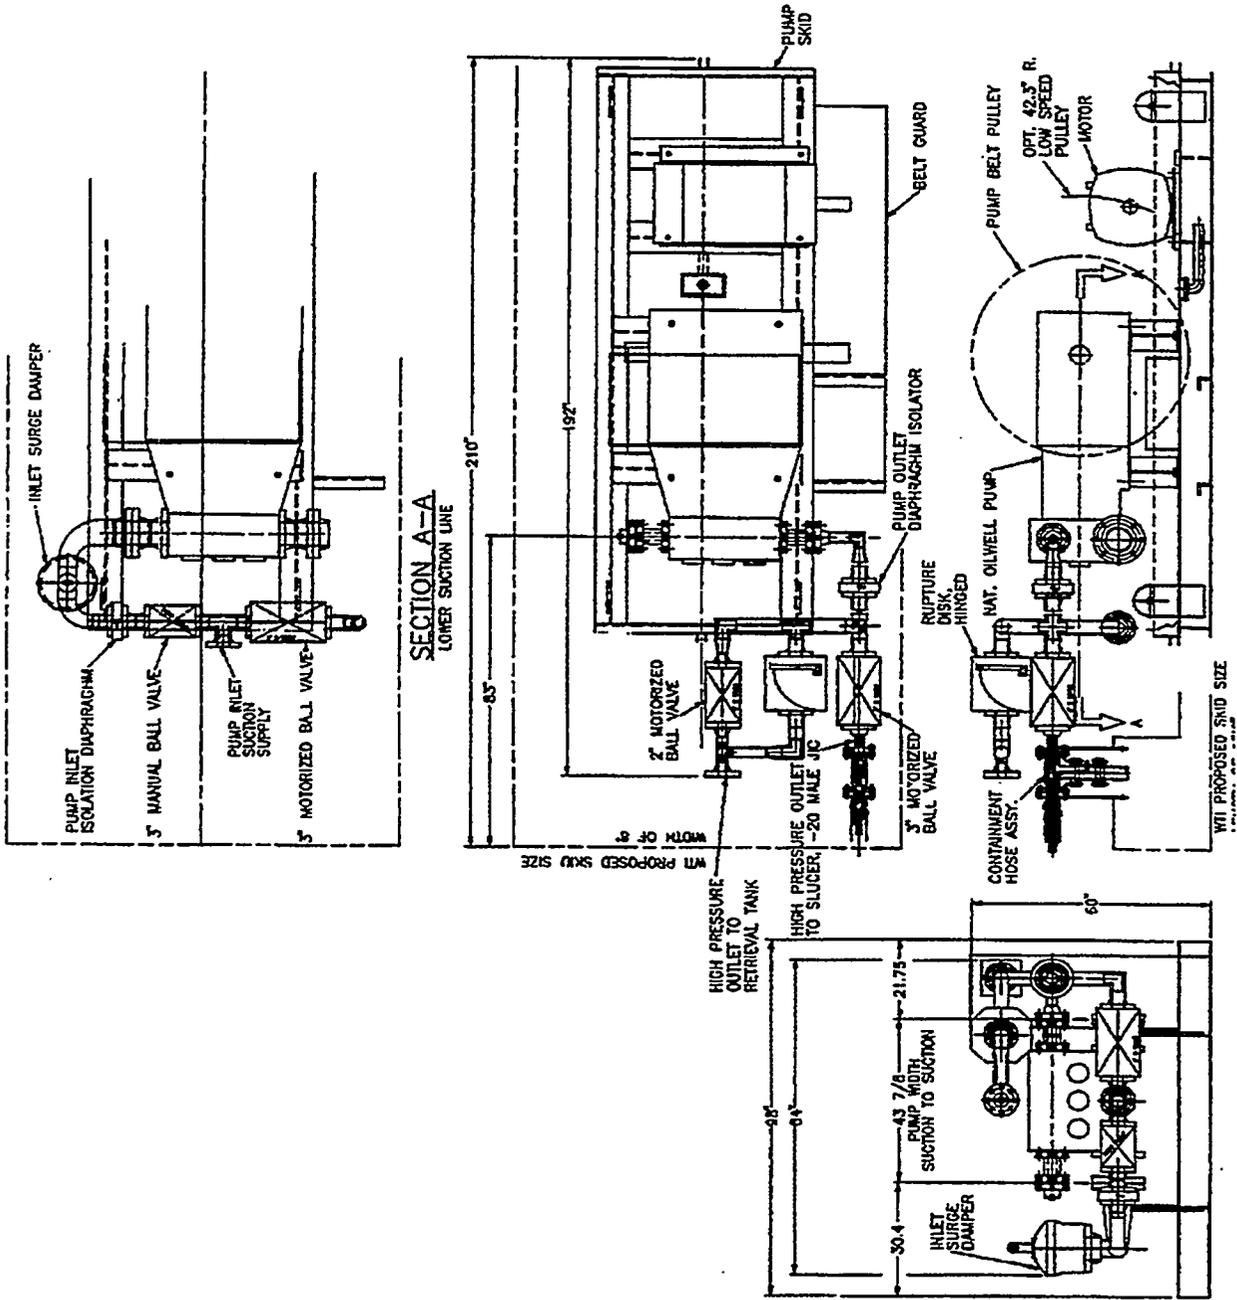
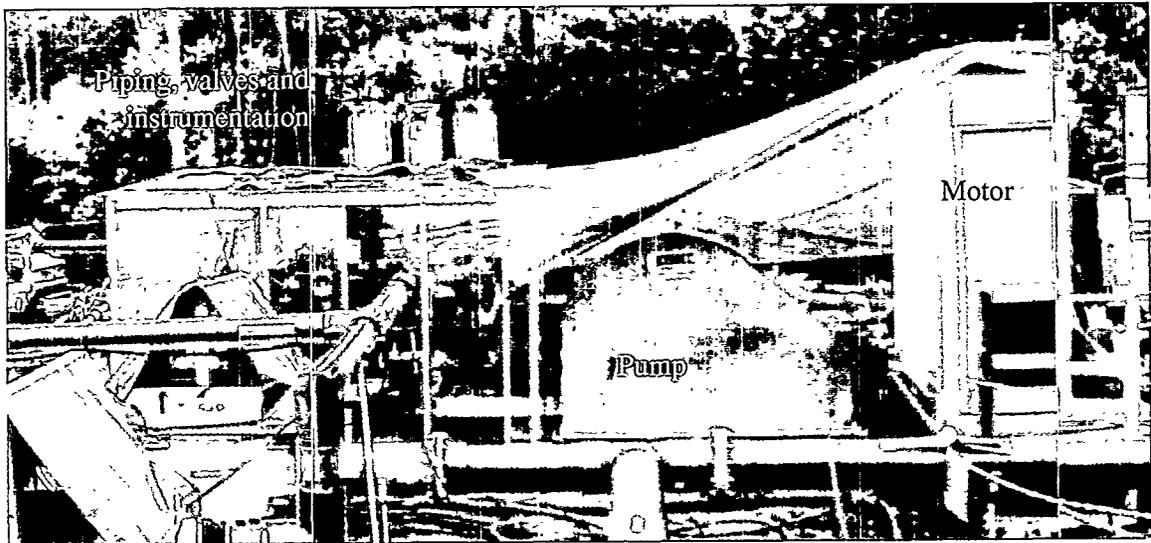
Figure 3.10 High-pressure pump skid

The skid included four plug valves<sup>1</sup> (one 3-in. ANSI 600 lb, one 2-in. ANSI 1500 lb, and two 3-in. ANSI 1500 lb) with electric actuators. The valve operating conditions are listed in Table 3.2.

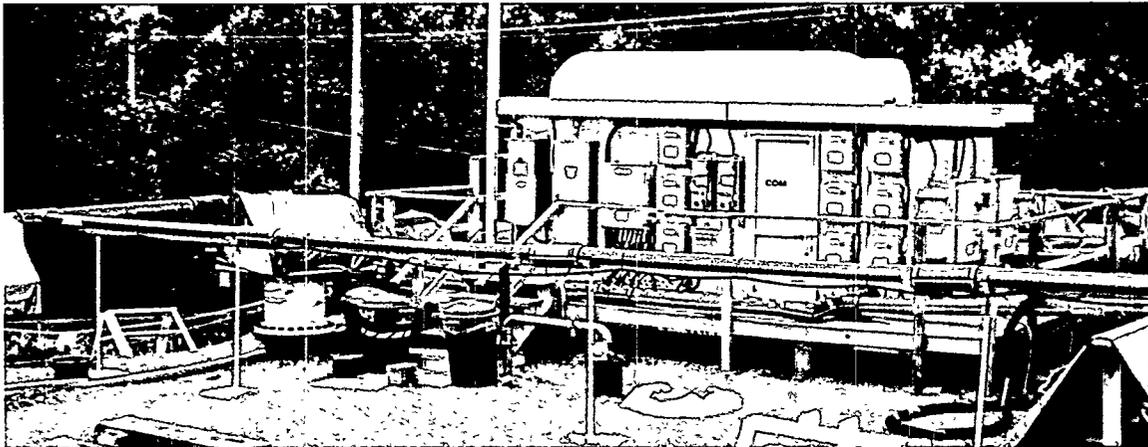
Figure 3.12 Transfer pump skid

- Low-pressure transfer pump to transfer contents from the sluicing tank to the mixing tank (Tank T9)
- Mixer in Tank T9 to maximize slurry mixing
- Low-pressure feed pump (200 psi progressive cavity Moyno pump) to lift contents from the mixing tank and feed to the high-pressure pump
- Strainer to remove larger particles from the feed to the nozzle
- Process water system used to flush the lines after transfer and provide other process water needs at the site
- Associated piping and valves including tank drop legs and riser modifications
- Containment piping, riser confinement boxes and confinement skid enclosures.

The transfer pump skid is shown in Figure 3.12.

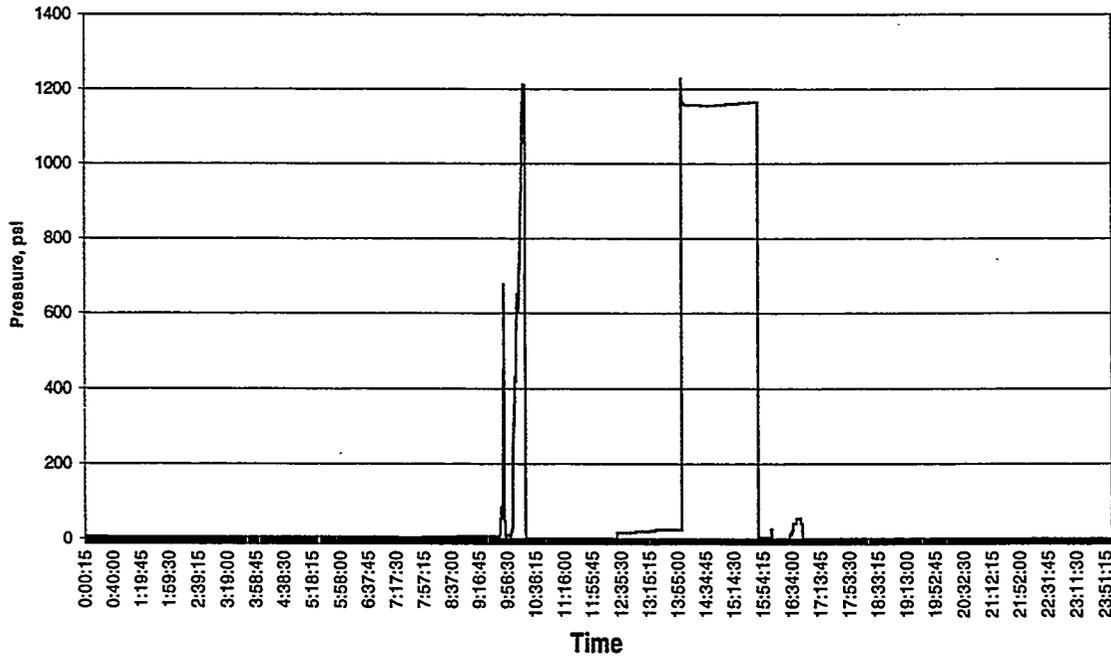
**Figure 4.5 Sluicer pump operating history March 31, 1998**

The sluicer pump startup operations were initiated at the end of March, 1998. The chronology of events is summarized in Appendix A, Table A.1. The pump was operated over the period from March 31 to April 7, 1998 in the local and remote control configurations. A readiness review was completed April 7, 1998 and the team was informed April 8, 1998 that the system was approved for installation at OHF. A series of plots shown in Figures 4.5 through 4.10 summarize the pressure history of the sluicer pump during this period. The maximum operating pressure obtained was ~1300 psi.

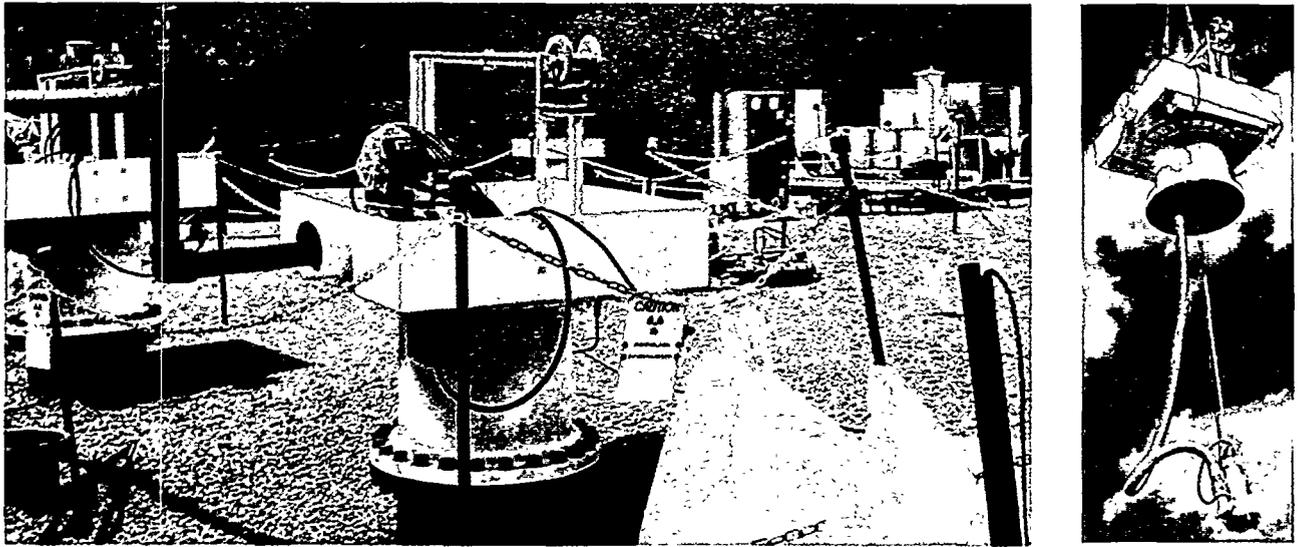
**Figure 5.1** OHF site riser spools, tank risers, and the variable height submersible pump

The OHF site riser spools (white boxes) and the tank risers where the borehole-miner extendible nozzle is installed are shown in Figure 5.1. The variable-height submersible pumps are adjusted manually.

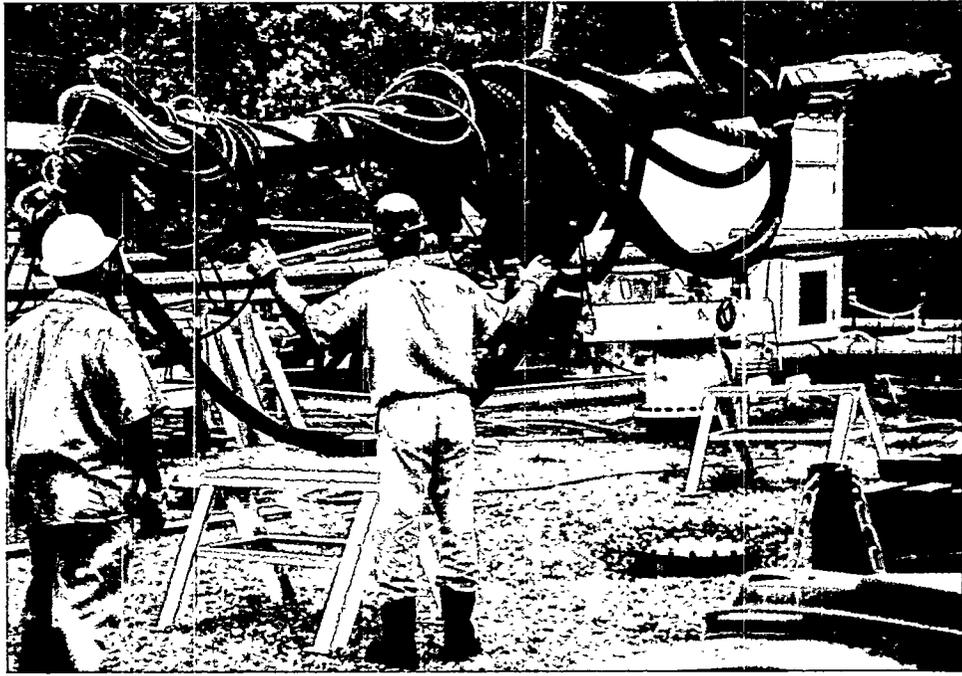
Figure 5.2 Transporting the extendible-nozzle mast from the transfer truck

The extendible-nozzle mast, shown in Figure 5.2, was transported to the OHF site via truck. The mast and platform can be installed separately or hoisted as an integral unit, as shown in Figure 5.3. The 0.38-in. diameter nozzle was installed on the borehole-miner extendible-nozzle system when it was deployed to sluice the OHF tanks. The orientation of the extendible nozzle above and below ground is depicted in Figure 5.4. Remote cameras, shown in Figure 5.5, were used to observe transfers in both the sluice and recycle tanks.

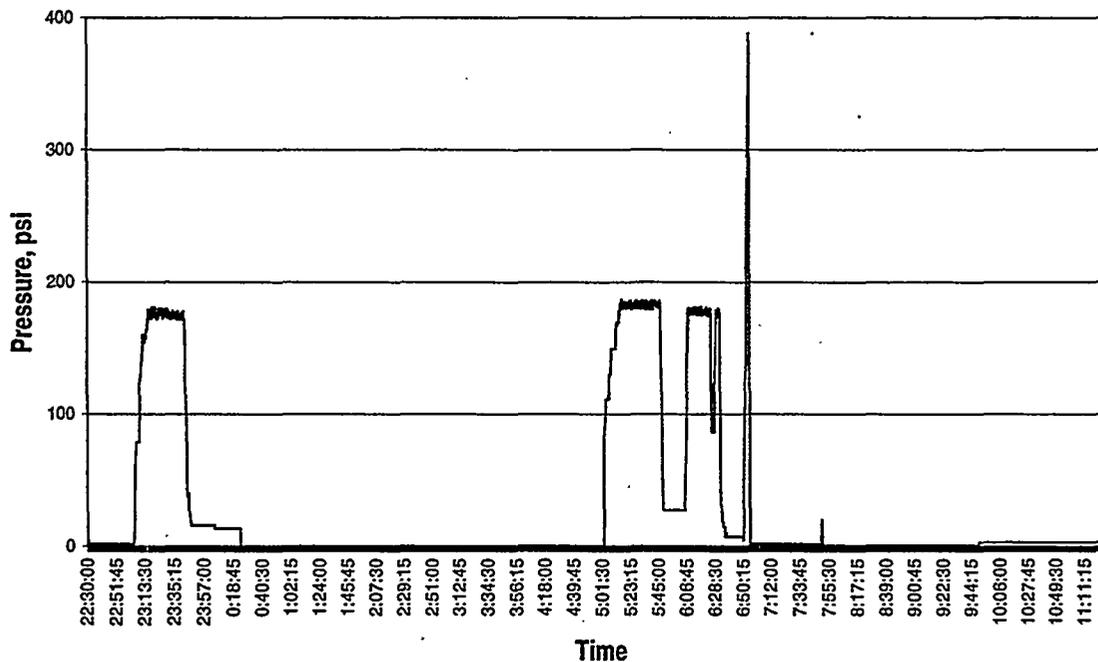
**Figure 5.6** Sluicer pump operation during remediation of Tank T3

The contents of Tanks T3 and Tank T9 were sluiced on June 28-29, and 23,500 gal of waste and process rinse water was transferred to MVST. The sluicer pump operating pressure during sluicing is shown in Figure 5.6. Excluding a pressure spike, the maximum operating pressure was ~ 190 psi. Although sluicing and transfer were successfully completed, several problems arose during sluicing, including the following:

- A sudden increase in discharge pressure from high pressure pump HPP320-2 and intake pressure to the sluicer pump led the team to believe that a rupture disk had been blown. The team replaced the rupture disk, but encountered difficulties that ultimately lead to the spread of contamination inside the transfer pump skid. It was later determined that the rupture disk had not failed, and that the unusual pressure observations could be attributed to the failure of the mechanical pressure relief valve on the sluicer pump skid.

- A signal transmitter board for the radiation meter malfunctioned and required repair.
- A high differential pressure developed across strainer STR355-1 leading the team to believe it had become clogged. The team switched strainers and continued sluicing. The strainer was eventually unclogged through a process of flushing and maintenance performed on discharge valve MOV 360-1.

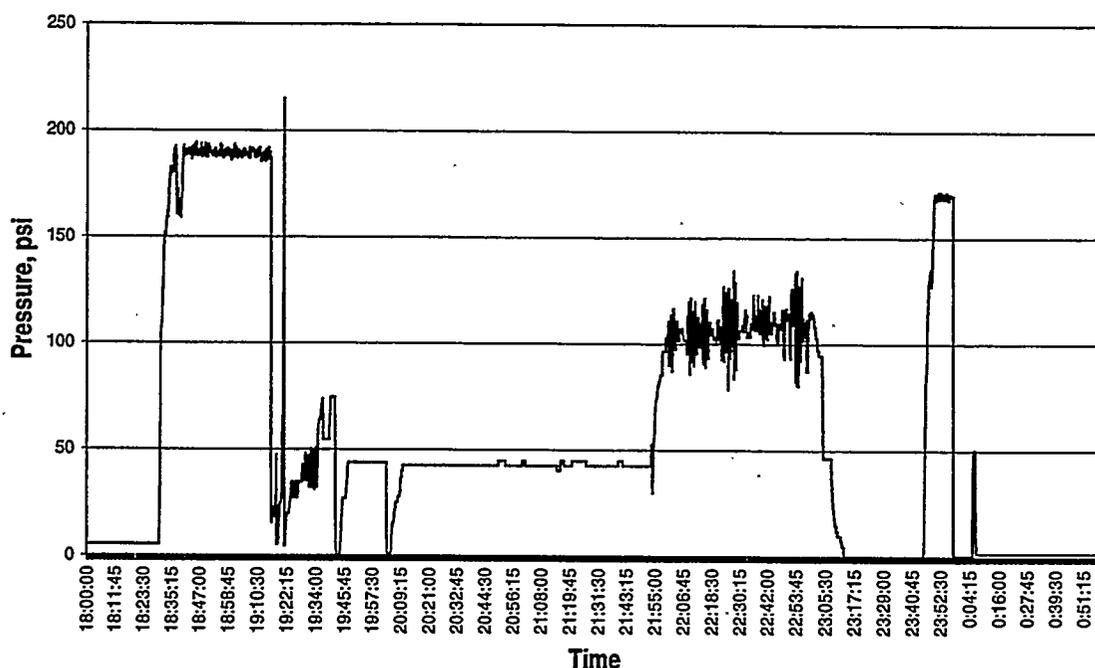
Figure 5.7 Sluicer pump operation during remediation of Tank T4

The fourth and final attempt to sluice Tank T4 was conducted on July 13-14, 1998. The contents of Tank T4 were sluiced, and 13,421 gal of waste and process rinse water were transferred to MVST. The sluicer pump operating pressure during sluicing is shown in Figure 5.7. Excluding a pressure spike, the maximum sustained operating pressure was ~ 195 psi. Although sluicing and transfer were successfully completed, problems arose with the potentiometers on the sluicer hydraulic controls, which limited operation of the borehole miner. Also, the strainer discharge valve MOV 360-1 failed to open.

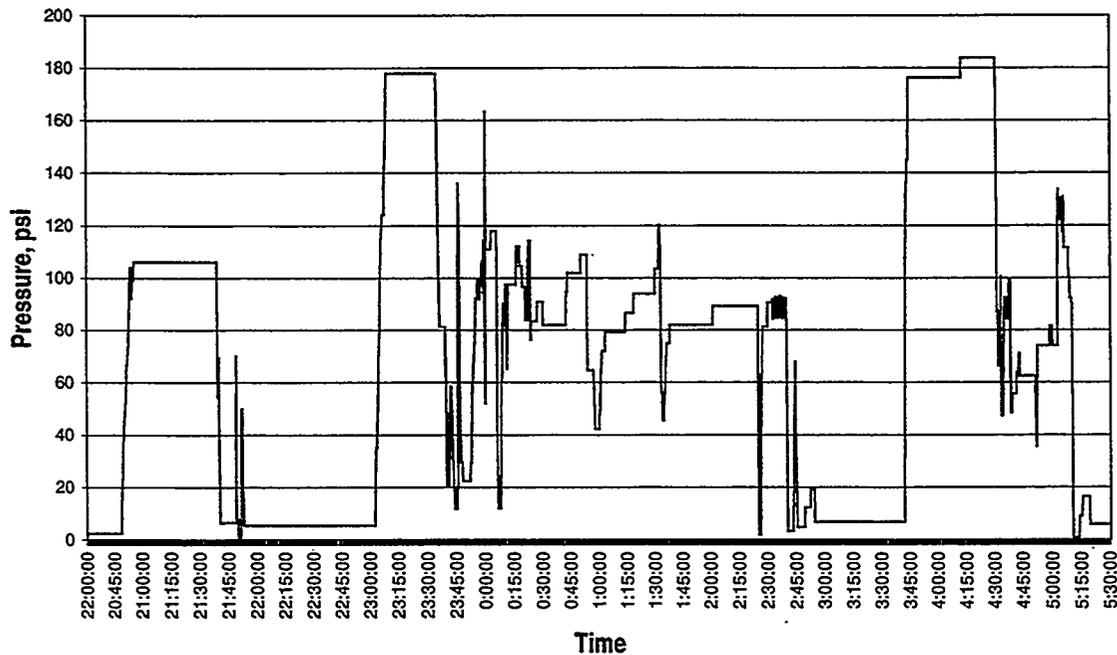
Figure 5.8 Sluicer pump operation during remediation of Tank T2

- The rupture disk in HPP320-1 failed and the team switched to HPP320-2 to conduct the remaining sluicing activities.
- The borehole-miner extendible nozzle failed to remain straight when extended. It is believed that one of the cables controlling the extendible nozzle stiffening function had failed or was no longer connected. (This was not verified visually).
- Several of the LEDs on the sluicer control unit were no longer functioning, due to the sluicer potentiometer problem discussed during Tank T4 operations.
