INHIBITING LOCALIZED CORROSION IN MILD CARBON STEEL

E.N. Hoffman
 P.E. Zapp
 B.J. Wiersma
 K.H. Subramanian

Savannah River National Laboratory
 Savannah River Site
 Aiken, SC 29808

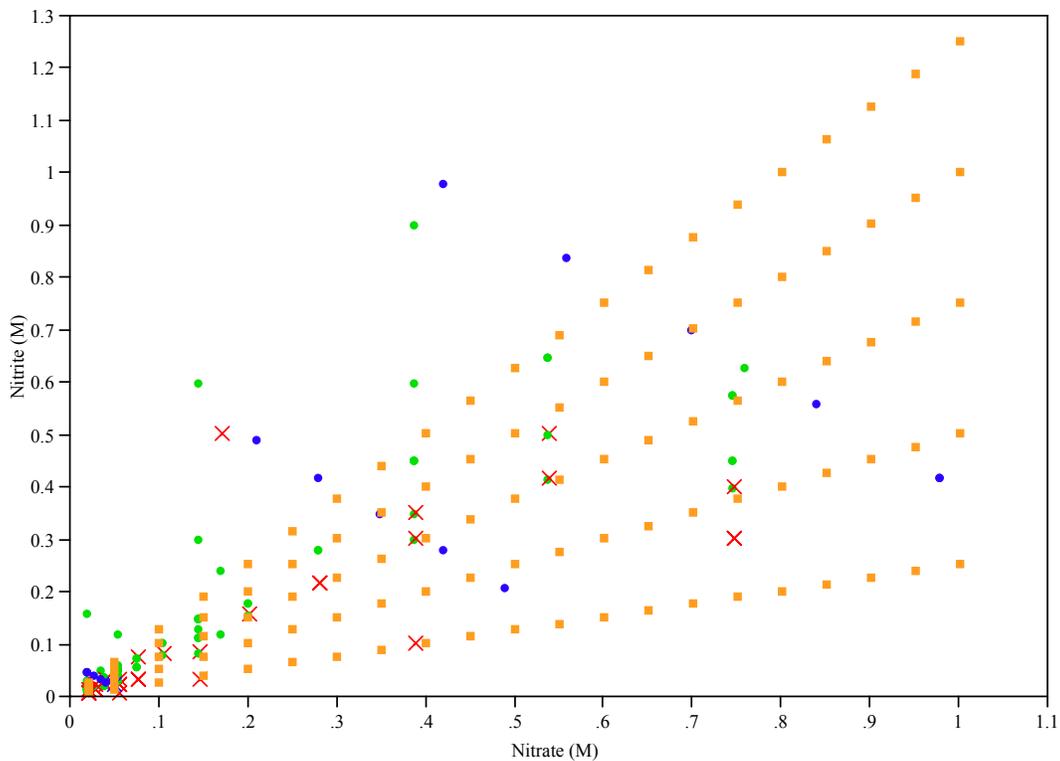
Figure 1. Solution chemistry design matrix compared to previously tested solutions.

An experimental program was undertaken to investigate the potential for relaxing the current chemistry control program without significantly affecting the risk of pitting by reducing the required nitrite concentration. An experimental matrix determined using logistical regression, provided a strategy for experimentation⁵. Figure 1 plots the existing data and the design points where a pitted outcomes from various testing programs are represented by a blue “X” or a red “X” and outcomes that showed no pitting are represented by a solid blue circle “•” or a solid green circle “•”. The design points (□) used for the experimentation described herein shown in Figure 1 were based on 5 constant ratios of nitrate to nitrite. The experimental matrix was designed to provide sufficient data to develop a predictive tool for corrosion vulnerability within the concentration range of 0.02 to 1.00 M nitrite.

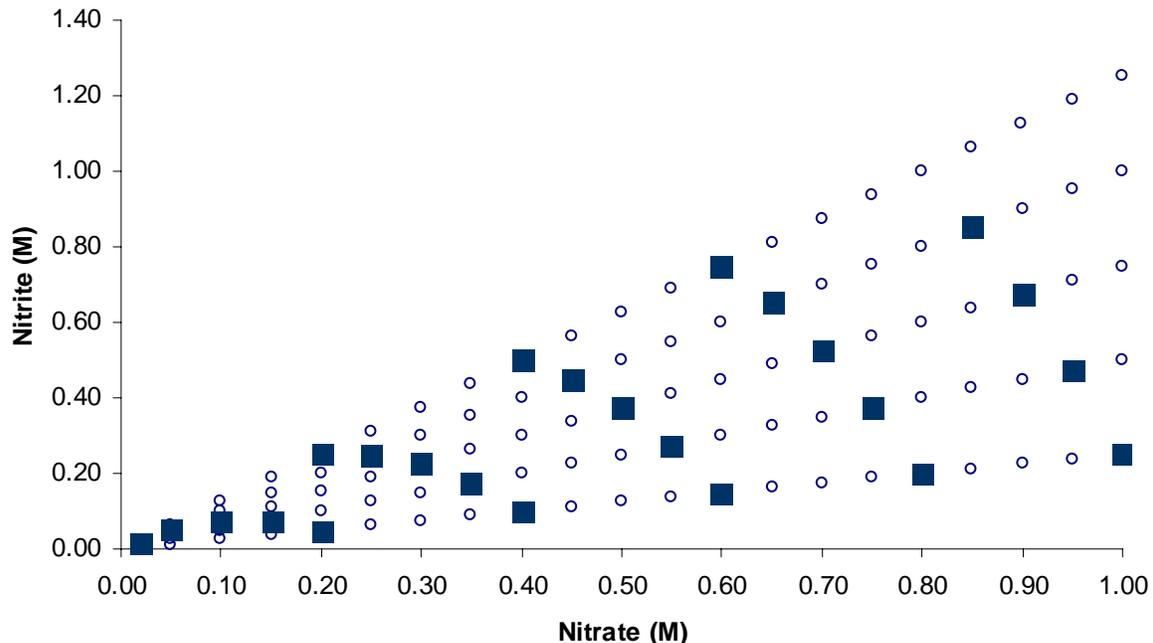
Figure 2. Selection of simulated tank solutions for coupons denoted squares.

Simulated Tank Solutions Simulated waste tank solutions were batch prepared using distilled water and reagent-grade chemicals: sodium chloride, sodium sulfate anhydrous, sodium carbonate, sodium bicarbonate, sodium nitrite, and sodium nitrate. The pH was maintained to 10.0 using a constant molar ratio of 7 to 13 for sodium carbonate to sodium bicarbonate, respectively. The gram amount of carbonate and bicarbonate added was determined based on the nitrite amount. A subset of 24 solutions were prepared based on a statistically determined experimental design⁵, see Figure 2. The design space was defined by molar concentrations of nitrate between 0.02 and 1.00 M with temperature being fixed at 40 °C. Assuming that only nitrate and nitrite would be added to the solutions, the statistical design deliberately contains series of solutions consisting of R-values (molar concentration ratio of inhibitor species to the sum of the aggressive species) to further investigate the value of the ratio in the prediction of corrosion response.

Sodium nitrate and sodium nitrite varied based on statistical modeling values. Sodium chloride and sodium sulfate were introduced to promote corrosion. Sodium chloride was added based on maximum amount allowable under current chemistry control limits, see Equation 2. Sodium sulfate was added based on the 84 wt% of the maximum amount allowable under current chemistry control limits, see Equation 3.

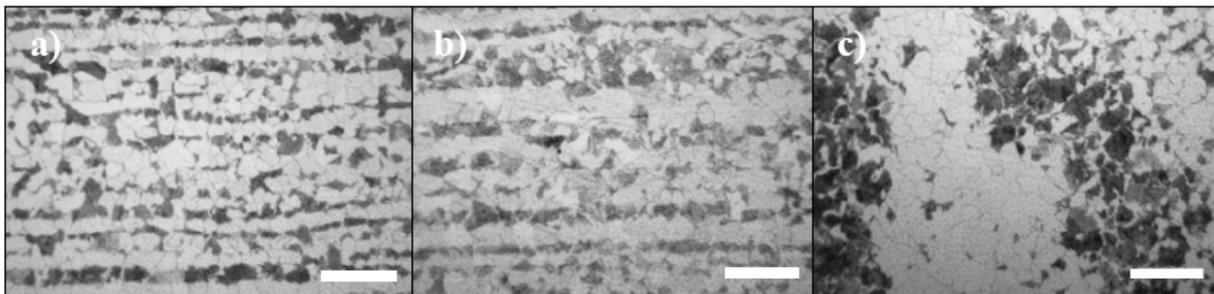
Figure 3. Microstructure of A537 coupons with sections perpendicular to the a) longitudinal b) transverse c) short directions. Scale bar equals 30 microns.

The microstructure of the A537 coupons revealed a layered ferritic/pearlitic structure with elongated grains on the longitudinal-traverse and short-transverse directions as expected, see Figure 3. The broad plane of the coupons was the section perpendicular to the short direction. This orientation is the plane that faces the interior of the tanks. Therefore, corrosion along this plane was the focus of the coupon study. The average grain size in this plane was 10-15 microns in diameter. The EDS analysis confirmed the presence of Mn-S based inclusions within the microstructure, see Figure 4.

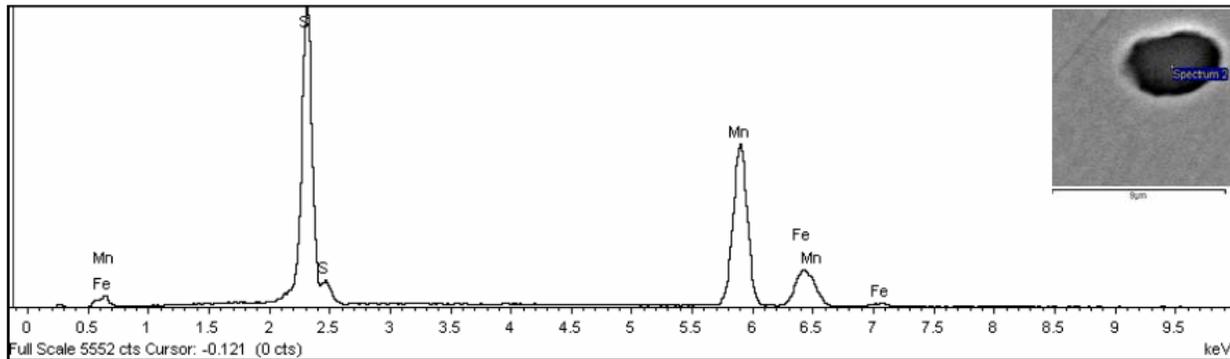
Figure 4. EDS of A537 coupon identifying presence of manganese and sulfur. SEM insert, top right, illustrates location of chemical analysis. Scale bar equals 9 microns.

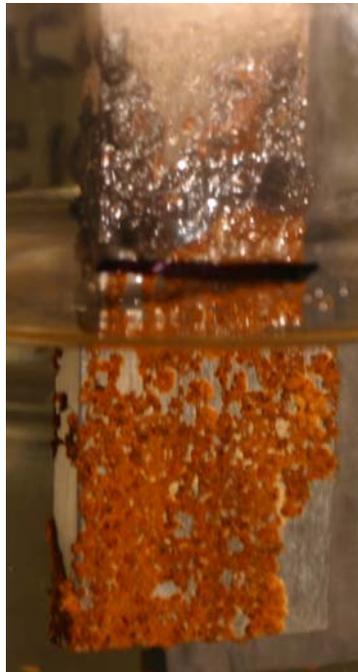
Figure 5. As-received coupon immersed in solution containing 0.02 M nitrate and 0.015 M nitrite at 16 weeks. The sample experienced pitting in the solution space. The corrosion product crept towards the vapor space region vertically from the interface region.

Significant variation in corrosion response occurred after the 19 week immersion testing based on the simulated waste solution used. The solution containing 0.02 M nitrate and 0.015 M nitrite, which is the lowest total sum of nitrate and nitrite used in the solutions exhibited distinctive pitting in the solution space, see Figure 5. Numerous samples within the moderate nitrate and nitrite concentrations exhibited little if any corrosion in the solution space, yet experienced significant uneven localized corrosion in the interface and vapor space, see Figure 6 and Figure 7. The corrosion response in the vapor and interface space seemed to creep from the interface region, see Figure 5. The type of corrosion which occurred in the vapor and interface space on the coupons was generally uneven local corrosion rather than highly localized pitting corrosion. Although less visible damage occurred, the heat treated samples followed a similar trend compared to the as-received samples.

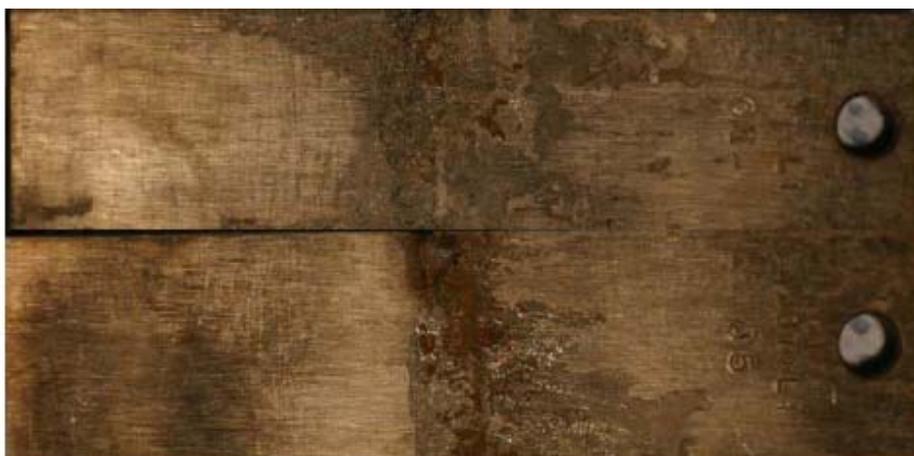
Figure 6. As-received coupons after 19-week exposure to 0.02 M nitrate and 0.015 M nitrite (top), and 0.2 M nitrate and 0.05 M nitrite (bottom). The interface space (center) is flanked by the vapor space (right), and the solution space (left).

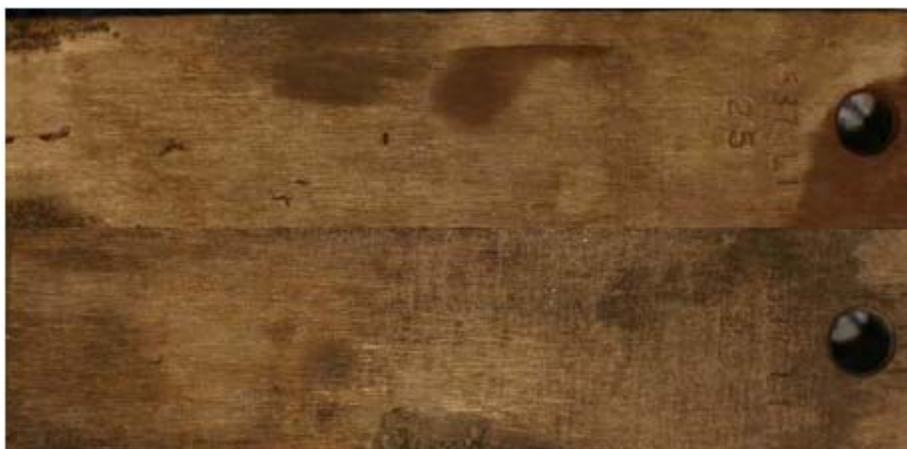
Figure 7. Heat treated coupons after 19-week exposure to 0.02 M nitrate and 0.015 M nitrite (top), and 0.2 M nitrate and 0.05 M nitrite (bottom). The interface space (center) is flanked by the vapor space (right), and the solution space (left).

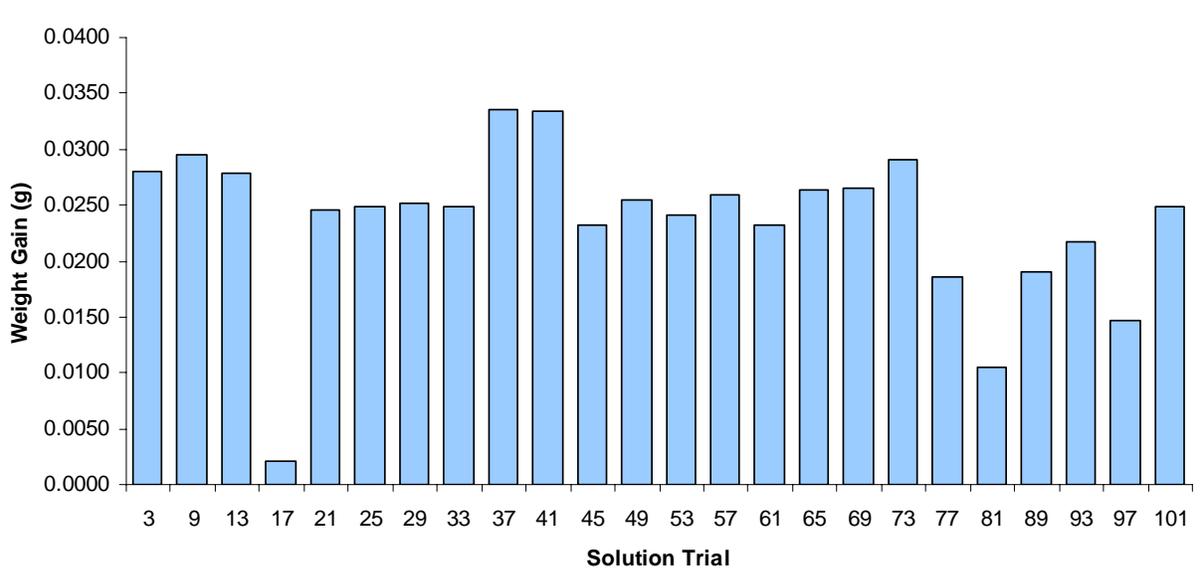
Figure 8. Weight gain due to oxide scale formation resulting from $700\text{ }^\circ\text{C}$ heat treatment.

The heat treatment at $700\text{ }^\circ\text{C}$ formed an oxide scale on the coupons. The weight gain due to scale formation varied from coupon to coupon, see Figure 8. The average weight gain was 0.024 g . The change in thickness averaged $0.002''$ and is not significant. It should not be assumed the scale formation is uniform between or within sample. After the 19 week immersion test, both the as-received and heat treated coupon series lost weight. On average, the drop in weight was larger for the as-received compared to the heat treated coupons with average weight loss for the two series being 1.09 and 0.77 g , respectively, see Figure 9. Variations in the oxide scale should be taken into account when evaluating the weight loss for the heat treated.

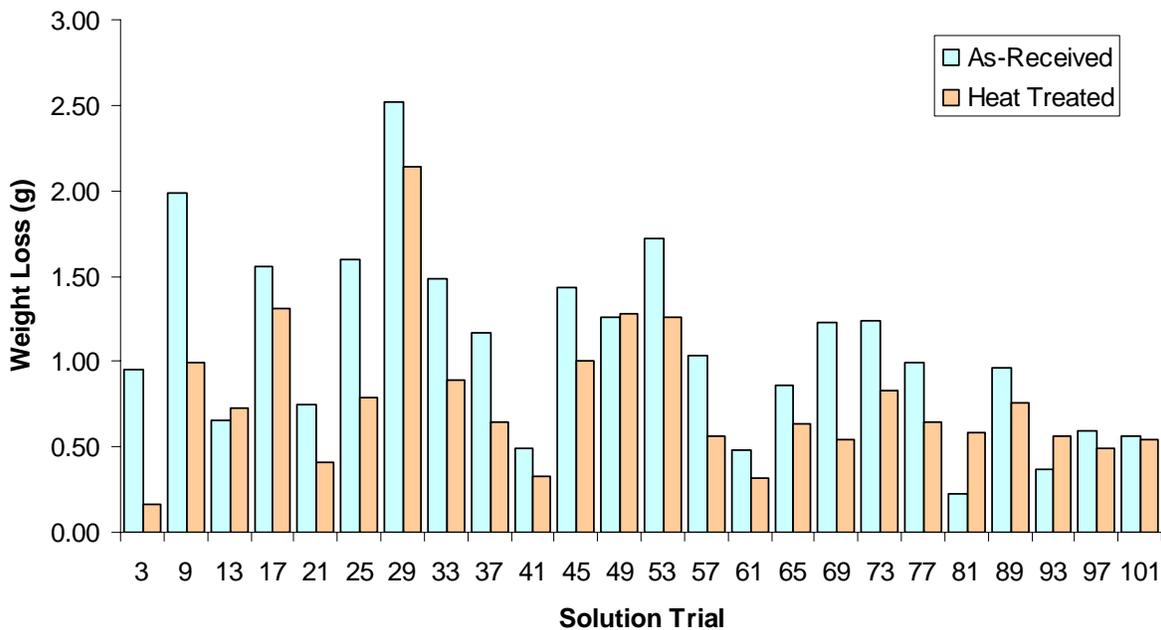
Figure 9. Weight lost after 19 week immersion testing for as-received and heat treated series.

Pit depth results from both the as-received and heat treated coupon series do not show an influence of solution concentration on pit depth. In the as-received series, the maximum pit depth was 0.0183” found on a coupon subjected to 0.1 M nitrate and 0.075 M nitrite. The maximum corroded area was 2.1” long, from a solution of 0.85 M nitrate and 0.85 M nitrite. For the heat treated samples, the maximum pit depth was 0.027” from a solution containing 0.9 M nitrate and 0.675 M nitrite, while the maximum length was 2.092” from a solution containing 0.25 M nitrate and 0.25 M nitrite.

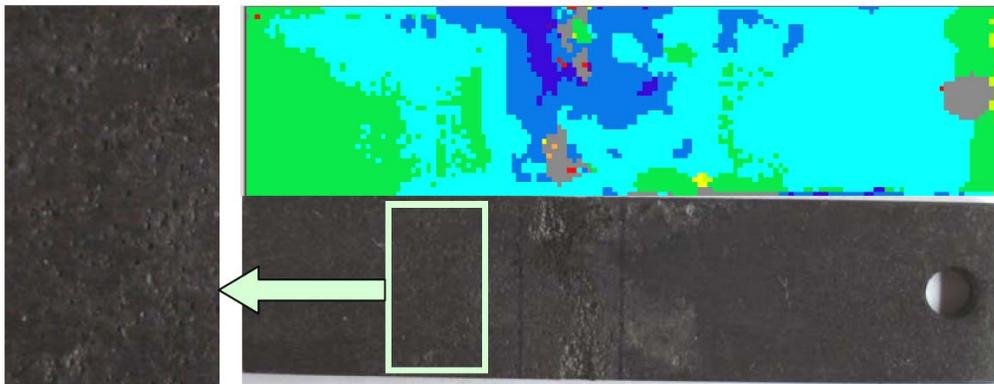
Figure 10. Coupon with as-received surface after 19 week exposure to solution containing 0.020 M nitrate and 0.015 M nitrite. UT scan and corresponding digital image of coupon. Enlarged image of pitting in solution area is shown on the left.

The majority of material loss occurred at the interface region, as can be seen in Figure 10-Figure 11. The coupons immersed in the solution containing 0.020 M nitrate and 0.015 M nitrite, pitting in the solution space was visible by eye, however, due to the narrow size of the pits, detailed measurement of pit depth was not possible. As shown in Figure 10, the UT scan suggests general corrosion loss in the solution space. However, this measurement is a result of the testing procedure, as is evident when comparing the corresponding digital image of the surface.

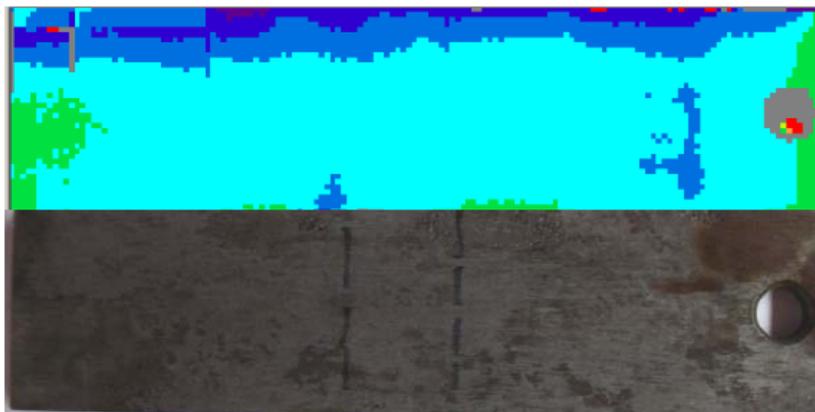
Figure 11. Heat treated coupon after 19 week exposure to solution containing 0.020 M nitrate and 0.015 M nitrite. UT and corresponding digital image are shown.

When comparing the as-received coupon corrosion response to the heat treated coupon exposed to the same solution chemistry, less material loss due to corrosion occurred, particularly at the interface region. The majority of the corrosion occurred along the side parallel to the length of the coupon. This corrosion response could be due to the variation in microstructure that occurs on the sides of the coupon, as well as surface tension effects related to the side regions of the coupons. The minimum measured thickness of the heat treated coupon was 0.143" compared to the 0.141" of the as-received sample.
