Pretreatment Applied Engineering, Corrosion Assessment for Tank Materials: 1995 Final Report

Graham T. MacLean

Westinghouse Hanford Company, Richland, WA 99352
U.S. Department of Energy Contract DE-AC06-87RL10930

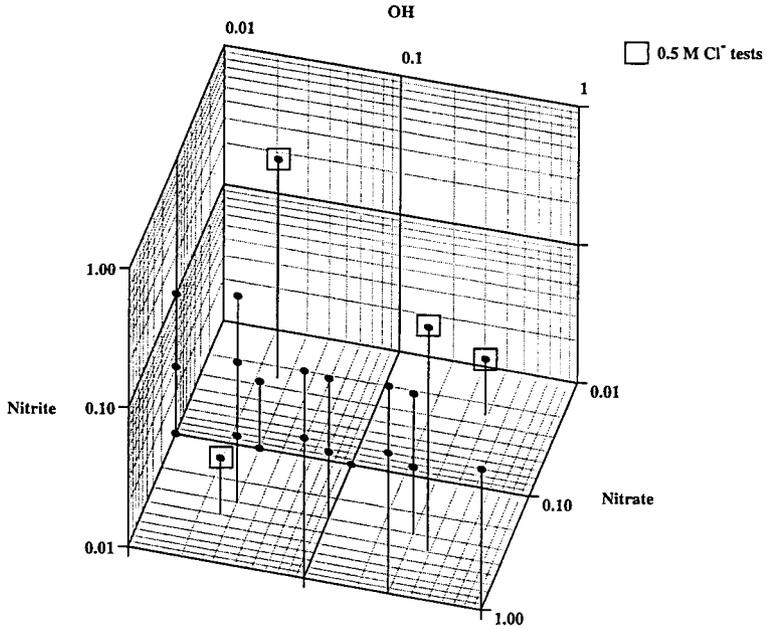
Figure 1. 1995 Test Matrix for Sludge Washing Corrosion Assessment.

1995 Test Matrix Corrosion Assessment for Sludge Washing

Nitrate, nitrite, and free hydroxide are the three independent variables that have the most effect on the corrosion response. A statistical experimental design was used to define the test solution compositions because of the expected complexity of the interaction among these variables and the wide variety in the tank solution compositions. The range of each variable is shown below:

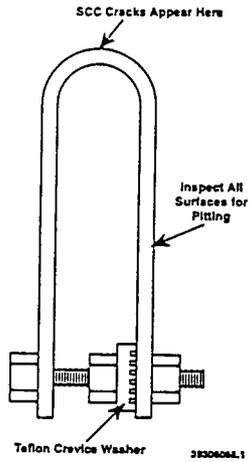
Figure 5. Configuration of the U-bend Specimen Used for Static Corrosion Testing.

Additionally, there were 24 static solution tests containing A-515 coupons. Tests were performed in two-liter polypropylene bottles containing three totally immersed U-bends and three totally immersed flat, uniform corrosion specimens. Three U-bends and three flat specimens were also mounted at the solution/vapor interface in each bottle. Each U-bend (shown schematically in Figure 5) at the solution/vapor interface was positioned with the maximum stressed region at the interface. Polytetrafluoroethylene crevice washers were used under the stressing bolts for all the U-bends to serve as a crevice corrosion test. The test bottles were maintained at $93 \pm 3^\circ\text{C}$ in three air ovens (eight bottles/oven). Each bottle was sparged with carbon dioxide-free air at 1.3 L/day to maintain the oxygen concentration (the carbon dioxide was scavenged with Ascarite). An air condenser was fitted to each of the 24 containers. Deionized water was added to each container as needed to compensate for evaporation losses.

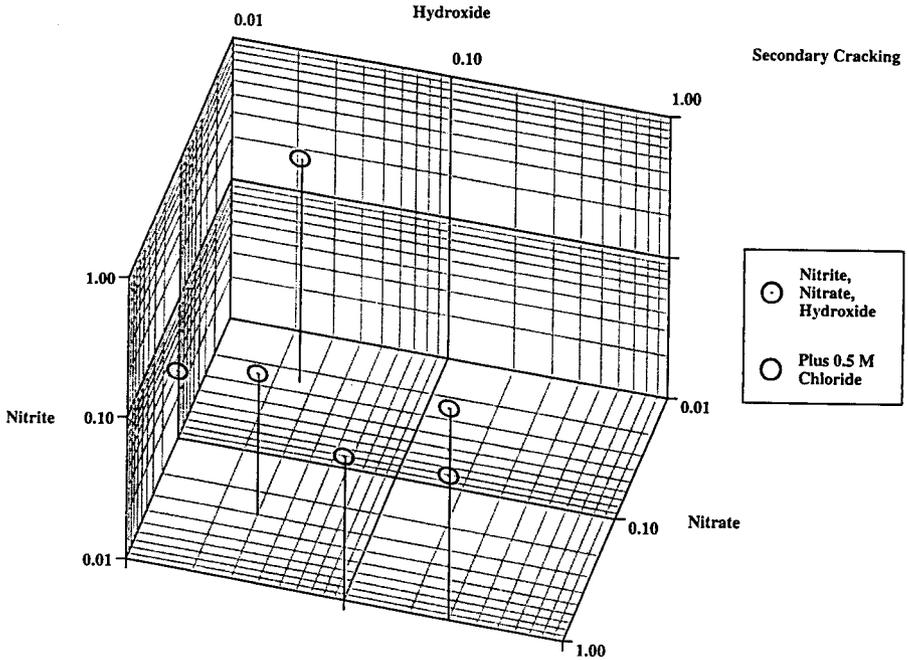
Figure 6. Sludge-Washing Compositions That Led to Secondary Cracking in 1995 Test Matrix.

Secondary cracking on the slow strain rate specimens also occurred, with one exception, for solutions with either a 10:1 ratio of nitrate to nitrite or a 10:1 ratio of both nitrate to nitrite and nitrate to hydroxide. The exception was solution 6, which has a low concentration of nitrate with a 3.3:1 ratio of nitrate to nitrite and 10:1 ratio of nitrate to hydroxide. The specimens in the solutions that had a 10:1 ratio of nitrate to hydroxide and a 3.3:1 to 1:1 ratio of nitrate to nitrite had the lowest average corrosion rates measured.

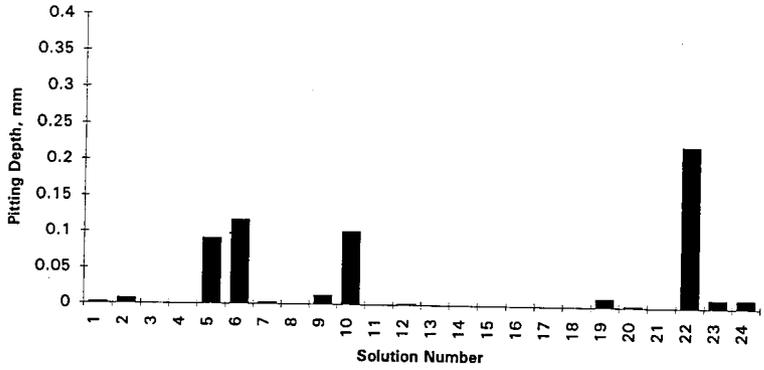
Figure 7. Maximum Pit Depth for Specimens Immersed in Solutions.

The maximum depth of pitting, crevice attack, and waterline attack is shown in bar charts for the twenty-four solutions in Figures 7 through 11. Sludge-washing compositions that lead to pitting, crevice, or waterline attack depth ≥ 0.05 mm were identified in the 1995 Test Matrix, Figure 12. Pitting depths, in general, were <0.5 mm for specimens tested in both the immersed condition as well as the vapor phase of most of the solutions. This was not true for solutions 1, 5, 6, and 10, as well as for the high chloride solutions. The depth of the crevice attack was greater than for the pits in all solutions where both were present. The occurrence and density of pitting was greater for specimens in the vapor phase as compared to the immersed specimens, but the pits were often very shallow. Waterline attack was present on the specimens in the vapor phase for most of the solutions, with depths comparable to the depths of the crevice attack. A comparison of the corrosion coverage (pitting density, crevice attack area, or waterline attack area) versus the depth of the attack is given in Table 8. There appears to be little correlation between the density of the attack and the depth of the attack for these solutions.

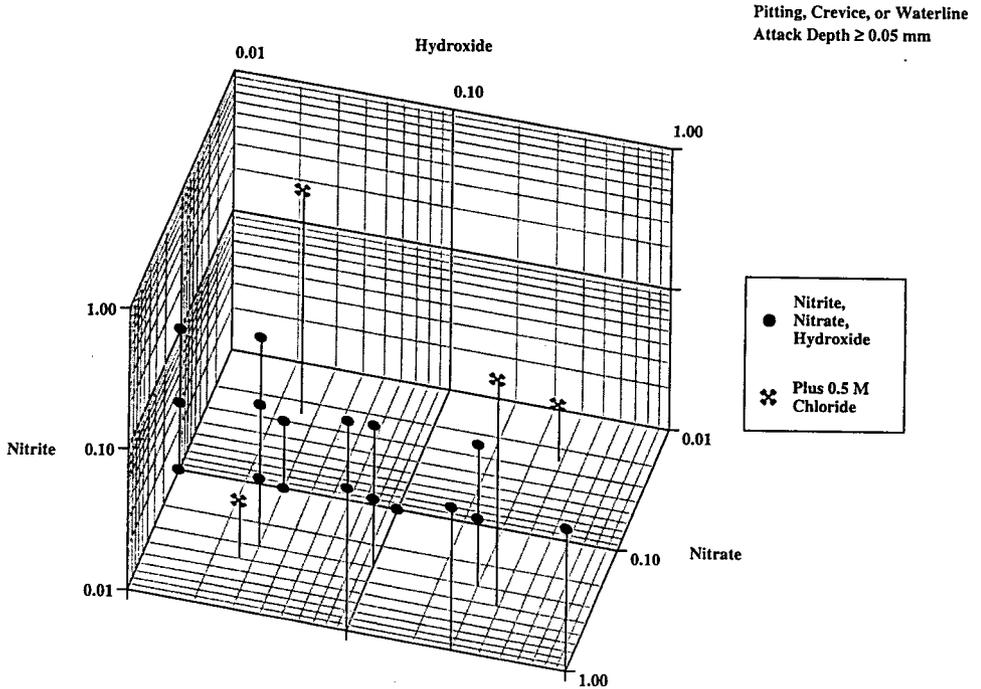
Figure 12. Sludge-Washing Compositions That Led to Pitting, Crevice, or Waterline Attack ≥ 0.05 mm in the 1995 Test Matrix.

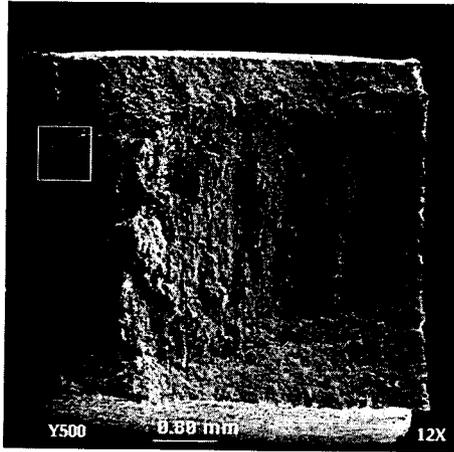
Figure A.1a. Fracture of Specimen from Air

Figure A.1b. Higher Magnification of Fracture Surface

SEM photographs of the fracture surfaces at magnifications of 12X and 100X of the slow strain rate specimens are shown in Appendix A. A classic intergranular fracture appearance is not apparent for any of the specimens tested. The fracture surface appearance is not always consistent with complete ductile tearing, however. For example, there is a quasi-cleavage appearance to the fracture surface of the specimen tested a slower strain rate in solution 12, shown in Figure A.27b. Some specimens exhibited a reddish-brown corrosion product on the interior of the fracture surface that was not evident on the edges of the fracture surface. It is hypothesized that during the testing a small amount of the solution had siphoned into the interior of the fracture surface through a small crack in the gage section (implying that a crack opened early in the testing), leading to a fracture appearance as shown in Figure A.11a. Additionally, the FY 95 and FY 94 specimens tested in solution 20 (solution 12), including the specimen tested at the lower strain rate, showed evidence of secondary cracking readily observable at a magnification of 10X. This secondary cracking can be seen in the gage section shown in Figures A.7a, A.9a, A.10a, A.15a, A.21a, A.24a, and A.26a. All except for Figure A.10a represent fracture surfaces of specimens tested in low nitrite/nitrate ratio solutions or the presence of high chloride in the solution. Sludge-washing compositions that lead to secondary cracking are identified in the 1995 Test Matrix, Figure 6. The presence of secondary cracking perpendicular to the applied stress during slow strain rate tests has been used as a criteria for SCC in some environments. This presents a dilemma in how to adequately characterize SCC for slow strain rate tests.

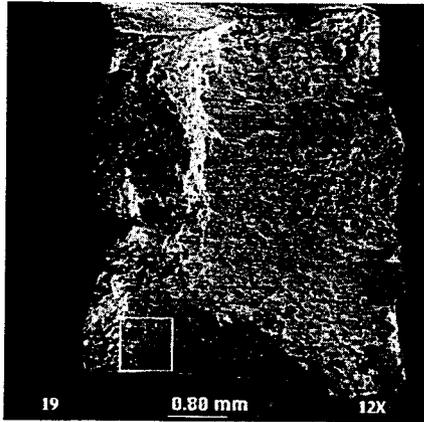
Figure A.26a. Fracture of FY94 Specimen from Solution 12

Figure A.26b. Higher Magnification of Fracture Surface

1. Secondary cracking was noted on the gage lengths perpendicular to the applied stress for specimens that were tested in seven solutions: 6, 8, 9, 12, 14, 20, and 23.
2. Solutions 12 and 20 indicated no SCC by the Ondrejcin criterion, but these were duplicates of a solution (#2) that indicated SCC (11% elongation) in the FY 94 testing. When the strain rate was decreased by 1/4, the elongation decreased but was still above the Ondrejcin criterion.

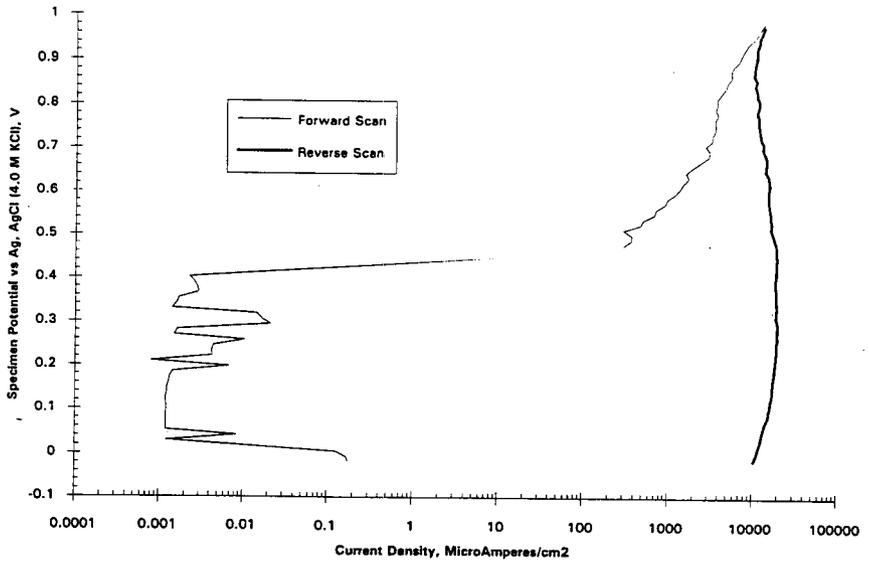
Figure B.1. Potentiodynamic Scan in Solution 1

Starting at the open circuit corrosion potential, the electrochemical potential on the metal specimen is increased in the anodic direction at a constant rate (0.2 mV/s). The potential at the abrupt current increase is known as the pitting potential. In the case of the present tests, the potential scan is reversed at 1.0 V anodic to the open circuit potential, and the voltage is returned to the open circuit value at a rate of 0.2mV/s. When a metal starts to pit, the current increases abruptly, giving a characteristic signature. Once pits initiate and grow, they tend to persist so that the current remains high, causing the formation of a current hysteresis loop. During the reverse scan, the point at which the current decreases and becomes equal or less than the forward scan current is called the protection potential because the growth of the propagating pits is halted. The protection potential is thought to be the lowest potential that permits pitting to initiate; consequently, it has the greatest relevance for predicting pitting propensity for actual service. Figure B.19 illustrates how the pitting and protection potential are defined. At the low current ranges ($\leq 0.1\mu A/cm^2$), the logarithmic current amplifier in the potentiostat becomes noisy and creates the current spikes observed in the current-potential data.

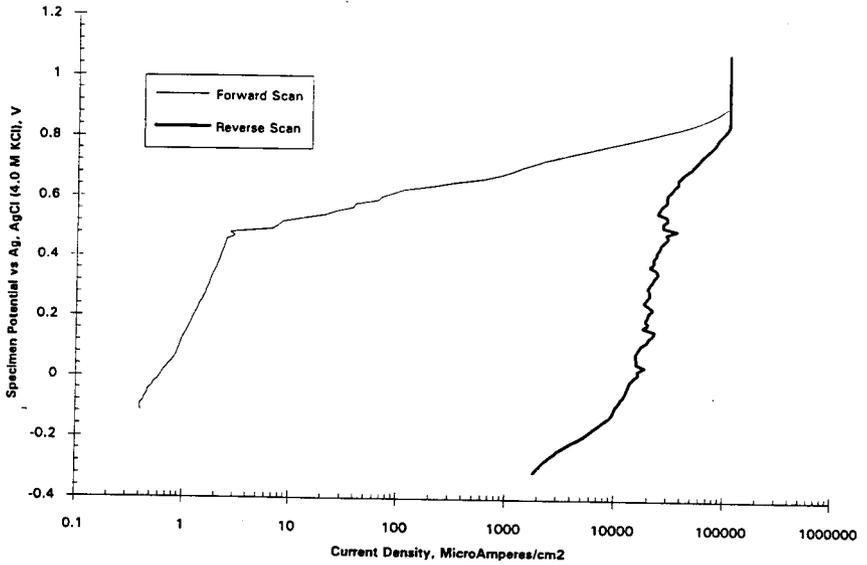
Figure B.24. Potentiodynamic Scan in Solution 24

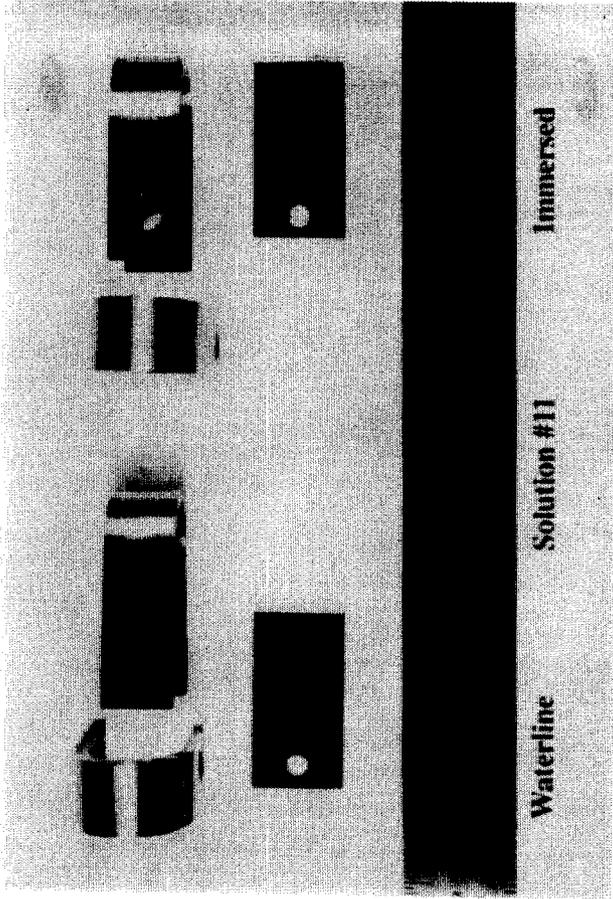
Figure C.11 Solution 11: Representative Specimens After Removal from Test Solution (no cleaning)

Photographs shown in Appendix C were taken of representative specimens from each test solution prior to cleaning. The U-bends and coupons from solutions 1, 9, 11, 13, and 18 exhibited shiny, post-test surfaces in the immersed phase, similar to the pre-test condition of the surface. One solution, solution 11, exhibited a shiny post-test surface in the vapor phase.

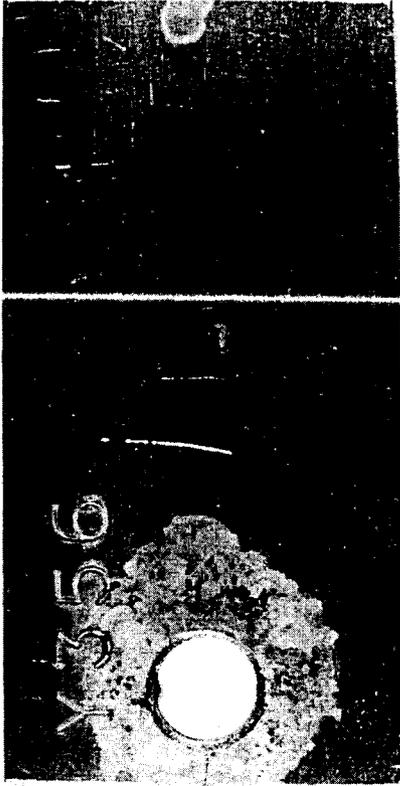
Figure E.1 Totally Immersed Weight Loss Specimen from Solution 2.
Note crevice attack around hole.

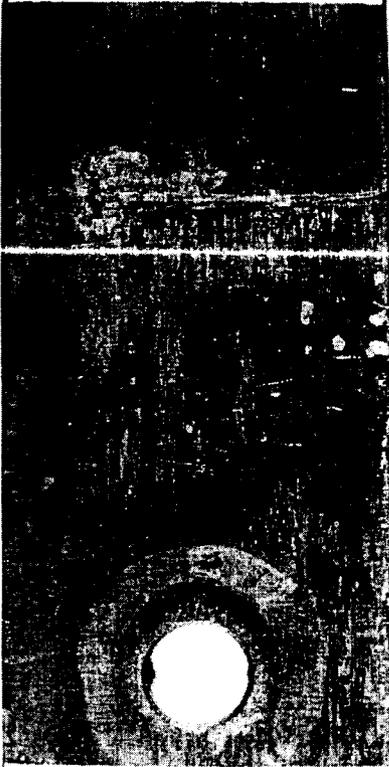
Figure E.4 Air/Solution Weight Loss Specimen from Solution 5.
Note waterline attack.

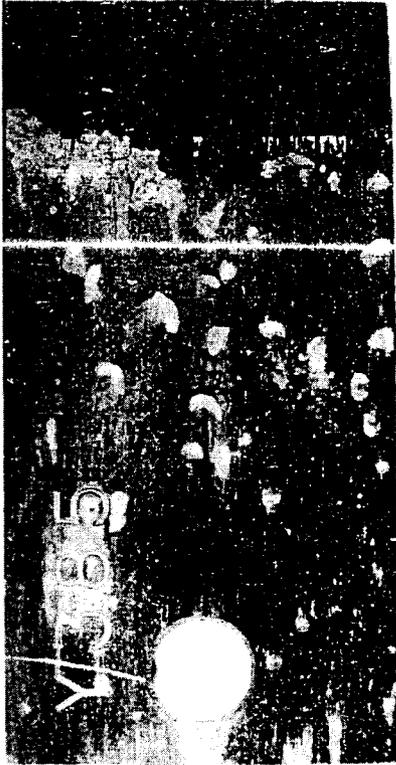
Figure E.6 Air/Solution Weight Loss Specimen from Solution 6.
Note waterline attack and pits in the vapor phase.

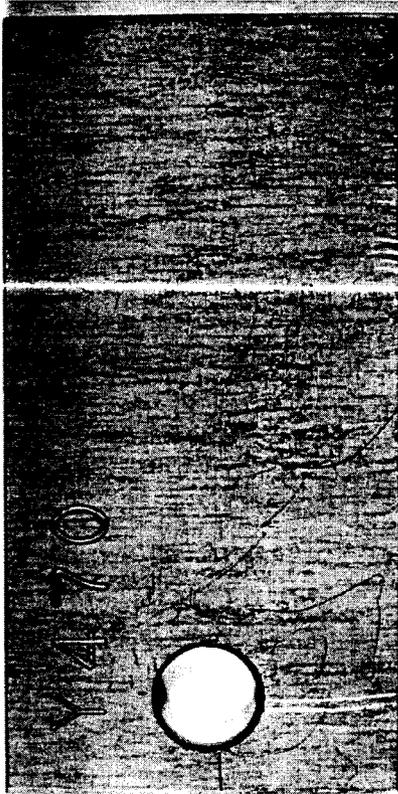
Figure E.11 Totally Immersed Weight Loss Specimen from Solution 21.
Note pristine appearance of surface.

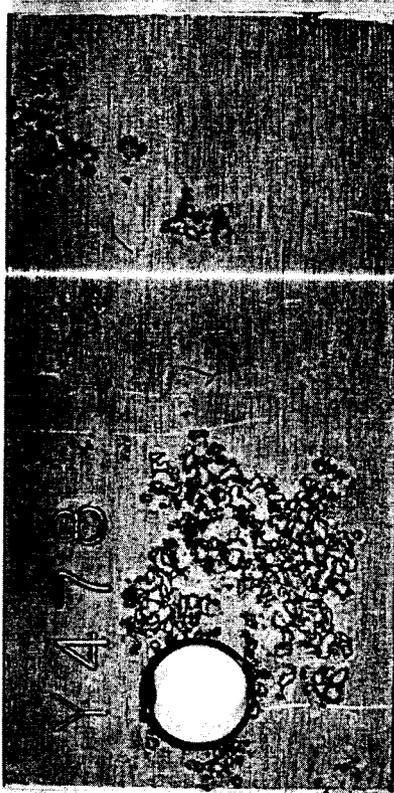
Figure E.12 Totally Immersed Weight Loss Specimen from Solution 22.
Note deep pits present on the specimen surface and crevice
attack at hole.

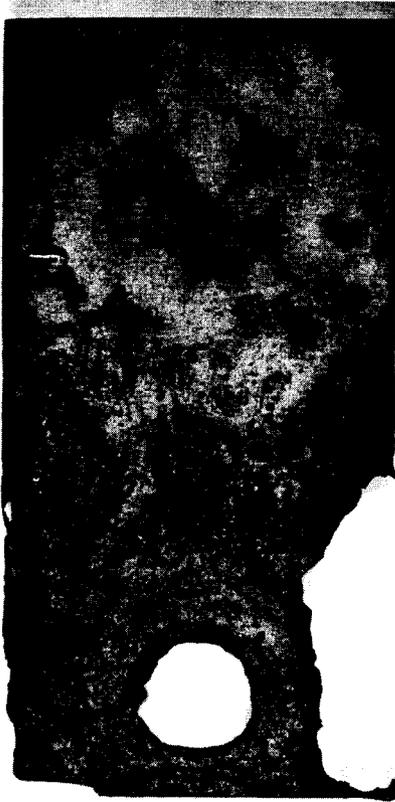
Figure E.13 Air/Solution Weight Loss Specimen from Solution 23.
Note extensive removal of metal at and above the
waterline due to massive waterline attack.

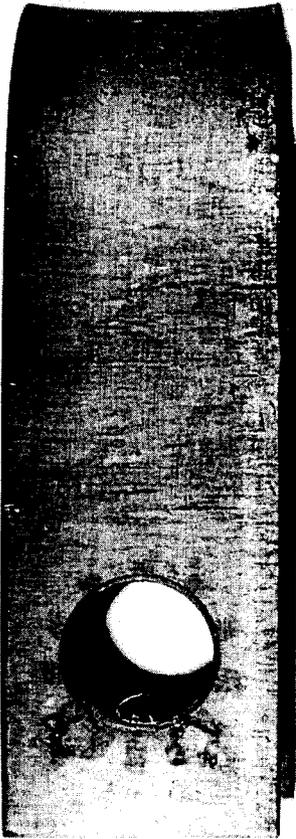
Figure E.15 Totally Immersed U-Bend Specimen from Solution 23.
Note small amount of crevice attack around hole.
