Paper 06637

VAPOR SPACE AND LIQUID/AIR INTERFACE CORROSION OF LOW CARBON STEEL IN COMPLEX RADIOACTIVE HIGH LEVEL RADIOACTIVE WASTE

Karthik H. Subramanian and Bruce J. Wiersma
Westinghouse Savannah River Company
Savannah River Site
Aiken SC 29808

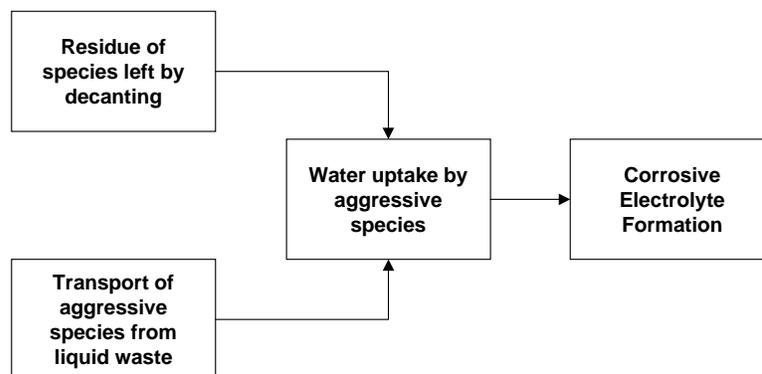
steel tank, left by evaporation or decanting of supernate. Alternatively, species may have been deposited on the tank wall by evaporation from the supernate, transport as an aerosol, and then condensation on the tank wall. In sufficiently humid conditions the residue can adsorb atmospheric moisture and dissolve, forming a corrosive electrolyte. A schematic of these mechanisms is shown in Figure 1.

FIGURE 1: Hypothesized VSC Mechanism

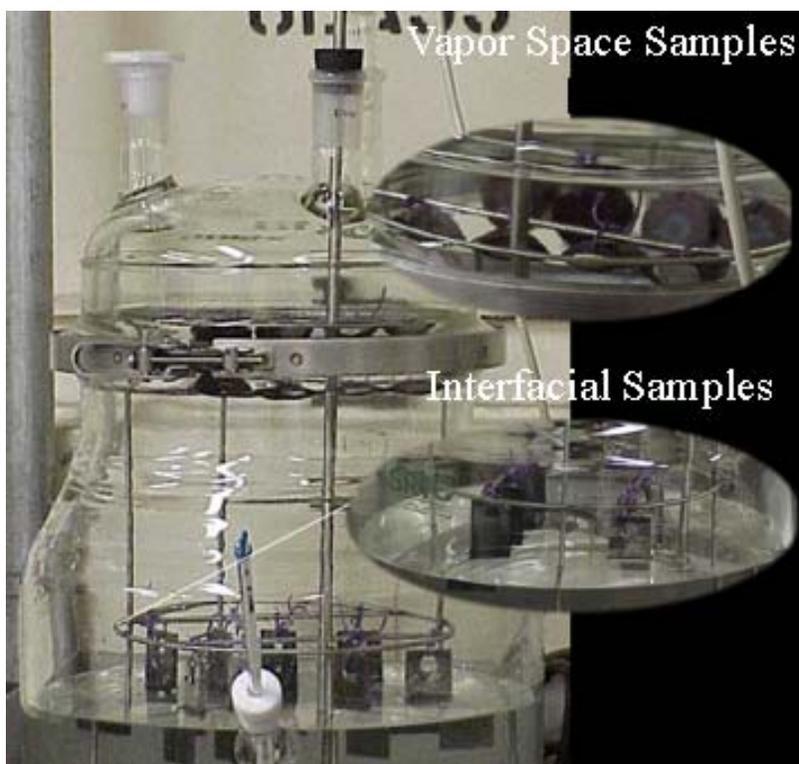
The testing in the vapor space was done on metallurgically mounted ¼-in. thick round disk coupons. The liquid air interfacial testing was done on 2-in x 1-in x 0.125 in. standard pitting coupons. A photograph of the experimental test setup is shown in Figure 2. The insets give higher magnification of the coupons exposed to the vapor space and the coupons exposed to the liquid/air interface.

FIGURE 2: Experimental Test Setup

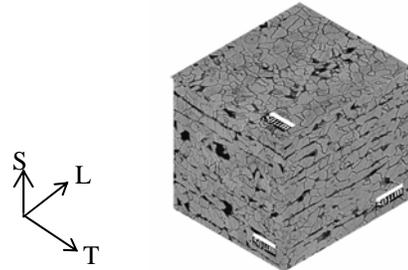
The tanks were fabricated with semi-killed, hot-rolled A537-C1.1 plate, with nominal composition shown in TABLE 1. The A537 steel is a ferritic/pearlitic steel with the microstructure shown in FIGURE 3. A representative coupon is shown in FIGURE 4.

FIGURE 3: Microstructure of ASTM A537 Cl.1 Steel.

The tanks were made from hot-rolled plate and tend to have manganese sulfide and aluminum oxide inclusions that are oriented parallel to the rolling direction. Previous experiments have shown that pitting on polished coupons above simple waste simulatant has initiated in rows suspected to be in line with these inclusions.³ Other studies revealed that nitrate-induced pitting in these steels typically initiates around manganese sulfide or aluminum oxide inclusions.⁴

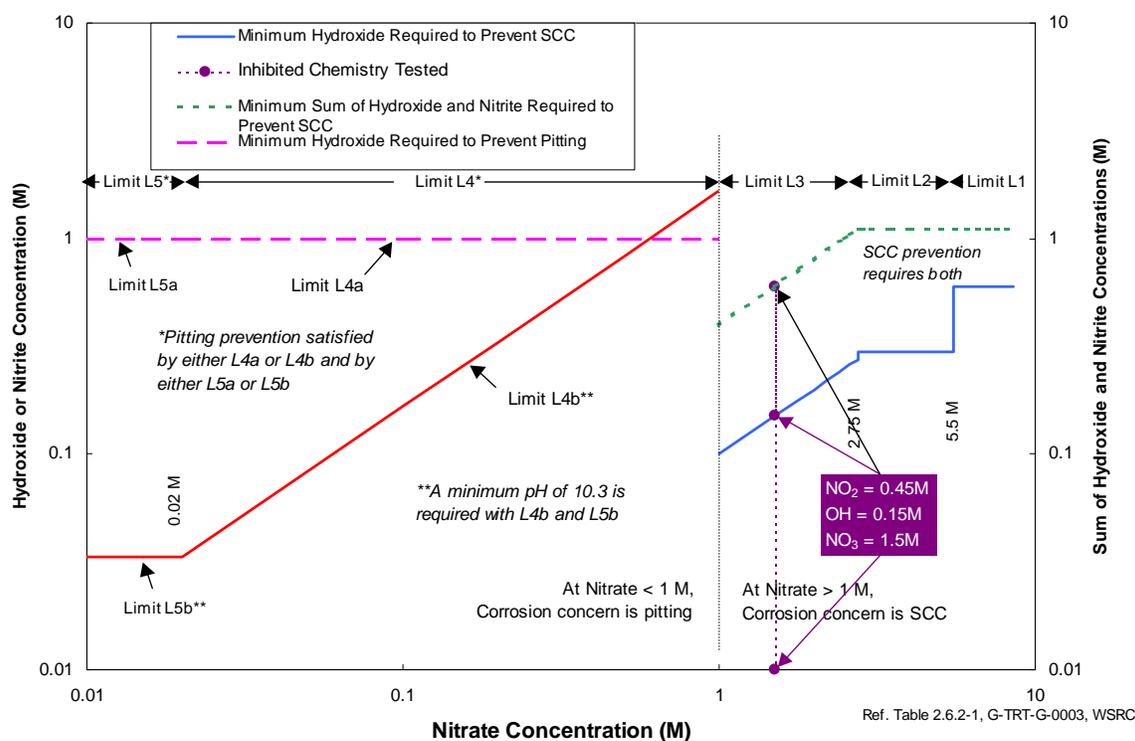
A graphical representation of the chemistry control program is shown in FIGURE 6. The summary indicates the hydroxide and nitrite levels that are to be maintained as a function of nitrate concentration. The inhibited chemistry tested is indicated

on the graph. Limit L3, the regime within which the pitting studies were done, addresses the nitrate range that is typical of fresh waste. The limit is specified to prevent nitrate-induced stress corrosion cracking, as pitting is not expected, based primarily on engineering judgment. The limit was based upon a combination of operational experience and the knowledge of the corrosion mechanisms. A minimum hydroxide concentration of 0.1 M was conservatively selected to maintain inhibiting conditions in 1M nitrate waste solutions. The minimum hydroxide concentration and the minimum sum of hydroxide and nitrite in L3 over the range 1 M nitrate to 2.75 M nitrate were selected to transition smoothly to the L2 limit at 2.75 M nitrate. Limit L3 carries a maximum temperature of 70°C, or 105°C if the sum of hydroxide and nitrite concentrations exceeds twice the nitrate concentration.

FIGURE 6: Summary of Chemistry Control Program and Chemistry Tested

The pitting studies were conducted within this regime as it is expected to be the most aggressive contributing to pitting in the vapor space and at the interface, particularly at the boundary conditions tested. The limited hydroxide and nitrite availability at the interface may lead to pitting at the interface due to inhibitor depletion during extended periods of waste level stagnancy. Additionally, the limited hydroxide availability may diminish the hypothesized inhibitive effect of hydroxide within the vapor space. The testing was conducted at the boundary conditions to provide a conservative approximation of pitting rates, even though the tanks are currently operated at much high hydroxide concentrations.

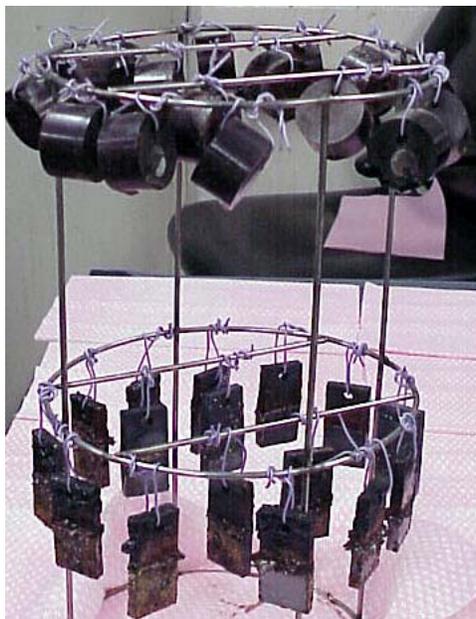
The solution rack as removed from exposure is shown in FIGURE 7.

FIGURE 7: Solution 1 Solution Rack as Removed.

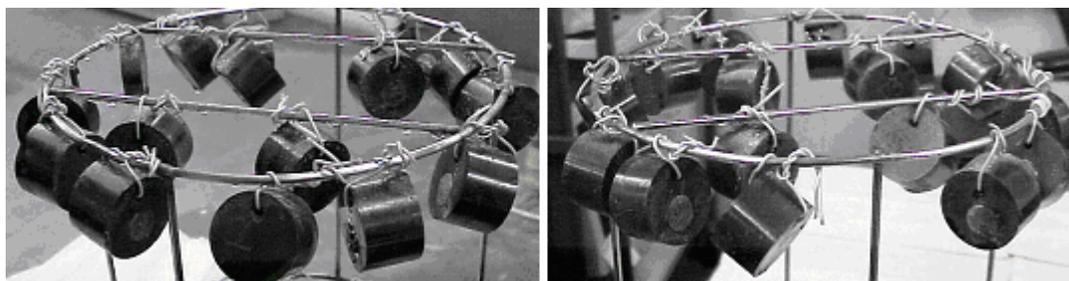
The visual analysis of the vapor space coupons, shown in Figure 8 revealed severe corrosion on the polished specimens with the initial deposits, but only spotty corrosion on polished specimens without the initial deposits. The heat treated coupons exhibited severe corrosion only when deposits and indents were both present. The other coupons exhibited spotty corrosion, but were largely protected. It is important to note that the indented coupon without the deposit did not exhibit corrosion.

FIGURE 8: Vapor Space Coupons as Removed from Exposure to Solution 1.

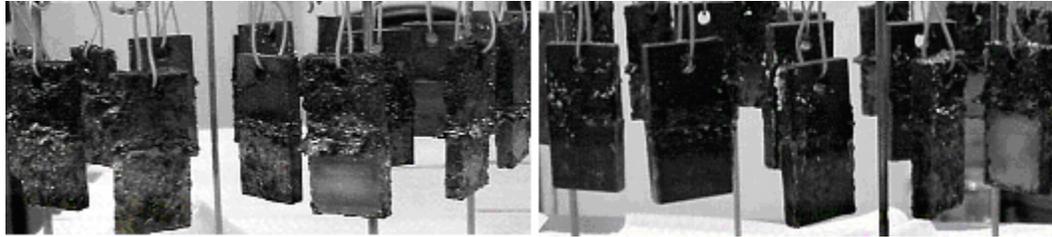
The polished specimens of the liquid air coupons were severely corroded above the line and moderately corroded below the line. The below the line corrosion was limited to the “outer surface” of the coupon, while the “inner surface” of the coupons appeared uncorroded. This may be due to liquid level stagnancy on the outer surface, since the stirring motion within the cell was limited to the center of the cell. The coupons are then presented after cleaning in Clarke’s solution, once again with the inner surface first, and the outer surface following. The polished coupons had a significant amount of corrosion just above the liquid level including growth of the oxide scale approximately $\frac{1}{4}$ ” from the surface of the coupon. However, corrosion below the level was limited to the outer surface of the coupon where liquid was stagnant. The heat treated coupons exhibited a similar growth of oxide scale and delamination of the heat treatment layer.

FIGURE 9: Liquid/Air Interface Coupons as Removed from Exposure to Solution 1.

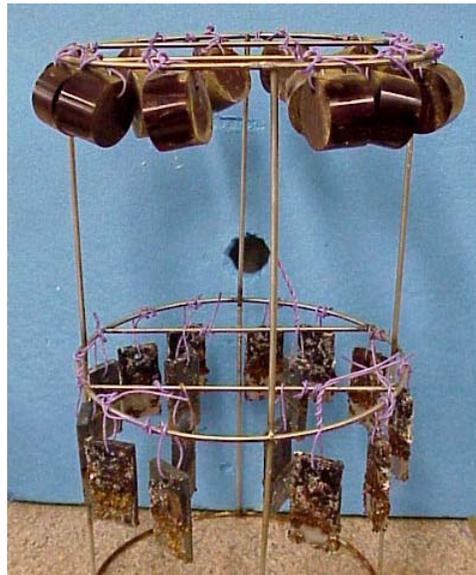
FIGURE 10: Solution 2 Rack as Removed.

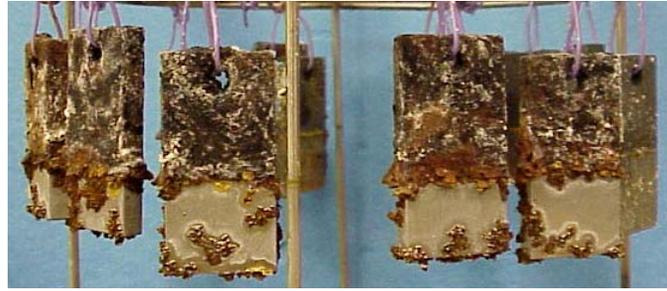
The polished specimens of the liquid air coupons were severely corroded above the line and moderately corroded below the line. The below the line corrosion was limited to the “outer surface” of the coupon, while the “inner surface” of the coupons appeared uncorroded. This may be due to liquid level stagnancy on the outer surface, since the stirring motion within the cell was limited to the center of the cell. The polished coupons had a significant amount of corrosion just above the liquid level including growth of the oxide scale approximately $\frac{1}{4}$ ” from the surface of the coupon. However, corrosion below the level was limited to the outer surface of the coupon where liquid was stagnant. The heat treated coupons exhibited a similar growth of oxide scale and delamination of the heat treatment layer.

FIGURE 11: Solution 2 Liquid/Air Interface Coupons as Removed.

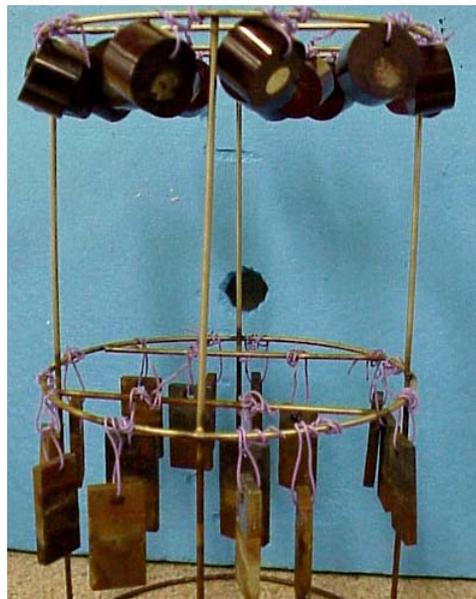
The coupons as removed from the test solutions are shown on the coupon rack in FIGURE 12.

FIGURE 12: Tank T Rack as Removed

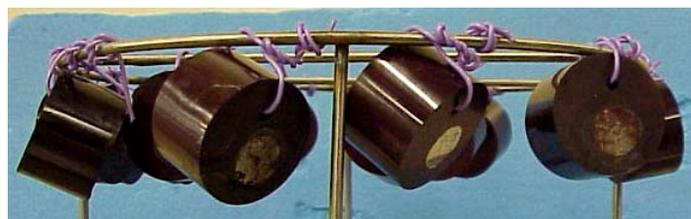
The vapor space coupons and liquid/air interfacial coupons are shown in FIGURE 13 and FIGURE 14 respectively. The coupons exhibit only minor staining and there is no evidence of localized or general corrosion.

FIGURE 13: Vapor Space Coupons from Tank T Solution Exposure

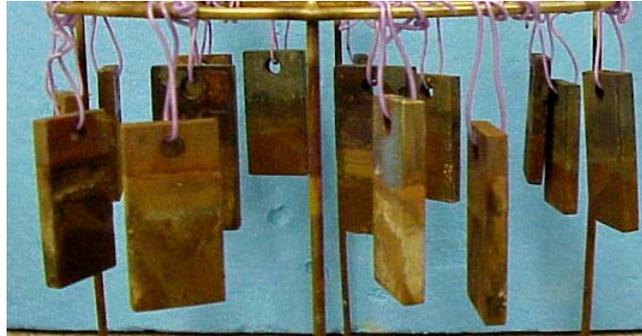
FIGURE 14: Liquid/Air Interface Coupons from Tank T Solution Exposure

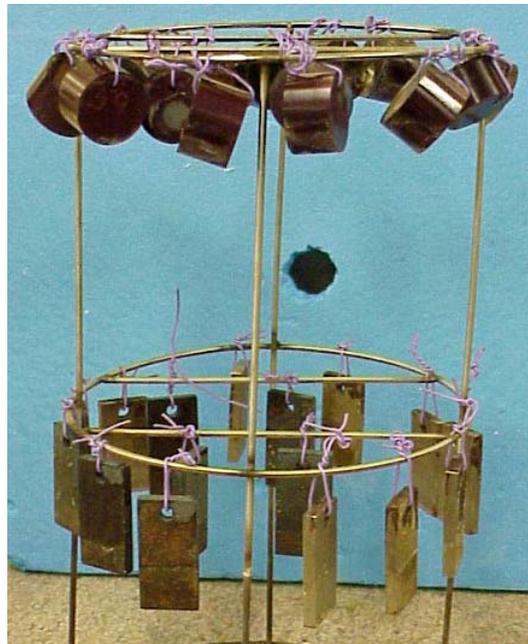
The coupon rack as removed from the Tank P solution is shown in FIGURE 15

FIGURE 15: Coupon Rack as Removed from Tank P Solution

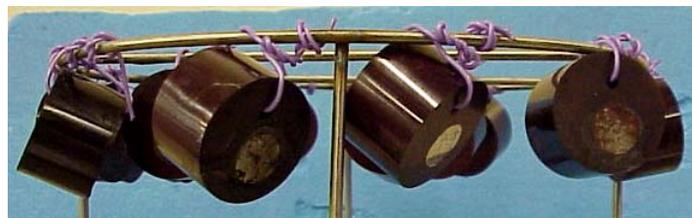
The vapor space and liquid/air interfacial coupons as removed from the solution are shown in FIGURE 16 and FIGURE 17 respectively. Once again, it is seen that there is minor staining and no corrosion on any of the coupons. In fact, many of the coupons retained their initial shiny condition.

FIGURE 16: Vapor Space Coupons as Removed from Tank P Solution Exposure.

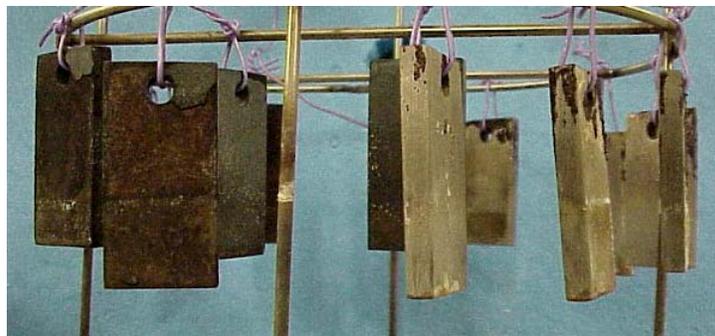
FIGURE 17: Liquid/Air Interface Coupons as Removed from Tank P Solution Exposure.

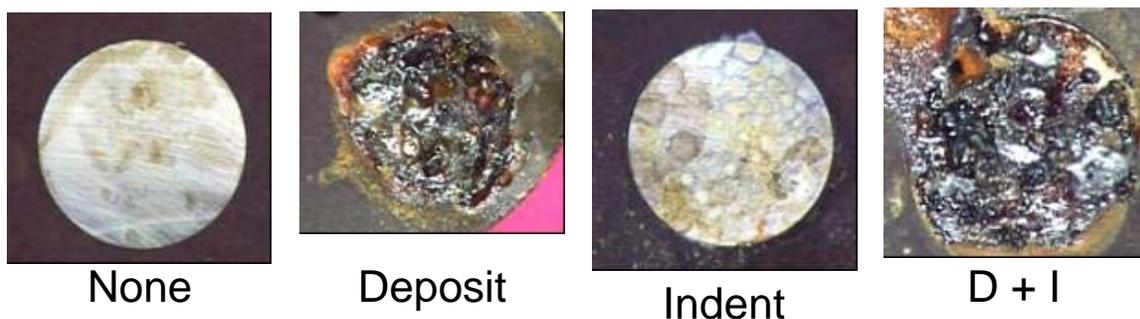
The pitting in the vapor space coupons exposed to solutions 1 and 2 could not be quantified, but some general observations were made. The polished vapor space coupons exposed to solution 1 and solution 2 are shown in FIGURE 18 and FIGURE 19 respectively. These figures show the coupons with no surface modifications, the coupon with a surface deposit, the coupon with indents, and the coupons with the deposit and the indent ('D + I'). It is seen that the coupons with the deposits exhibited extensive corrosion, but there didn't appear to be any significant transport of the salts to the vapor space during the test period. These results were similar to those of solution 2. The results suggest that decanting of the solution and the consequent residual species may be the primary parameter mechanism by which aggressive species may be available for corrosion in the vapor space. In addition, the extent to which the initial solution is inhibited prior to decanting of the solution plays a key role in the corrosion in the vapor space. In this case, the final solution pH was measured to be 9.8 and 9.9 for solution 1 and solution 2 respectively, but still did not lead to transport of the species into the vapor space. The indented coupons were broadly corroded and the indents did not provide any specific location for extensive corrosion as expected for the polished specimens.

FIGURE 18: Polished Vapor Space Coupons Exposed to Solution 1.

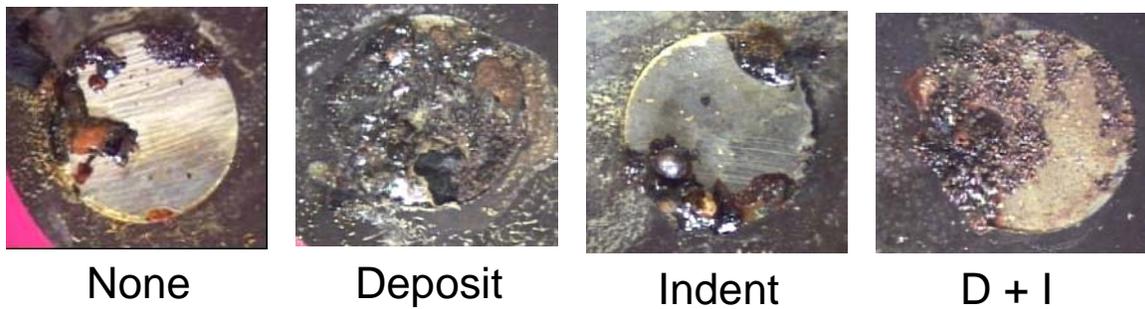
FIGURE 19: Polished Vapor Space Coupons Exposed to Solution 2

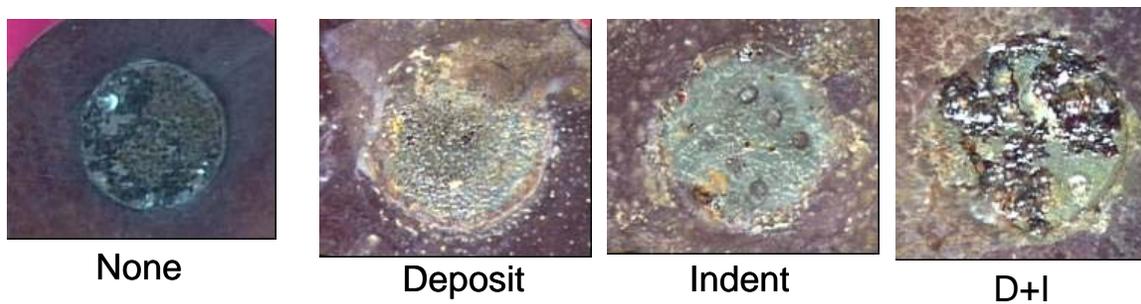
The heat treated coupons for vapor space coupons exposed to solutions 1 and 2 exhibited minor corrosion only in the indented specimens and specifically when surface deposits were present. These results are shown in FIGURE 20 and FIGURE 21 for solution 1 and solution 2 respectively.

FIGURE 20: Heat Treated Vapor Space Coupons Exposed to Solution 1.

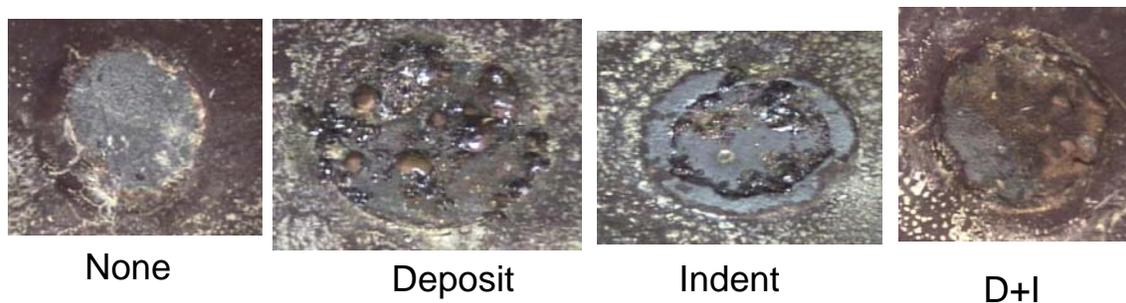
FIGURE 21: Heat Treated Vapor Space Coupons Exposed to Solution 2.

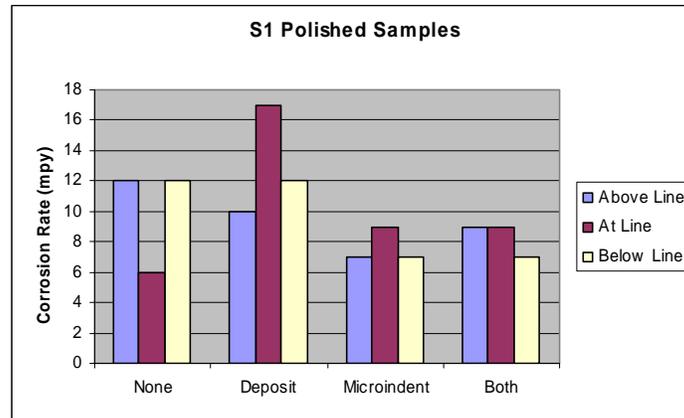
The pitting in the liquid/air interface coupons exposed to solutions 1 and 2 were measured and corresponding corrosion rates were determined. The pitting rates were calculated below the liquid line, at the liquid line, and just above the liquid line. The results for the polished coupons are shown in FIGURE 22 and FIGURE 23 for solutions 1 and 2 respectively. The results indicate that the pitting rates are between 6-10 mpy for solution 1 while 3-6 for solution 2. In addition, the pitting rates were higher and sometimes only measurable above the line for solution 2 while evident for solution 1. These results suggest that even minimum quantities of minor waste constituents known to be corrosion inhibitors, such as chromate and phosphate, reduce the corrosion rate. This is further corroborated by the fact that the heat treated coupons exposed to solution 2 remained protected, while those exposed to solution 1 exhibited pitting as shown in FIGURE 24.

FIGURE 22: Pitting Rates for Liquid/Air Interface Coupons Polished Exposed to Solution 1.

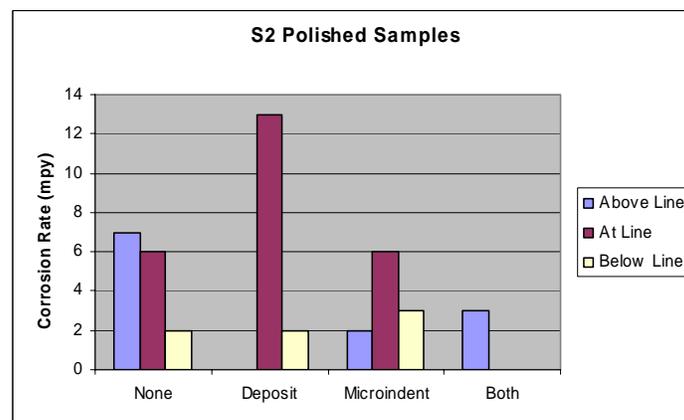
FIGURE 23: Pitting Rates for Liquid/Air Interface Polished Coupons Exposed to Solution 2.

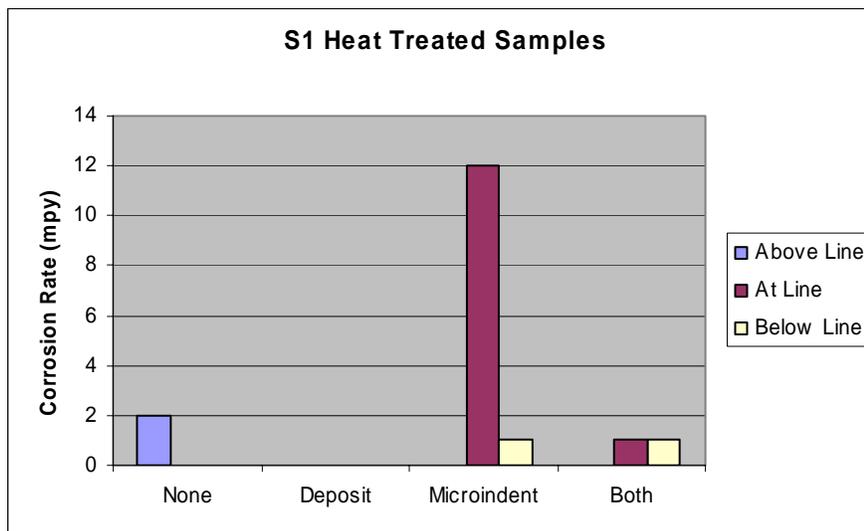
FIGURE 24: Pitting Rates for Liquid/Air Interface Heat Treated Coupons Exposed to Solution 1.
