**CLOSURE OF HLW TANKS – PHASE 2
FULL SCALE COOLING COILS GROUT FILL
DEMONSTRATIONS**

E. K. Hansen and A. D. Cozzi

June 2008

Process Science and Engineering
Savannah River National Laboratory
Aiken, SC 29808

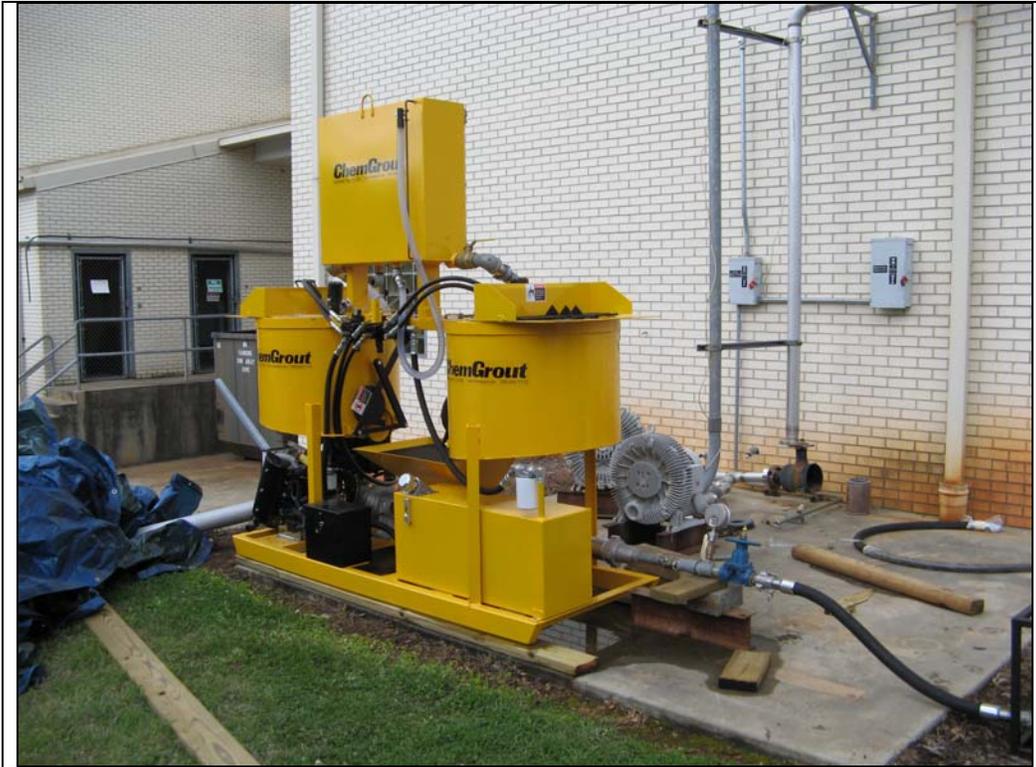
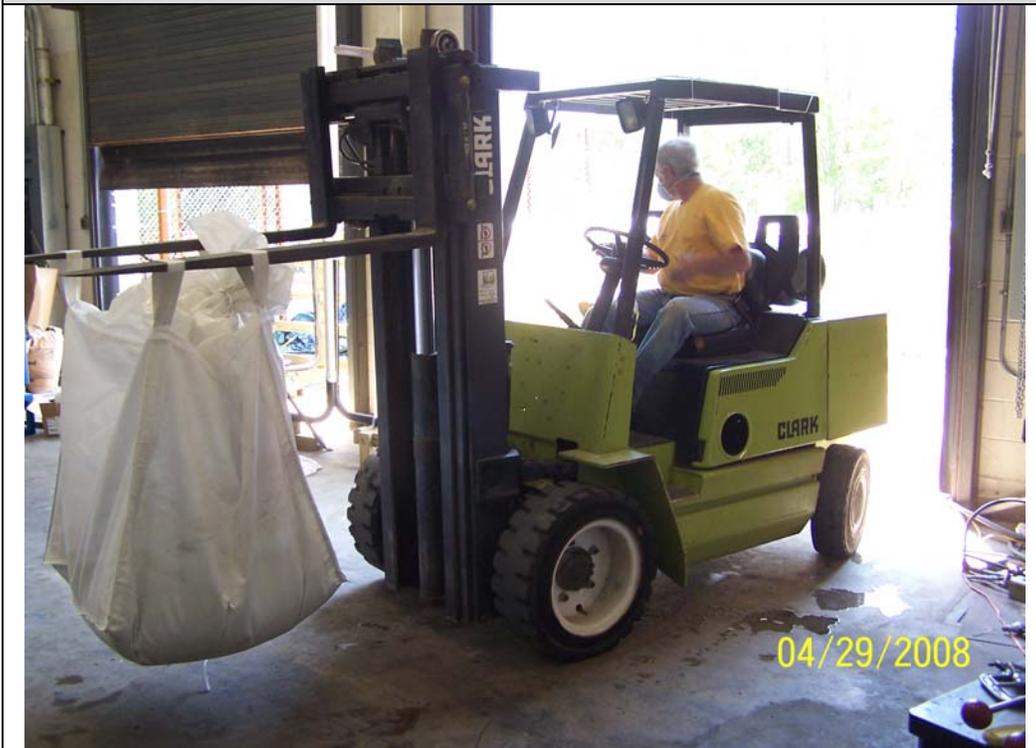
Figure 2-14 ChemGrout GC-500-DH and Supersack

GC-500-DH

Supersack for Solids Addition

To assist in the addition of dry solids (MF 816 and slag) into the mixing tanks, the solids were pre-batched into supersacks that contained enough solids to make a 38 gallon batch of grout. Each supersack contained eight 55 pound bags of MF 816 and 48.89 pounds of Slag. Figure 2-14 shows a supersack being transported to the mixer.

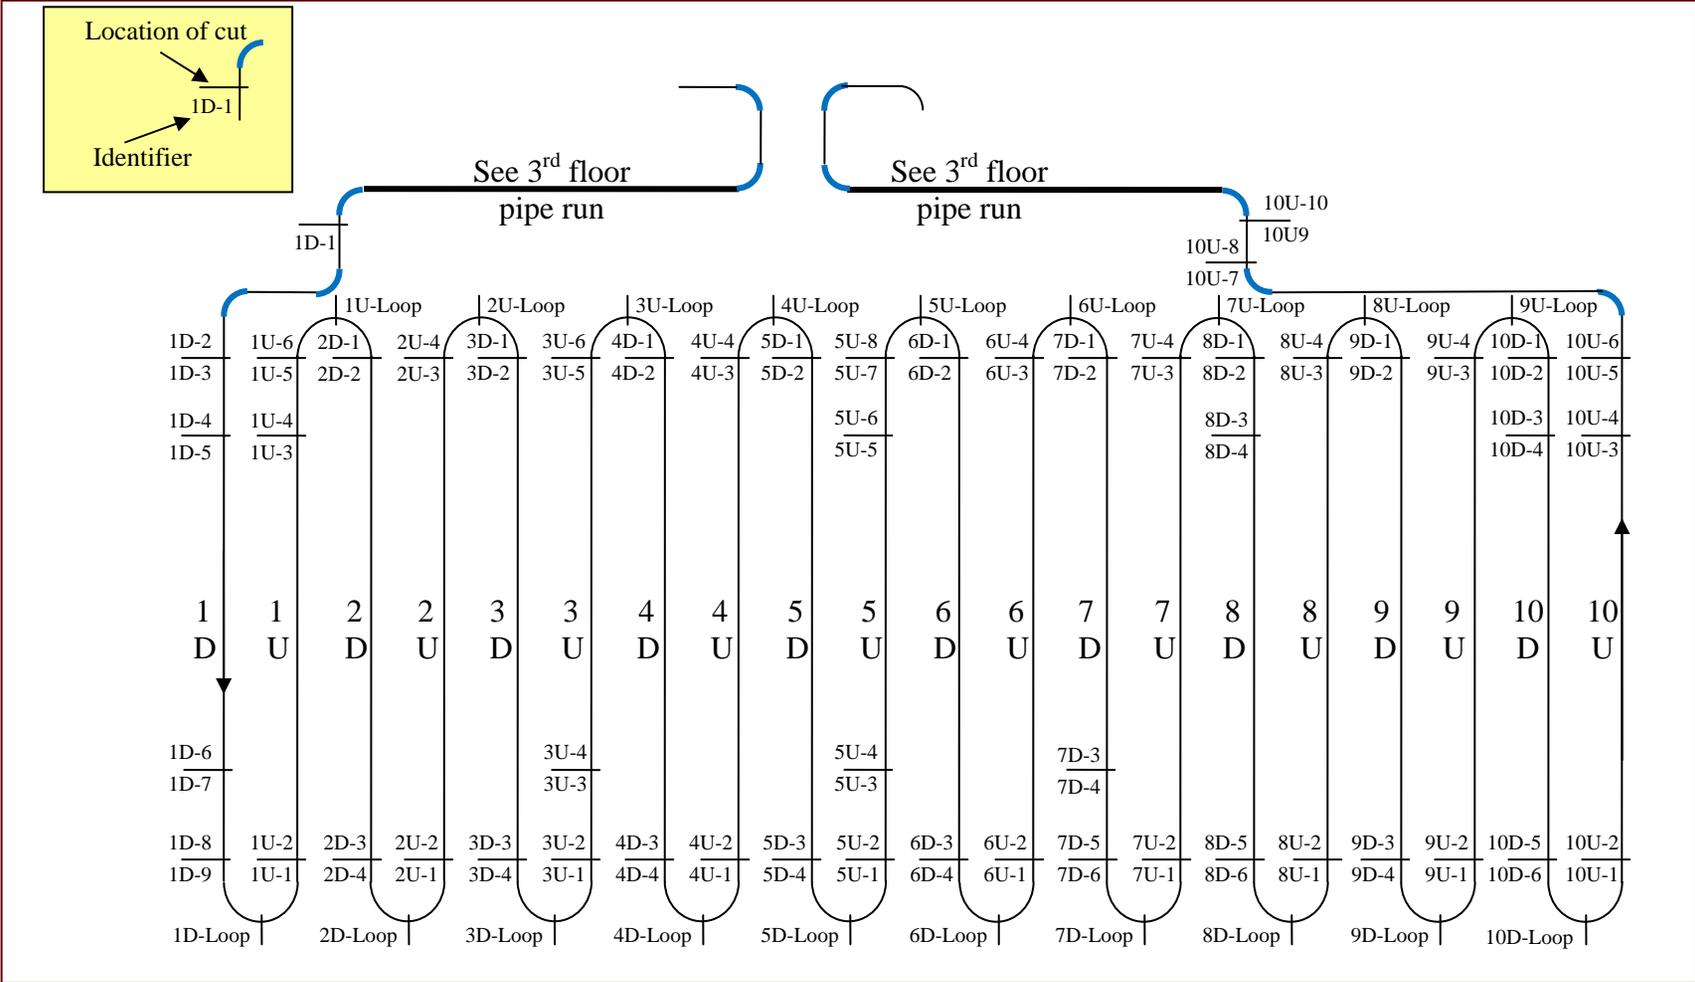
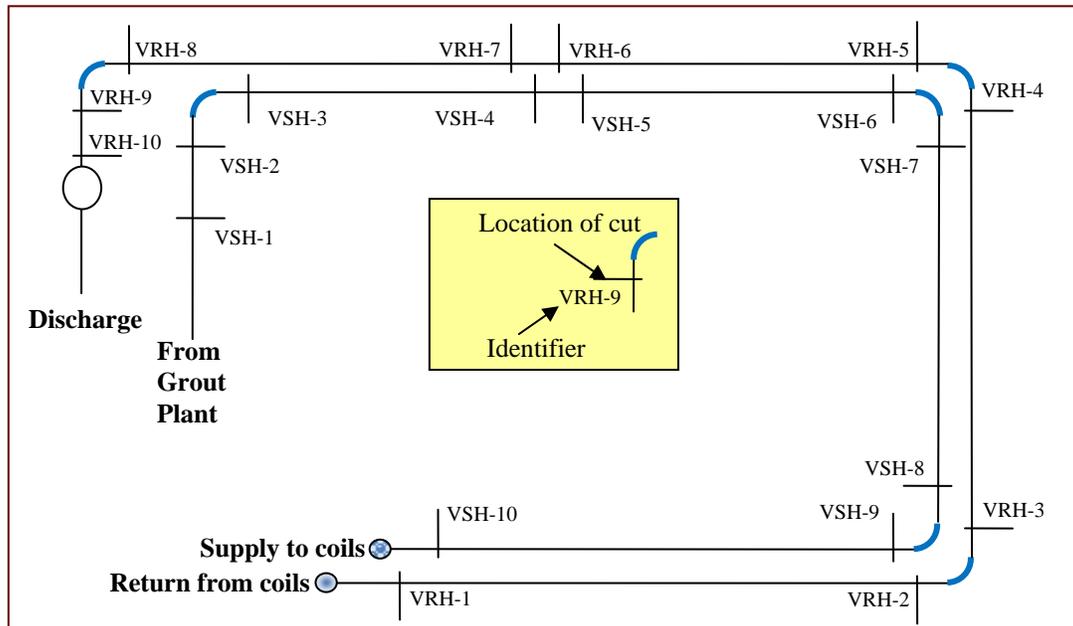
Figure 2-19 Vertical Cooling Coil Assembly - Section Marks

Figure 2-20 Horizontal Piping Run for the Vertical Cooling Coil Assembly on the 3rd floor – Section Marks

The sectioning of the vertical cooling coil assembly after the grout has cured is shown in Figure 2-19 and Figure 2-20. These figures show where the cuts in the vertical and horizontal piping were made. A majority of the sections of piping were photographed after the sections were cut flush using a chop saw. Sections of piping between the cuts were also photographed.

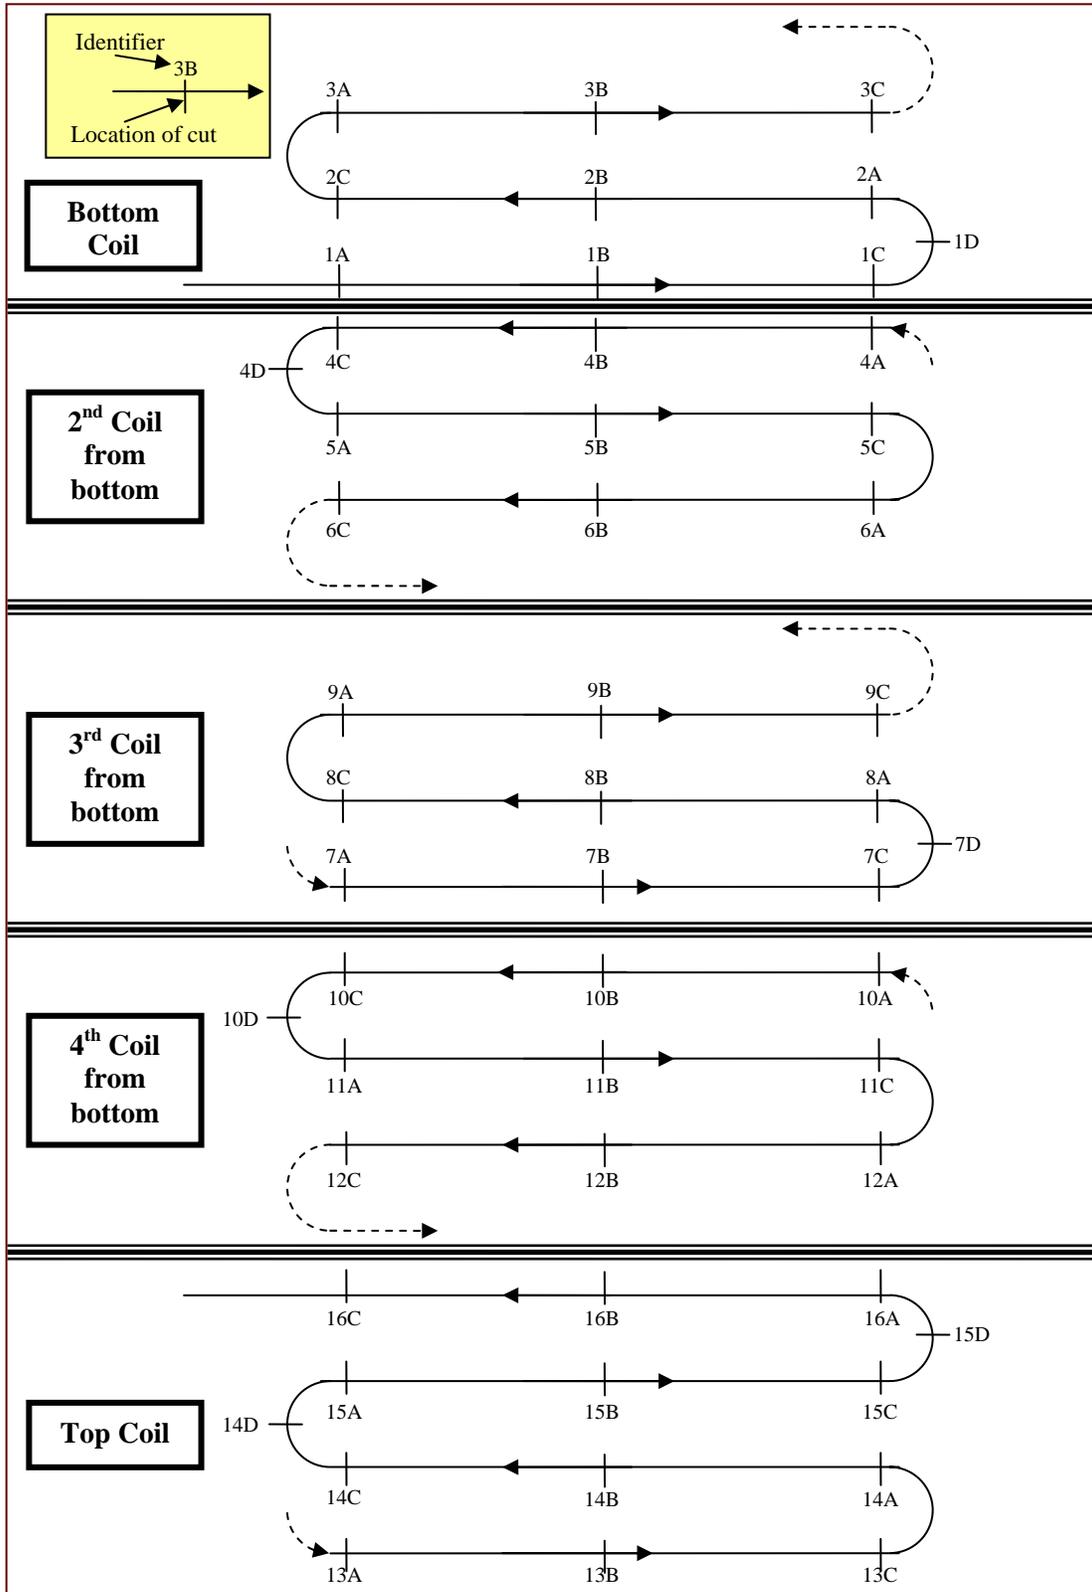
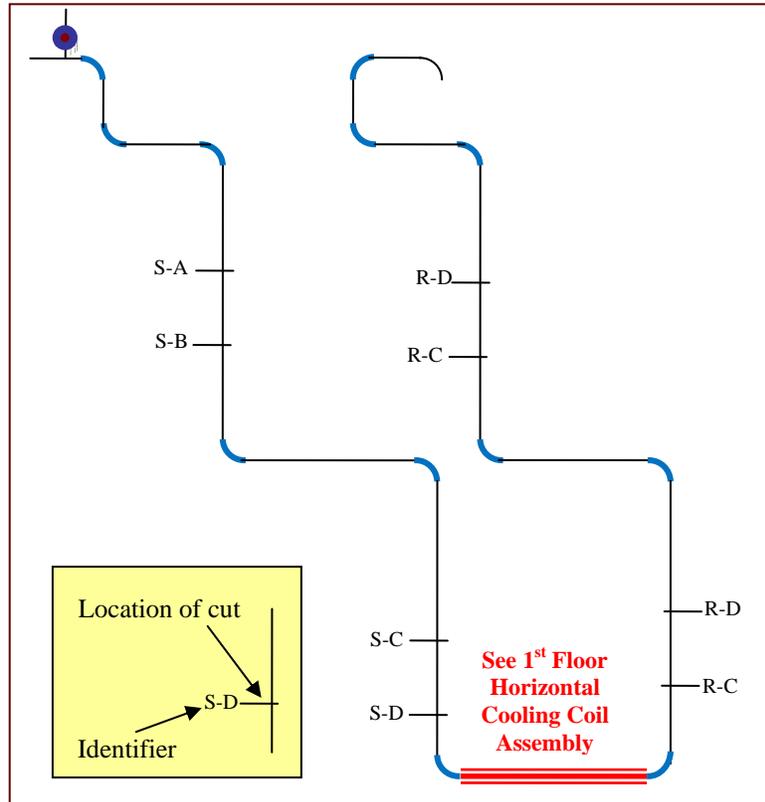
Figure 2-21 Horizontal Cooling Coil Assembly Located Outside – Section Marks

Figure 2-22 Vertical Piping Run for the Horizontal Cooling Coil Assembly – Section Marks

The sectioning locations of the horizontal cooling coil assembly after the grout has cured are shown in Figure 2-21 and Figure 2-22. These figures show where the cuts in the vertical and horizontal piping were made. A majority of the sectioned piping were photographed after the sections were cut flush using a chop saw. Sections of piping between the cuts were also photographed.

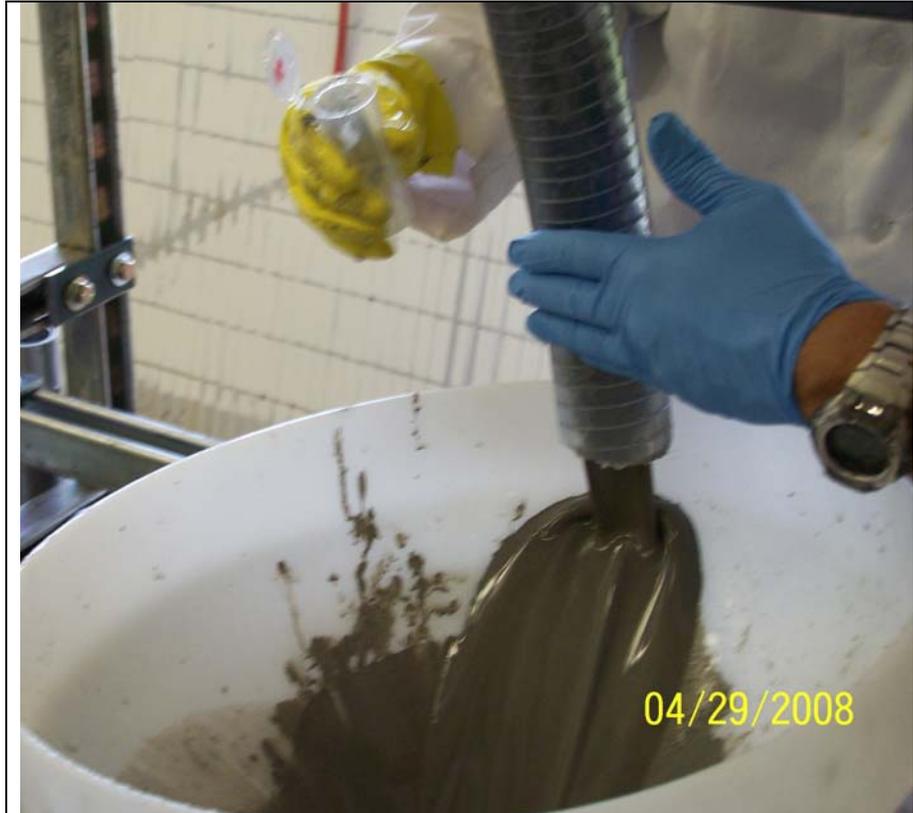
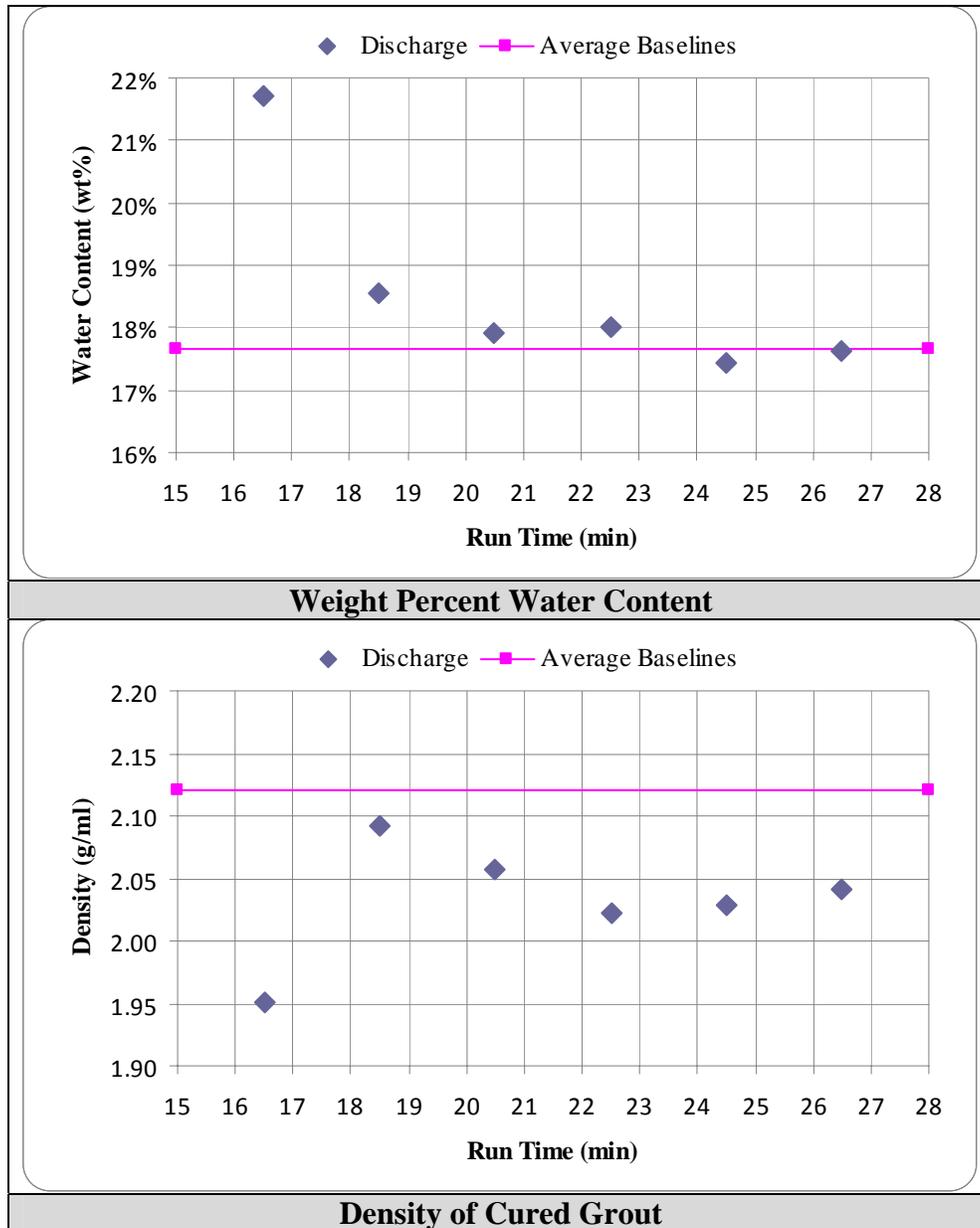
Figure 3-3 Typical Grout Discharging the Vertical Cooling Coil Assembly - Sampling

Figure 3-4 Physical Properties of Discharged Grout for the Vertical Cooling Coil Assembly

Sampling of the discharge occurred over a period of twelve minutes and resulted in thirteen samples being pulled. The grout discharging the cooling coil assembly is shown in Figure 3-3, just before a sample is about to be taken. Visually, the grout looked very smooth upon discharge. The water content and density of the cured grout samples are provided in Figure 3-4. The first sample ($t = 15.5$ minutes into the run) was not analyzed because it contained mostly water. The remaining discharge and baseline samples when cured did not have any bleed water. Based on the water content data, five minutes (total run time of 20.5 minutes) after the grout was first observed to be leaving the discharge of the assembly, the characteristics of the grout in the assembly matched those of the batched material. In essence, the mixing zone, given this pumping condition, required approximately 35 gallons of additional grout over that required to fill the cooling coil (cooling coil fill volume was approximately 125 gallons). This data compares well to that of the pressure data. The grout density data from bench scale testing is 2.07 g/ml [5]. The density data indicates that the samples, as well as the bench scale are similar, but all the discharge samples were lower in value than the baseline and bench samples, indicating that the discharge samples had slightly more entrained air or voids.

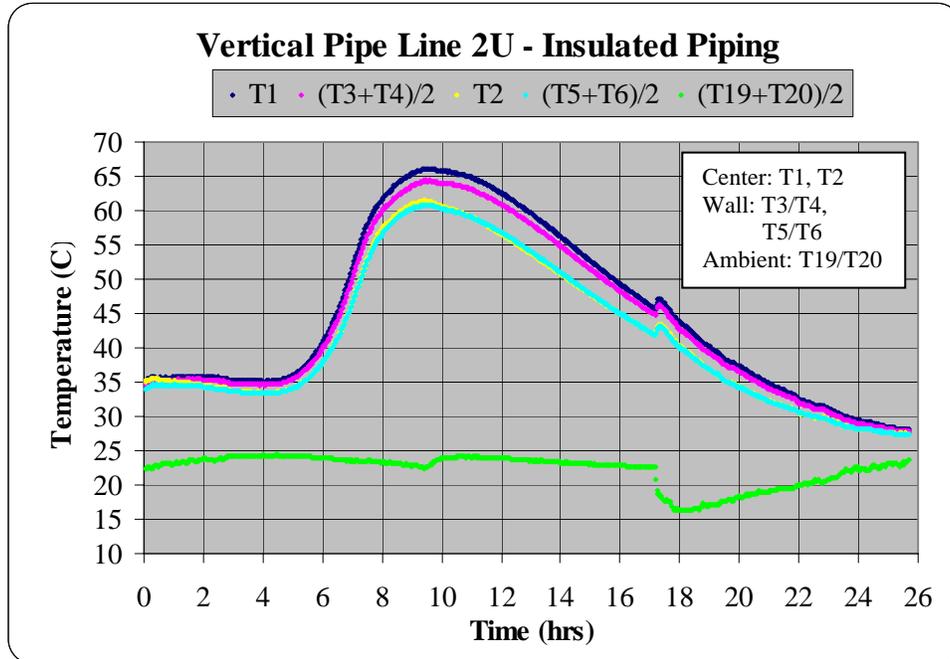
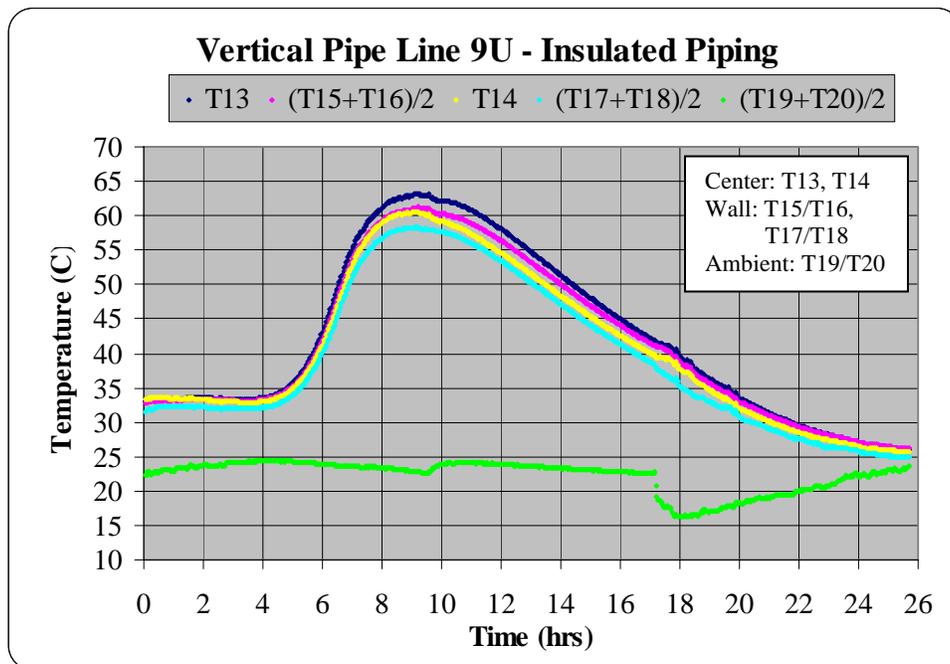
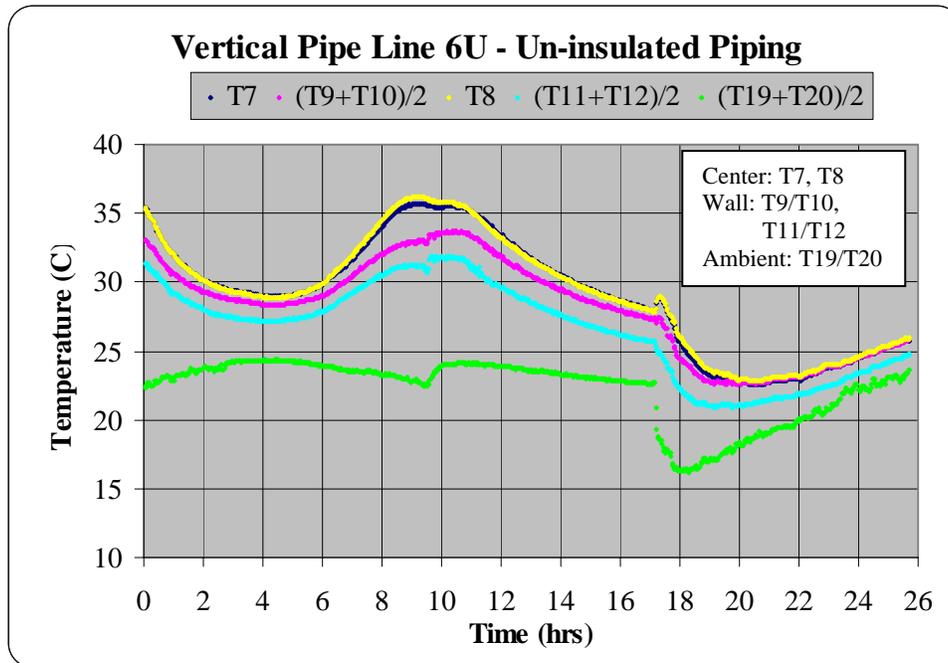
Figure 3-5 Temperature Measurements of Insulated Pipe 2U

Figure 3-6 Temperature Measurements of Insulated Pipe 9U

Figure 3-7 Temperature Measurements of Un-insulated Pipe 6U

The temperatures of the curing grout, for the insulated piping sections are shown in Figure 3-5 and Figure 3-6 and the un-insulated piping sections are shown in Figure 3-7. These figures clearly show that if the piping is insulated (such as having cured grout around the pipe, although the heat transfer characteristics of the insulation is most likely not the same as the tank grout fill), then the heat of hydration will cause the temperature of the curing grout to be greater than that of an un-insulated pipe. The insulated pipe reached a maximum temperature of 65°C as compared to 35°C for the un-insulated pipe. The thermal properties of the curing grout, piping and final heat sink (grout or air) will determine the actual temperature increase. The maximum temperature for all conditions peaks around 9.5 hours after the cooling coil assembly was filled. This data compared well to the peak observed in the normalized heat flow [5]. At approximately

seventeen hours into the curing cycle, the ambient temperature dropped due to the opening of the high bay doors in the morning. There is active air motion in the location where the vertical cooling coil assembly was located. The ventilation system of the building maintains a fairly constant temperature at this location if the high bay doors are maintained closed.

- The maximum temperature of the curing grout peaked around 9.5 hours after the cooling coil assembly was filled. This data compared well to the peak observed in the normalized heat flow [5].

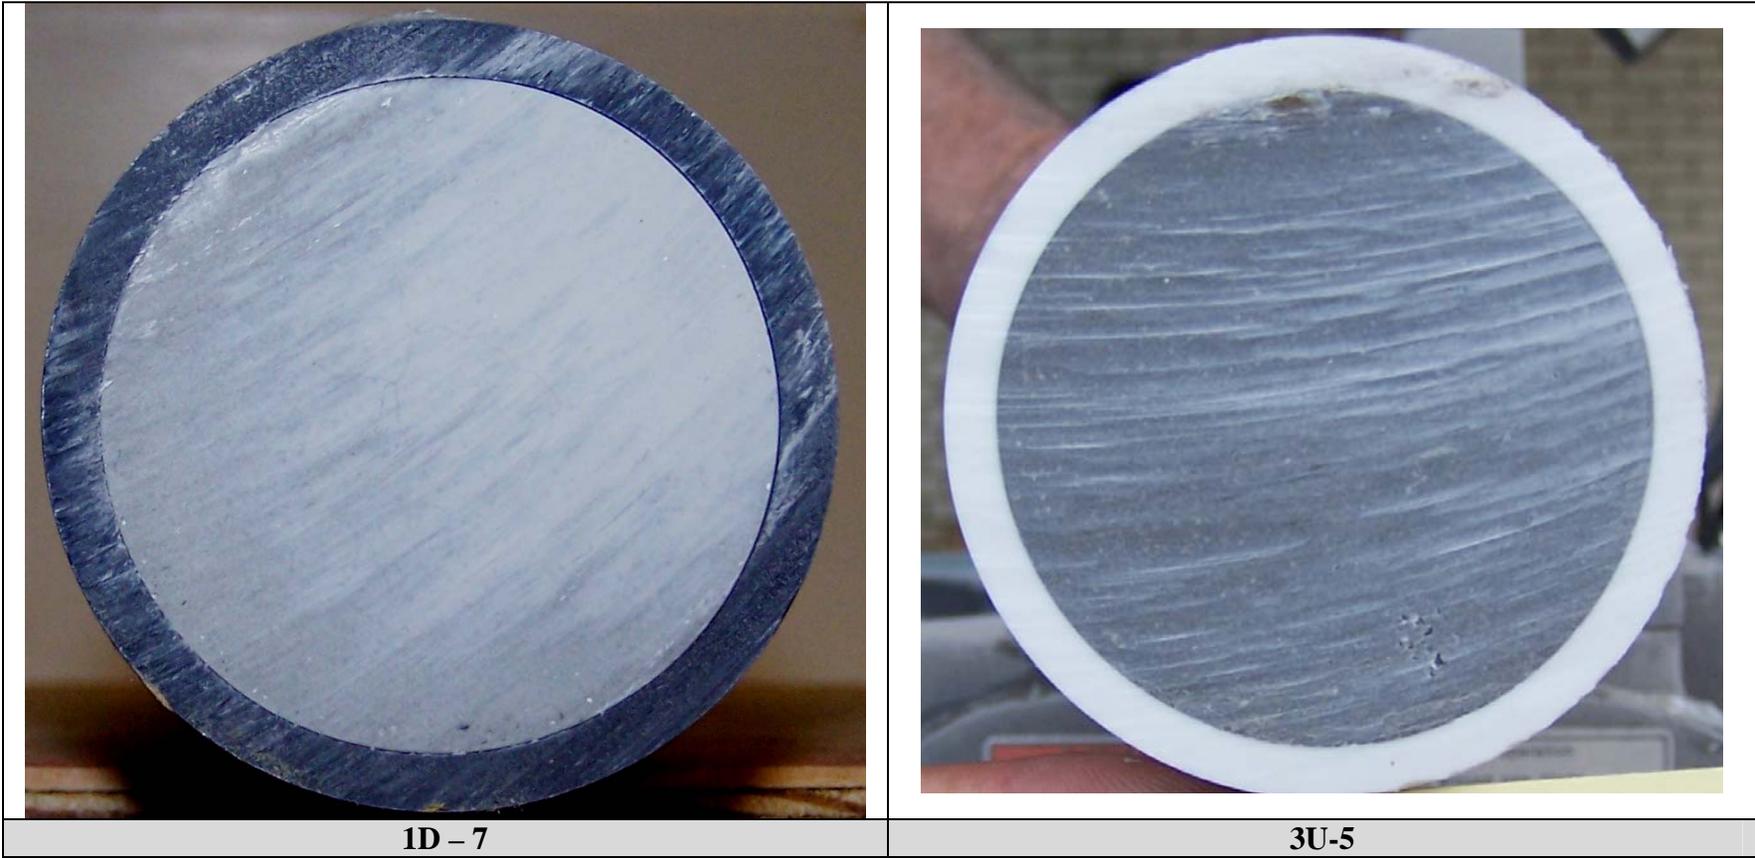
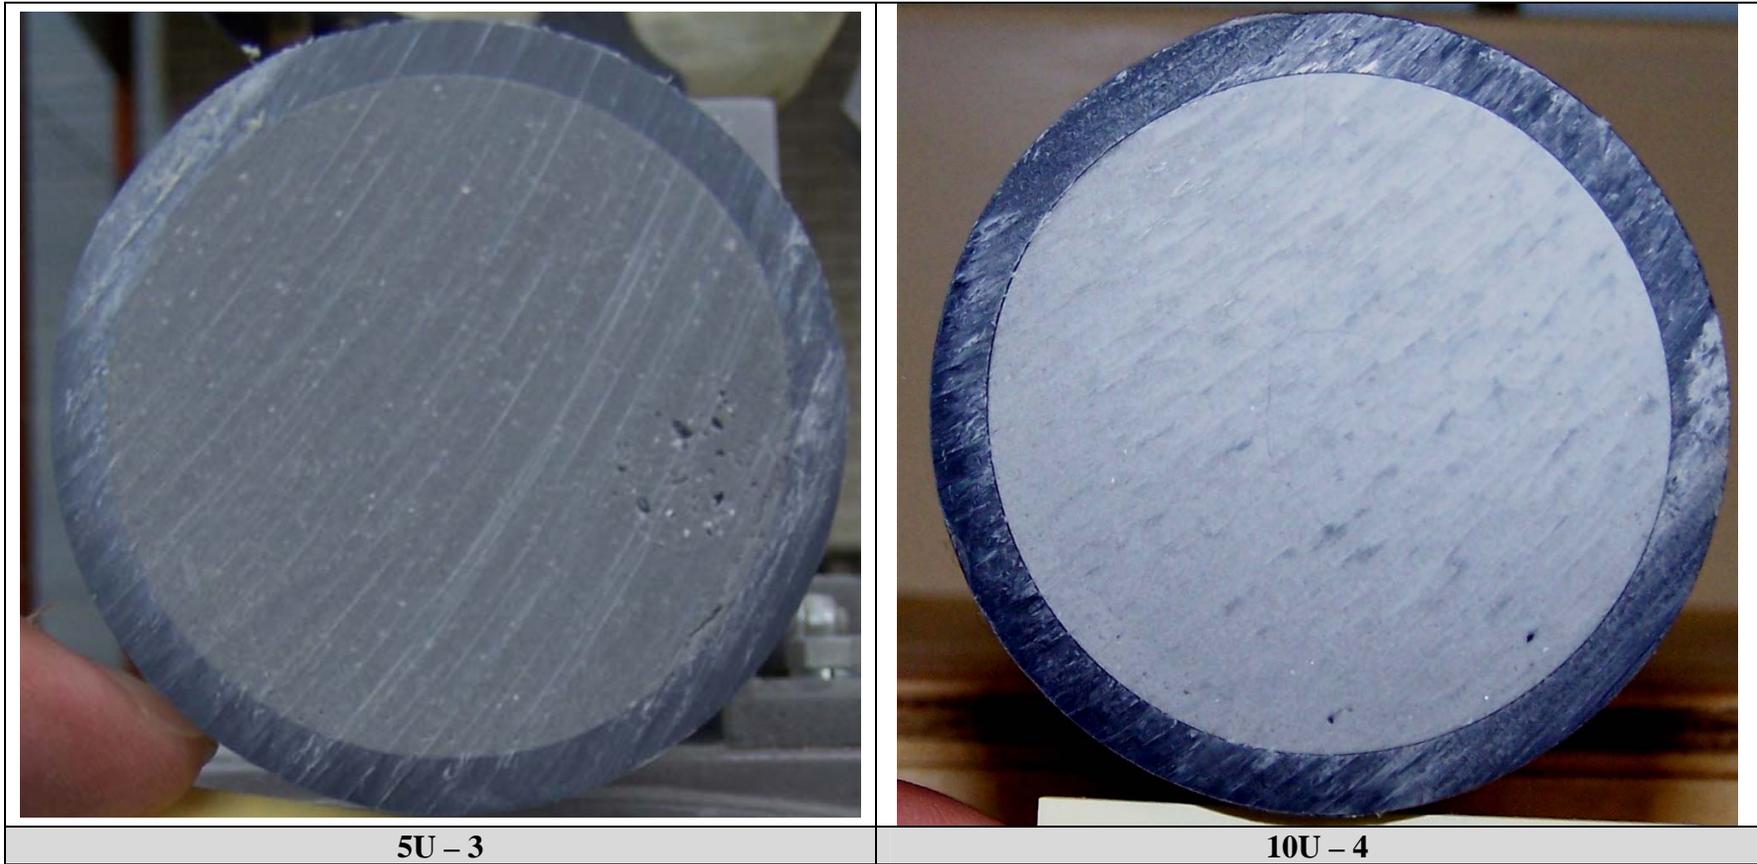
Figure 3-8 Sectioned Vertical Piping 1D and 3U from the Vertical Cooling Coil Assembly

Figure 3-9 Sectioned Vertical Piping 5U and 10U from the Vertical Cooling Coil Assembly

Examples of sectioned vertical piping of the cured grout are shown in Figure 3-8 and Figure 3-9. Reference 10 contains additional pictures of the cured grout for the vertical cooling coil assembly. Visual examination of all of the vertical sections of piping showed that they were filled with grout and none of them visually had four volume percent void (see Figure 2-18 for what constitutes four volume percent). Very small voids were observed in some of the cuts. There were no continuous voids in any vertical sections. Radiographs of some of the vertical sections are provided in Reference 11 and they do not show voids greater than four volume percent, nor are they continuous. There are no radiographs of the grout made from the bench scale testing [5] for comparison.

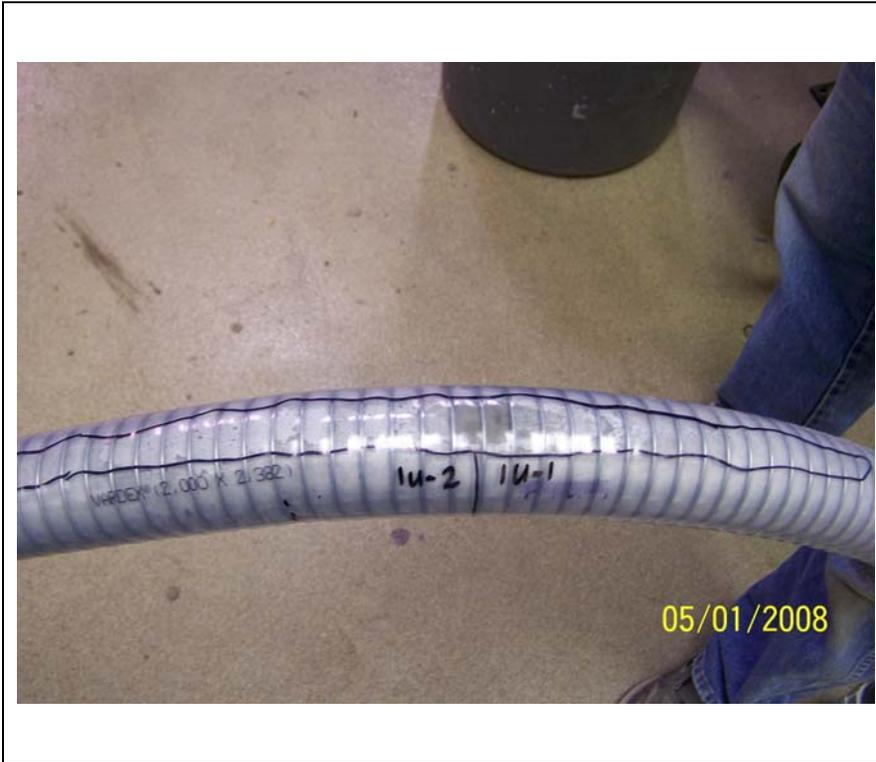
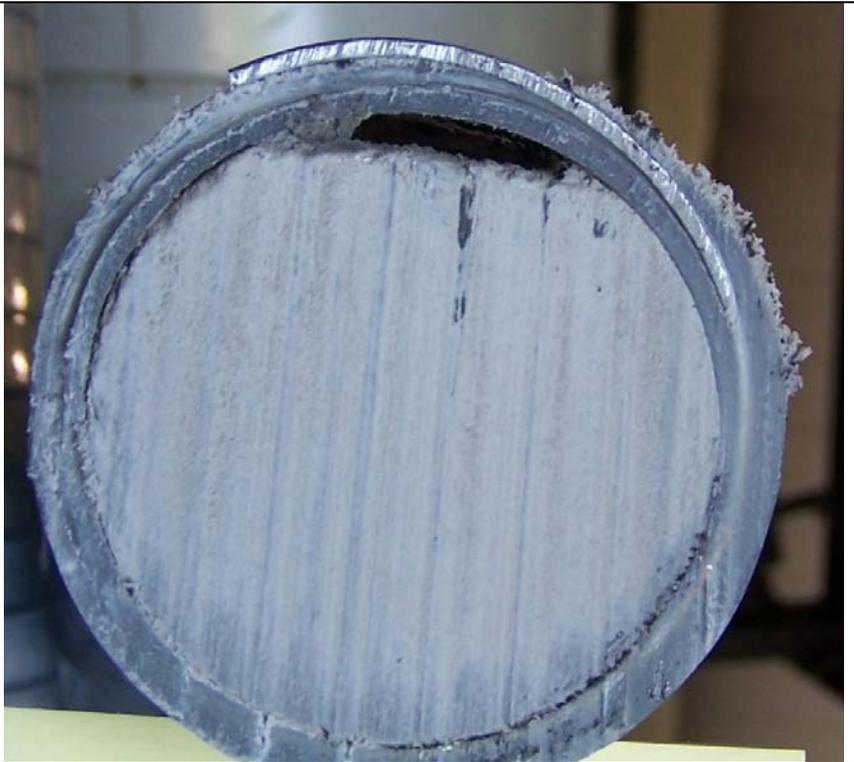
Figure 3-10 Voids in the Upper Loops in the Vertical Cooling Coil Assembly

Upper Loop 1U

Cut Section from Middle of Upper Loop 1U

Air voids were present in all horizontal sections of piping. The voids were close to or exceeded the four volume percent in the horizontal supply line, see Figure 3-11. Voids were also present in the return headers and the 180° 2-foot radius bends at the top part of the cooling coils, see Figure 3-10 and Figure 3-11. In Figure 3-10 the 180° 2-foot radius bend is marked, showing a section where air bubbles were present, but the actual voided bubble length is approximately two to four inches of piping for this loop. The supply header seemed to contain a much larger upper void as compared to the other horizontal piping. The reason for this air is due to the mixing/pumping process employed and the supply header is the first section of horizontal piping, where large voids would displace themselves. The paths for air entrainment in this process (see Figure 3-12) are from air associated with the dry solids being mixed into a slurry, vigorous mixing in the mixing tank, discharging the grout onto the meshed grate at the hopper inlet, and the recirculation line returning a large fraction of the flow onto the meshed grate of the hopper inlet. Based on the experiences with the vertical cooling coil fill, the mixing/pumping process for the horizontal cooling coil assembly was changed to further minimize air entrainment. Additional pictures of the sectioned horizontal piping and 180° 2-foot radius bends for the vertical cooling coil assembly are provided in References 15 and 18.

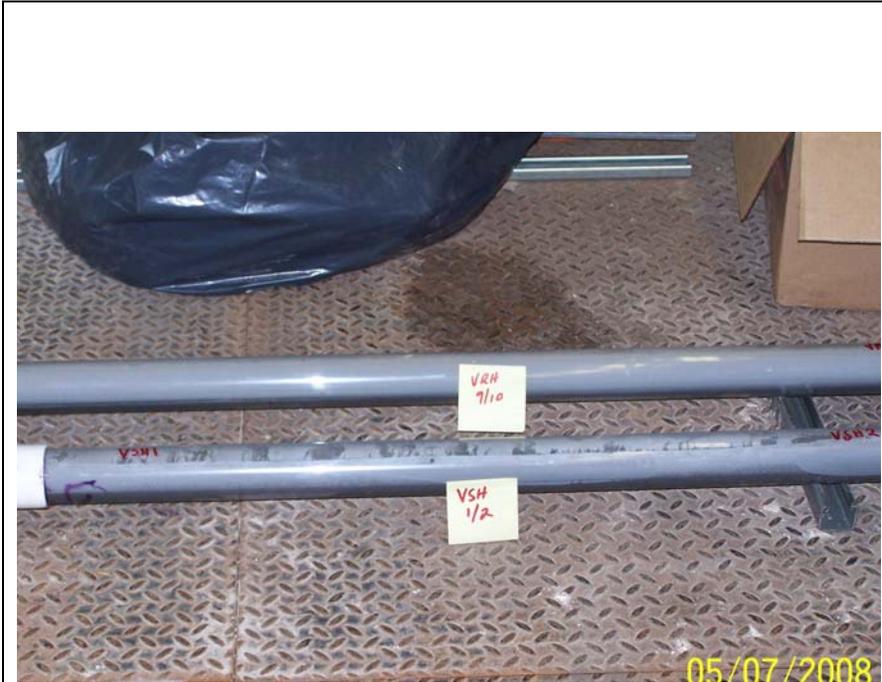
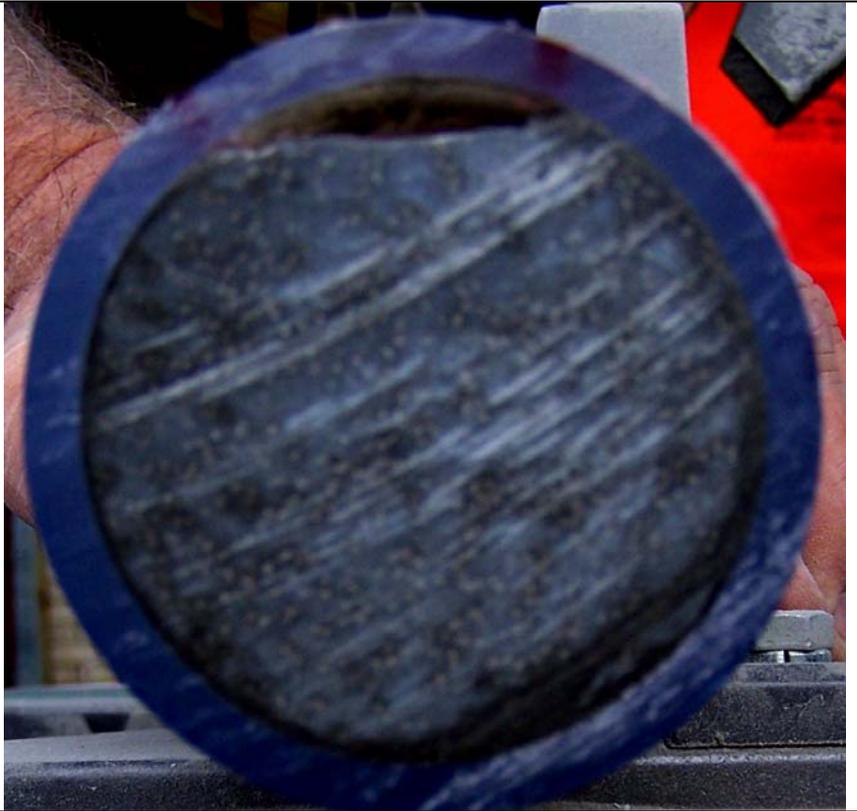
Figure 3-11 Voids in Horizontal Piping VSH1 in the Vertical Cooling Coil Assembly

Supply and Return Header VSH1

Cut Section From Supply Header - VSH1

- Filling of the vertical cooling coil assembly had all four of the air entrainment processing steps described above and this mode of operation is not recommended. Air gaps existed in the horizontally sections of piping that may have exceed four volume percent.

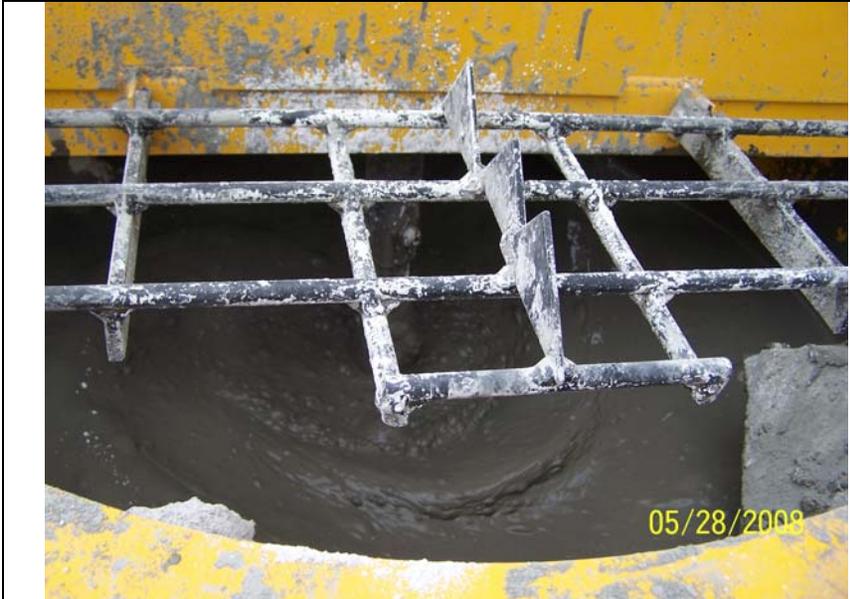
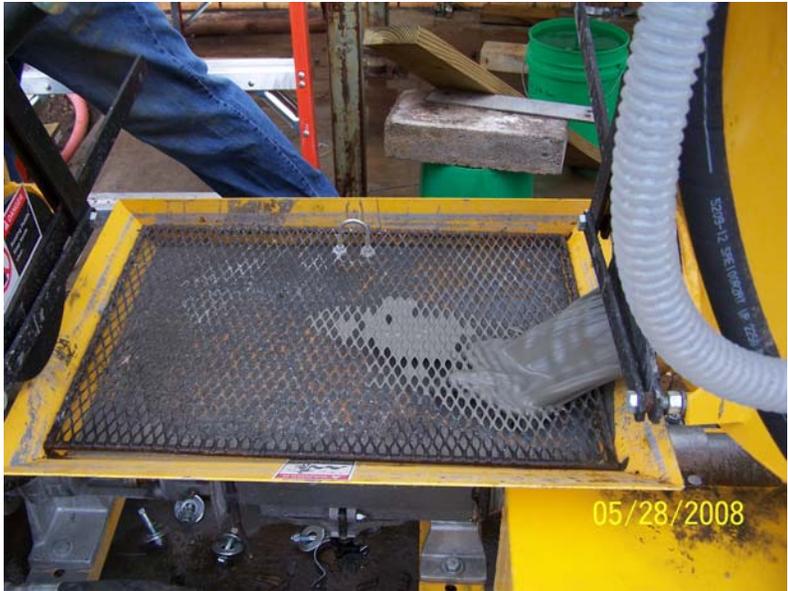
Figure 3-12 Process Locations that Lead to Air Entrainment

Mixer on GC-500-DH – Dry Solids to Slurry

Discharge of grout over pump section hopper grating

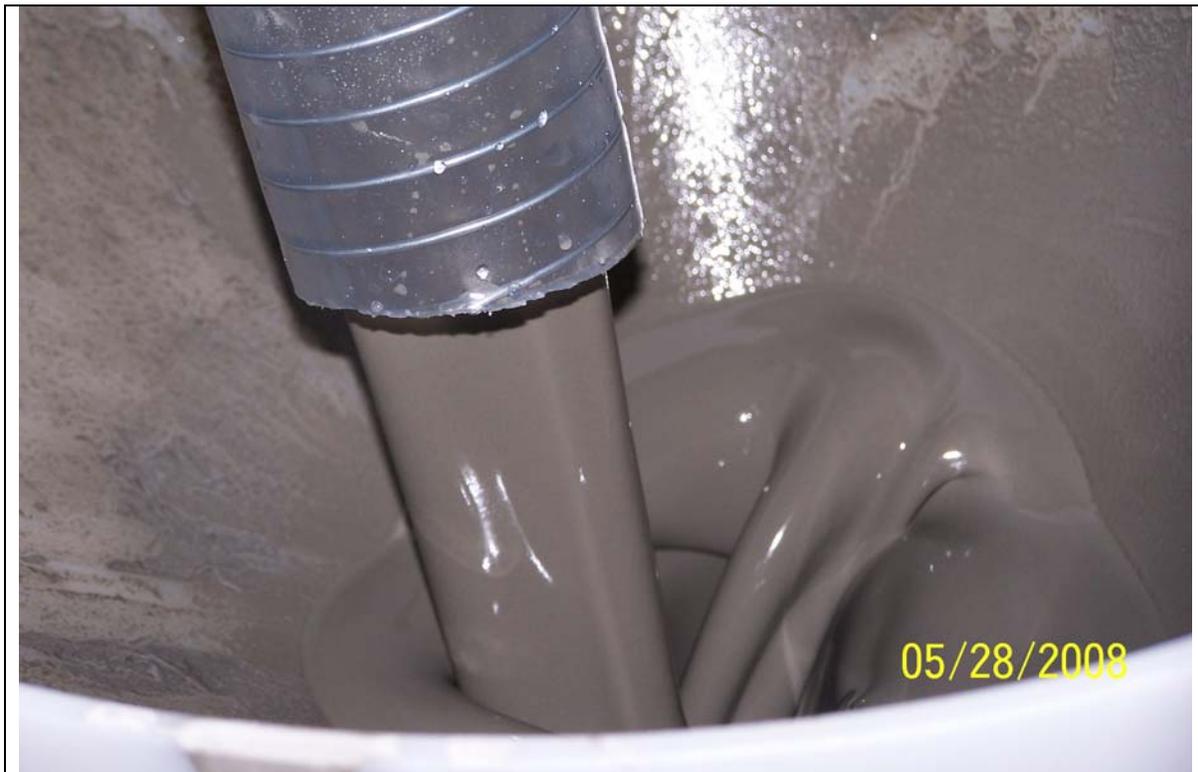
Figure 3-14 Typical Grout Discharging the Horizontal Cooling Coil Assembly

Figure 3-15 Physical Properties of Discharged Grout for the Horizontal Cooling Coil Assembly

Sampling of the discharge occurred over a period of 7.5 minutes, resulting in sixteen samples. The grout discharging the cooling coil assembly is shown in Figure 3-14. Visually, the grout looked very smooth and consistent throughout the run, after the first sample had been pulled. The water content and density of the cured grout are provided in Figure 3-15. The first sample ($t =$ nine minutes into the run) was not analyzed because it contained mostly water. The remaining discharged and baseline samples when cured did not have any bleed water. Based on the water content data, 1.5 minutes (total run time of 10.5 minutes) after the grout was first observed to be leaving the discharge of the assembly, the grout in the assembly contained that of the batched material. In essence, the mixing zone, given this pumping condition, coincidentally required approximately 35 gallons of additional grout over that of the grout required to fill the cooling coil assembly (total assembly volume was approximately 200 gallons). This quantity of grout compares exactly to the vertical cooling coil assembly, though the flow rates and piping configurations are very different. The actual mixing zone for the horizontal cooling coil assembly is smaller than that of the vertical cooling coil assembly, since the volume of grout in the horizontal cooling assembly is much greater than that of the vertical cooling coil assembly. The velocity of the grout most likely had an influence on the mixing zone, but is not quantified in this report. All of the discharge sample densities, except for the last sample, were greater than the baseline density. All of the grout densities, except the last discharge sample, from this test exceeded the bench scale test density of 2.07 g/ml [5], which indicates that the discharge samples contained less air than either the bench scale or baseline densities.
