**CLOSURE OF HLW TANKS – PHASE 2
FULL SCALE COOLING COILS GROUT FILL
DEMONSTRATIONS**

E. K. Hansen and A. D. Cozzi

June 2008

Process Science and Engineering
Savannah River National Laboratory
Aiken, SC 29808

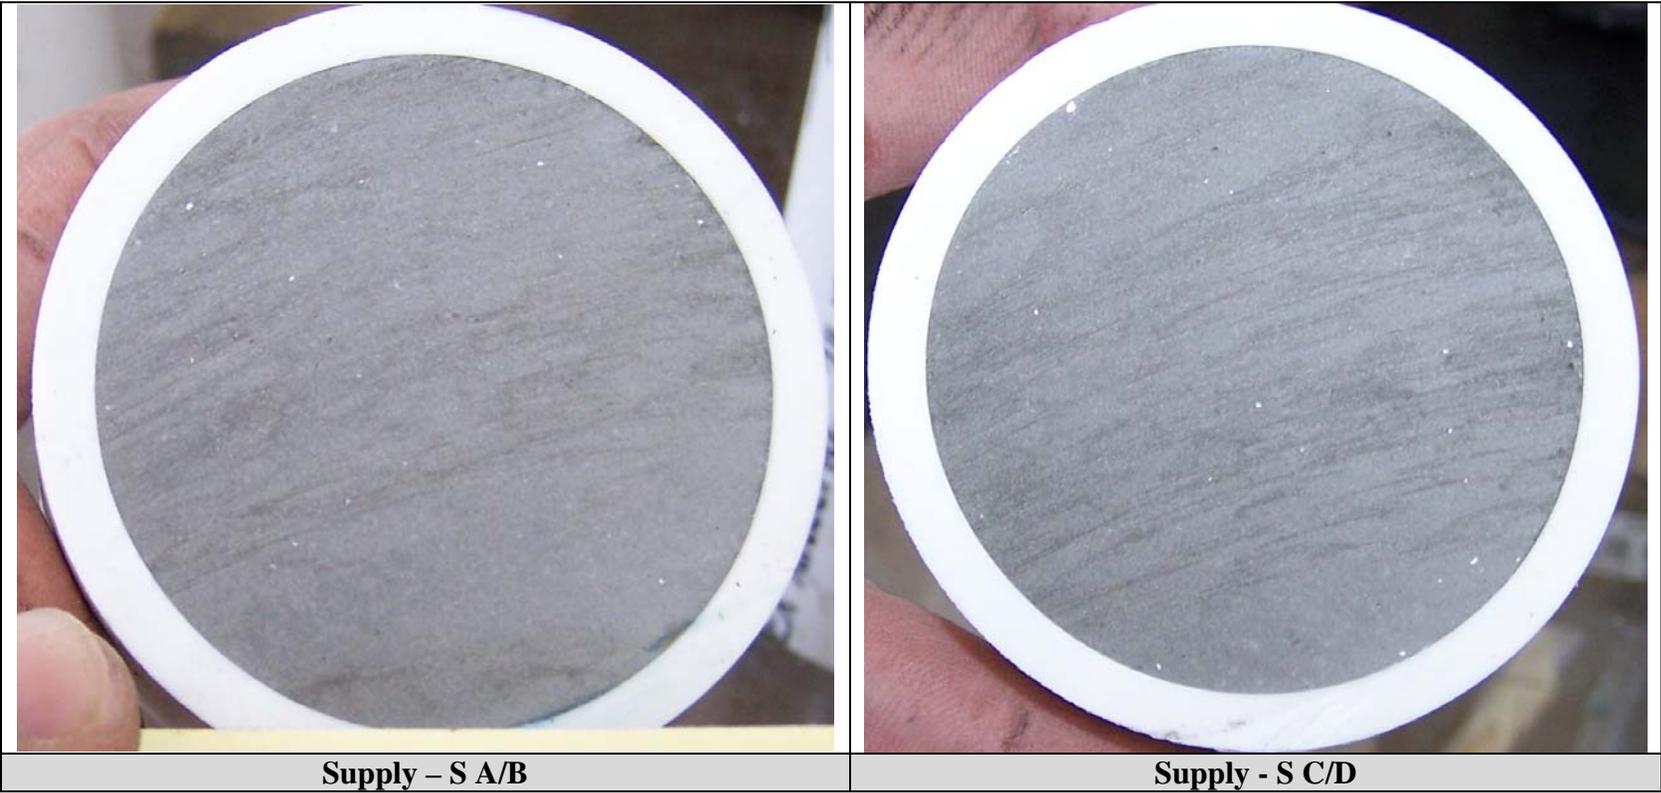
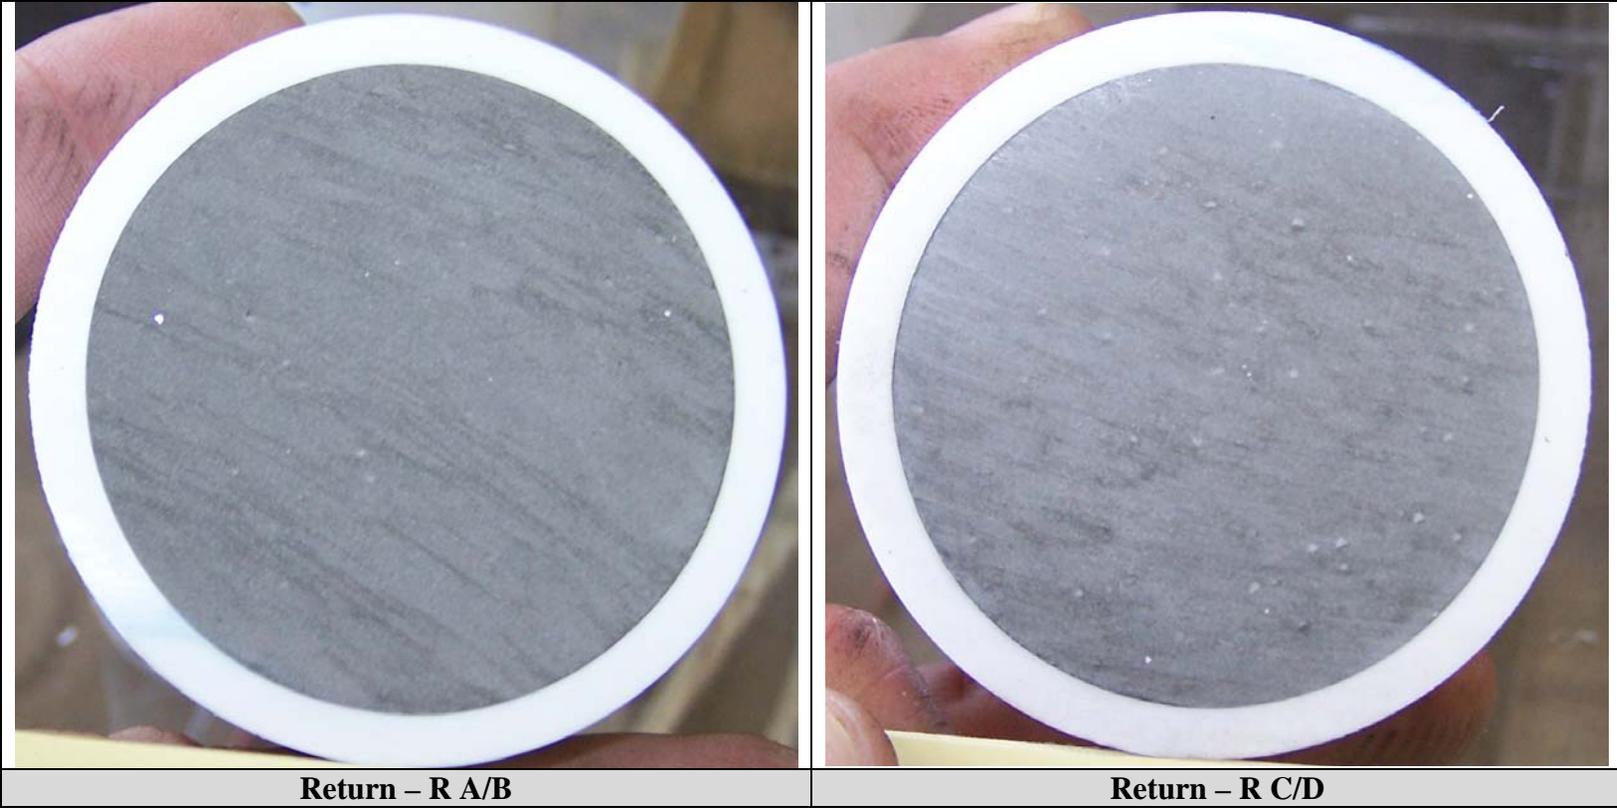
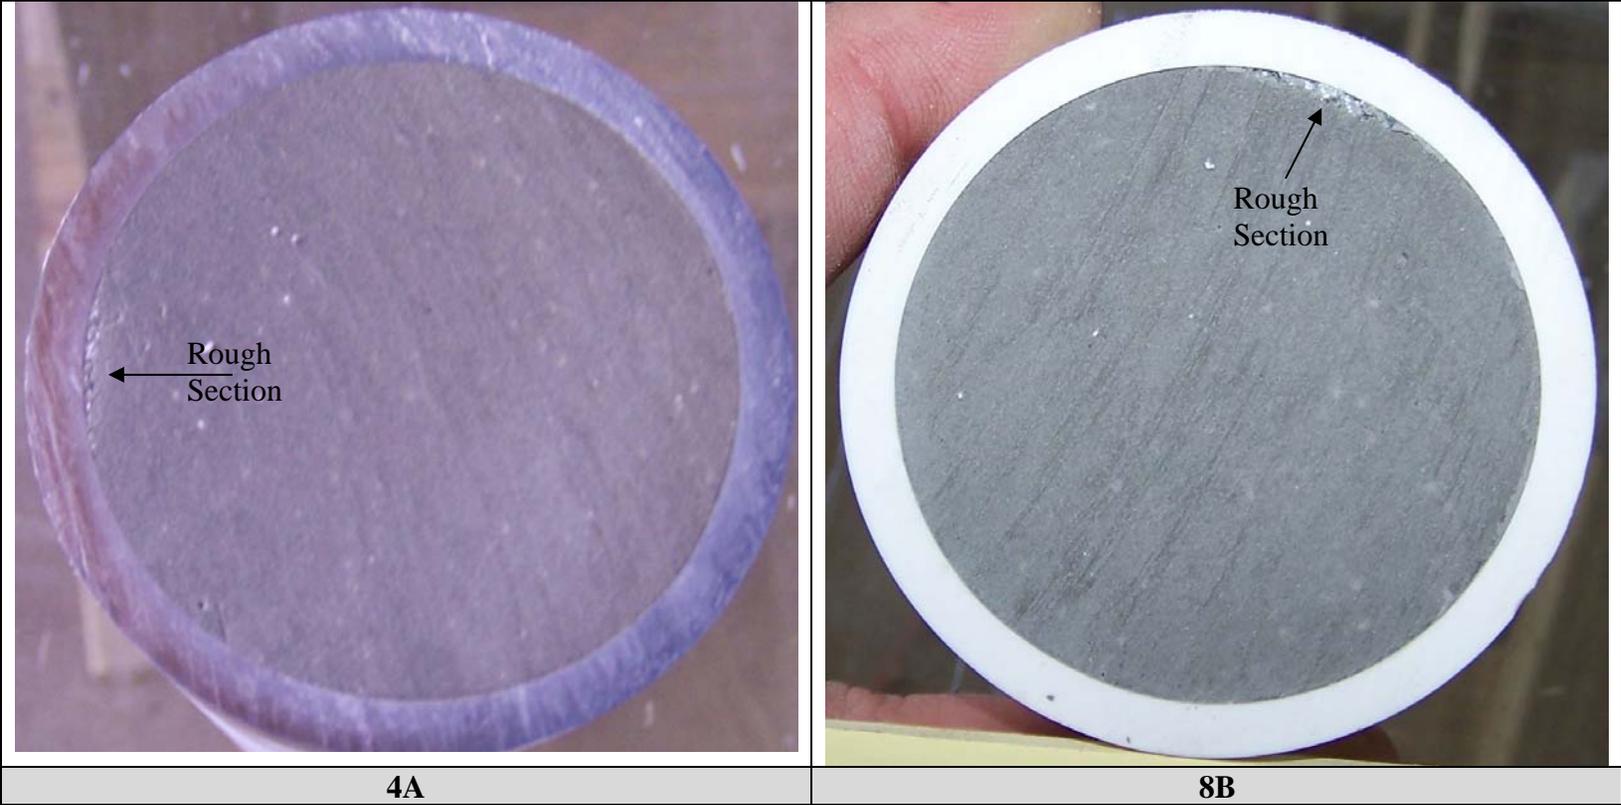
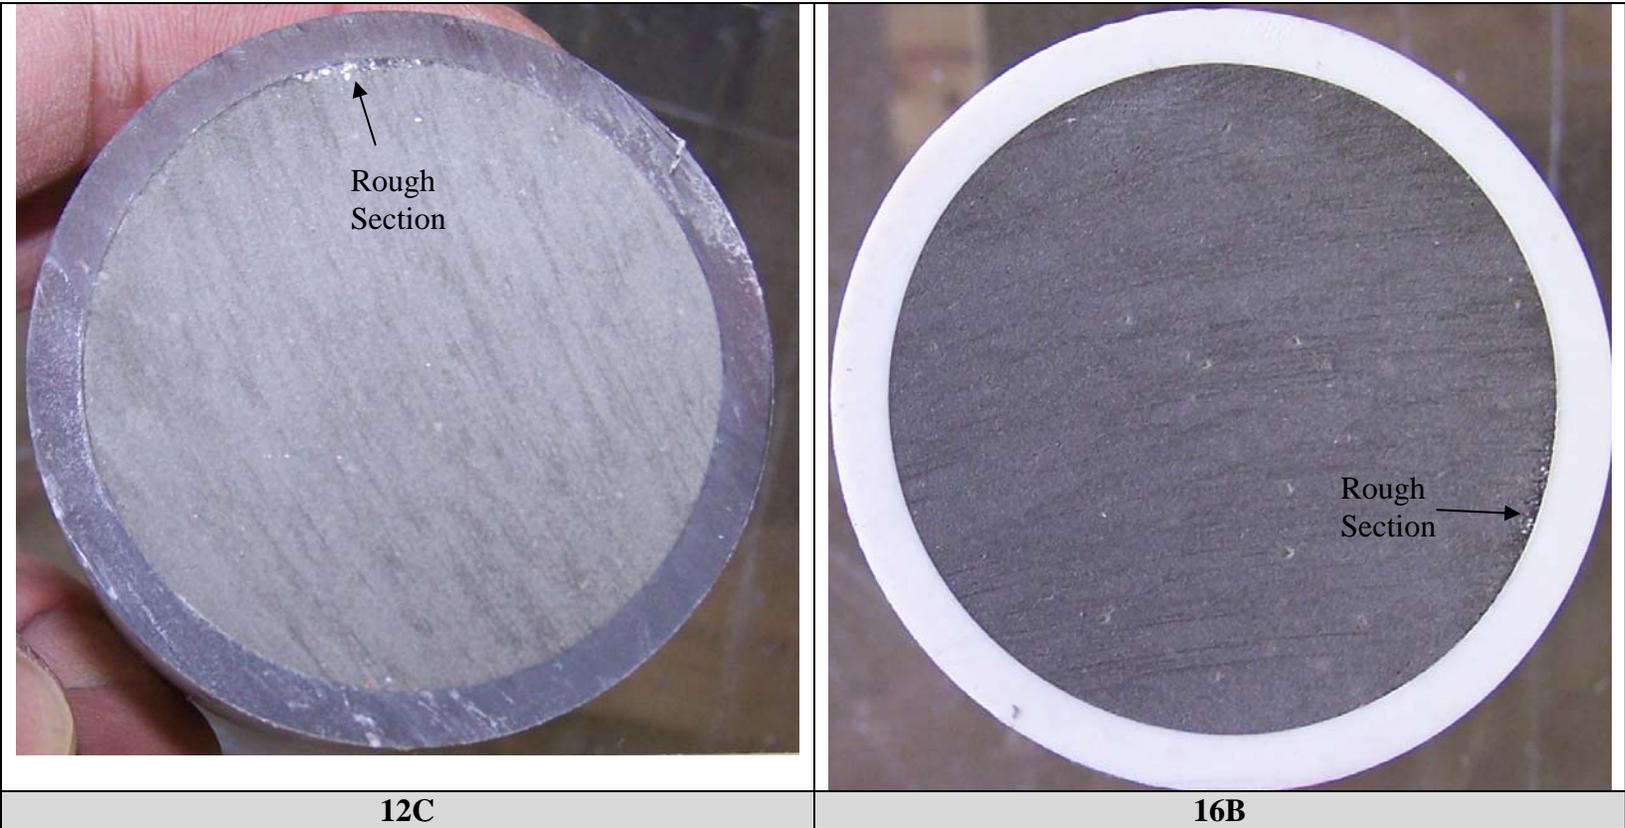
Figure 3-16 Sectioned Vertical Supply Piping – Horizontal Cooling Coil Assembly

Figure 3-17 Sectioned Vertical Return Piping – Horizontal Cooling Coil Assembly

Figure 3-18 Sectioned 4A and 8B Horizontal Piping – Horizontal Cooling Coil Assembly

Figure 3-19 Sectioned 12C and 16B Horizontal Piping – Horizontal Cooling Coil Assembly

Sectioning of various locations in the vertical runs showed them to be filled completely with grout and with hardly any noticeable air voids. Examples of these vertical sections are shown in Figure 3-16 and Figure 3-17. Upon filling of the horizontal sections of piping, visual observations were made using the sections of transparent piping and there were no observable air voids on top of the lines. Visual observations were made the next morning and they showed that the air in the grout had traveled to the tops of the horizontal piping. The ability for the air to move upward leads one to conclude that this grout did not set immediately. For the horizontal runs in the outside assembly, over 99% of the sectioned locations were observed to be solid in nature, as shown in Figure 3-18 and Figure 3-19. Upon closer inspection, one can see a very

small rough area, much less than four volume percent in each of these photographs. The rough areas are located on the outer diameter and on the top of the pipe. Figure 3-20 is a piece of cured grout that was extruded from the pipe to expose the top surface of the grout and a cross section was cut to examine the rough area. This piece of grout also contained a visible void, that if cut, would have looked like what is in Figure 3-21. Figure 3-20 is typical of how the top surface of the grout looked in the horizontal sections of piping and is fairly uniform. In Figure 3-21, there is a large and small void. A walk down of the 380 feet of transparent piping yielded four large type voids approximately 1.25 inches long and 28 small voids 0.25 to 0.5 inches long. Assuming the voids have the longest lengths for their size, the length of the voids add up to 19 inches, which is less than 0.5% of the length of transparent piping. Additional photographs of the sectioned cured grout in the horizontal cooling coil assembly can be found in Reference 11.

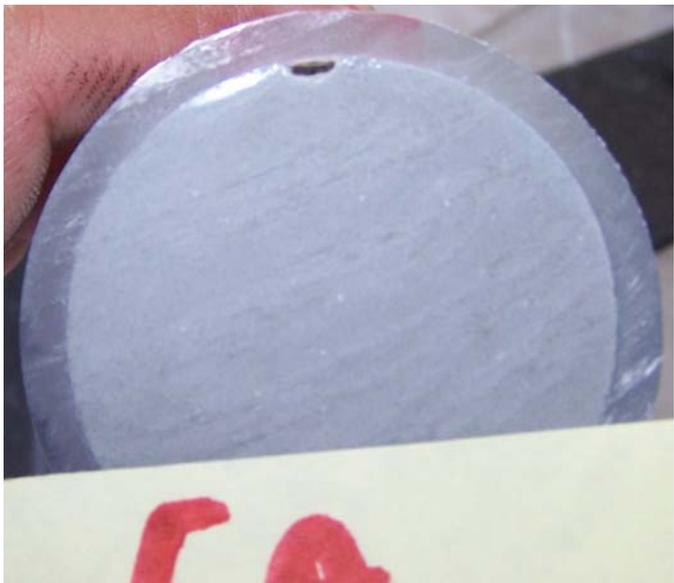
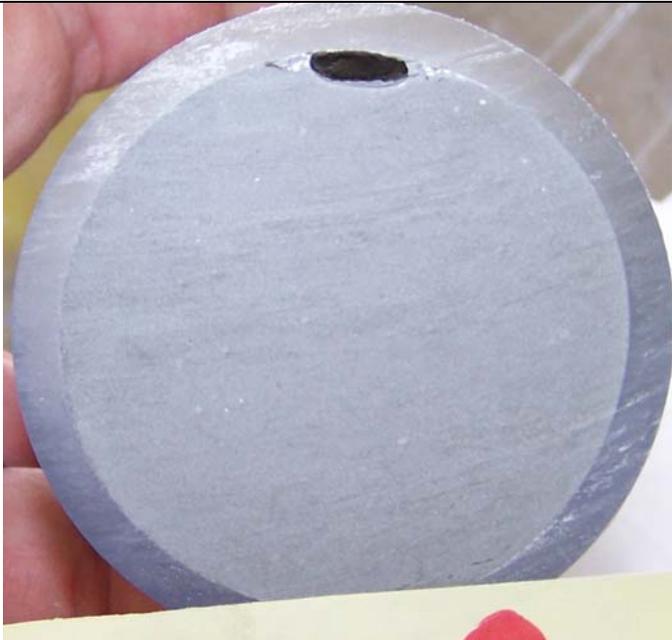
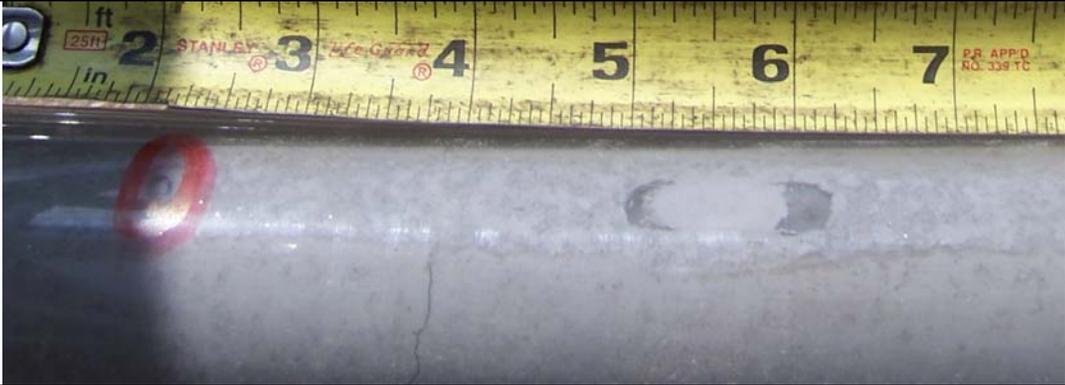
Figure 3-21 Sectioned 5A Horizontal Piping – Horizontal Cooling Coil Assembly

5A – Small Hole – Cut off center

5A – Large Hole – Cut off center

5A – Top View of Pipe, small hole on left, large hole on right
