Corrosion Testing of Carbon Steel in Acid Cleaning Solutions (U)

Westinghouse Savannah River Company
Savannah River Site
Aiken, SC 29808

DOCUMENT: WSRC-TR-2002-00427

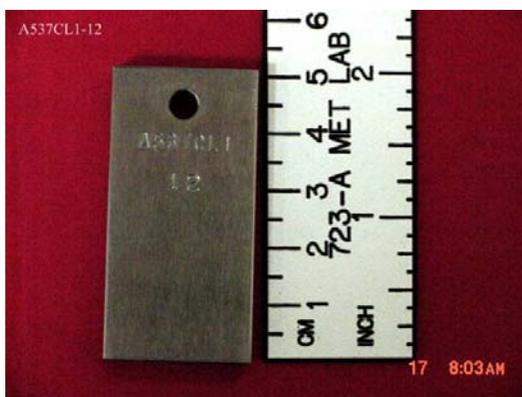
Figure 1 shows a typical A537 coupon. The coupons were nominally 2 x 1 x 0.25 inches and contained a 0.2 inch diameter hole near the top of the coupon. The coupons were ground and polished to a 600-grit finish on each surface. Each coupon was stamped with the type of material and a unique identification number. On average the coupons weighed approximately 60 grams.

Figure 1. A537 Carbon Steel Coupon Prior to Testing.

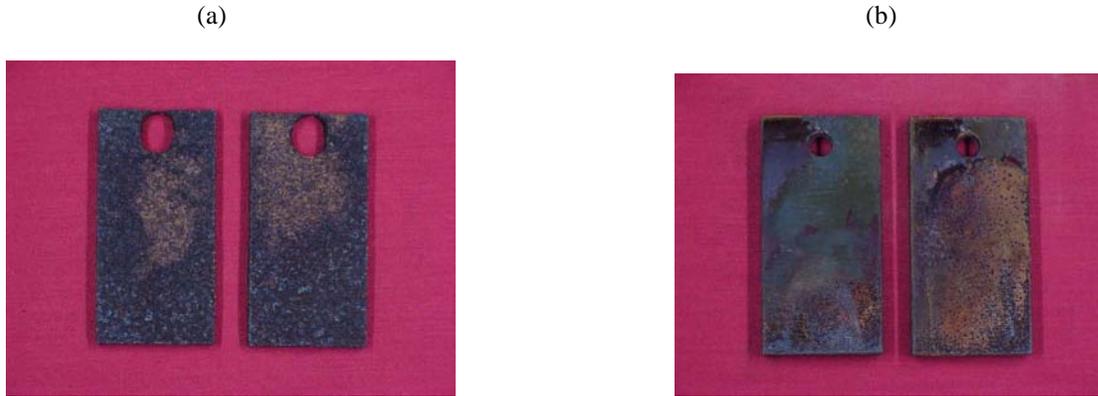
Figures 2- 4 are photographs of the coupons after they were removed from solution, but prior to cleaning. In general, both types of material had the same appearance. Figure 2 shows coupons that were immersed only in nitric acid (0.3 M and 3.0 M). The coupons that had been immersed in the 3 M solution exhibited severe general attack and an indication of crevice attack where the teflon string had been inserted into the hole. The coupons that were immersed in the 0.3 M solution exhibited light general attack and had no evidence of crevice attack near the hole. There was an insignificant amount of corrosion product on these coupons exposed to the more dilute acid.

Figure 2. Photographs of A537 coupons exposed to (a) 3 M nitric acid and (b) 0.3 M nitric acid.

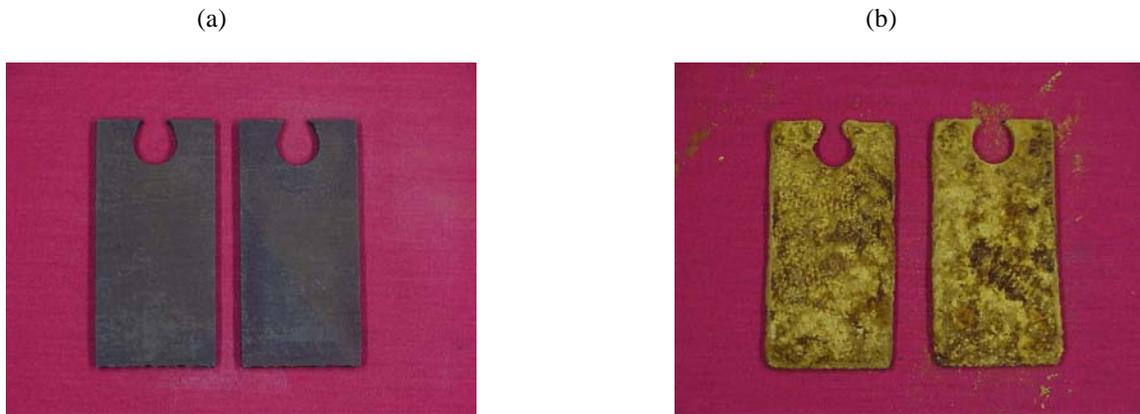
Figure 3 shows coupons that were immersed in 3 M nitric acid and various concentrations of oxalic acid. All coupons exhibited severe general attack and crevice attack where the teflon string had been inserted into the hole. In all cases, the corrosive attack had eaten through the top edge of the coupon and the coupon had fallen to the bottom of the bottle. Further crevice attack ensued on the edge that the coupon had rested. For the most part the coupons were free of iron oxides and had a few crystalline deposits. However, the A285 sample that had been immersed for 9 days, exhibited a significant number of yellowish-green crystalline deposits.

Figure 3. Photographs of coupons exposed to 3 M nitric acid and 8 wt. % oxalic acid. (a) A537 for 3 days and (b) A285 for 9 days.

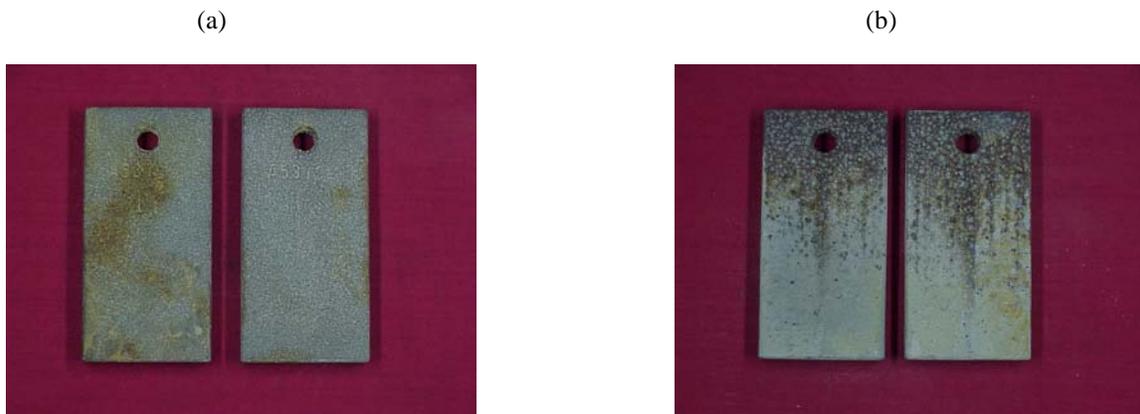
Figure 4 shows coupons that were immersed in 0.3 M nitric acid and various concentrations of oxalic acid. These coupons exhibited light surface attack and no evidence of crevice attack. The whole surface was coated with yellowish green crystalline deposits. However, there was no evidence of iron oxide formation on the surface.

Figure 4. Photographs of A537 Carbon Steel Exposed to: (a) 0.3 M nitric acid, 4wt.% oxalic acid and (b) 0.3 M nitric acid, 8 wt. % oxalic acid.

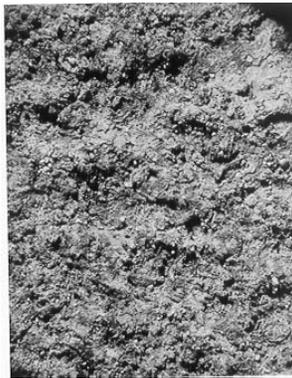
Figures 5-7 are micrographs of the coupons that reveal the morphology of the corroded surface after cleaning. Figure 5 shows the surface of a coupon that had been exposed to 3 M nitric acid. The surface is rough and bumpy, indicative of general corrosion.

Figure 5. General Corrosion of A537 Coupon in 3 M Nitric Acid (12X).

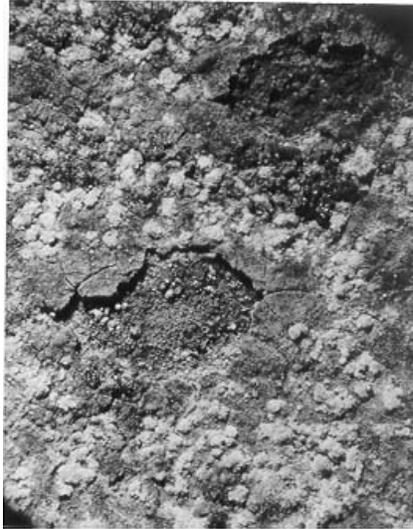
Coupons that had been immersed in 3 M nitric acid with various amounts of oxalic acid were very similar in appearance to that of coupons immersed in the 3 M nitric acid solution. The only exception was the coupon that had been exposed for 9 days rather than 3. Figure 6 shows the surface of this coupon. Several areas were evident where there appears to be a film present on the surface that has cracked and flaked off. Although it was not analyzed this film is likely ferrous oxalate.

Figure 6. Breakdown of Ferrous Oxalate Film (12X).
