ORNL/TM-13437

South Tank Farm Underground Storage Tank Inspection Using the Topographical Mapping System for Radiological and Hazardous Environments

Robotics and Process Systems Division

Date Published—July 1997

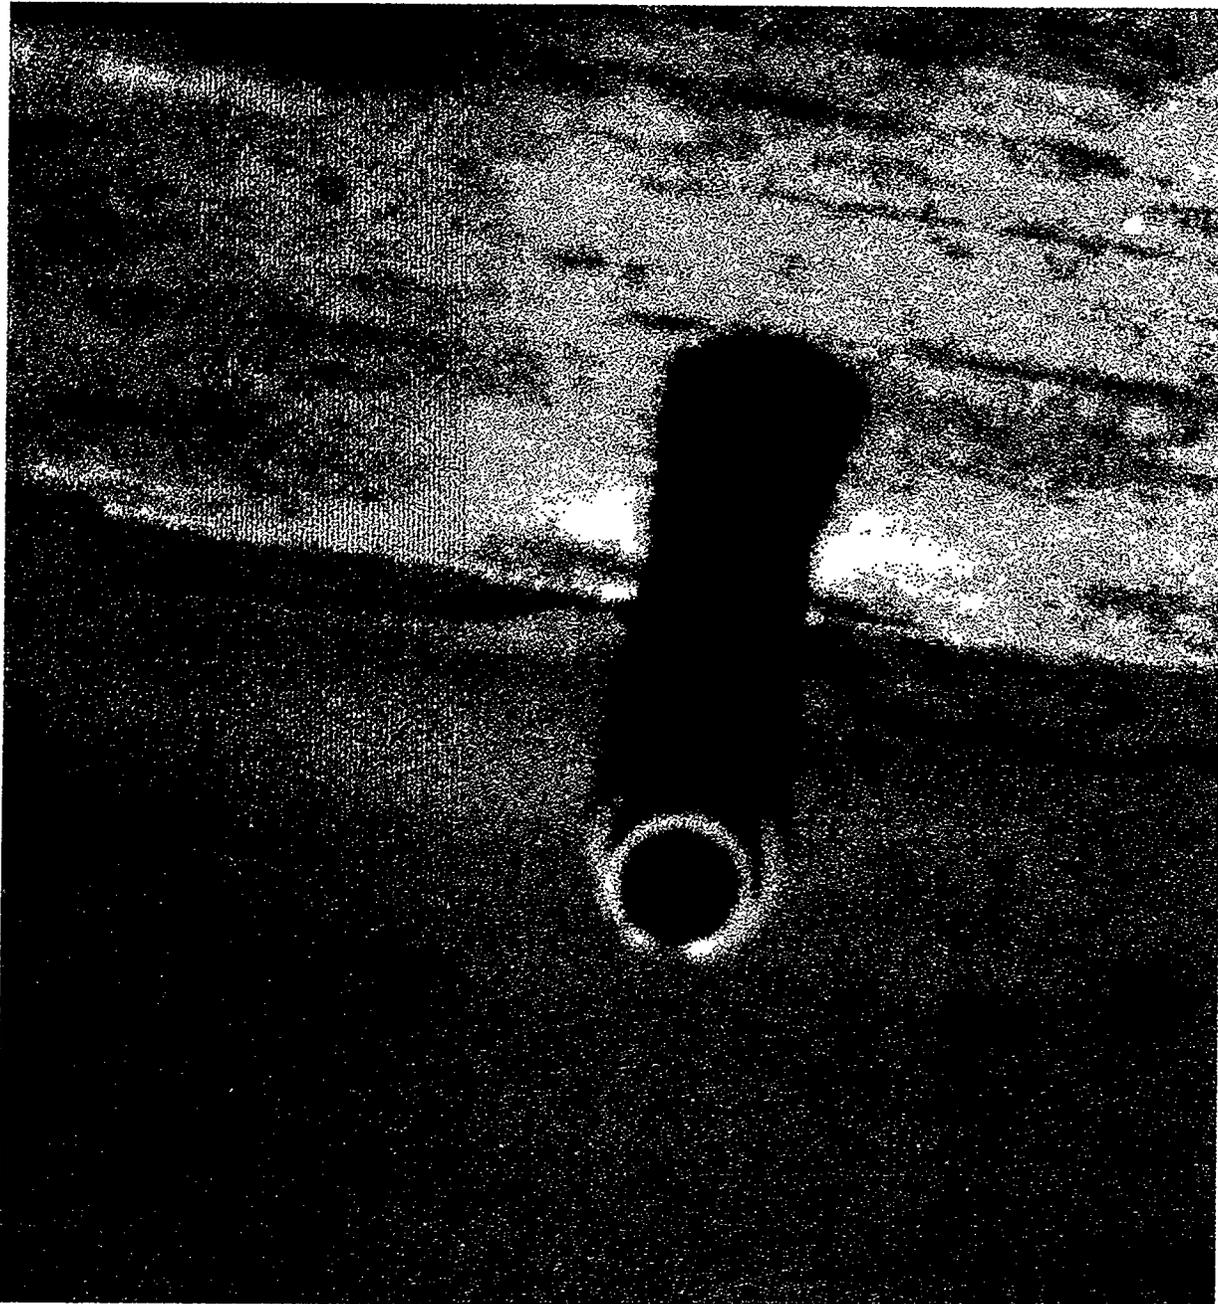
ORNL South Tank Farm
Underground Storage Tank Wall Inspection
W6 Riser #1

Figure D.12. UST W6 riser 1 photograph.

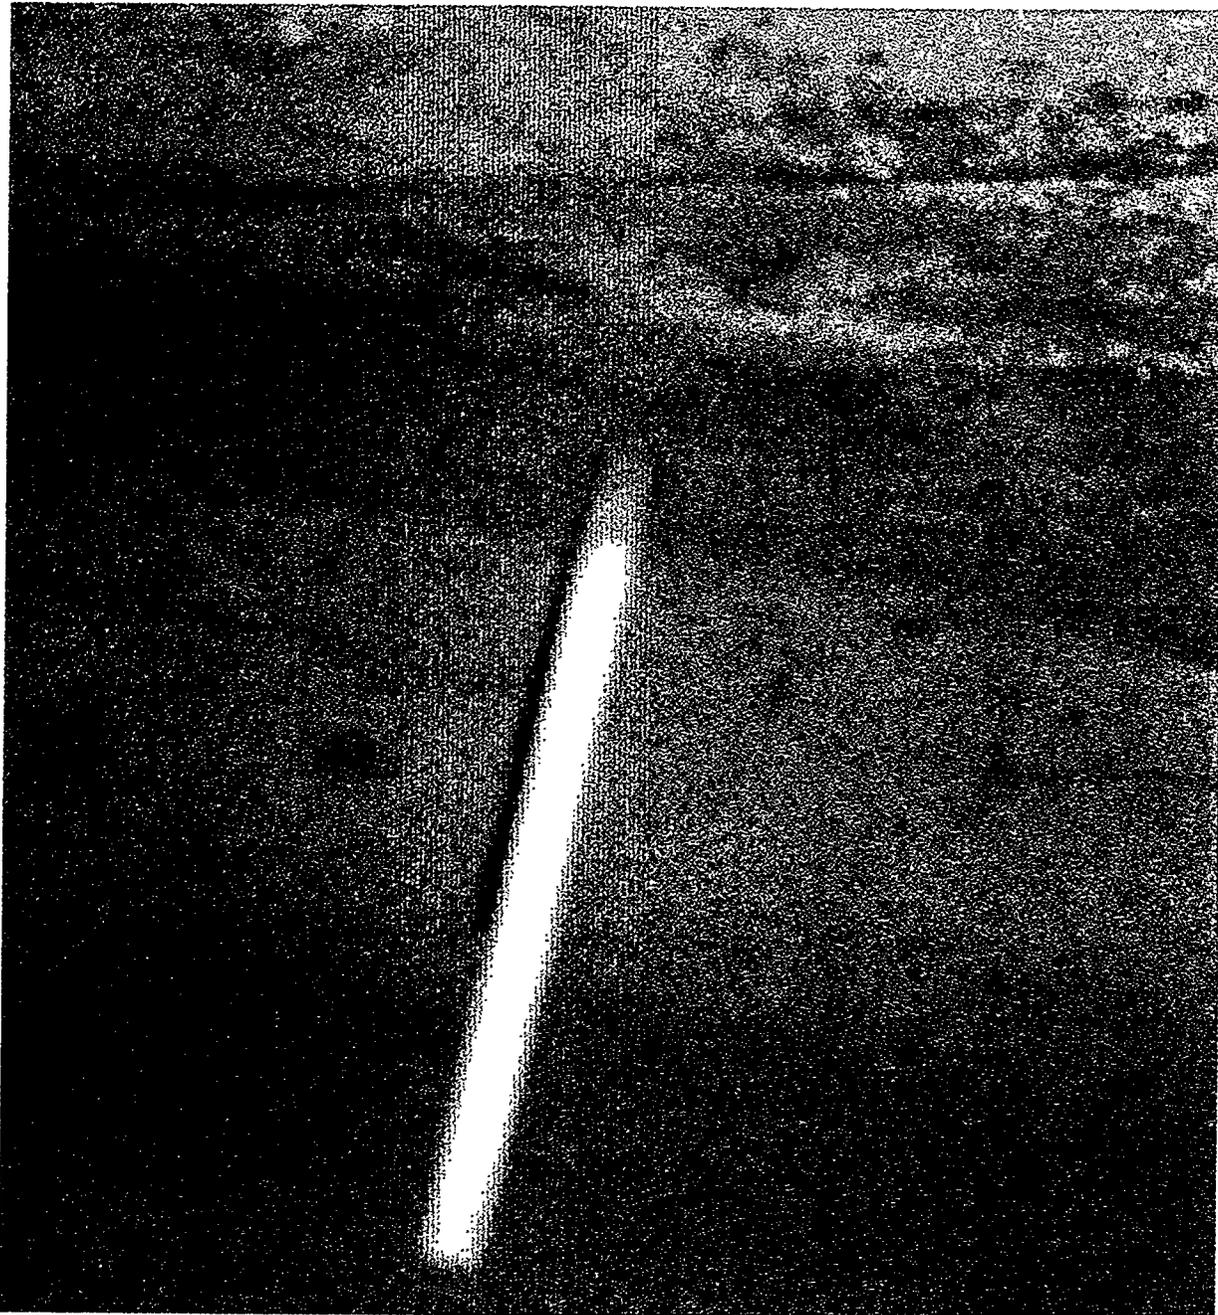
ORNL South Tank Farm
Underground Storage Tank Wall Inspection
W6 Riser #2

Figure D.13. UST W6 riser 2 photograph.

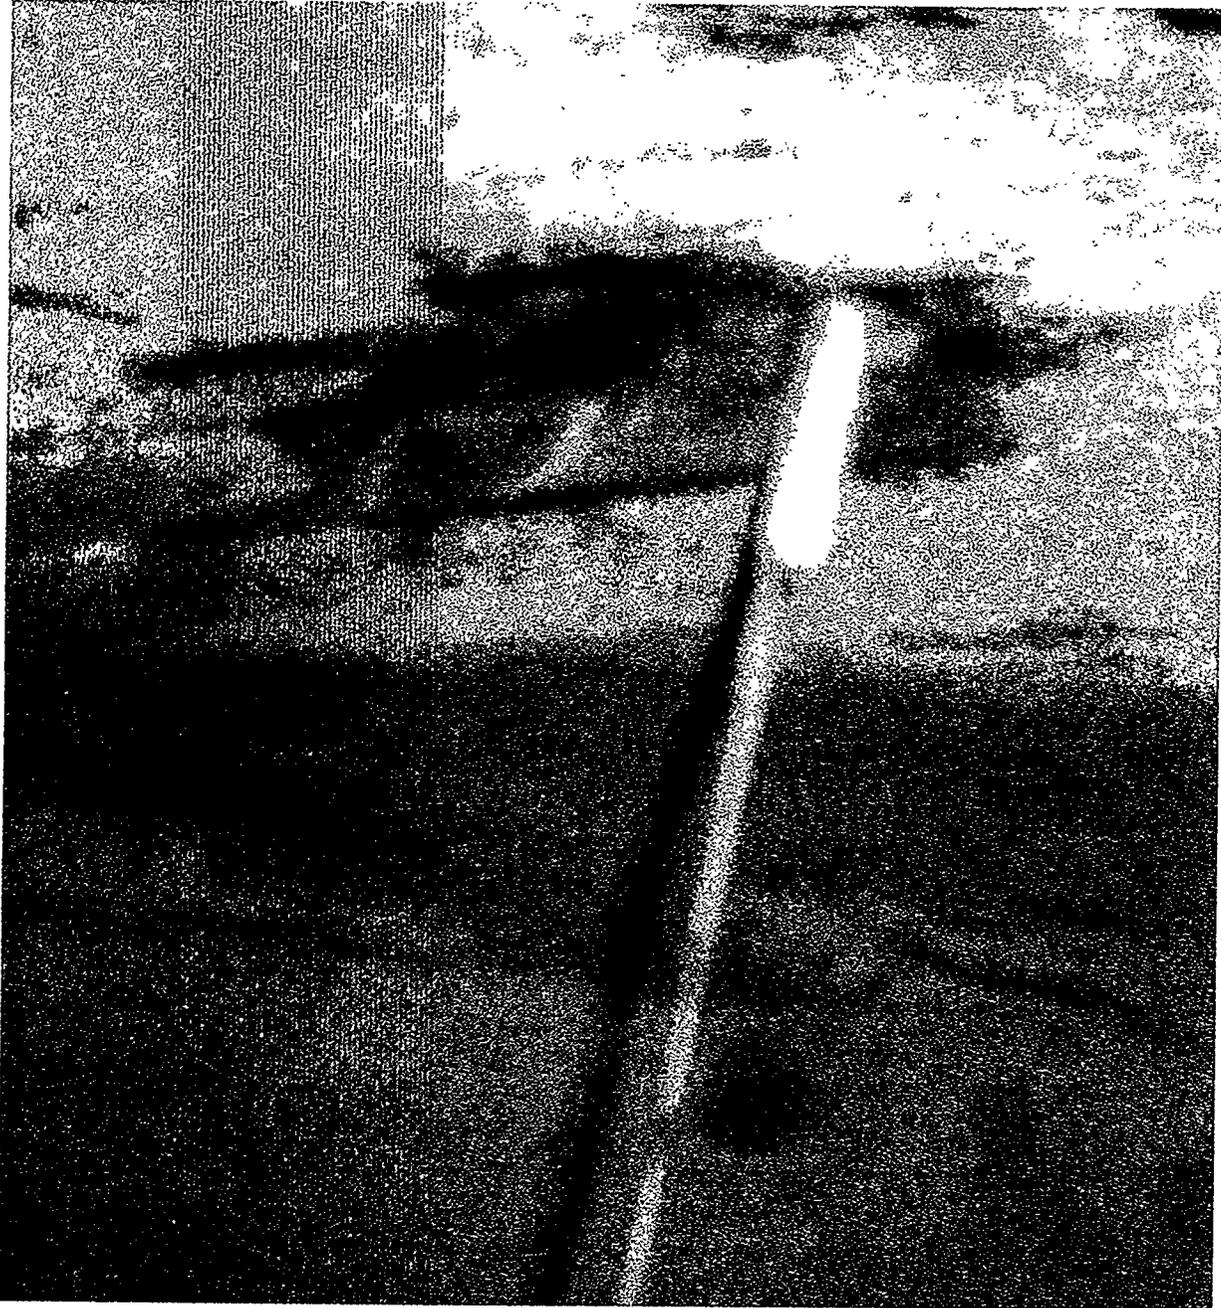
Figure D.14. UST W6 riser 3 photograph.

ORNL South Tank Farm
Underground Storage Tank Wall Inspection
W6 Riser #3

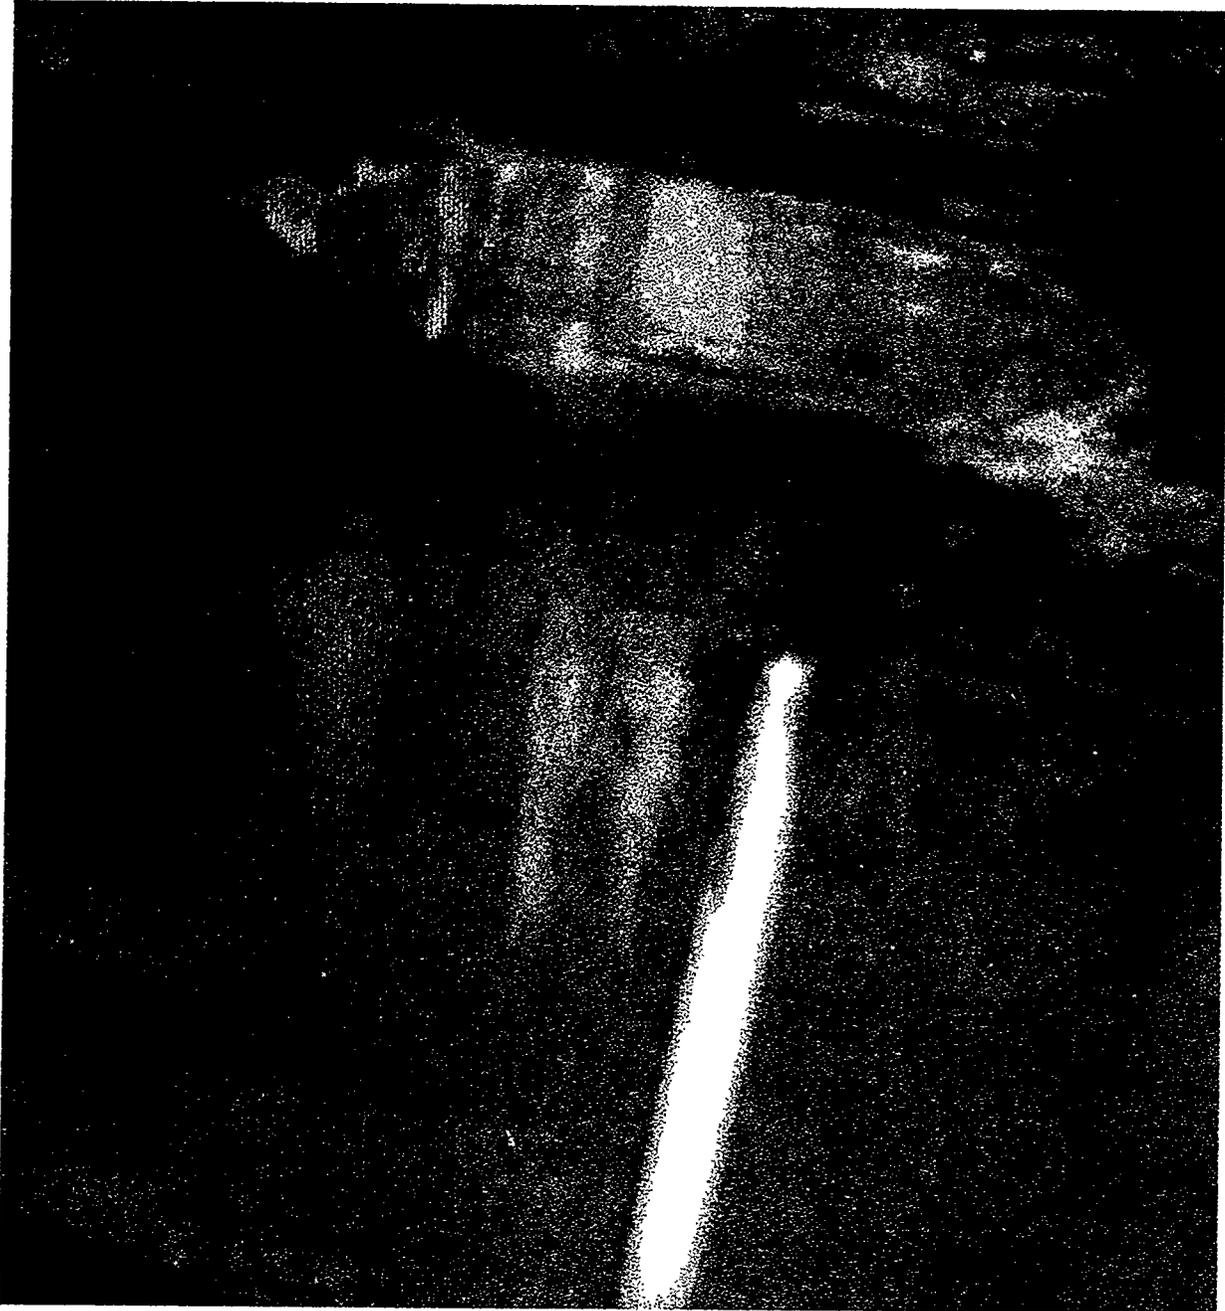
Figure D.15: UST W6 riser 4 photograph.

ORNL South Tank Farm
Underground Storage Tank Wall Inspection
W6 Riser #4

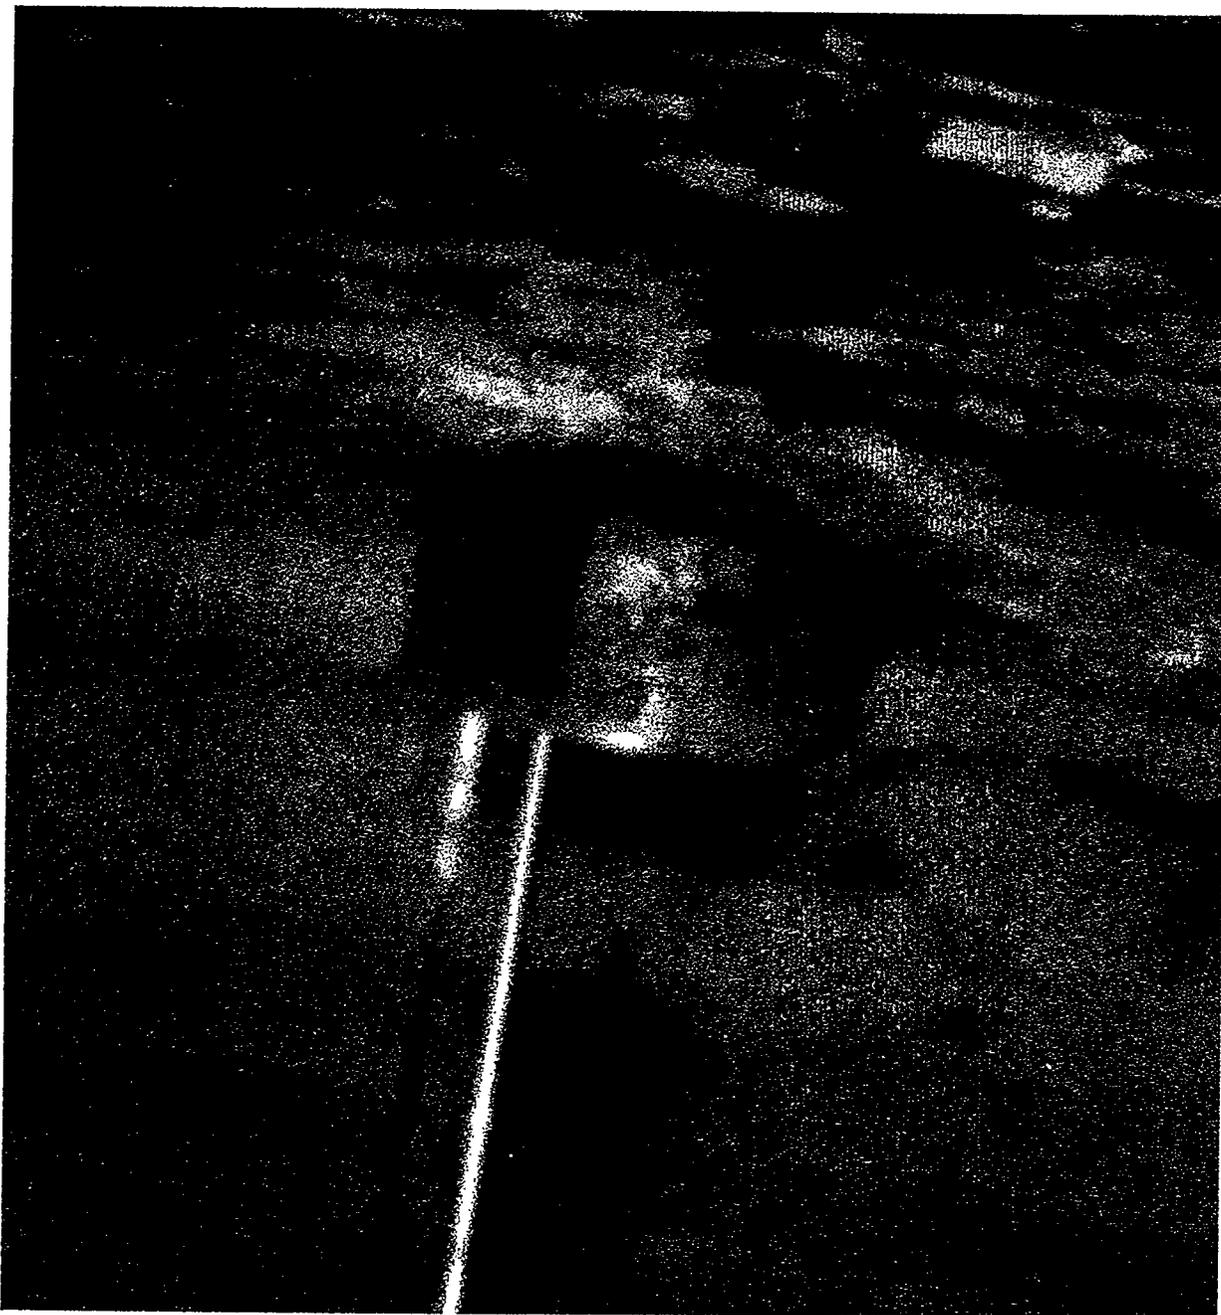
Figure D.17. UST W6 riser 6 photograph.

ORNL South Tank Farm
Underground Storage Tank Wall Inspection
W6 Riser #6

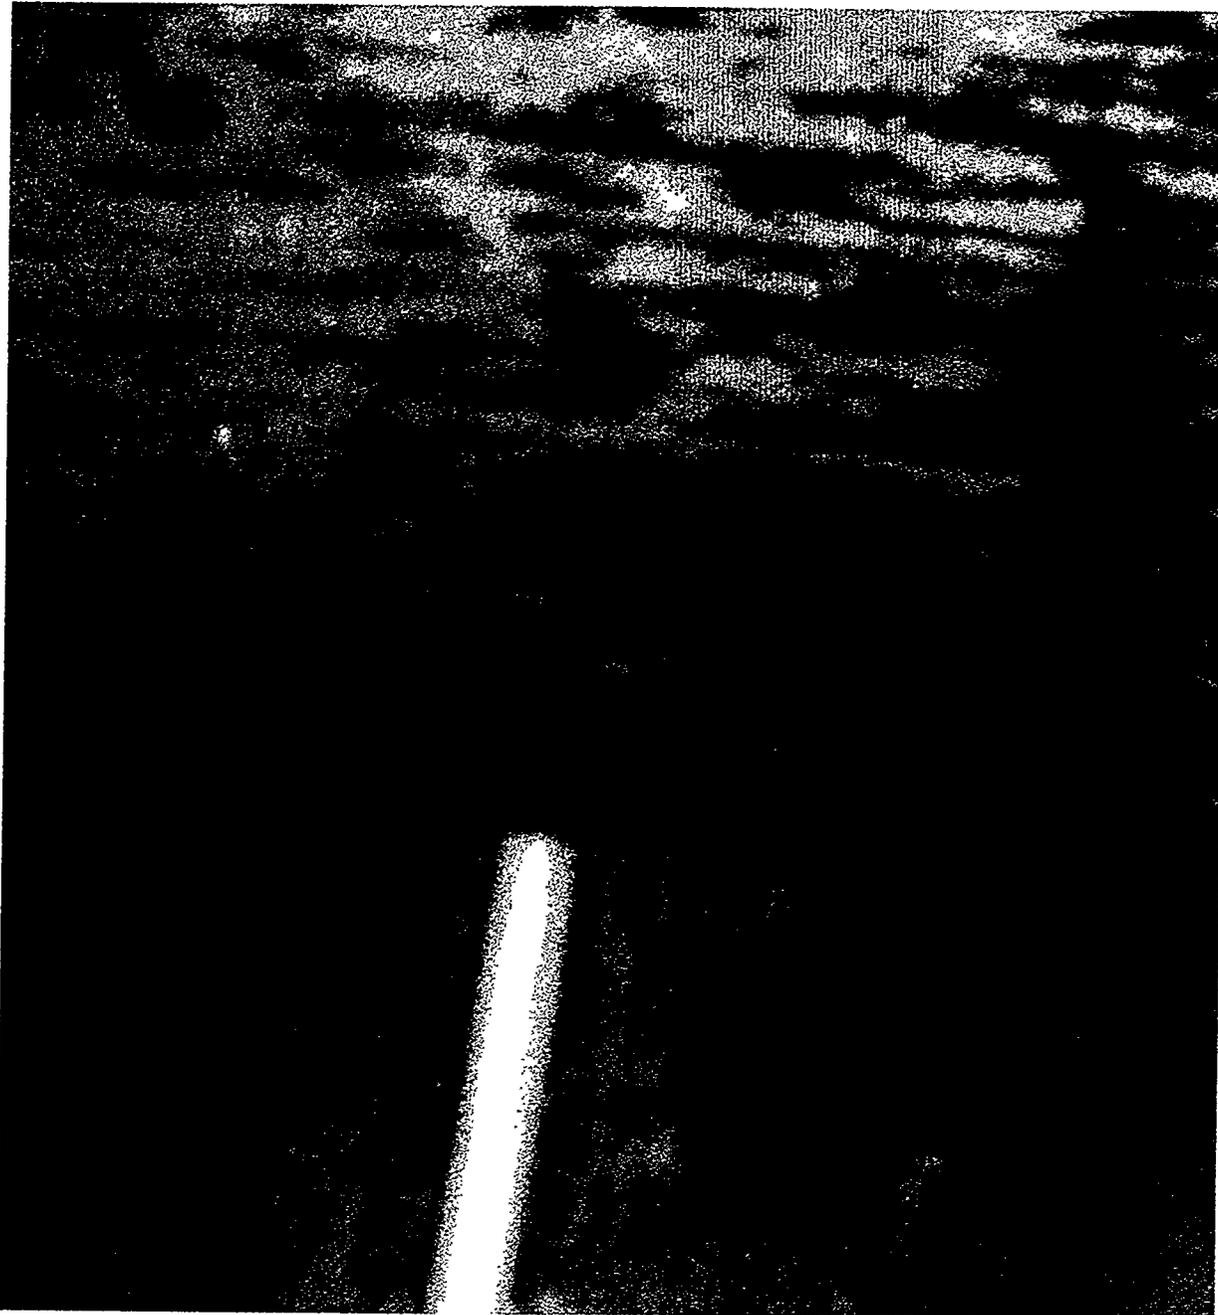
Figure D.19. UST W6 riser 8 photograph.

ORNL South Tank Farm
Underground Storage Tank Wall Inspection
W6 Riser #8
