**Ultrasonic Examination of Double-Shell  
Tank 241-SY-101 Examination  
Completed March 2004**

A.F. Pardini  
G.J. Posakony

July 2004

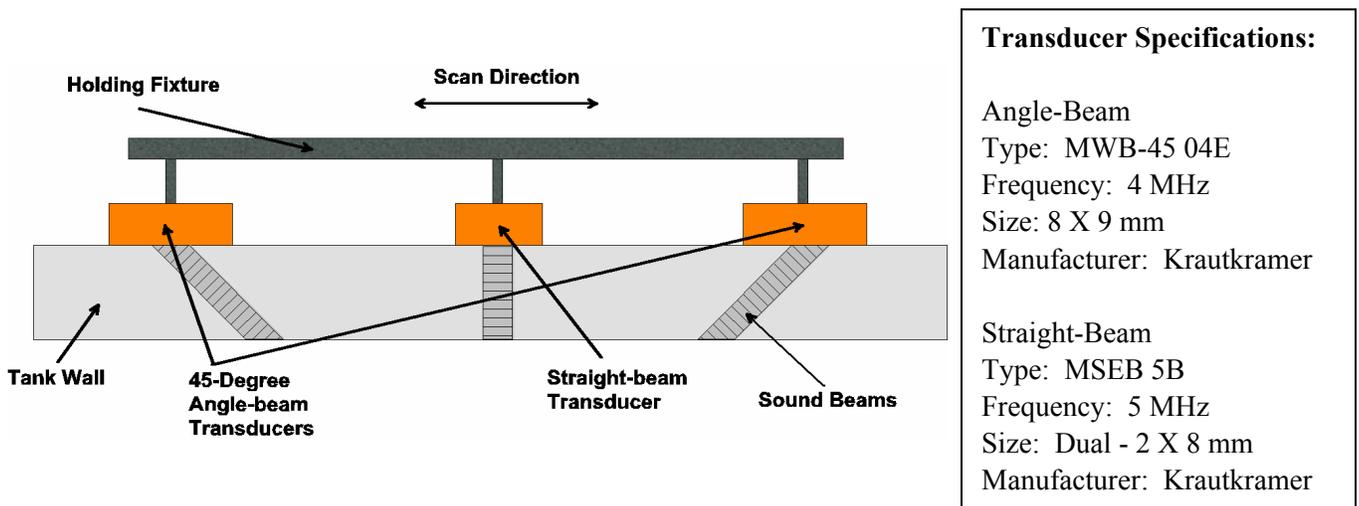
Figure 3.1. Transducer Configuration for Examining the Primary Tank Wall

Figure 3.1 provides an example of the scanning configuration generally used during an examination of the primary tank wall. However, other configurations can be used at the discretion of the COGEMA UT Level III (i.e., 45-degree transducers can be removed for simple wall thickness measurements). The functional diagram in Figure 3.1 shows one straight-beam and two angle-beam transducers ganged together for examining the primary tank wall. The straight beam is designed to detect and record wall thinning and pitting, and the angle beams are designed to detect and record any cracking that may be present. These transducers are attached to the scanning bridge and they all move together. Information is captured every 0.035-in. (or as set by the NDE inspector) as the assembly is scanned across a line. At the end of each scan line the fixture is indexed 0.035-in. (or as set by the NDE inspector) and the scan is repeated. The mechanical scanning fixture is designed to scan a maximum of 15-in. and then index for the next scan line. The scanner can be reconfigured for wider scans. The hard copy provides a permanent record that is used for the subsequent analysis.

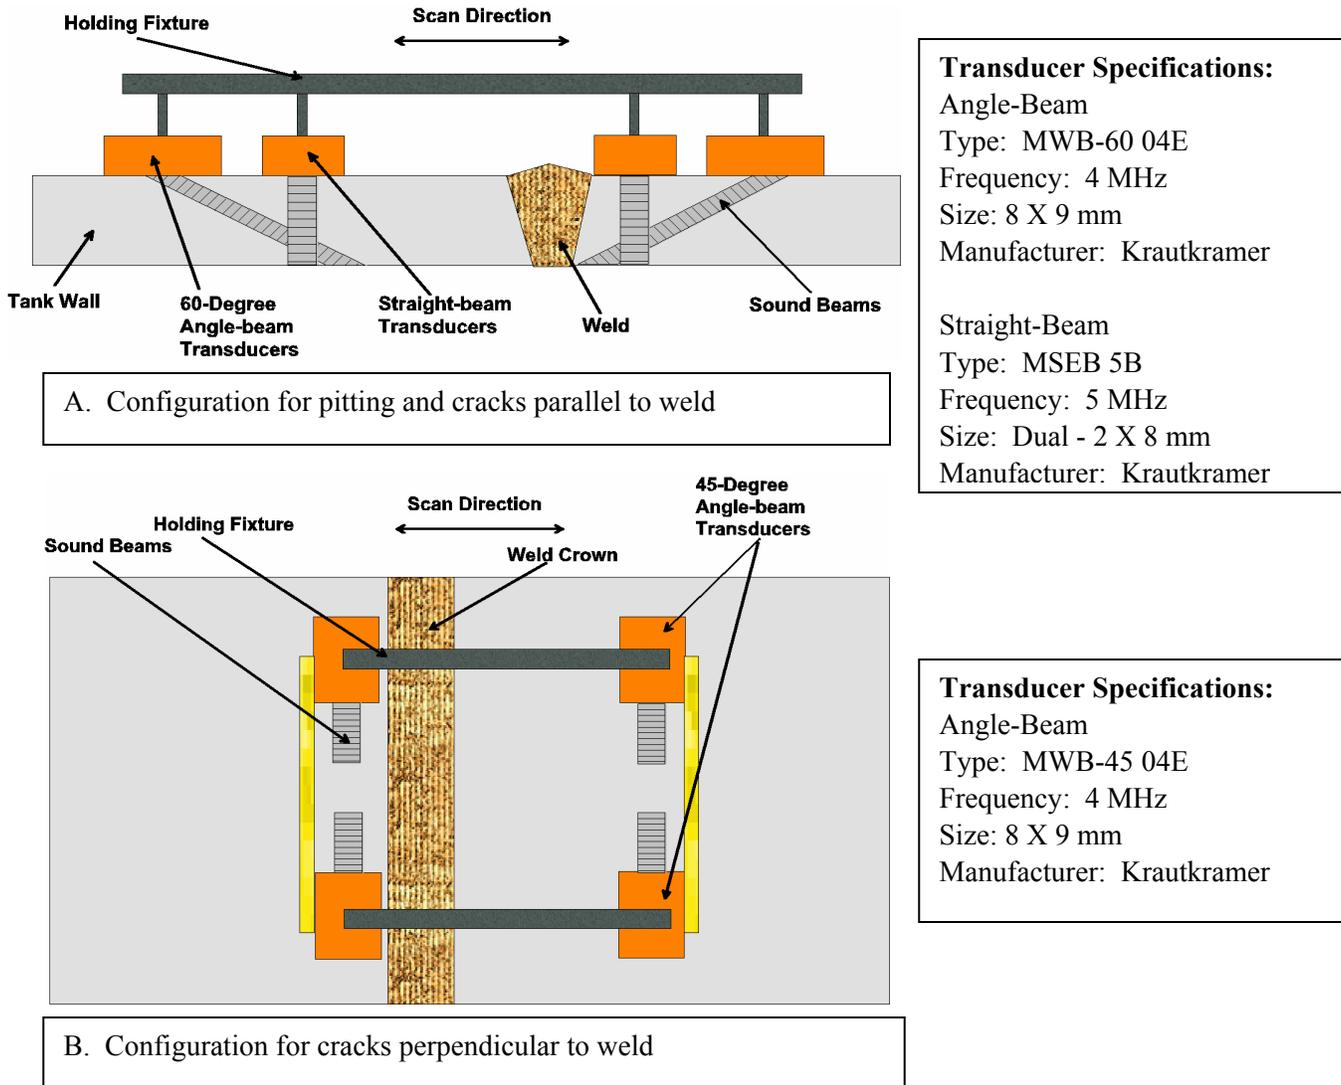
**Figure 3.2.** Transducer Configurations for Examination of Weld Zone in the Primary Tank Wall

Figure 3.2 is a functional sketch that shows the configurations for examination of the weld zone. The area of interest (HAZ of the weld) is adjacent to the weld. Both cracks and pitting may occur in this region. The “A” portion of this sketch shows the 60-degree angle-beam transducers used for detecting cracks parallel to the weld. The straight-beam transducers in this sketch are used for detecting and recording any pitting or wall thinning that may be present. All transducers are ganged together. The scanning distance traveled is limited to a total of approximately 5.0-in. The sketch titled “B” shows the arrangement for detecting cracks that may lie perpendicular to the weld. Four 45-degree, angle-beam transducers are used for this inspection. Again the transducers are ganged together but the scan is limited to a total of approximately 4.0-in. The weld zone requirements are shown in Figure 3.3. The scan protocol, data capture, and index are the same for examining other weld areas in the tank.

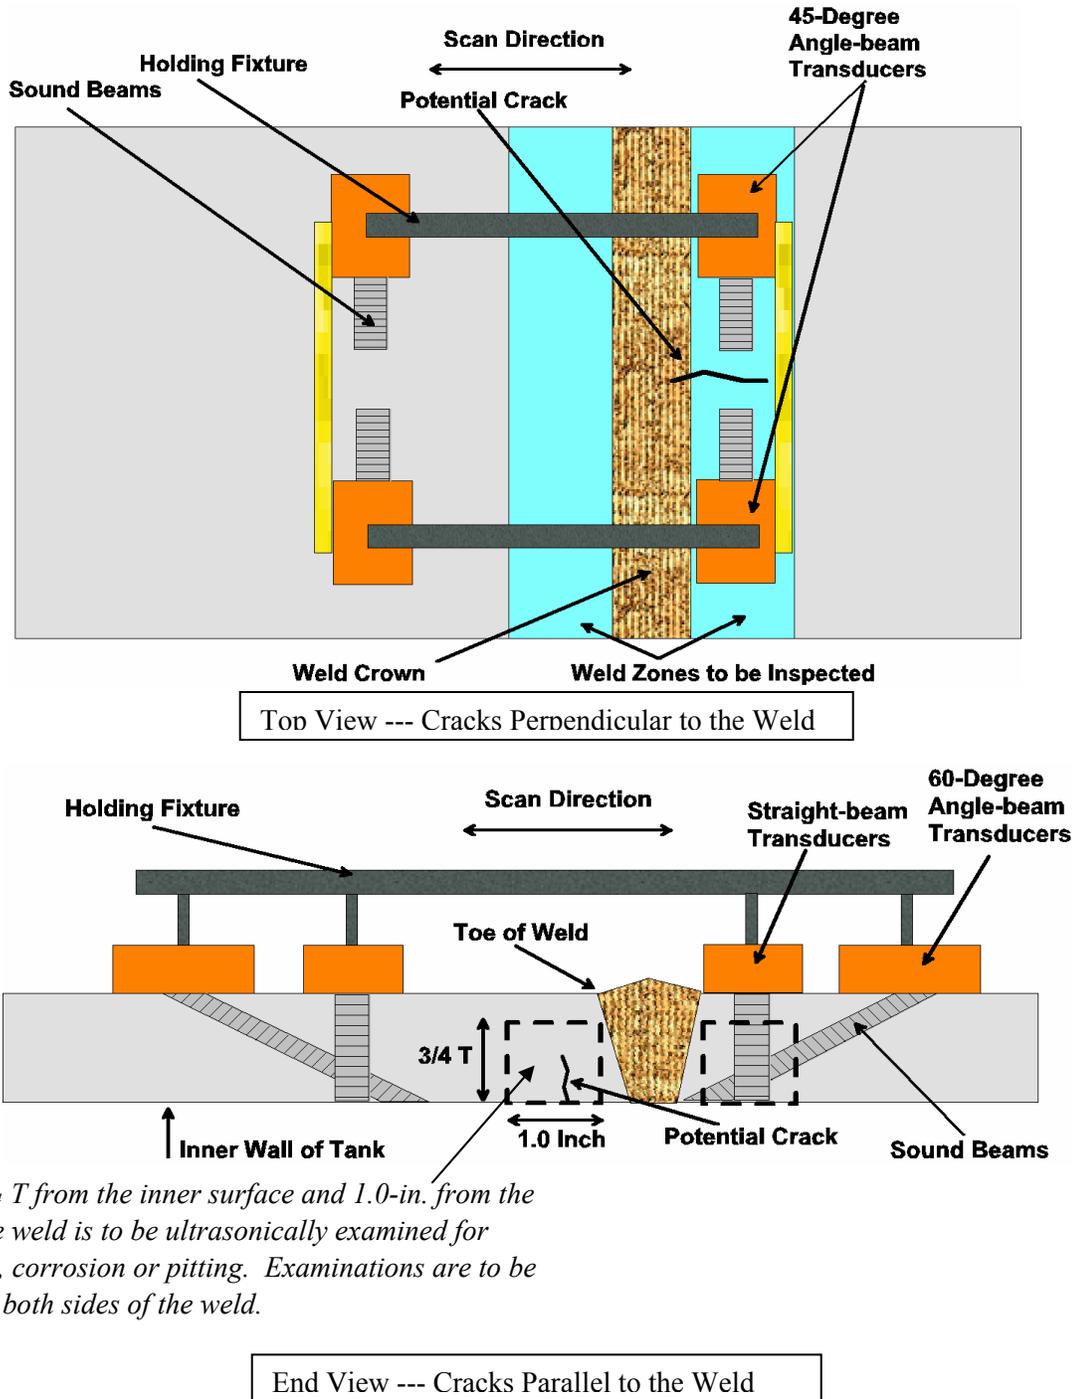
**Figure 3.3.** Views of the Weld Zone to be Ultrasonically Examined in the Primary Tank Wall

In the HAZ, the requirement for characterizing cracks that lie perpendicular or parallel to welds in the primary tank wall is described in Figure 3.3. The HAZs are located on either side of the weld and defined as being within 1-in. of the toe of the weld and on the inner three-quarters of the thickness ( $3/4T$ ) of the shell course plate. These zones are considered most likely to experience stress-corrosion cracking.

*A zone  $3/4 T$  from the inner surface and 1.0-in. from the toe of the weld is to be ultrasonically examined for cracking, corrosion or pitting. Examinations are to be made on both sides of the weld.*

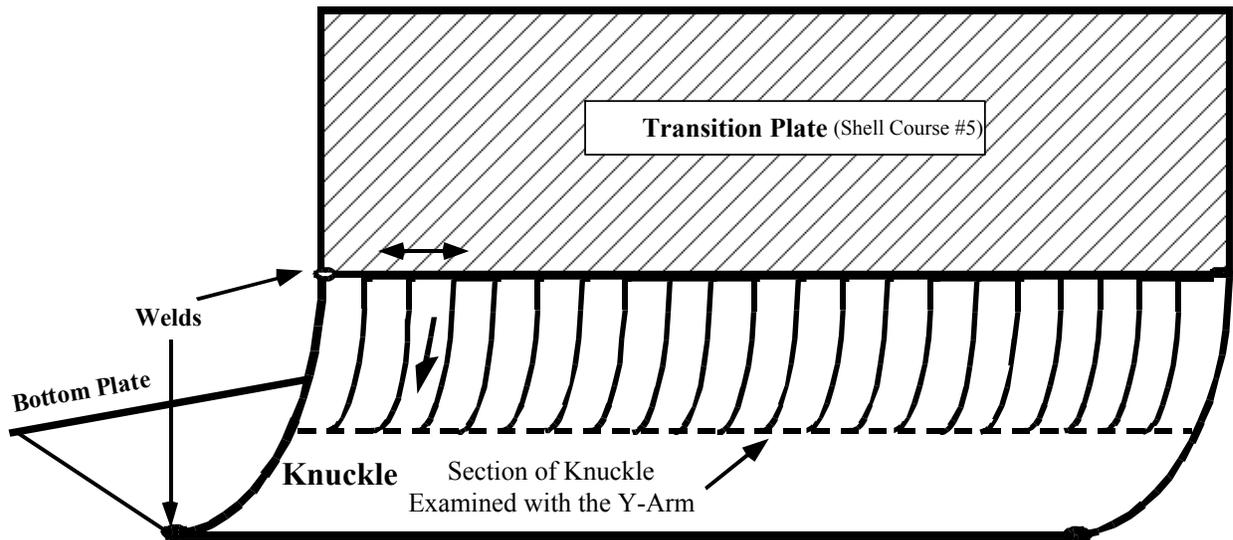
Figure 3.4. Sketch of a Section of the Knuckle Examined with the Y-Arm Scanner

Examination of the knuckle utilizes a modified scanning bridge known as the Y-arm scanner. The Y-arm provides scanning of the transducers directly on the knuckle region. The Y-arm is a special fixture that attaches to the AWS-5D magnetic wheel crawler. Its purpose is to extend the reach of the transducer assembly. This extension allows the transducer assembly to follow the curve of the upper portion of the knuckle below the transition shell course #5 to upper knuckle weld. It is designed to hold the dual 0-degree or two 45-degree transducers in the same configuration as used for the examination of the tank wall. The transducer configuration used for crack detection in this examination was two opposing 45-degree angle-beam transducers that were rotated 90-degrees from the orientation used for the wall crack inspection. This configuration is designed to detect cracks that are in a circumferential direction with respect to the axis of the tank. Figure 3.4 is a sketch showing the area of the section of the knuckle examined using the Y-arm fixture. With the transducer positioned 1-in. below the transition shell course #5 to upper knuckle weld, the scanning bridge was set to scan the transducer downward an additional distance of approximately 11-in. in 0.035-in steps (or as set by the operator). Upon completion of the scan, the bridge was indexed circumferentially 0.035-in. (or as set by the operator) and the scan downward is repeated to obtain a pixel size 0.035-in. x 0.035-in. (or as set by the operator).

The upper portion of the knuckle area was scanned utilizing the Y-arm scanner attached to the AWS-5D crawler. The Y-arm scanned the transducers down around the knuckle approximately 11-in. from a starting position 1-in. down from the upper knuckle weld joining shell course #5 to the knuckle. The knuckle was examined for wall thinning, pitting, and cracks oriented circumferentially around the primary tank. The results indicated that the minimum measured thickness in the approximately 20 circumferential feet of knuckle area examined with nominal thickness of 0.875-in. was 0.842-in. There were no areas that exceeded the reportable level of 10% of the nominal thickness. No pitting or circumferentially oriented crack-like indications were detected in the upper portion of the knuckle area.

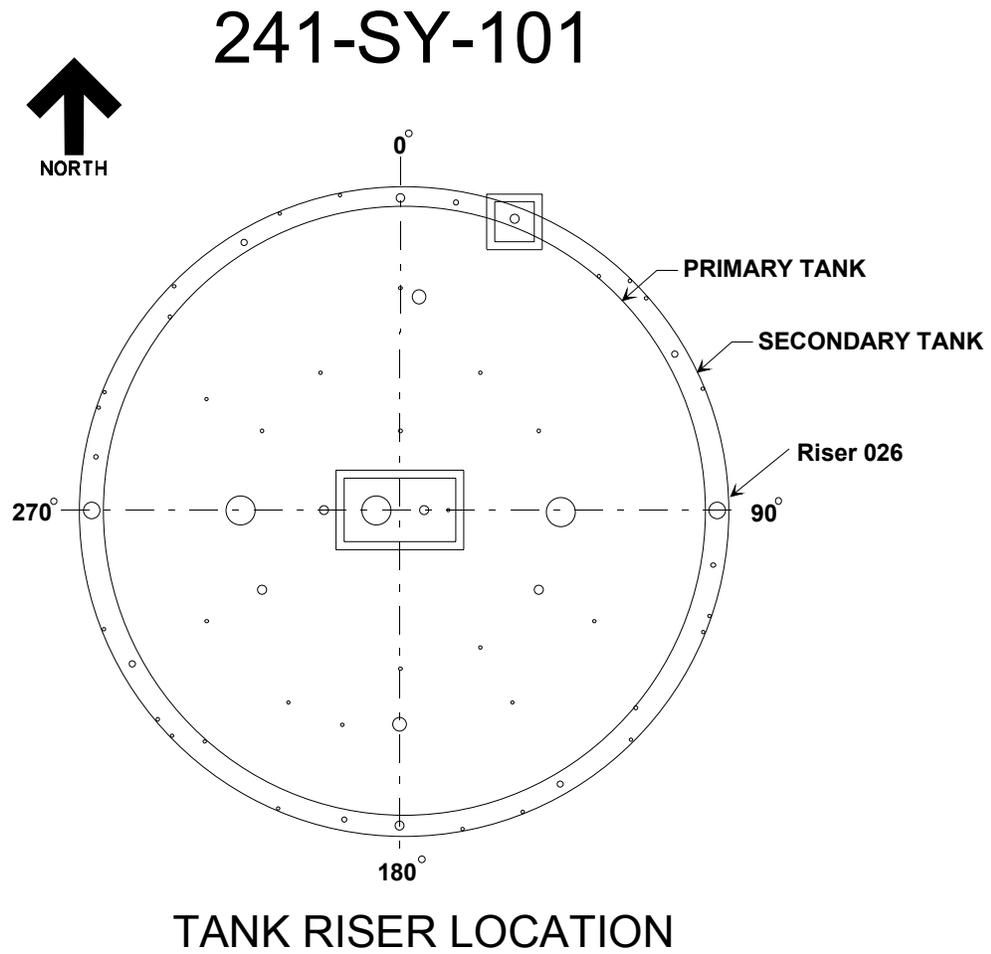
Figure 4.1. UT of 241-SY-101 from Riser 26

Tank 241-SY-101 is located in the Hanford 200 West area in SY Tank Farm. The crawler and associated scanner that hold the transducers were lowered into the 24-in. riser located on the east side of 241-SY-101 and designated as Riser 26. Figure 4.1 provides a graphic of the location of this riser.
