**Pacific Northwest
National Laboratory**

**Ultrasonic Examination of Double-Shell
Tank 241-AP-104 Examination
Completed August 2004**

A..F Pardini
G.J. Posakony

August 2004

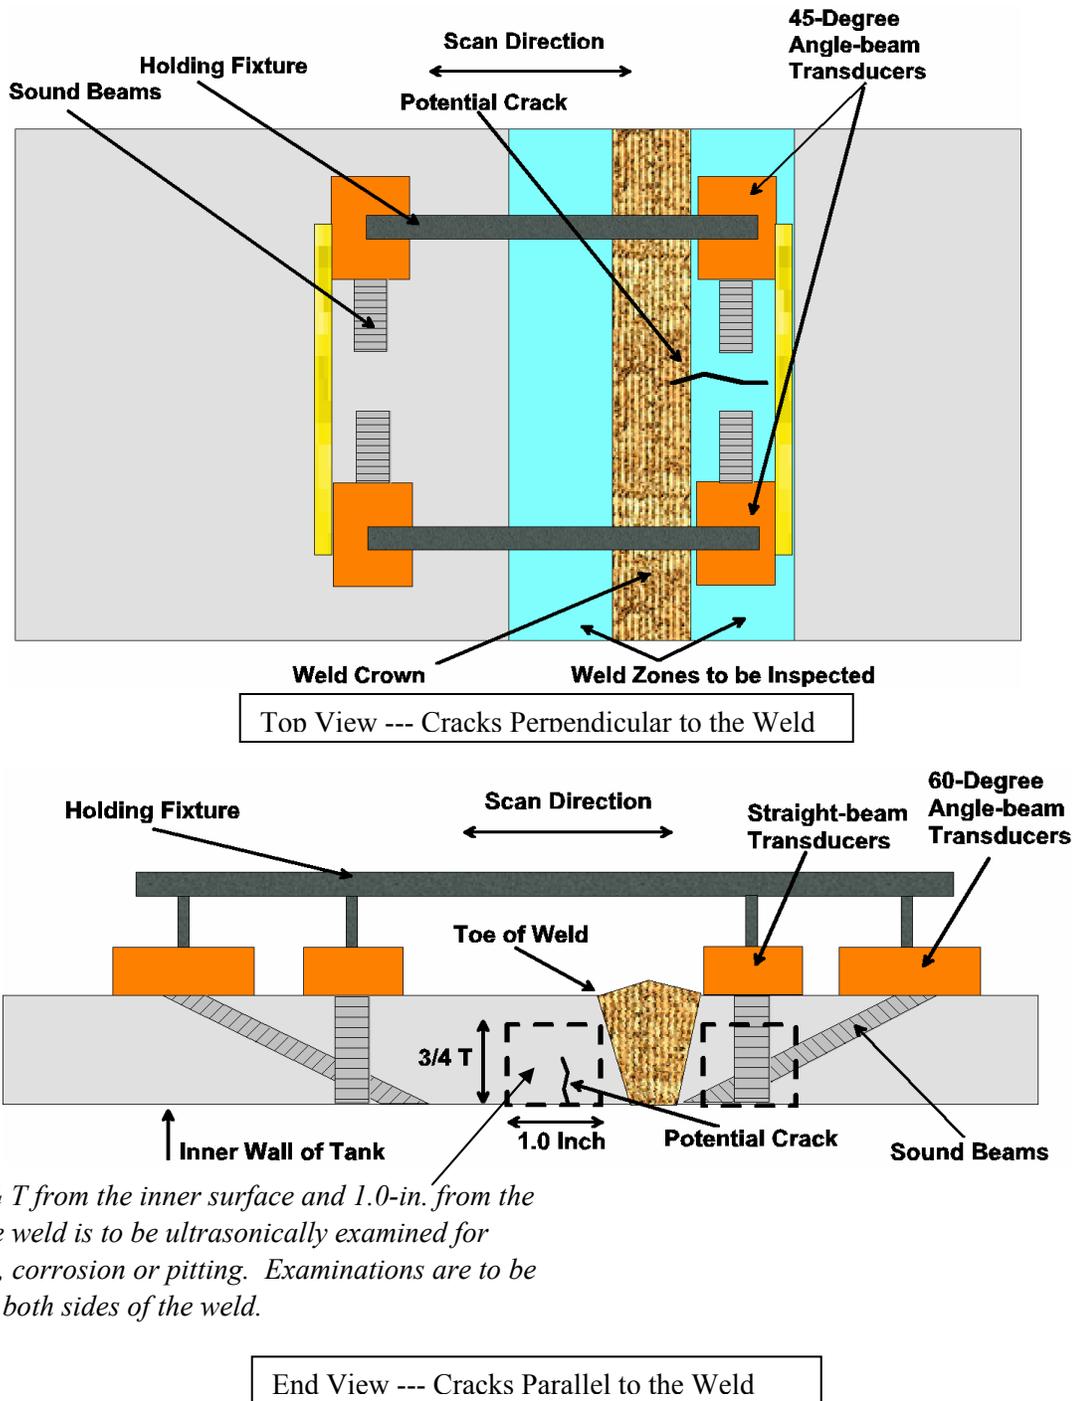
Figure 3.3. Views of the Weld Zone to be Ultrasonically Examined in the Primary Tank Wall

In the HAZ, the requirement for characterizing cracks that lie perpendicular or parallel to welds in the primary tank wall is described in Figure 3.3. The HAZs are located on either side of the weld and defined as being within 1-in. of the toe of the weld and on the inner three-quarters of the thickness ($3/4T$) of the shell course plate. These zones are considered most likely to experience stress-corrosion cracking.

A zone $3/4 T$ from the inner surface and 1.0-in. from the toe of the weld is to be ultrasonically examined for cracking, corrosion or pitting. Examinations are to be made on both sides of the weld.
