**Pacific Northwest
National Laboratory**

**Ultrasonic Examination of
Double-Shell Tank 241-AY-101
Examination Completed March 2007**

AF Pardini
DR Weier

June 2007

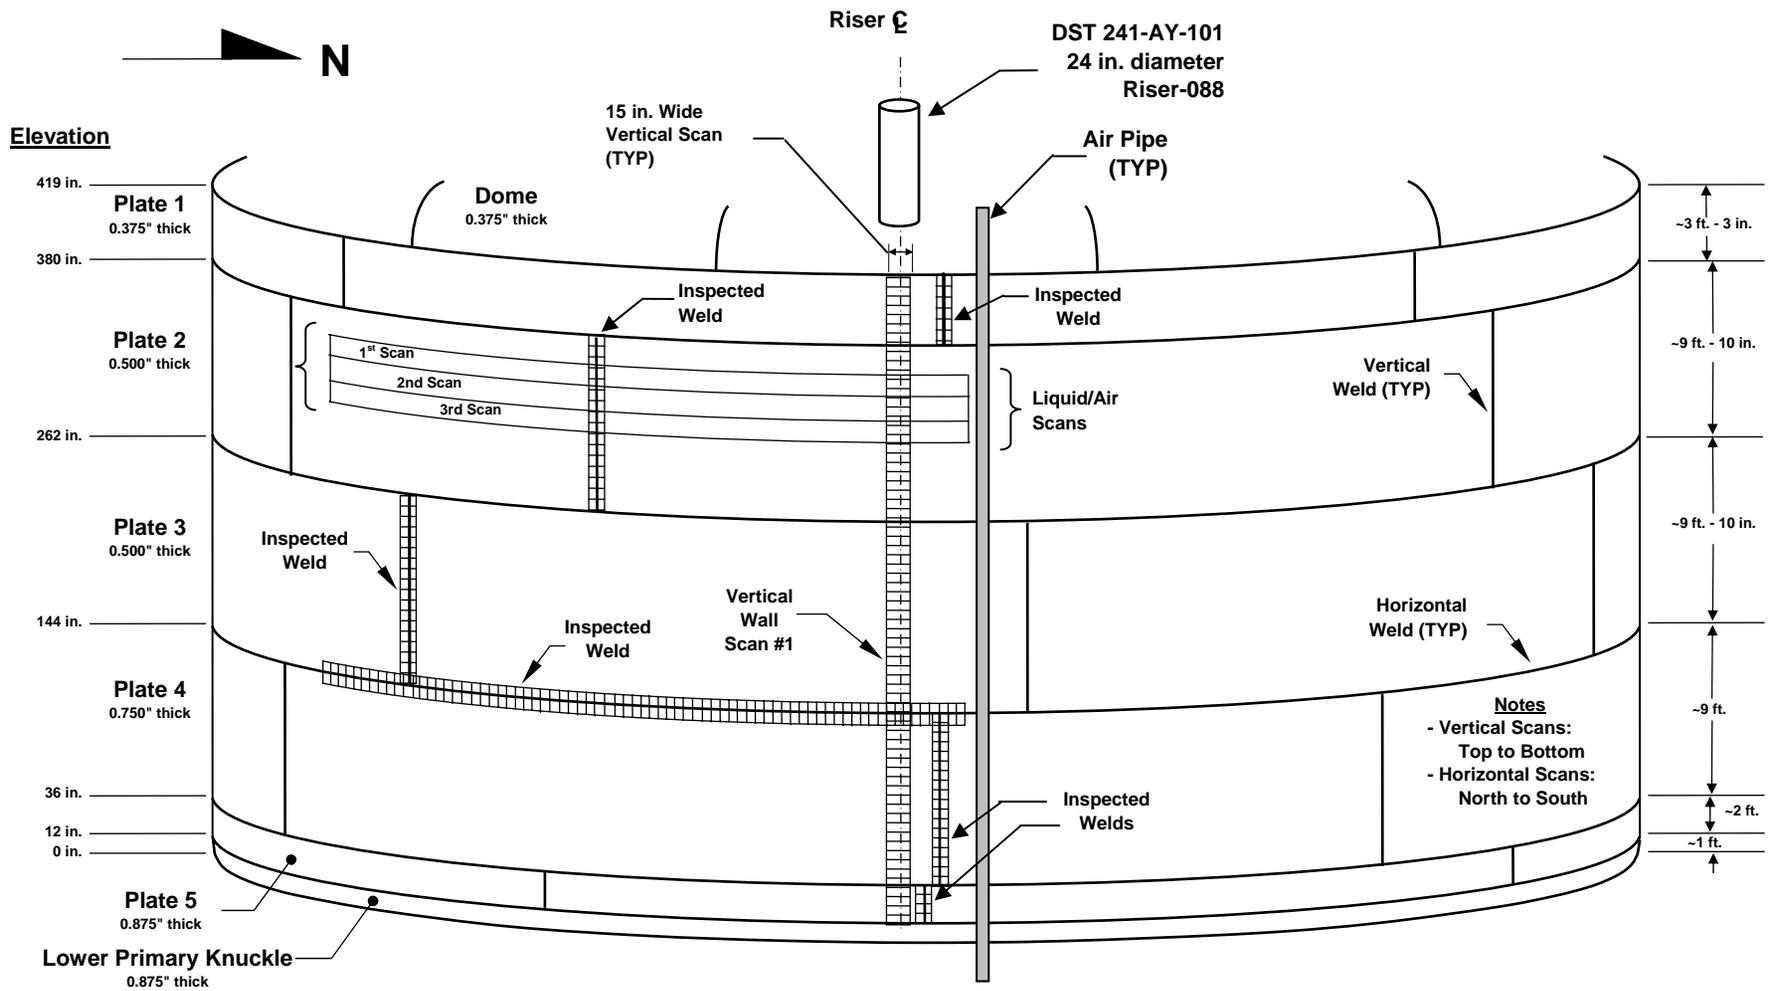
Figure 4.2. Sketch of Scan Paths on 241-AY-101 Primary Tank from Riser 88

Figure 4.2 describes the areas on the primary wall of Tank 241-AY-101 that were ultrasonically examined from Riser 88 located on the east side of the tank. One 15-in.-wide vertical scan path was performed on Plates #1, #2, #3, #4, and #5 below the entrance to Riser 88. Vertical weld HAZ examinations were done on Plates #1, #2, #3, #4, and #5, and the horizontal weld HAZ examination was done between Plate #3 and Plate #4. Additionally three 15-in.-wide horizontal scans were performed in the liquid-air interface (LA) region on Plate #2.

One 15-in.-wide vertical scan path was performed on Plates #1, #2, #3, #4, and #5 from Riser 88. The plates were examined for wall thinning, pitting, and cracks oriented vertically on the primary tank wall.

- The nominal thickness of Plate #1 is 0.375-in. and the minimum thickness in this area was 0.372-in. Plate #1 results indicate no areas that exceed the minimum thinning reportable level of 10% of the nominal thickness. No pitting or vertical crack-like indications were detected in Plate #1.

- The nominal thickness of Plate #2 is 0.500-in. Plate #2 results indicate one area with minimum thickness of 0.434-in. exceeds the minimum thinning reportable level of 10% of the nominal thickness. No pitting or vertical crack-like indications were detected in Plate #2.

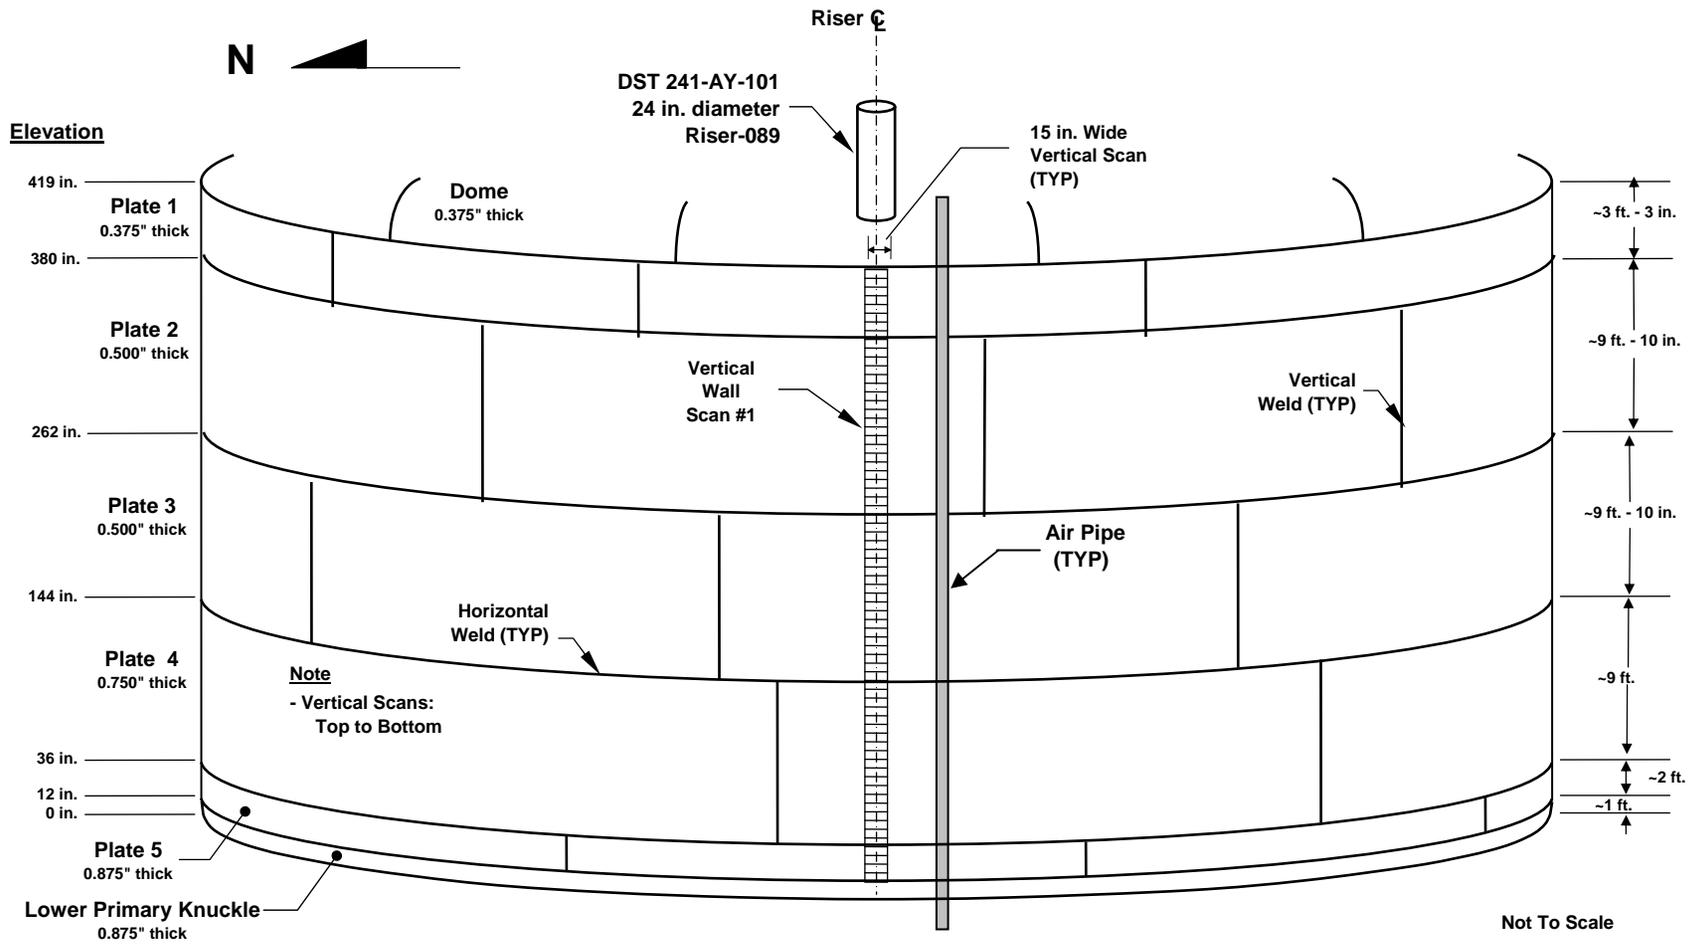
Figure 4.3. Sketch of Scan Paths on Tank 241-AY-101 Primary Tank from Riser 89

Figure 4.3 describes the areas on the primary wall of Tank 241-AY-101 that were ultrasonically examined from Riser 89 located on the west side of the tank. One 15-in.-wide vertical scan path was performed on Plates #1, #2, #3, #4, and #5 below the entrance to Riser 89.
