**Pacific Northwest  
National Laboratory**

**Ultrasonic Examination of  
Double-Shell Tank 241-AP-107  
Examination Completed February 2008**

AF Pardini  
DR Weier  
KK Anderson

April 2008

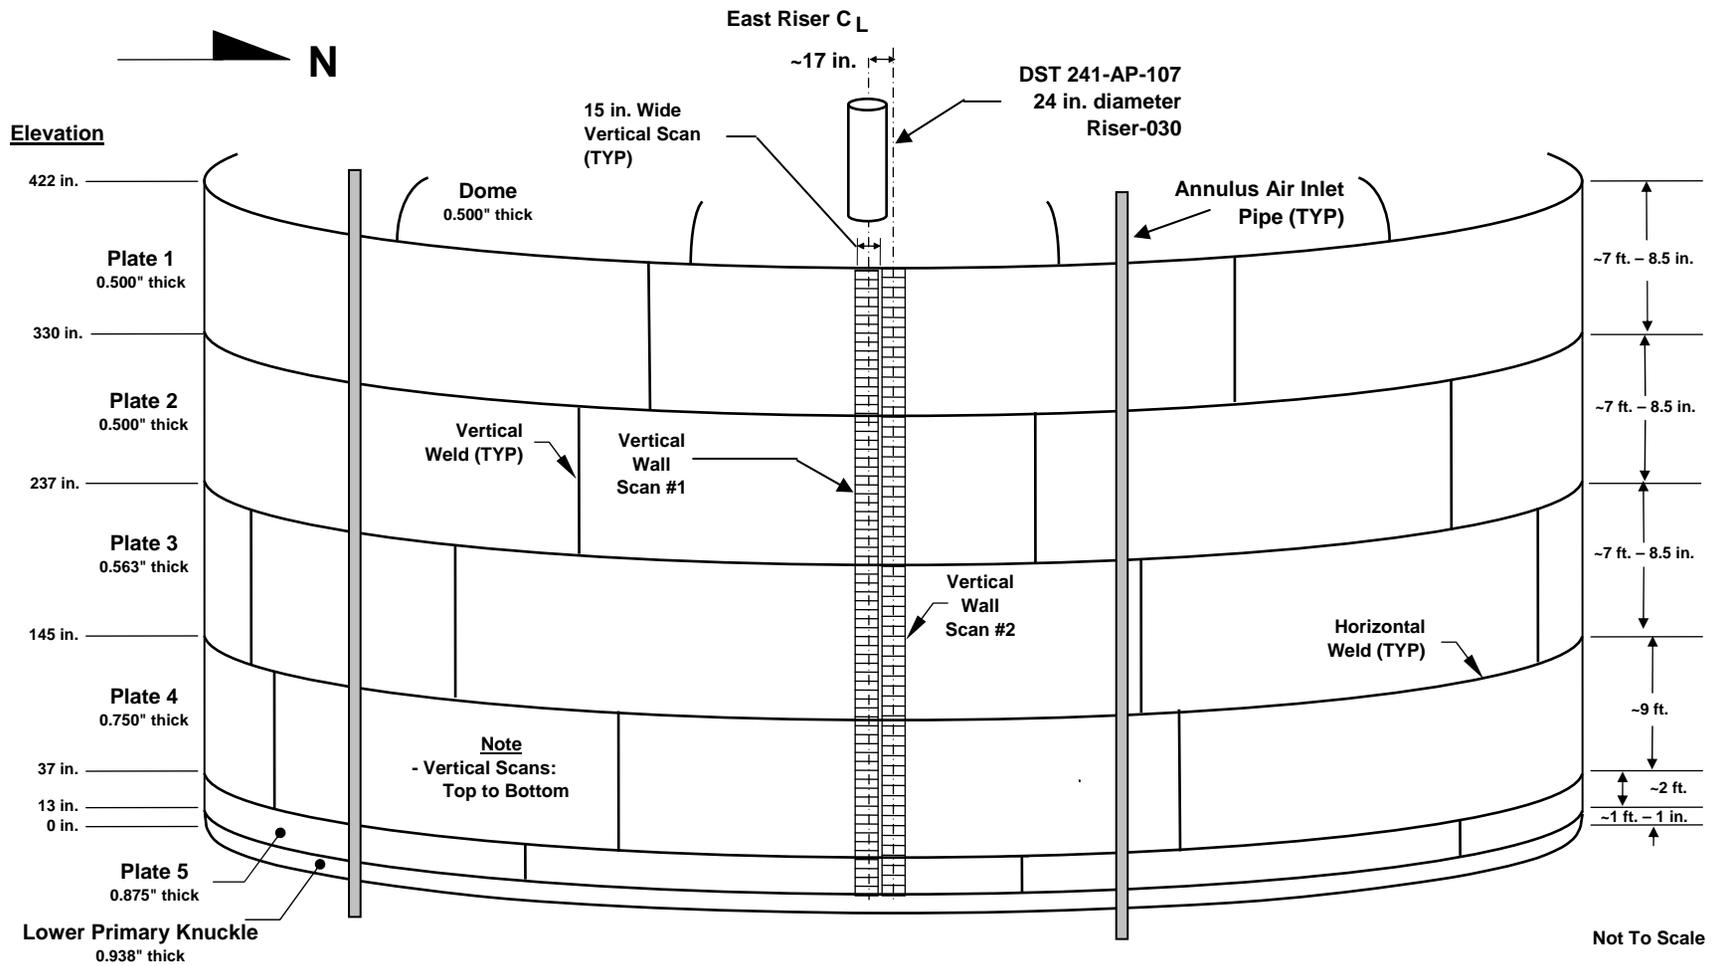
**Figure 4.2.** Sketch of Scan Paths on 241-AP-107 Primary Tank from Riser 30

Two 15-in.-wide vertical scan paths were performed on Plates #1, #2, #3, #4, and #5 from Riser 30. The plates were examined for wall thinning, pitting, and cracks oriented vertically on the primary tank wall. There were no areas of wall thinning that exceeded the reportable level of 10% of the nominal thickness. No pitting or vertical crack-like indications were detected in Plates #1, #2, #3, #4, or #5.

Figure 4.2 describes the areas on the primary wall of Tank 241-AP-107 that were ultrasonically examined from Riser 30 located on the east side of the tank. Two 15-in.-wide vertical scan paths were performed on Plates #1, #2, #3, #4, and #5 below the entrance to Riser 30.

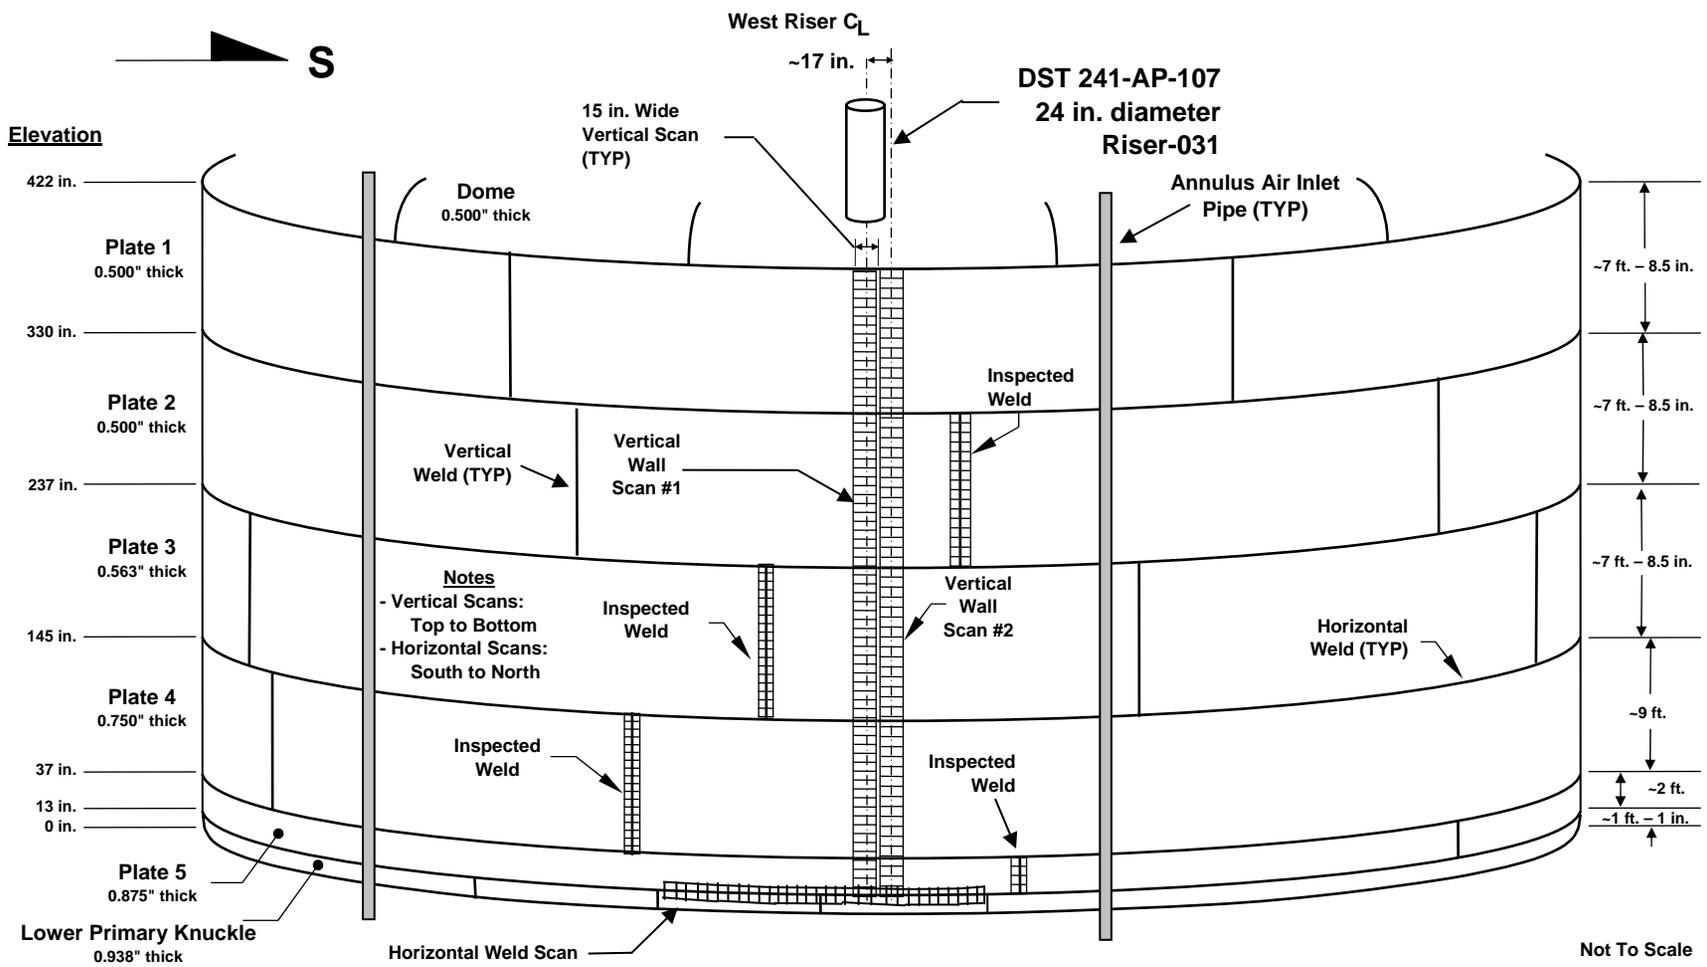
**Figure 4.3.** Sketch of Scan Paths on Tank 241-AP-107 Primary Tank from Riser 31

Two 15-in.-wide vertical scan paths were performed on Plates #1, #2, #3, #4, and #5 from Riser 31. The plates were examined for wall thinning, pitting, and cracks oriented vertically on the primary tank wall. There were no areas of wall thinning that exceeded the reportable level of 10% of the nominal thickness. No pitting or vertical crack-like indications were detected in Plates #1, #2, #3, #4, or #5.

Figure 4.3 describes the areas on the primary wall of Tank 241-AP-107 that were ultrasonically examined from Riser 31 located on the west side of the tank. Two 15-in.-wide vertical scan paths were performed on Plates #1, #2, #3, #4, and #5 below the entrance to Riser 31. Vertical weld HAZ examinations were done on Plates #2, #3, #4, and #5, and the horizontal weld HAZ examination was done on the transition Plate #5 to knuckle weld.
