RPP-18399, Rev. 0

# Electrochemical Corrosion Studies, Core 308, Segments 14R1 and 14R2, Tank 241-AY-102

J. B. Duncan, ChemMet, Ltd. PC  
G. A. Cooke, CH2M HILL  
Richland, WA 99352  
U.S. Department of Energy Contract DE-AC27-99RL14047

Key Words: Tank 241-AY-102, Sludge, Corrosion Potential

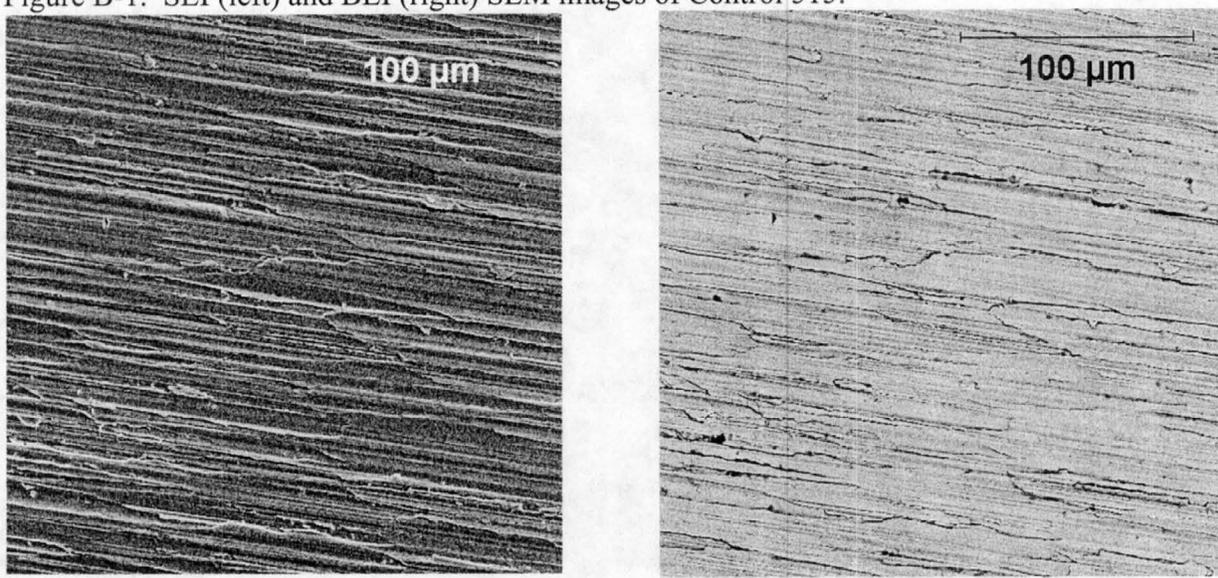
The original parallel scratches of the polished surface show clearly in both the SEI (Figure B-1, left) and BEI (Figure B-1 right) imaging mode. Some of the grooves appear to be compressed or folded (Figure B-2), perhaps by polishing the surface after the grooves had formed.

Figure B-1. SEI (left) and BEI (right) SEM images of Control 515.

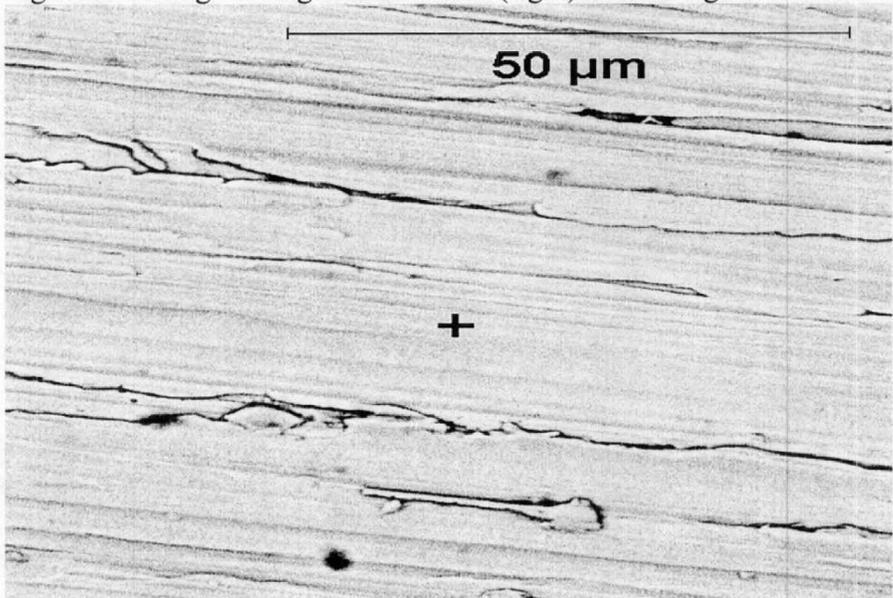
Figure B-2. Higher magnification BEI (right) SEM image of Control 515.
