Document Number: WHC-SD-WM-ETP-119, REV. 0

Document Title: Engineering Task Plan and Status of 241-S-106 Enraf Level Gauge Wire Break

WHC-SD-WM-ETP-119

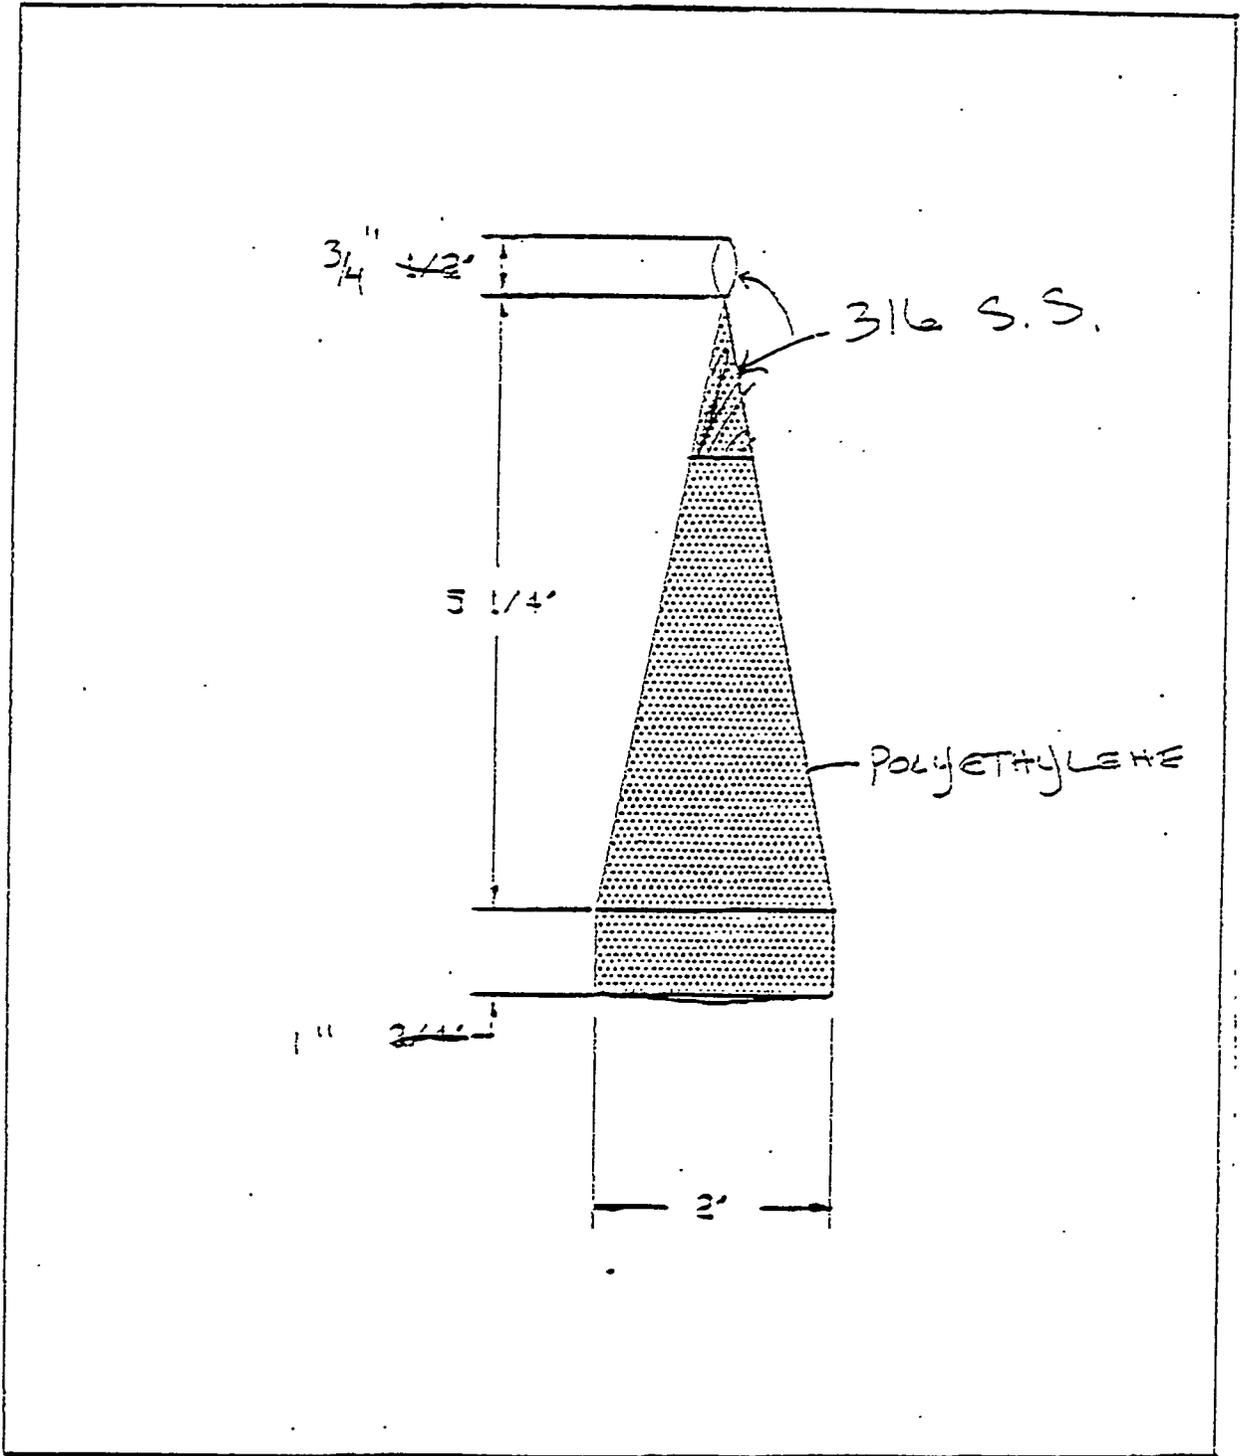
Figure 1 - LEVEL SENSOR PROBE

The new Enraf level displacement gauge in tank 241-S-106 has been found to be non-functional. The plummet and a portion of the 316 stainless steel wire is missing (see Figure 1). The cause of the failure has not been determined conclusively. However, it is thought that the polyvinyl chloride riser liner is degrading and forming hydrochloric acid that runs down the 316 stainless steel wire and this caused the failure. The question at hand is does the loss of the plummet and the potential for another loss in the future cause hazards that are not addressed in the existing safety basis.

Two hazards can be postulated from this incident. The first deals with whether the plummet can come into contact with the tank liner and cause corrosion due to the dissimilar metals (the liner is carbon steel and the plummet has some stainless steel). Figure 1 shows that the majority of the plummet is made of polyethylene. There is only a very small portion of stainless steel exposed. The hazard from this piece of equipment would be no greater than the other equipment known to be in the tank waste. In earlier times, it was a common practice to dispose of non-functioning equipment (like Food Instrument Corporation wires and plummets, thermocouple trees, etc.) in the tank. This is no longer an accepted practice. The second hazard deals with miscellaneous debris interfering with future retrieval equipment. Since the debris is known to exist in the tanks, the safety documentation dealing with retrieval will need to cover aspects such as missiles (mixer pumps picking up small objects and propelling them around the tank) and pump failures (equipment enters the pump intakes and causes pump failure).
