Document #: SD-WM-RPT-227

CHARACTERIZATION SAMPLING EQUIPMENT STATUS REPORT
01/1996 THRU 03/1996

CHARACTERIZATION SAMPLING EQUIPMENT STATUS REPORT - JANUARY THROUGH MARCH 1996

WHC-SD-WM-RPT-227

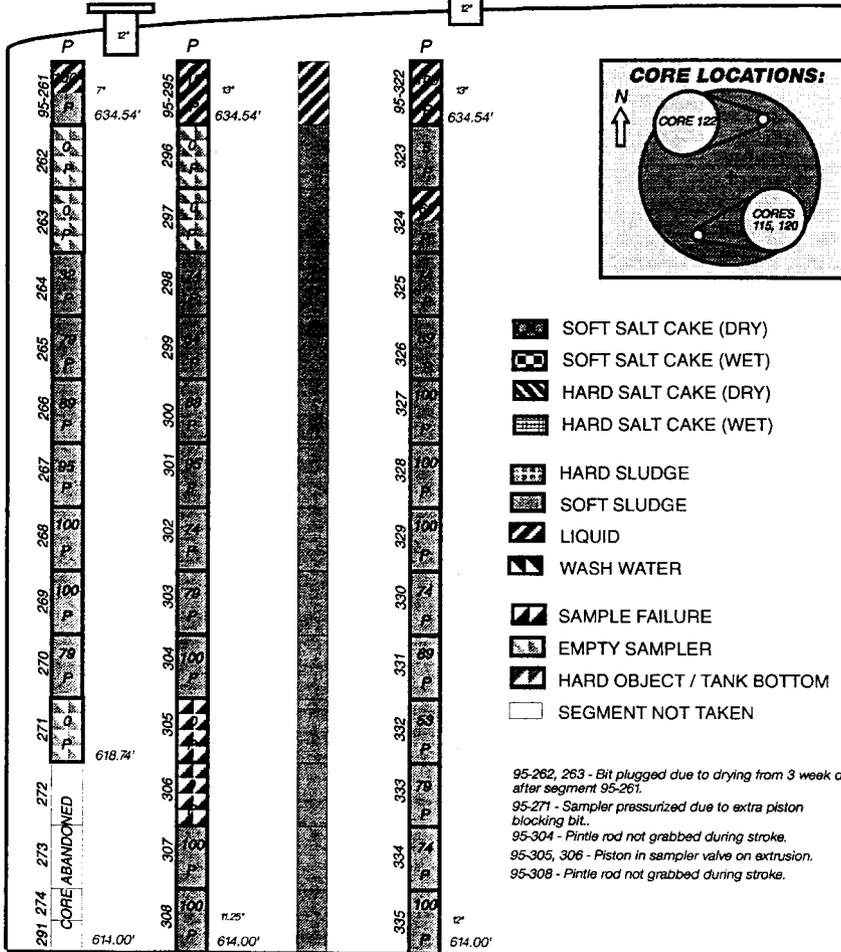
95-262, 263 - Bit plugged due to drying from 3 week delay after segment 95-261.
 95-271 - Sampler pressurized due to extra piston blocking bit.
 95-304 - Pintle rod not grabbed during stroke.
 95-305, 306 - Piston in sampler valve on extrusion.
 95-308 - Pintle rod not grabbed during stroke.

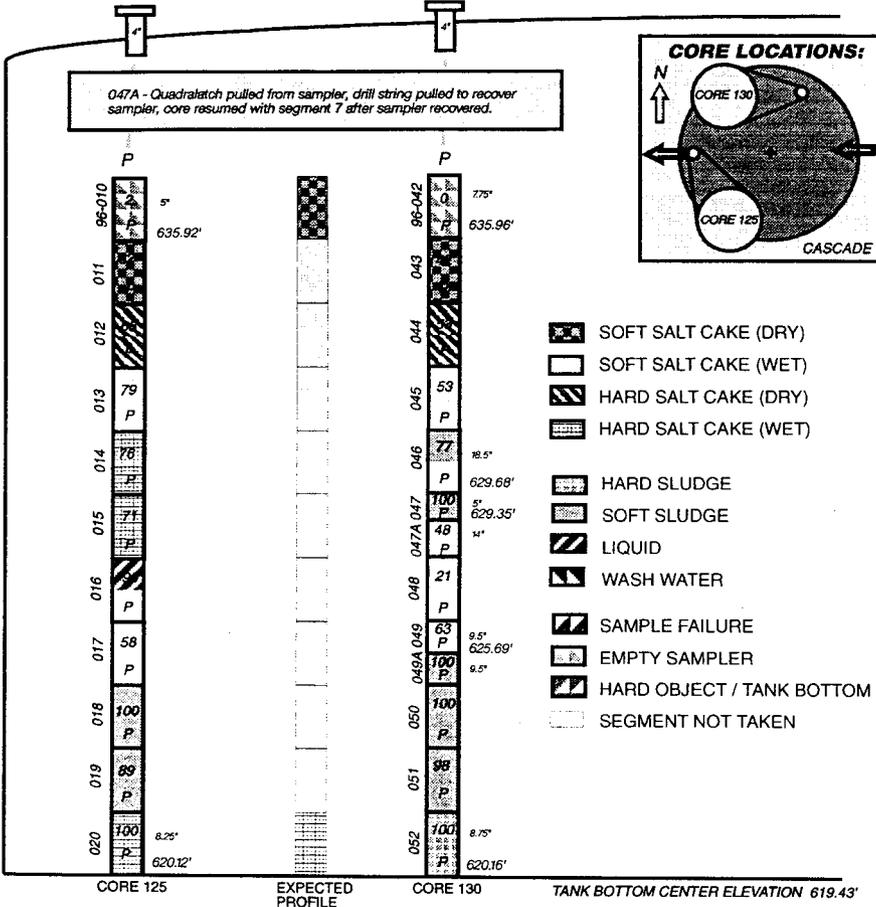
S-110 RMCS CORE PROFILE

047A - Quadratach pulled from sampler, drill string pulled to recover sampler, core resumed with segment 7 after sampler recovered.
