# A STRUCTURAL INTEGRITY ASSESSMENT OF UNDERGROUND PIPING ASSOCIATED WITH THE TRANSFER OF RADIOACTIVE WASTE

**A STRUCTURAL INTEGRITY ASSESSMENT OF UNDERGROUND PIPING  
ASSOCIATED WITH THE TRANSFER OF RADIOACTIVE WASTE**

**Bruce J. Wiersma**

Savannah River National Laboratory  
Washington Savannah River Company  
Savannah River Site  
Aiken, SC, 29808  
USA

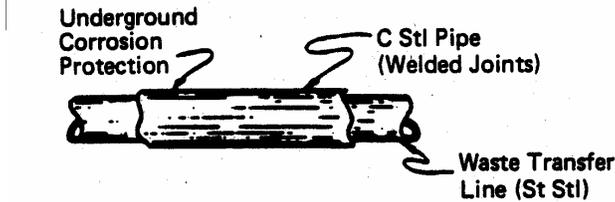
A cut-away drawing of the most common pipe design for the SRS transfer system is shown in Figure 1. This type of design has been utilized since 1960. The core pipe is typically made of 304L stainless steel and has been tested to ensure that it is not susceptible to intergranular attack [1]. The sizes of the

core piping range between 1-3 inches in diameter. Core piping that was installed prior to 1988 was Schedule 40 wall thickness, while since then Schedule 10 has been allowed. The piping was designed according to ASME B31.3. The design pressure for the piping was 150 psig, although the operating pressure for the line is typically in the 100 psig range.

Figure 1. Cut-away drawing of SRS waste transfer line system.

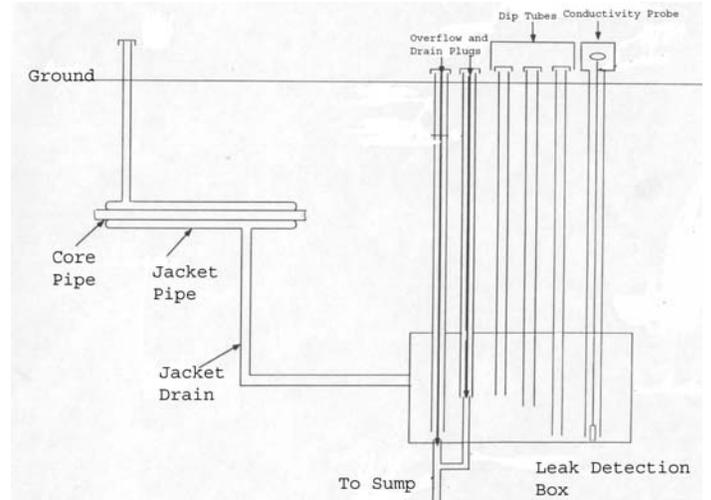
The leak tightness of the piping is monitored with an air pressure test. Figure 2 shows an example of a leak detection system (LDS). In the example, a portable air compressor delivers air through a portable air delivery system into the LDS via a dip tube. The air pressurizes the LDS, jacket and jacket drain line, and the jacket vent line. If the pressure in the line drops 1 psig within 20 minutes, the line is recorded as having failed. This test is sensitive enough to detect hole diameters of 0.01". This test is performed at least every two years for frequently used piping and is required for inactive piping (i.e., piping not used within the last two years) before it can be utilized.

**Figure 2. Sketch of underground piping leak detection system.**
