WSRC-TR-98-00373 (U)

*Structural Dimensions, Fabrication, Materials and
Operational History for Types I and II Waste Tanks*
(U)

Publication Date: October, 1998

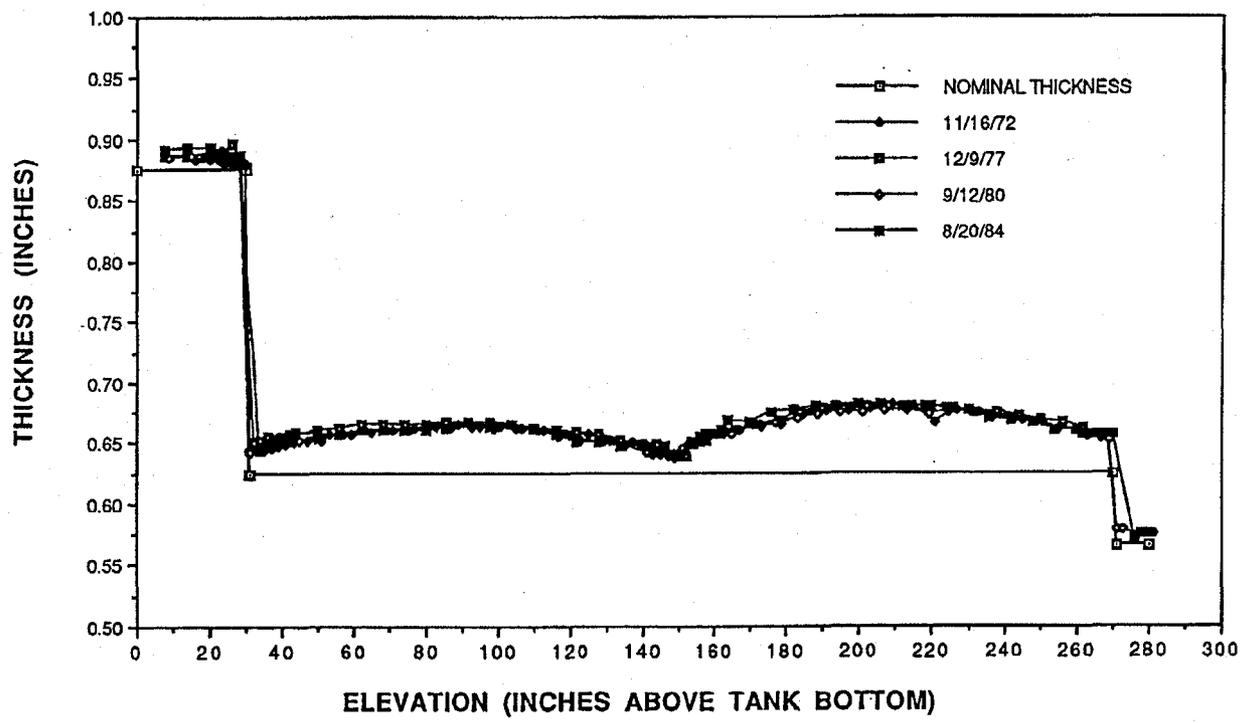
Figure 14. Ultrasonic thickness measurements for Tank 15.

TANK 15 WALL THICKNESS MEASUREMENTS

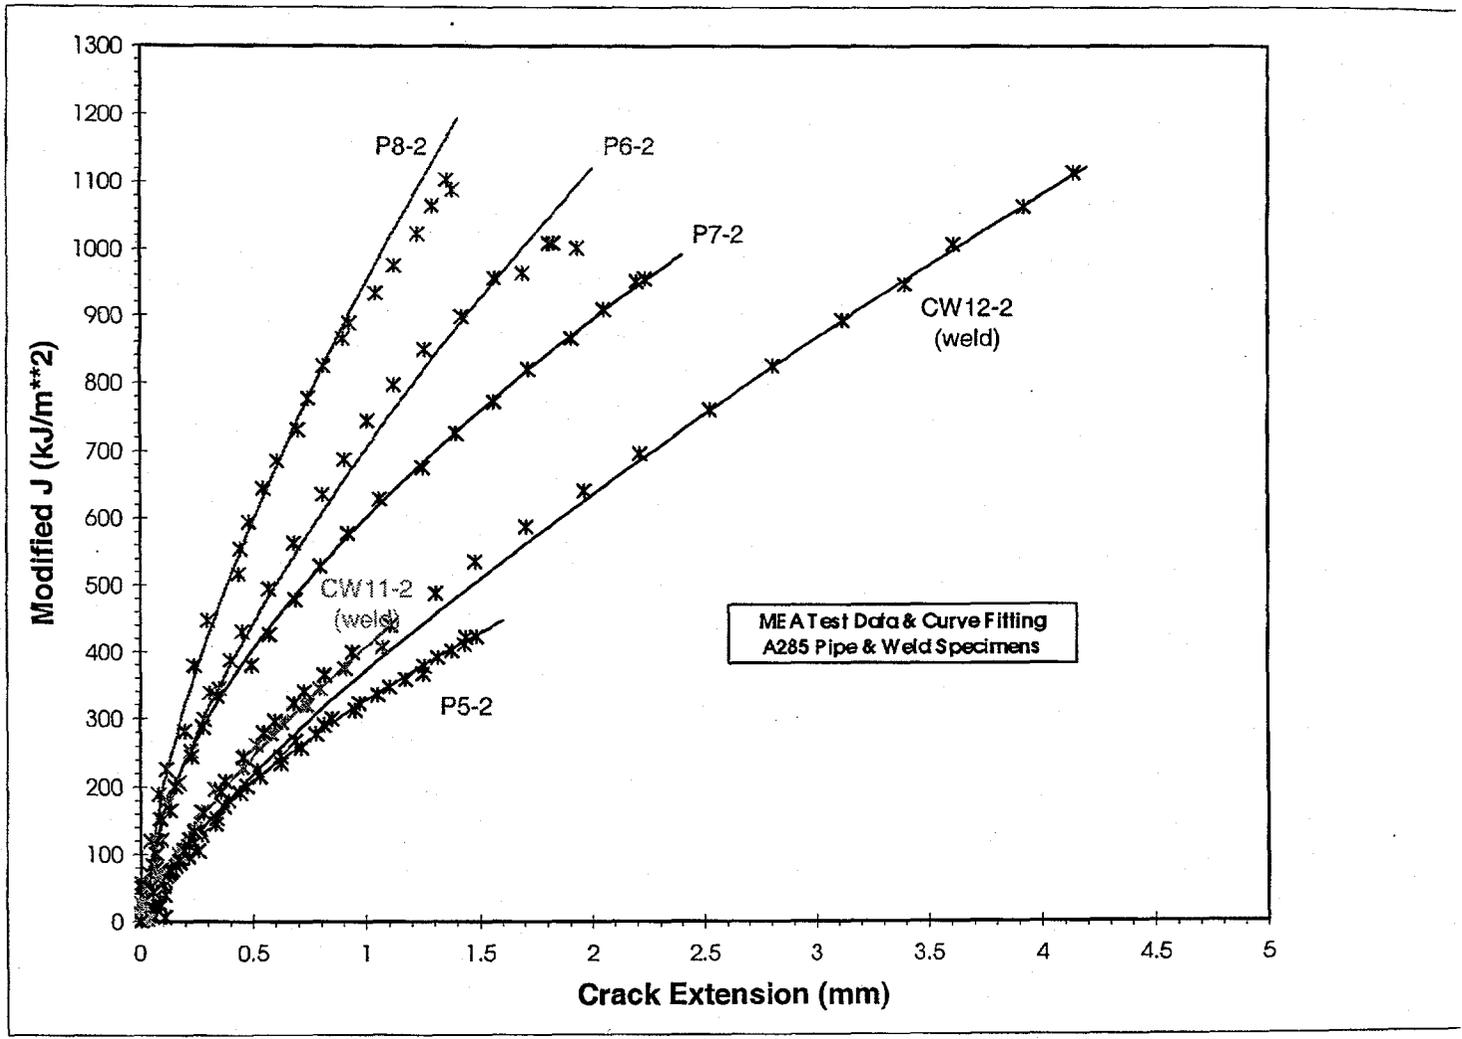
Figure 15. J modified vs. crack extension for A285 Carbon steel

The J_m vs. Δa , curves under static loading conditions are shown in Figure 15. The data was fit to a power law equation of the form, $J = C (\Delta a)^n$ where C and n are constants. The values for C and n are shown in Table 13. J_{Ic} is the energy at the onset of crack initiation. This value was calculated from the power law equation at a fixed crack extension of 0.2 mm. This fixed crack extension was chosen based on past experience and approximates the maximum blunting extension attainable with low strength structural steels. From this value, the elastic initiation fracture toughness K_{Jc} may be calculated from the following equation:

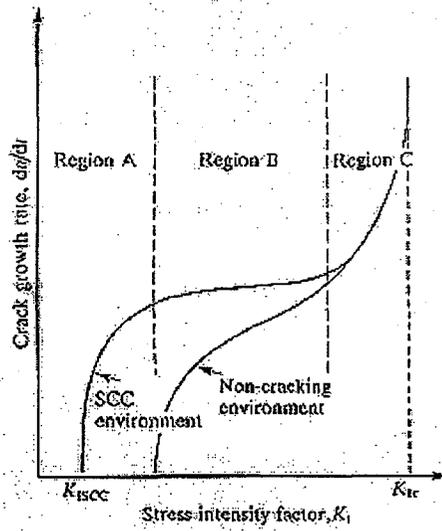
Figure 16. Testing of susceptibility to SCC by crack growth rate measurements.

However, should the threshold data reveal the potential for SCC in-service, it will be necessary to predict the crack extension based on crack growth rate data. Over region B in Figure 16, cracks grow at a constant rate that is independent of stress intensity and is faster than the crack growth rate in a non-cracking environment. It is believed that the growth rate is related to the corrosion processes that are occurring at the crack tip. Crack length as a function of time was also measured during the WOL tests. The growth rate

was also observed to be independent of the bulk solution chemistry. The average crack growth rate was 1.25 inches per year.

In region C of Figure 16 the stresses are very high, and the inter-atomic bonds break before any significant corrosion reactions can occur. The crack growth rate accelerates rapidly as the value for K_I approaches K_{Ic} for the material.

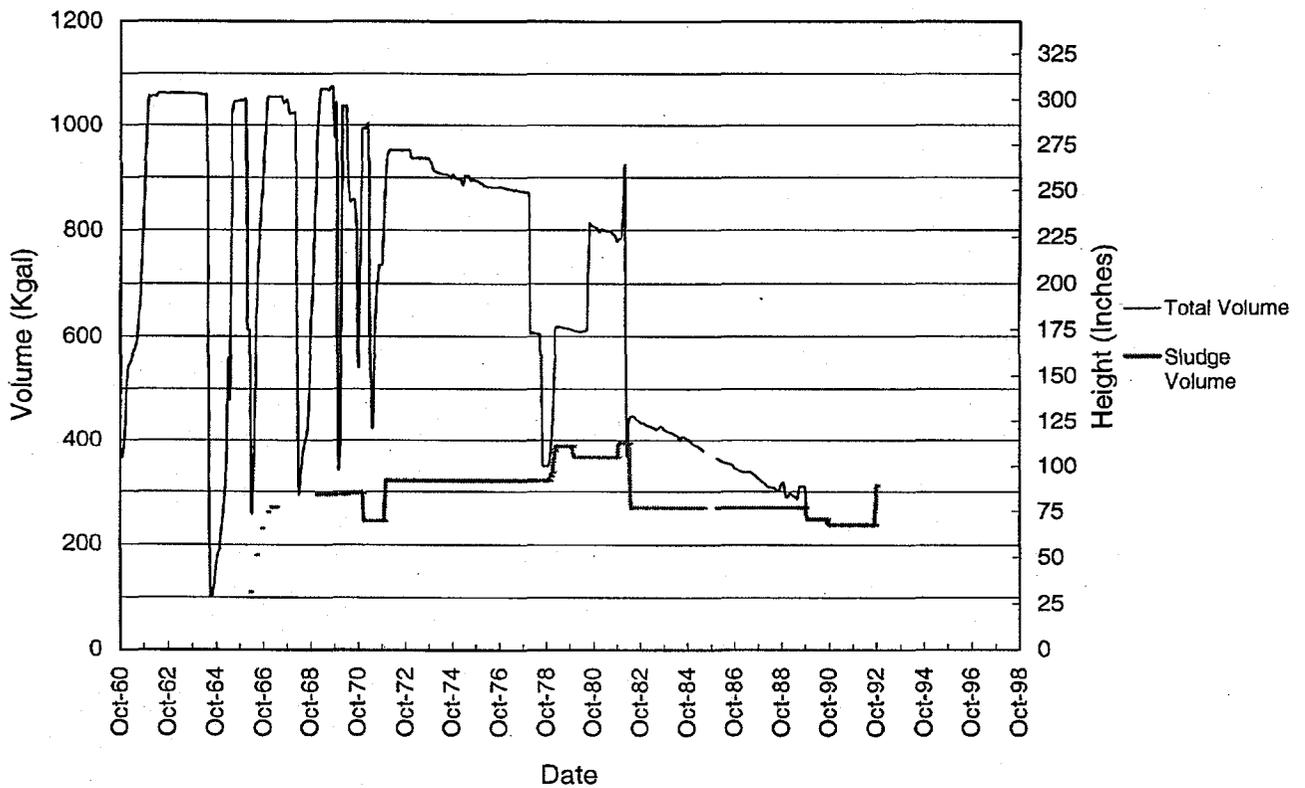
Figure 17. Waste volume and height in Tank 15.

Since 1982 Tank 15 has been inactive. Total volume has declined as the supernate evaporated to no measurable liquid after 1989. Present volume is about 240,000 gallons. (The higher value in Figure 17 reflects the parking of the level indicator above the sludge height.) The present sludge level is apparently not constant but varies across the tank from about 71 inches to about 35 inches (R. Ross, private communication).

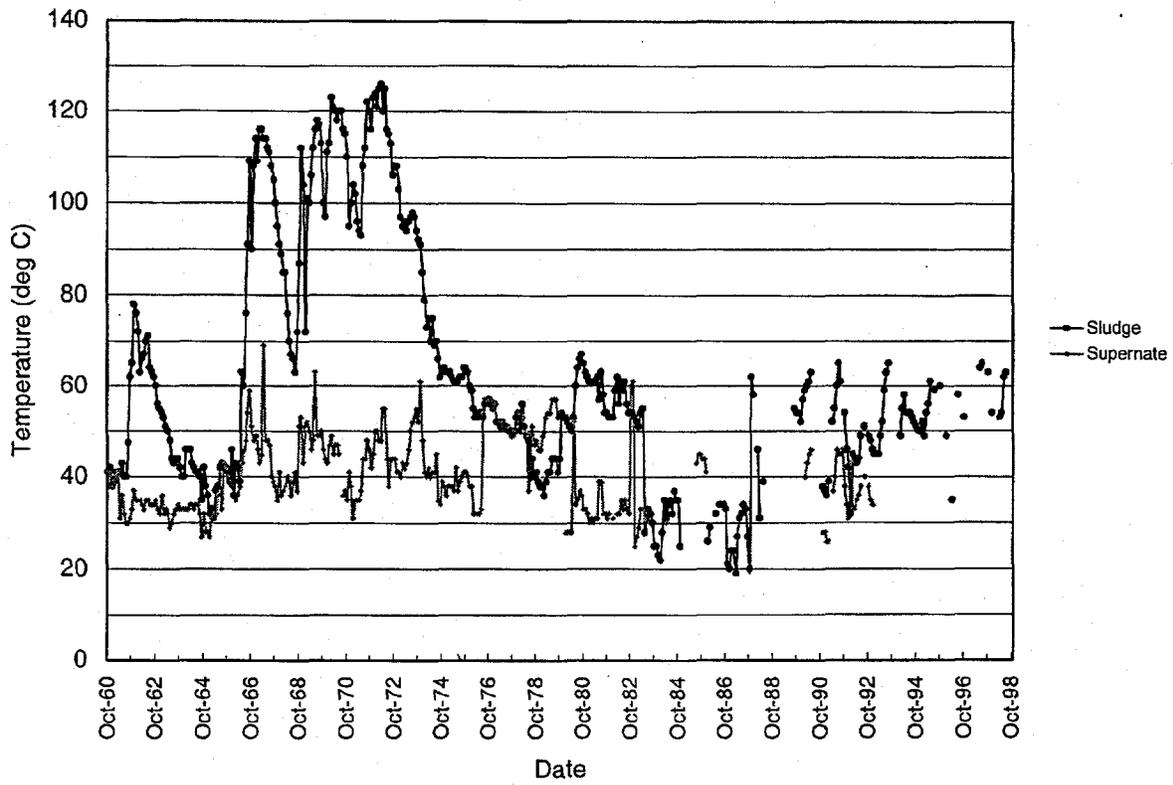
Figure 18. Tank 15 sludge and supernate temperatures.

Figure 18 shows a graph of the sludge and supernate temperatures in Tank 15. The sludge temperature peaked in accordance with receipts of fresh waste, rising to the range 115 to 125°C from 1966 to 1972 and falling below 70°C thereafter. Sludge temperatures have varied from 20 to 65°C in recent years with seasonal rises and falls and with cooling coil usage. Supernate temperatures have varied between 25 and 70°C.
