1. EDT 622329

Figure 2-1.	SY-1-1 Transfer System General Schematic.....	2-2
Figure 3-1.	SY-1-1 Transfer System HAZOP Node Diagram.....	3-9

HNF-3966 Rev 0

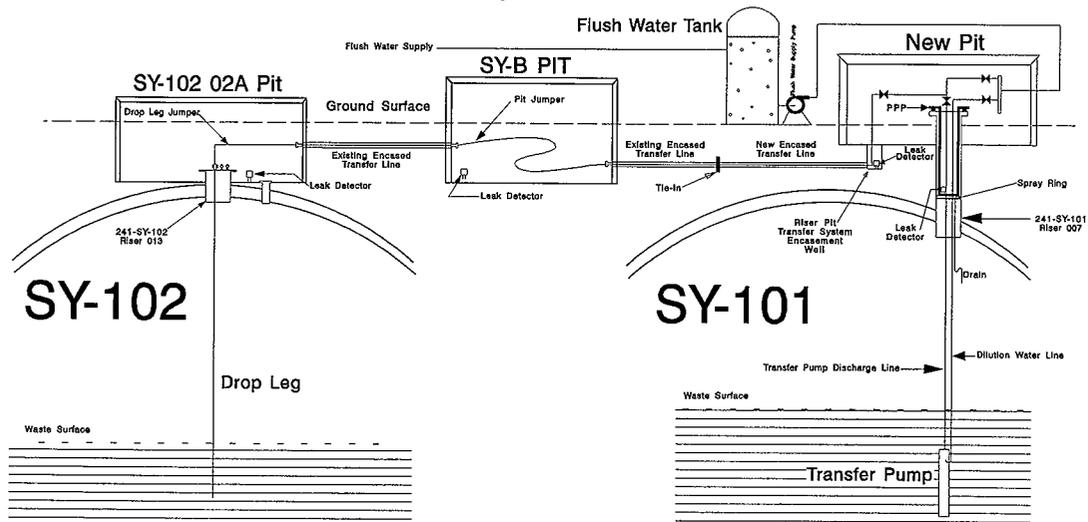
A diagram of the design concept of the waste transfer system is provided in Figure 2-1.

Figure 2-1 SY-101 Transfer System General Schematic

- The important features of the waste transfer system design are captured in the SY-101 Transfer System General Schematic, Figure 2-1 of the preceding section.
- Hazardous conditions associated with waste movement through existing transfer lines, moving pit cover blocks, opening tank risers, vehicle activity, and waste storage were considered to be adequately addressed by the existing AB Hazards Analysis and the hazard analysis performed to address crust growth (HNF-3645, *Hazard Evaluation For Tank 241-SY-101 Waste Surface Level Growth*). The intent of the HAZOP was to identify hazardous conditions related to the unique nature of installation of a transfer pump in an SY-101 riser not located in a pre-existing pit and the process and configuration for transferring the SY-101 waste to SY-102.

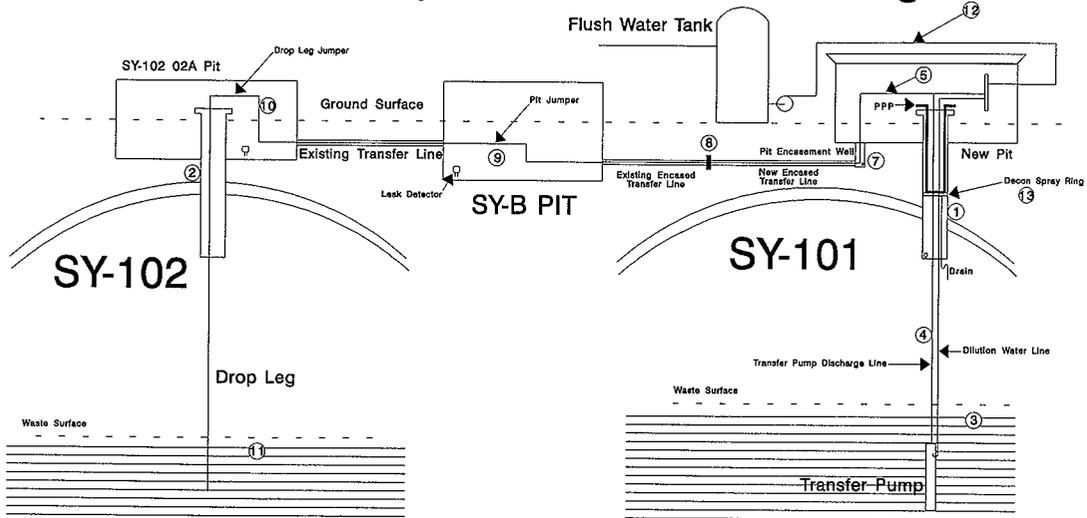
Figure 3-1 SY-101 Transfer System HAZOP Node Diagram

- Node 1: Install PPP and Pump Into Tank 241-SY-101 42" Riser
- Node 2: Install Drop Leg Into Tank 241-SY-102 02A Pit Riser
- Node 3: Tank 241-SY-101 Radioactive Waste
- Node 4: Waste Transfer Pump Line in Tank 241-Sy-101 Below PPP, Above Waste Surface
- Node 5: Transfer Line Within the Tank 241-SY-101 New Riser Pit
- Node 6: Deleted Due To Change In Design After the HAZOP Completed
- Node 7: Encasement Well In Tank 241-SY-101 New Riser Pit Located At the Low Point of Line
- Node 8: New Transfer Line Tie-In to Existing Transfer Line
- Node 9: New Jumper in SY-B Valve Pit
- Node 10: Tank 241-SY-102 02A Pump Pit Drop Leg Jumper
- Node 11: Tank 241-SY-102 Radioactive Waste
- Node 12: Flush/Dilution Water Supply Line Downstream of Supply Pump
- Node 13: Decon Spray Ring

The location of the nodes is shown on the SY-101 Transfer System HAZOP Node diagram, Figure 3-1.
