ENGINEERING CHANGE NOTICE

13a. Description of Change Document revised to reflect changes in 101-SY system design.	13b. Design Baseline Document? <input type="checkbox"/> Yes <input checked="" type="checkbox"/> No
---------------------------------------------------------------------------------------------------	----------------------------------------------------------------------------------------------------

Figure 2-1. Tank 241-SY-1-1 Transfer System General Schematic 2-3
 Figure 3-1. Tank 241-SY-1-1 Transfer System HAZOP Node Diagram 3-11

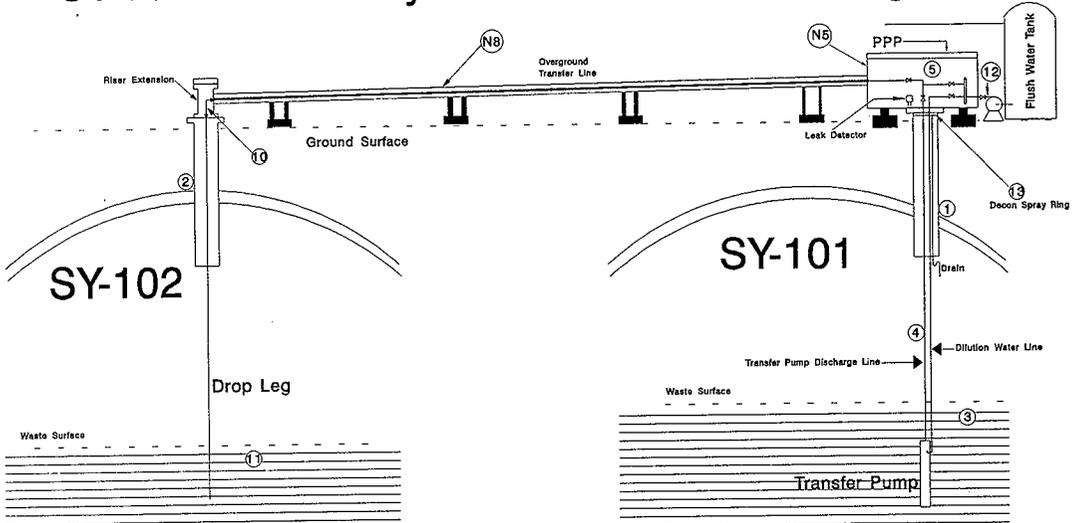
Figure 3-1 SY-101 Transfer System HAZOP Node Diagram

- Node 1: Install PPP and Pump Into Tank 241-SY-101 42" Riser
- Node 2: Install Drop Leg Into Tank 241-SY-102 42" Riser
- Node 3: Tank 241-SY-101 Radioactive Waste
- Node 4: Waste Transfer Pump Line in Tank 241-SY-101 Below PPP, Above Waste Surface
- Node 5: Transfer Line Within the Tank 241-SY-101 PPP
- Node 5N: PPP On 241-SY-101 42" Riser
- Node 6: Deleted Due To Change In Design After the Initial HAZOP Completed
- Node 7: Deleted Due To Change In Design After Initial HAZOP Completed
- Node 8: Deleted Due To Change In Design After Initial HAZOP Completed
- Node 8N: OGT Line
- Node 9: Deleted Due To Change In Design After Initial HAZOP Completed
- Node 10: Tank 241-SY-102 42" Riser Drop Leg Jumper
- Node 11: Tank 241-SY-102 Radioactive Waste
- Node 12: Flush/Dilution Water Supply Line Downstream of Supply Pump
- Node 13: Decon Spray Ring

The location of the nodes is shown on the Tank 241-SY-101 Transfer System HAZOP Node diagram, Figure 3-1.
