REFERENCE DOCUMENT: WAC-173-303-640

condition and integrity of these facilities. The plan is consistent with the Double-Shell Tank Waste Transfer Facilities Integrity Assessment Plan (Hundal 1998).

This Engineering Task Plan (ETP) identifies the elements of integrity assessment examination scope and examination methods for three DCRTs, seven catch tanks, and two ancillary facilities (one Lift Station and one Waste Unloading Facility). The purpose of the examinations is to determine the present condition of dangerous waste storage tank systems and to determine their leak tightness and structural stability, as required by WAC 173-303-640(2). From these examinations, appropriate conclusions and recommendations will be documented and maintained on record at each facility. Some parts of the examination scope have already been conducted. For example, leak checks have been conducted on two DCRTs, seven catch tanks, and the lift station.

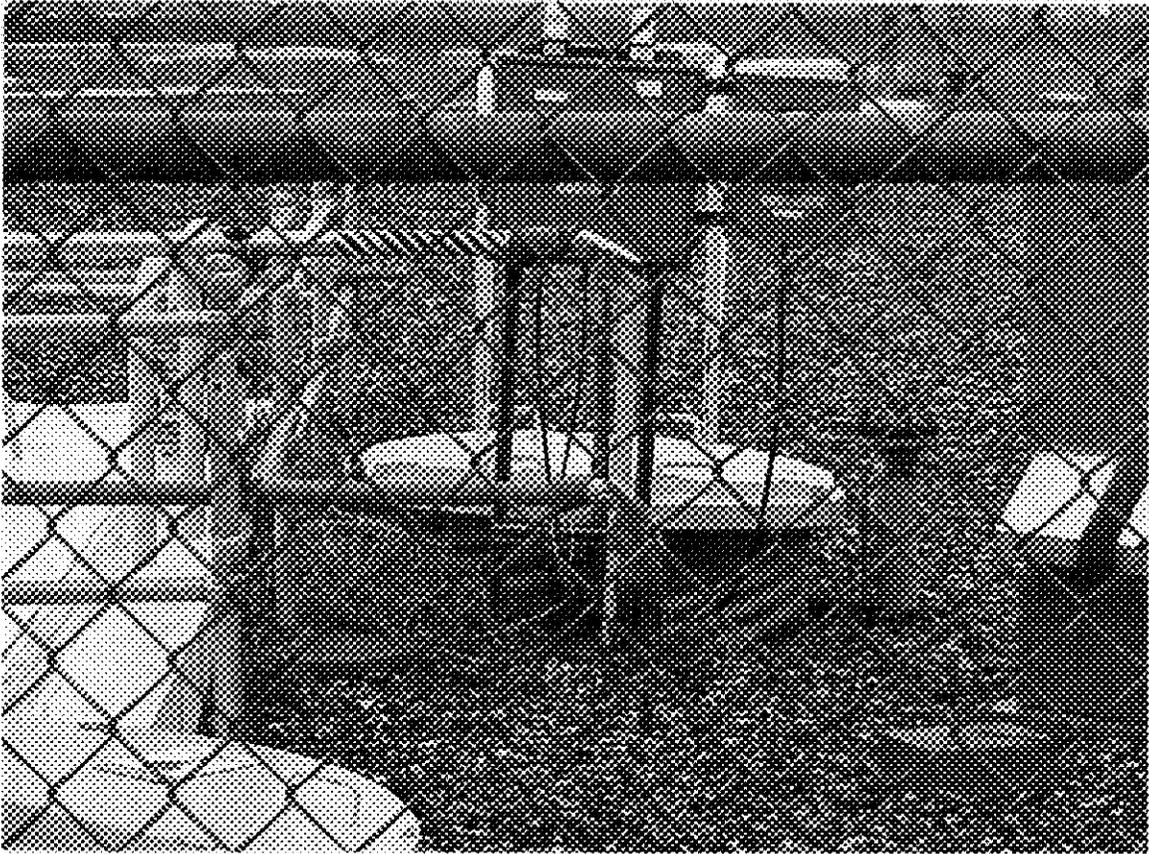
Figure B-6. View of Instrumentation Pit Entrance over the 244-BX
Double-Contained Receiver Tank.

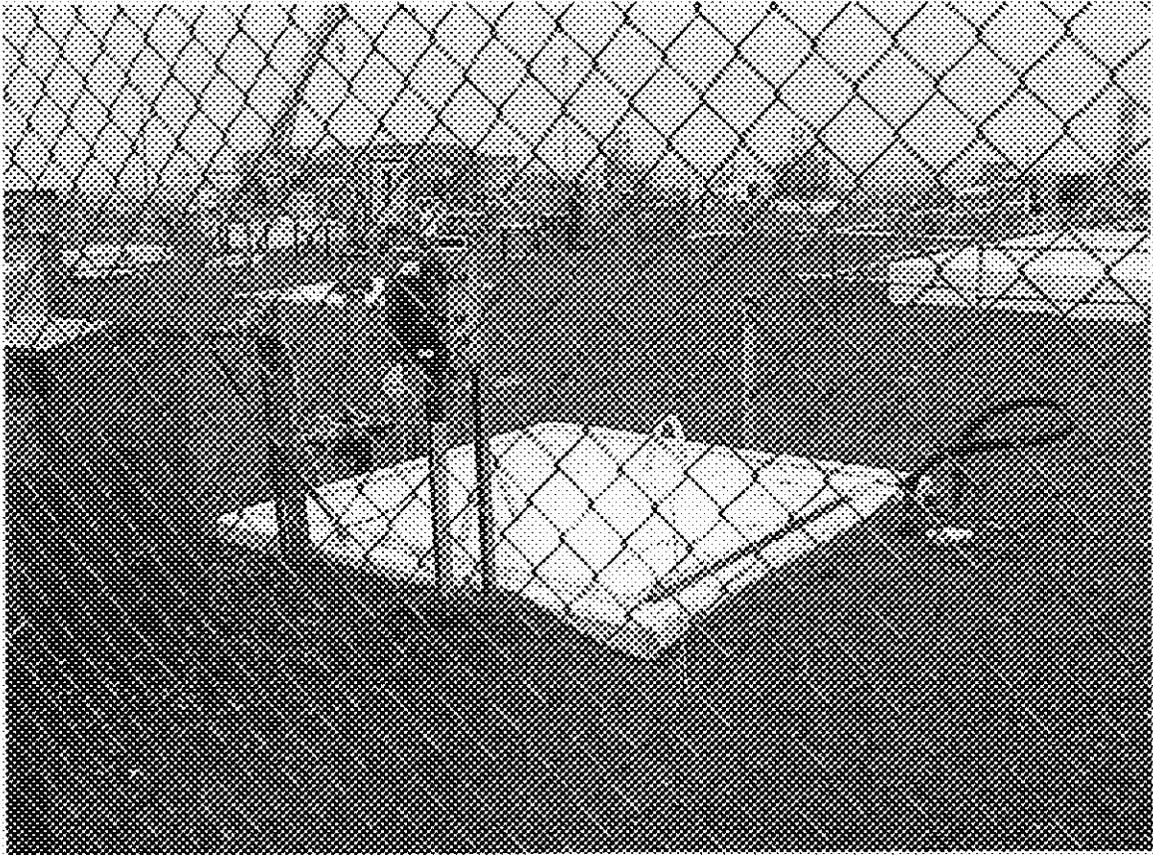
Figure B-15. 241-AZ-151 Catch Tank. Cover Block sits atop Catch Tank Pump Pit.

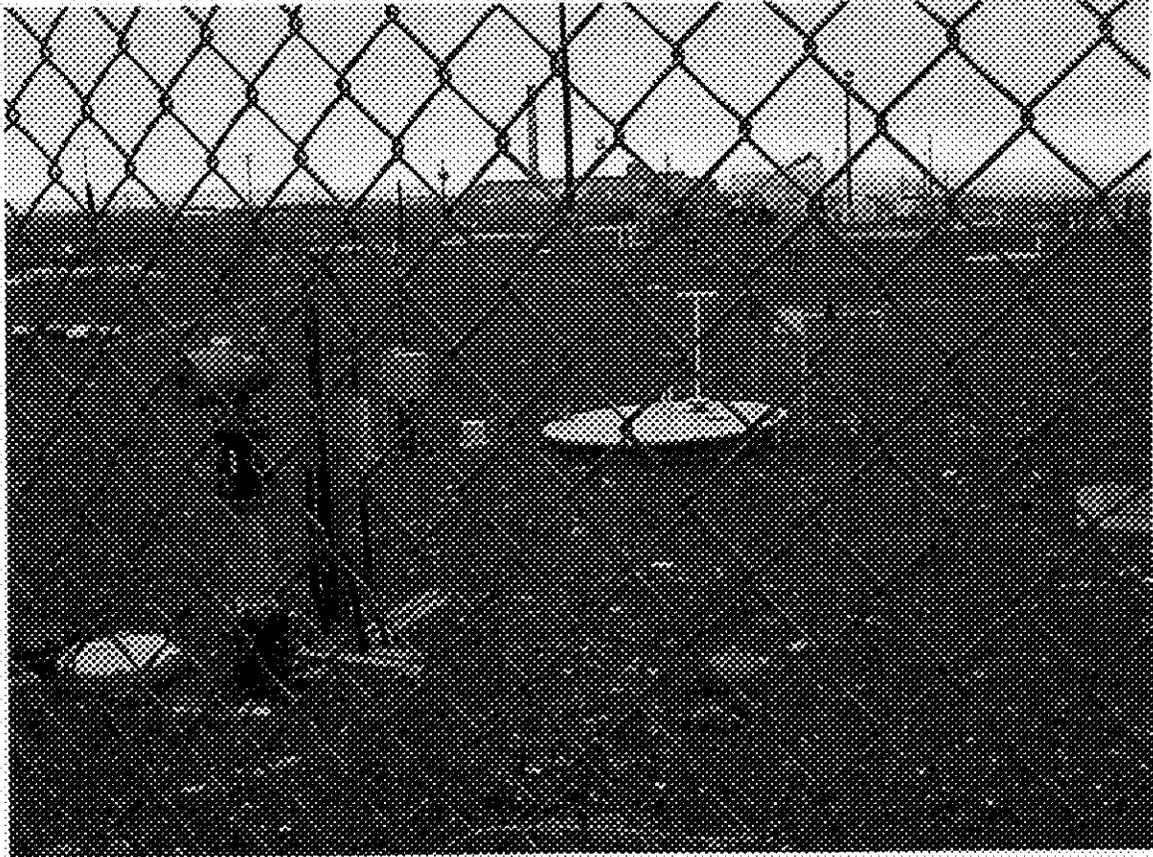
Figure B-27. 241-U-301B Catch Tank. Liquid Level Gage Assembly
in Foreground, Round Pump Pit Cover in Background.
