ENGINEERING DATA TRANSMITTAL

# Double-Shell Tank Integrity Assessments Ultrasonic Test Equipment Performance Test

D. C. Pfluger

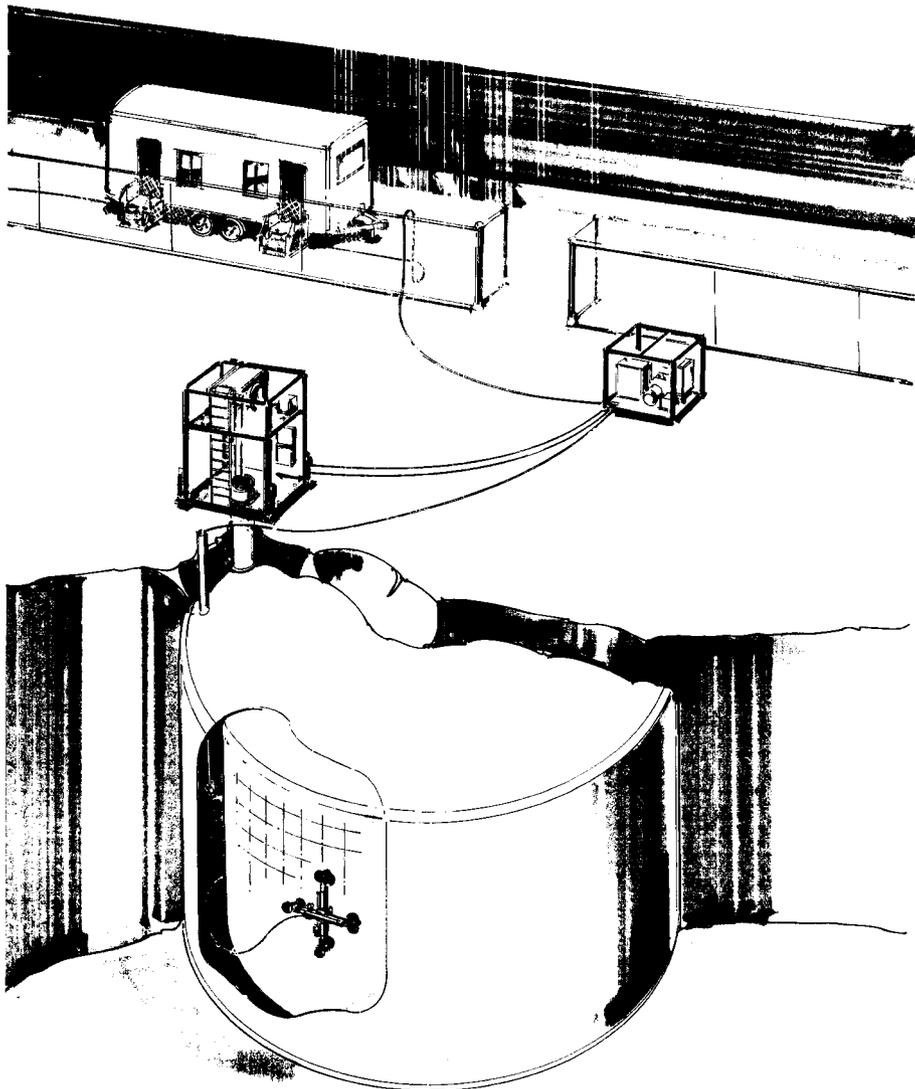
Figure 1. DSTI System's Deployment Configuration.

The examination equipment consists of a remotely controlled robotic mechanism mounted with cameras and ultrasonic probes that is inserted in the annulus space between the primary and secondary tanks of a DST. The equipment is controlled through cables that connect the robotic mechanism with the mobile control center (trailer) outside the tank farm fence. An artist's conception of the DSTI system's deployment configuration in the tank farms is shown in Figure 1.
