## Large Underground Radioactive Waste Storage Tanks Successfully Cleaned at Oak Ridge National Laboratory

# LARGE UNDERGROUND RADIOACTIVE WASTE STORAGE TANKS SUCCESSFULLY CLEANED AT OAK RIDGE NATIONAL LABORATORY

# The Gunite Tanks Radioactive Tank Cleaning System - Platform View

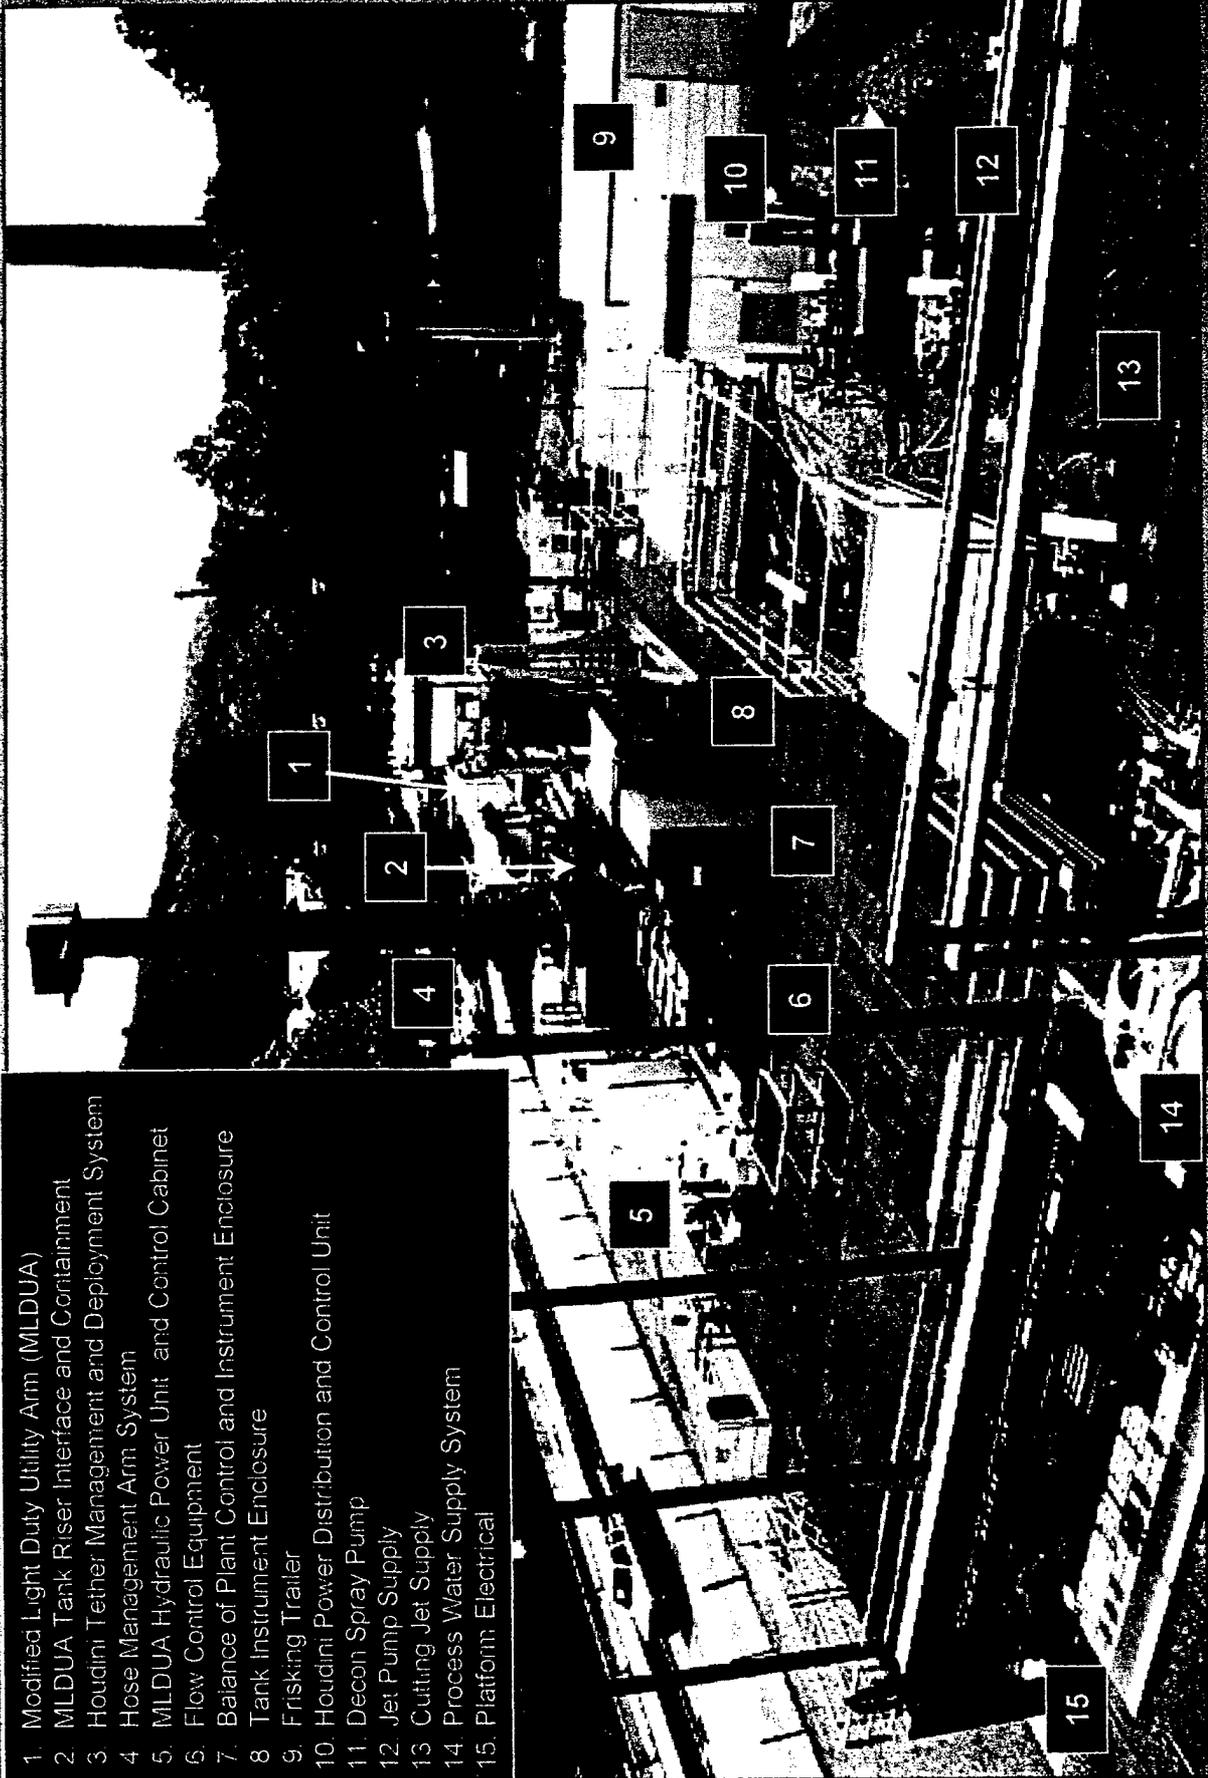
1. Modified Light Duty Utility Arm (MLDUA)
2. MLDUA Tank Riser Interface and Containment
3. Houdini Tether Management and Deployment System
4. Hose Management Arm System
5. MLDUA Hydraulic Power Unit and Control Cabinet
6. Flow Control Equipment
7. Balance of Plant Control and Instrument Enclosure
8. Tank Instrument Enclosure
9. Frisking Trailer
10. Houdini Power Distribution and Control Unit
11. Decon Spray Pump
12. Jet Pump Supply
13. Cutting Jet Supply
14. Process Water Supply System
15. Platform Electrical

The HMA can be retracted through a decontamination spray ring into a box and tube containment structure (Figure 1 - # 4) located on the platform above the tank. The containment structure is fitted with eight glove ports for access to power, control, and hose connections, and for maintenance operations. A spray wand is also provided for additional decontamination. The box-and-tube serve as the containment structure during transport of the HMA between tanks.

The MLDUA is an eight-degree-of-freedom manipulator that can deploy a 200-lb payload through risers as small as 12 inches in diameter. The MLDUA is equipped with a gripper end-effector allowing it to grasp other tools such as the CSEE. It has a vertical reach of 50-ft and an effective horizontal reach of 17.5-ft (including gripper and CSEE). The MLDUA is equipped with two cameras located at the mast and arm junction and an additional camera in the gripper. The system is designed for radioactive and high pH environments and includes a purge system to help prevent airborne and liquid contamination from leaking into the arm. The skid mounted MLDUA (Figure 1 - # 1) is positioned by a crane onto the tank platform where it rests on adjustable outriggers. A second skid contains the hydraulic power unit, oil reservoir, pumps, oil chiller, and controls cabinets (Figure 1 - # 5).

The tank riser interface and containment box (TRIC) provides a containment area where end-effectors are attached to the MLDUA (Figure 1 - # 2). The phone-booth-sized TRIC has glove and pass through ports on the three Lexan panel sides and a door and pass-through port on the fourth side. The TRIC is attached at the top

The BOP includes several auxiliary systems that provide support to the waste removal equipment. The low pressure water pump skid provides an interface with the plant process water system and supplies water to the decontamination spray ring, jet pump, and cutting jet pump skids (Figure 1 - # 7, # 11, # 12, and #13). An air compressor provides purge air for the MLDDUA and air for water system control valves. A skid mounted High Efficiency Particulate Air (HEPA) system with a continuous sampler provides negative pressure to the tanks to control airborne contamination. Electric power is supplied for 120-, 240-, and 480-volt uses. Two continuous air monitors check for airborne contamination at the site perimeter. A continuous monitor checks dose rate levels at the FCEB during transfer operations. A half-body monitor is used to check for personnel contamination.
