**Inactive Tanks Remediation Program
Batch I, Series I Tanks 3001-B,
3004-B, 3013, and T-30
Technical Memorandum**

Date Issued—May 1995

Prepared by
H&R Technical Associates, Inc.
151 Lafayette Drive
Oak Ridge, Tennessee 37831-4159

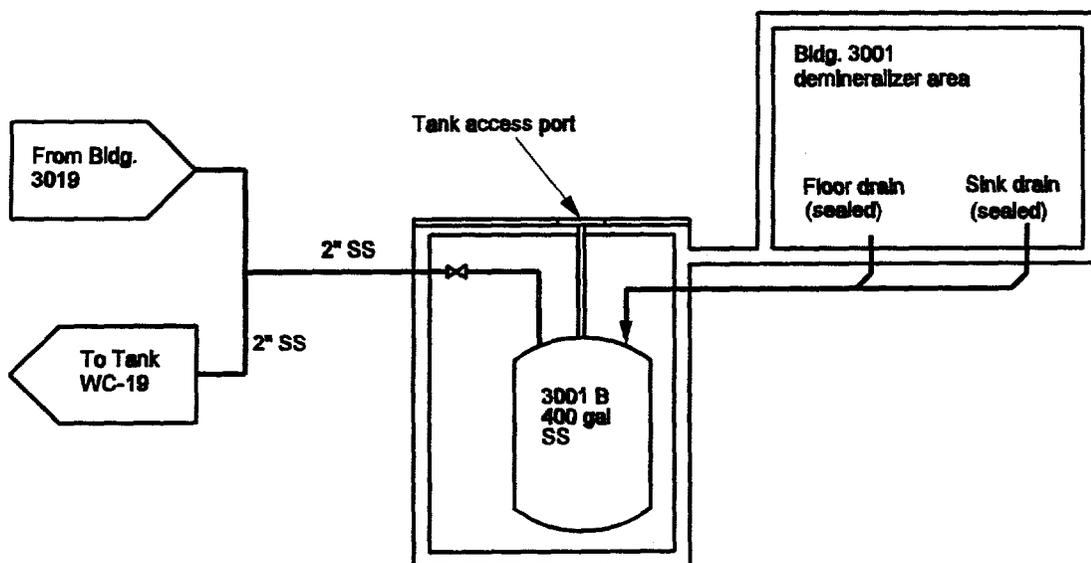
Fig. 1. Tank 3001-B.

Tank 3001-B is an ~300-gal stainless steel tank located in a concrete vault under the outside stairway landing adjacent to the south wall of Building 3001. System piping (see Fig. 1) consists of a 3-in. stainless steel header that served a sink and a floor drain in a hot lab in Building 3001 and a 2-in. stainless steel discharge line with isolation valve that connects to a 2-in. stainless steel header running from Building 3019 to tank WC-19. The hot lab equipment was removed around 1965 and the area now houses a demineralizer. Visual inspection of the area revealed that the two drains to tank 3001-B have been sealed.

Tank 3001-B was examined in 1993 and found to be empty. The tank was inspected by video camera in January 1995 and found to be empty. This tank is categorized as an industrial facility.¹ Table 2 shows the alternative actions for Tank 3001-B.

Field investigation in January 1995 shows that the inlet drains to this tank depicted on engineering drawings are sealed and that the tank has remained empty since the last examination. Thus, there is every indication that the tank is secure from receiving input through the engineered inlet piping system. Little possibility exists for the inflow of groundwater or surface water into the tank as a result of the tanks location in a concrete vault. This possibility is further lessened by the concrete pad over the vault and the fact that the surrounding paved area slopes away from the vault. Because the discharge line connects to the active LLLW system via a header to active tank WC-19, a remote possibility exists that back flow from this line could enter tank 3001-B. For this reason, consideration should be given to isolating the discharge line from 3001-B. This could be accomplished by excavating just south of the 3001-B vault to locate, cut, and cap the discharge line before it connects to the inlet line for WC-19. Cutting and capping the discharge line outside the vault would require excavating to a depth of ~8-10-ft. Tank 3001-B and its associated piping, thus secured from the probability of receiving further contamination and having been shown to pose no unacceptable risk, could be left in place until final remedial action is accomplished for Building 3001. Another alternative is to remove the tank from the vault. The top of the vault is located ~2 1/2 ft below the surface of the asphalt parking area. By removing the outside steel stairs to the second floor of Building 3001 and the concrete stair landing and excavating to allow removal of the vault covers, the

tank could be removed and the piping isolated within the vault. EPA and TDEC have agreed that this tank need not be remediated through the CERCLA process.

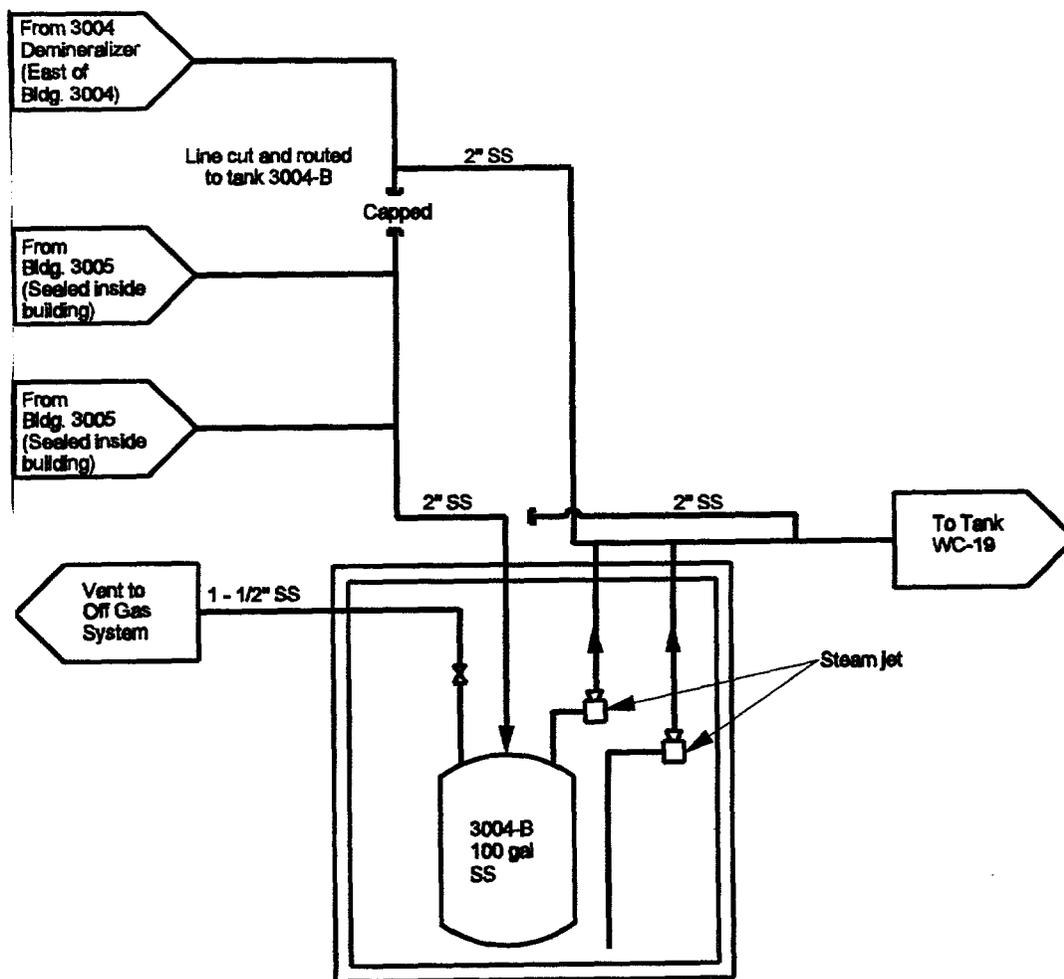
Fig. 2. Tank 3004-B.

Tank 3004-B is an ~100-gal stainless steel tank located in a vault just east of Building 3008. System piping (see Fig. 2) consists of a 2-in. stainless steel inlet header that served three drains in Building 3005 and a 2-in. stainless steel discharge line running ~95 ft to a valve box near Building 3001 where it joins a header going to active tank WC-19. The 200-ft length of the inlet piping includes about 80 ft of buried piping and about 120 ft of piping either underneath or embedded within the base slab of Building 3005. In addition, a 1 1/2-in. stainless steel line vents the tank to the off-gas system. The tank was installed in 1956 to serve the Low Intensity Test Reactor in Building 3005 and was removed from service in the late 1960s. Building 3005 is now used as a machine shop, and visual inspection shows that all three drains from that building to tank 3004-B have been sealed.

Tank 3004-B is categorized as an industrial facility (see footnote 1). The tank was emptied in 1993 and was found to be full of water when examined in January 1995. A field screening survey at that time indicated no radioactive content in the water. The water is thought to be condensate from the steam line serving the tank discharge steam jet. Table 3 shows the alternative actions for Tank 3004-B.

Field investigation shows that the drain lines from Building 3005 to tank 3004-B have been sealed. Thus, there is every indication that the tank is secure from receiving input through the engineered inlet piping system. The tank was emptied in 1993, and when examined again in January 1995, was found to contain liquid. The facility manager for the tanks suspects that the liquid is condensate from the steam line that served the discharge jet on the tank. The steam line should be isolated from the tank and the tank level should be monitored for a period of time to verify that this is indeed the source of liquid inflow to the tank. If the source of inflow is identified and eliminated, future surveillance and maintenance requirements would be minimal. Because the discharge line connects to the active LLLW system via an inlet line to active tank WC-19, a remote possibility exists that back flow from this line could enter tank 3004-B. For

this reason, consideration should be given to isolating the discharge line from 3004-B. This could be accomplished within the vault containing the tank and would require no excavation. If this alternative is chosen, the inlet line and the off-gas vent line should also be cut and capped within the tank vault. This would involve little additional expense and would ensure that the tank and its associated piping, thus secured from the probability of receiving further contamination and having been shown to pose no unacceptable risk, could be left in place until final remedial action is accomplished for Building 3001 and the surrounding area or until the tank could be removed and disposed of if economically feasible. EPA and TDEC have agreed that this tank need not be remediated through the CERCLA process.

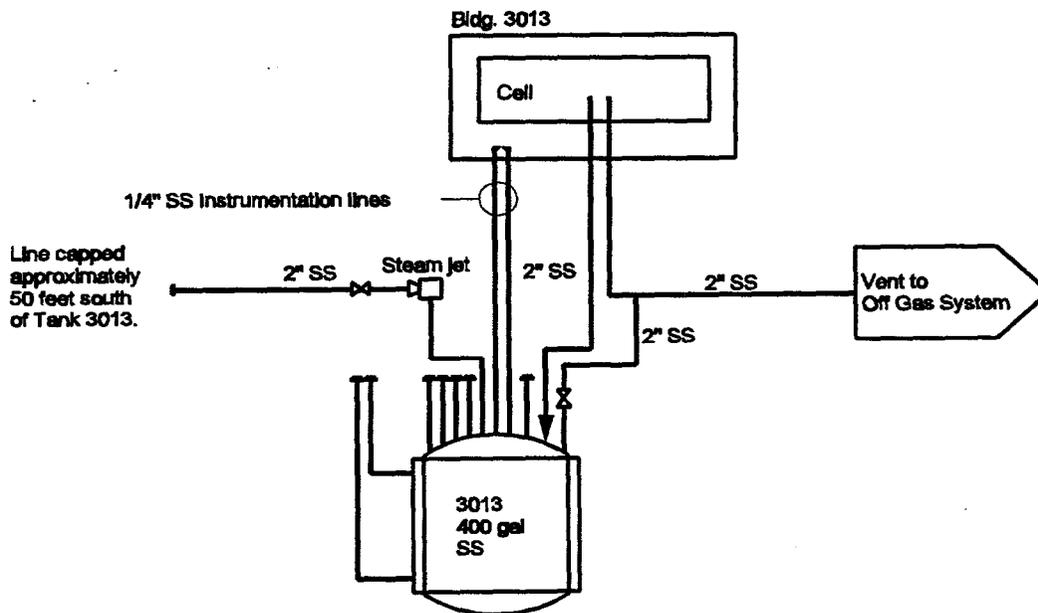
Fig. 3. Tank 3013.

Tank 3013 is an ~400-gal tank that is buried just south of Building 3013. System piping (see Fig. 3) consists of a 2-in. stainless steel inlet line from the cell beneath the floor of Building 3013, a 2-in. stainless steel vent to the off-gas system, and a 2-in. stainless steel discharge line that is cut and capped ~50 ft south of the tank. The inlet line is about 17 ft in length from the cell connection to the tank inlet connection. Of this 17 ft, ~8 ft are underneath Building 3013. The off-gas line runs approximately 5 ft vertically and 5 ft horizontally and then ties to the 2-in. off-gas vent line from the cell. Four spare nozzles in the tank head and two connections to the tank jacket are closed with blind flanges located above grade. In addition, two 1/4-in. instrumentation lines run from the tank to Building 3013 and are terminated with caps just above the floor of Building 3013. The nominal 3-ft, 10-in. diameter head and all the connections except the two tank jacket connections are constructed with flanged and gasketed connections below grade. The discharge steam jet is above ground and the steam supply to it has been removed.

Tank 3013 is categorized as an industrial facility (see footnote 1). The tank was emptied in 1993 and, when examined in January 1995, was found to contain ~216 gal of liquid. The facility manager conducting the examination noted that the gaskets in the above-ground flanges of the system piping appeared to have deteriorated and it is assumed that the gaskets in the underground flanges have suffered some degradation of their ability to seal. The liquid now in the tank likely came from rainfall or groundwater entering the tank through one or more of the seven flanges or through the joint of the tank head owing to degraded gaskets. Table 4 shows the alternative actions for Tank 3013.

Field investigation shows that the cell beneath Building 3013 that contains the inlet drains to this tank has been sealed. Before the building was turned over to the Chemical Technology Division, the floor of Building 3013 was scarified and a new layer of concrete put down that effectively sealed the access plug to the cell. This new floor surface was covered with a waterproof coating. Thus, there is every indication that the tank is secure from receiving input through the engineered inlet piping system. The tank was emptied in 1993 and when examined again in January 1995 was found to contain liquid. The facility manager for the tanks suspects that the liquid is rain water or surface runoff that entered the tank through deteriorated gaskets

in the flanged connections on top of the tank or through the gasketed connection of the top itself. The tank could be either left as is because the risk has been shown to be below the EPA target risk range and does not exceed a 10^{-6} risk level, or the tank could be removed if the cost of removal can be justified. EPA and TDEC have agreed that this tank does not need to be remediated through the CERCLA process.

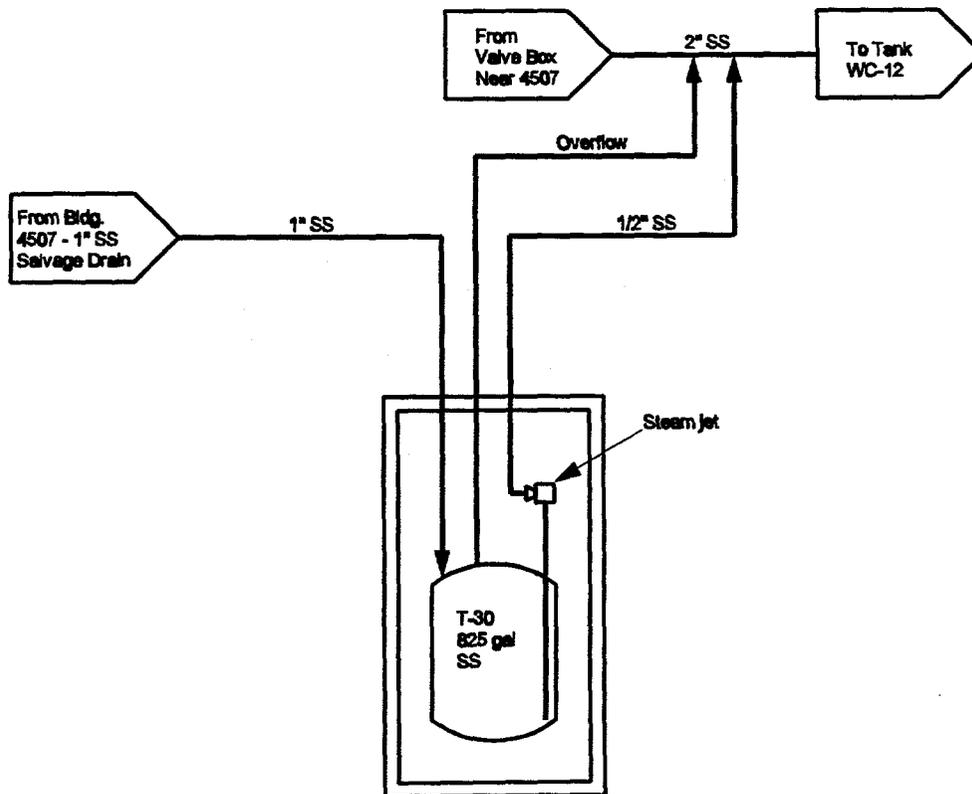
Fig. 4. Tank T-30.

Tank T-30 is an ~825-gal tank located in a concrete vault south of Building 4507. System piping (see Fig. 4) consists of a 1-in. stainless steel drain line from Building 4507, a 2-in. stainless steel overflow line, and a 1/2-in. stainless steel steam jet discharge line.

Tank T-30 is categorized as an industrial facility (see footnote 1). The tank was emptied in 1993. Field investigations of the tank in March 1995 have been hampered by both fixed and loose contamination within the tank vault. The tank's level instrumentation indicates that the tank has remained empty. Table 5 shows the alternative actions for Tank T-30.

Because of its location in a vault, little chance exists for ground or surface water to infiltrate into the tank. A remote possibility exists that back flow from the discharge header to the WC-10 tank farm could enter tank T-30 through the tank discharge or overflow lines. For this reason, consideration should be given to isolating the discharge and overflow lines from T-30. If this alternative is chosen, the inlet line should also be cut and capped within the tank vault. This would involve little additional expense and would ensure that the tank and its associated piping, thus secured from the probability of receiving further contamination and having been shown to pose no unacceptable risk, could be left in place until final remedial action is accomplished for Building 4507 and the surrounding area or until the tank could be removed and disposed of if economically feasible. Either alternative involving isolation or removal of the tank would require some decontamination of the tank and the tank vault. EPA and TDEC have agreed that this tank need not be remediated through the CERCLA process.
