FY 2003 VISUAL EXAMINATION OF IN-TANK AND TANK ANNULI AT 241-SY TANK FARM

Key Words: 241-SY-101, 241-SY-102, 241-SY-103, Annulus inspection, In-Tank Inspection

Abstract: This report documents the completion of the fy 2003 in-tank and annulus Video Inspections for the 241-SY tank farms. Representative photos of observed anomalies, water-streaks, corrosion deposits, pitting, and in-tank stains on the 241-SY-101, 241-SY-102, and 241-SY-103 in-tank and annulus primary walls have been included as appendices.

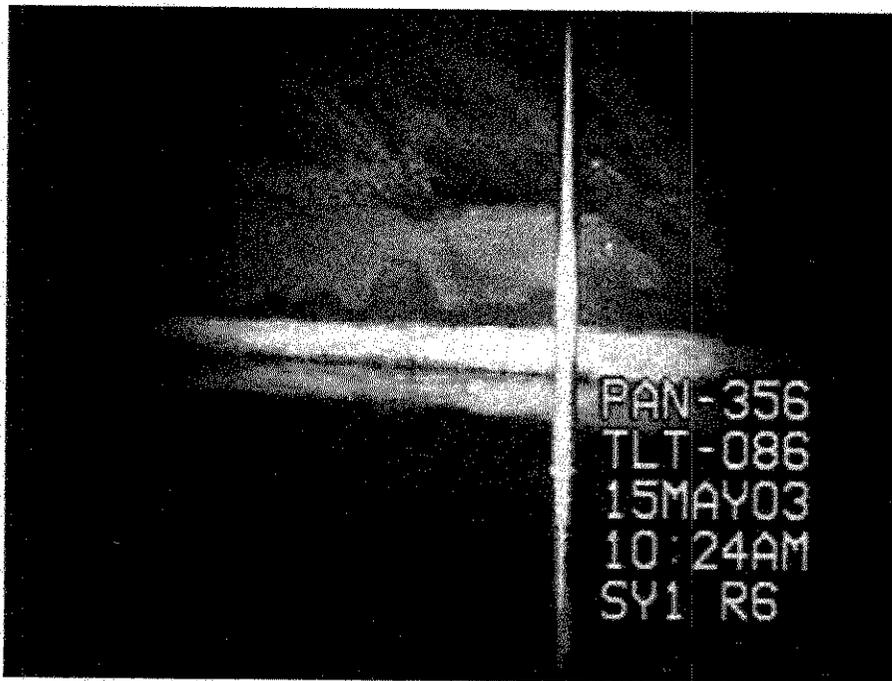
Figure 5 - SY-101 Riser 6, Primary Tank Interior, Crystal Waste Ring (2003)

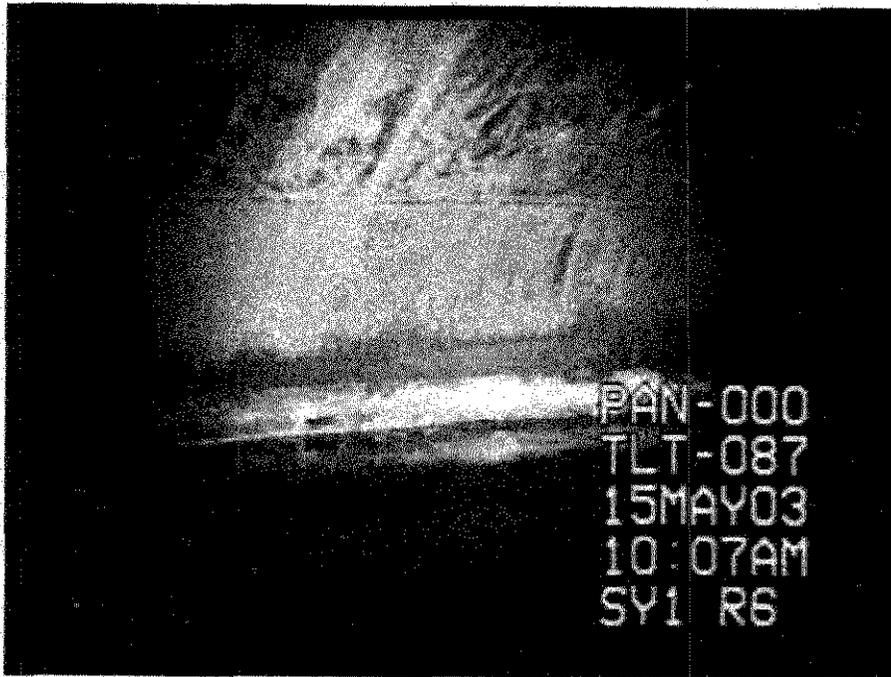
Figure 7 - SY-101 Riser 6, Primary Tank Interior, Waste Ring/Knuckle (2003)

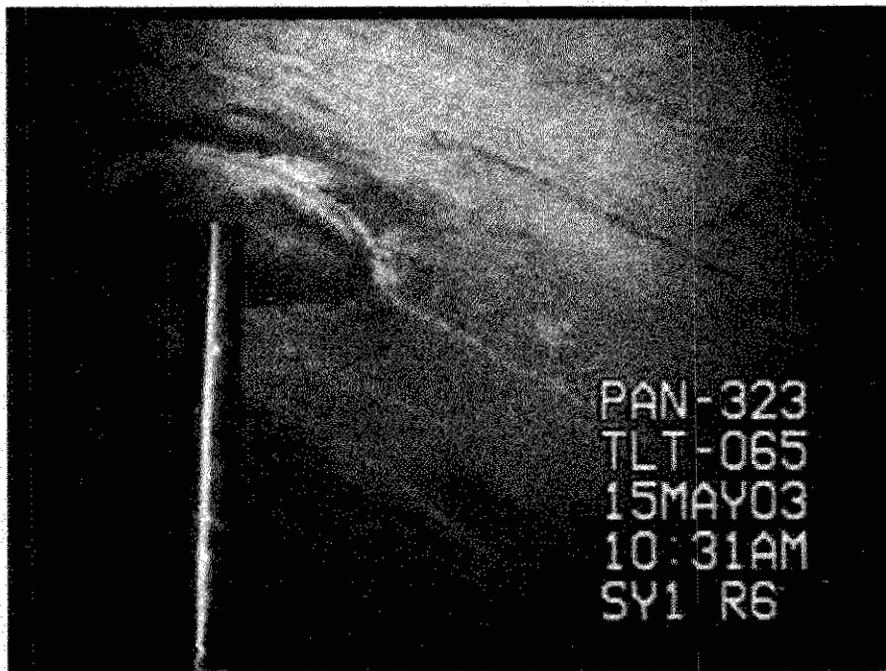
Figure 10 - SY-101 Riser 6, Primary Tank Interior, Dome Riser/Welds (2003)

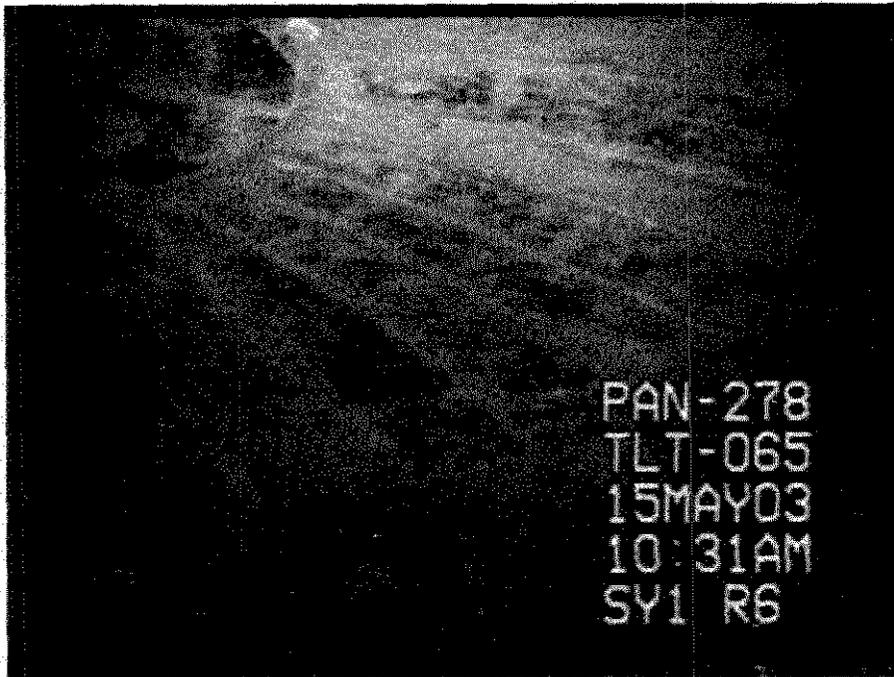
Figure 11 - SY-101 Riser 6, Primary Tank Interior, Dome Welds (2003)

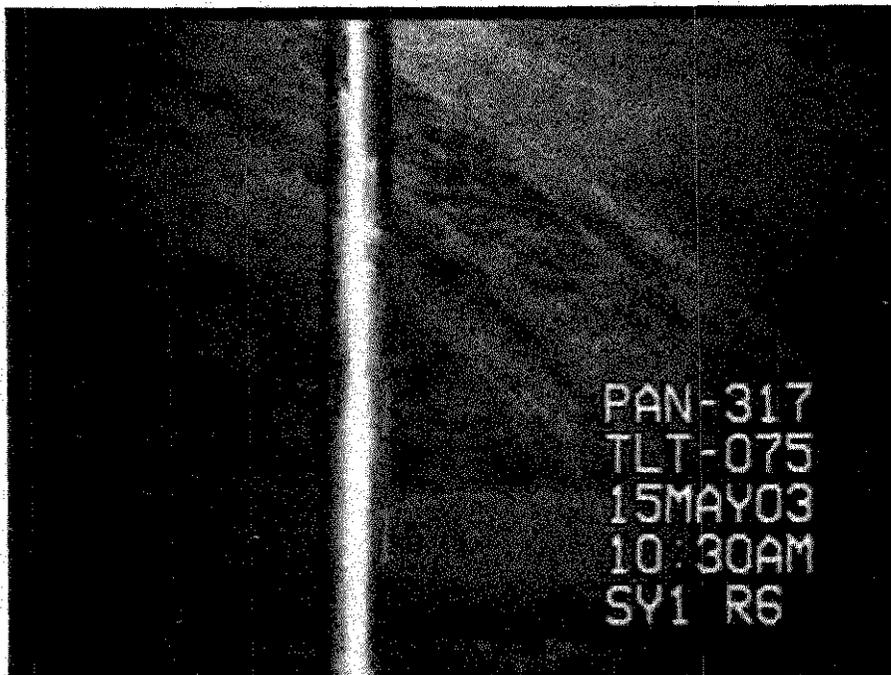
Figure 12 - SY-101 Riser 6, Primary Tank Interior, Dome/Wall (2003)

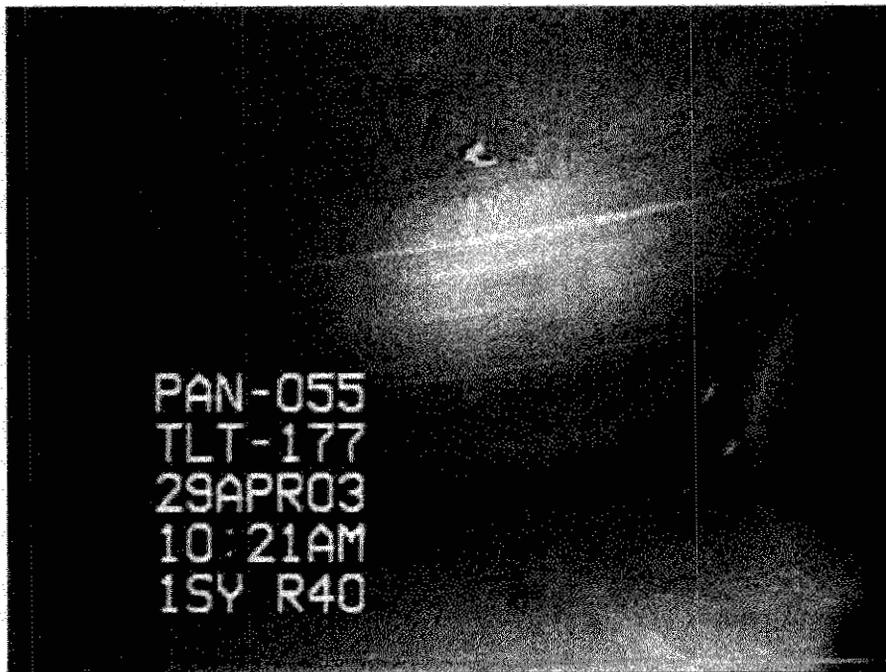
Video examination of the 241-SY-101 primary and secondary tank wall through annulus Risers 40, 43, 46, and 49 show a layer of light corrosion and mill scale with some minor pitting. Construction markings and laitance flow markings are clearly visible. There is no significant degradation of the dome area, haunch, primary/secondary wall, welds, or knuckle. Water Stains on the annulus floor are visible from Riser 40 and appear dry.

Figure 20 - SY-101 Riser 40, View of Annulus from Riser 40 (2003)

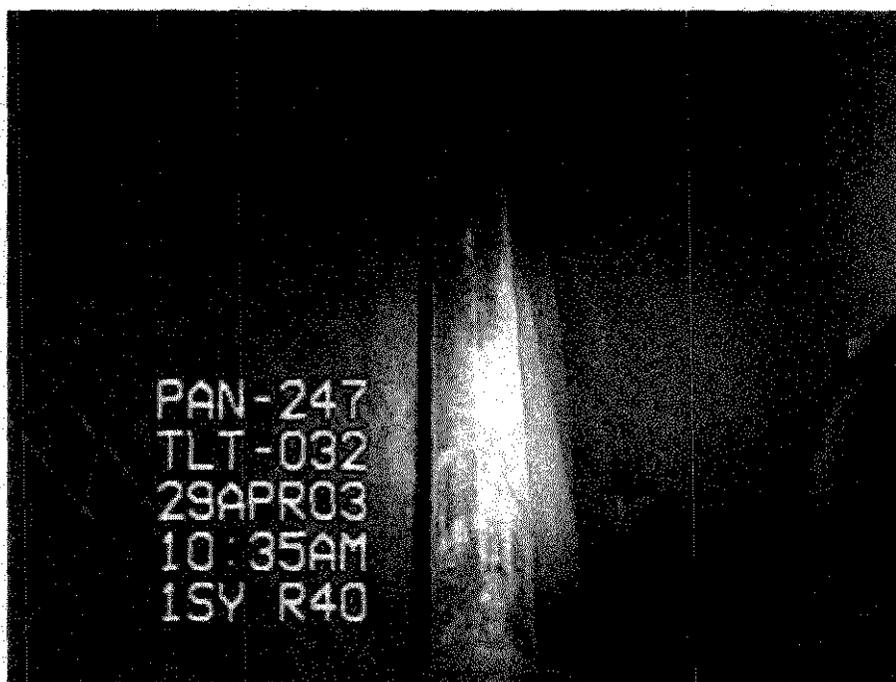
Figure 23 - SY-101 Riser 40, Primary Tank, Secondary/Primary Wall, Dome (Right, 2003)

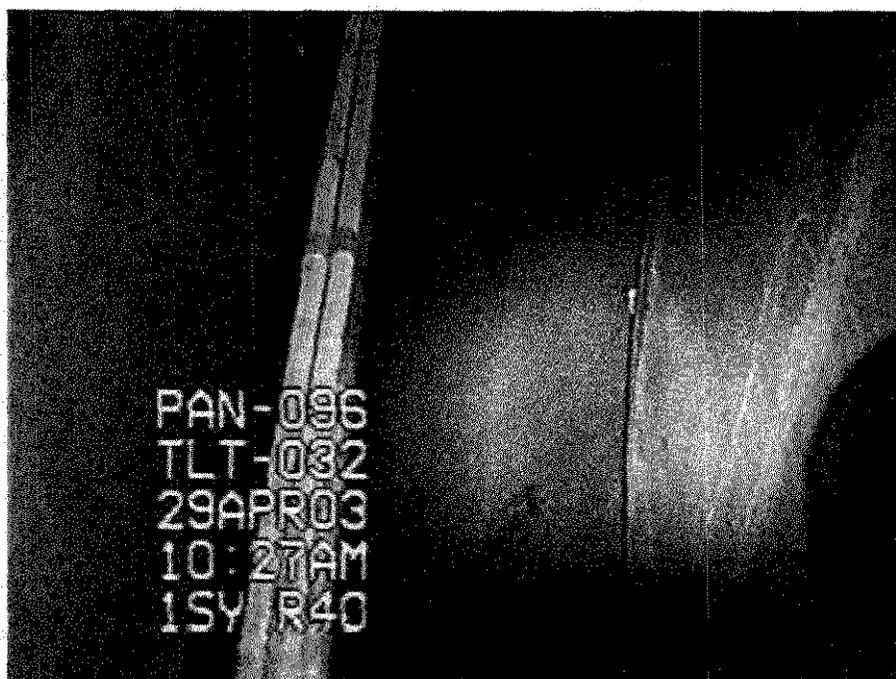
Figure 24 - SY-101 Riser 40, Primary Tank, Secondary/Primary Wall, Dome (Left, 2003)

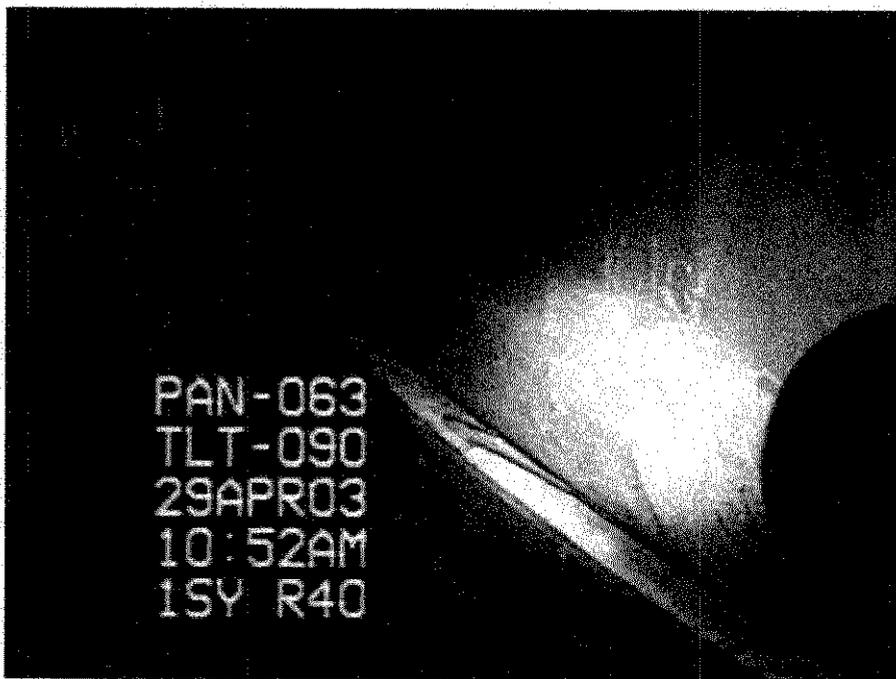
Figure 30 - SY-101 Riser 40, Primary Tank, Knuckle/Concrete Insulating Ring Junction (2003)

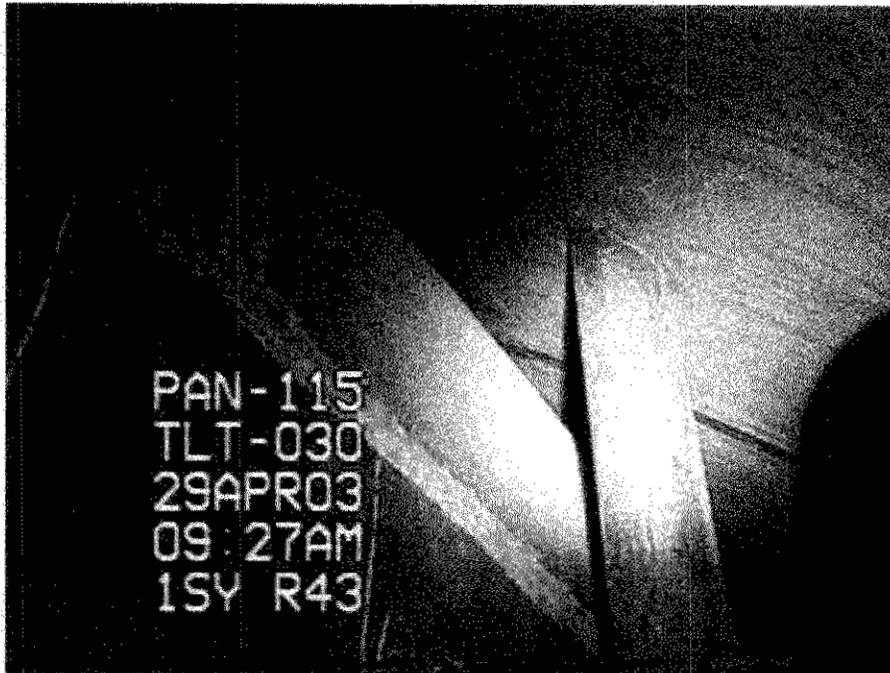
Figure 35 - SY-101 Riser 43, Primary Tank, Primary/Secondary Wall Junction (Right, 2003)

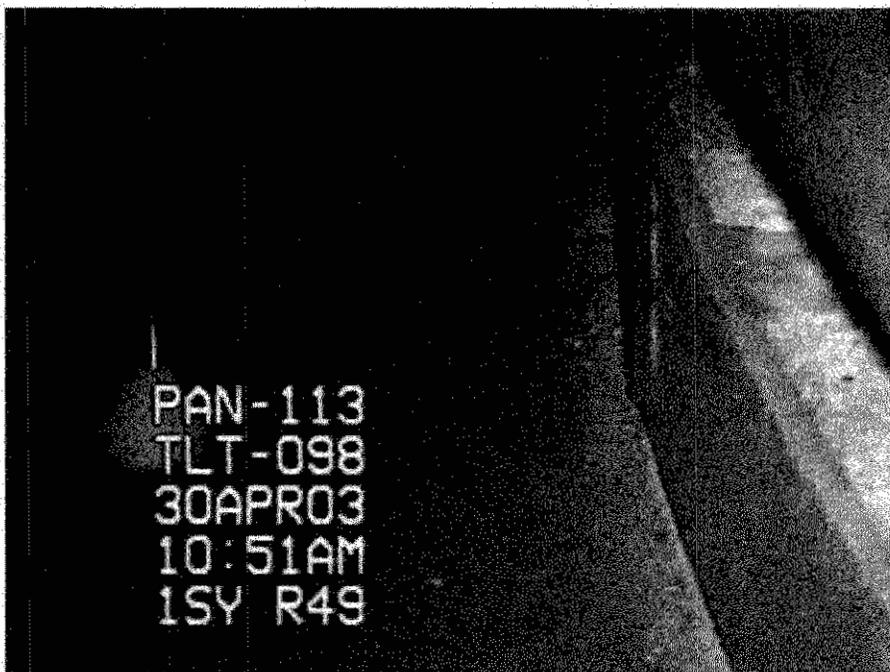
Figure 71 - SY-101 Riser 49, Primary Tank, Knuckle Weld (2003)

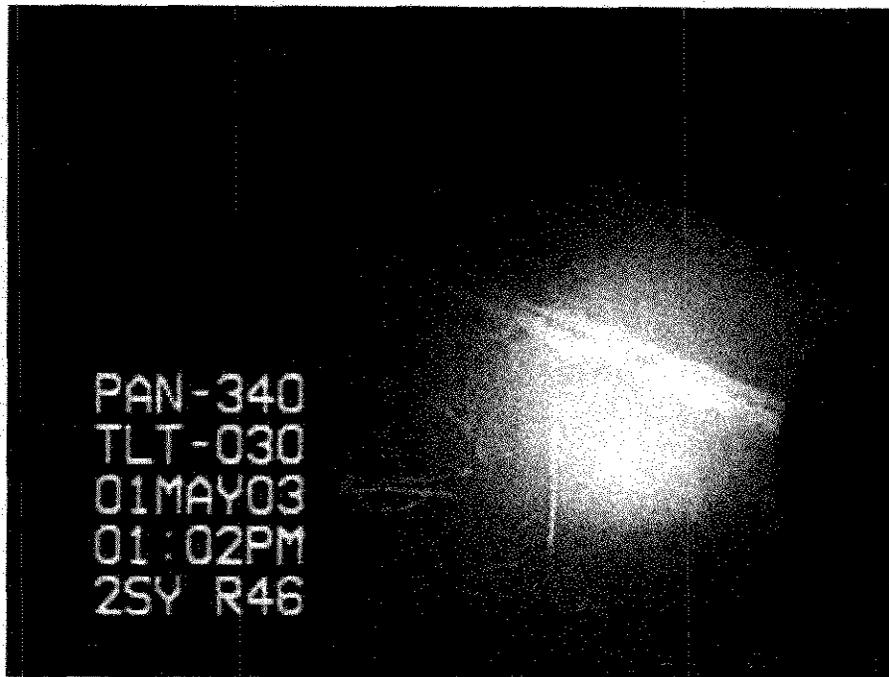
Figure 123 - SY-102 Riser 46, Primary Tank, Haunch/Horizontal Weld/Construction Marks (2003)

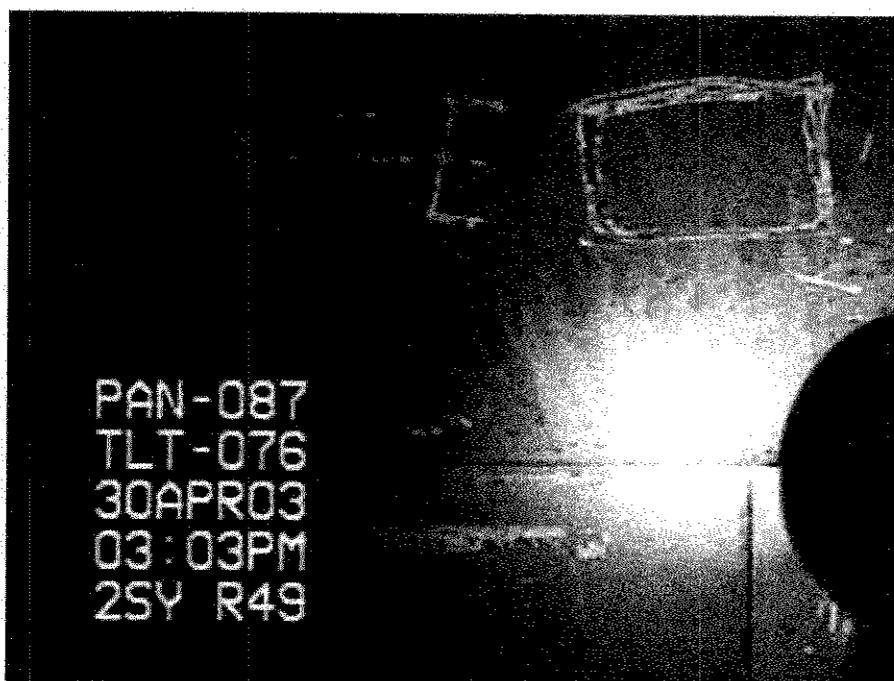
Figure 144 - SY-102 Riser 49, Primary Tank, Knuckle/Mill Scale/Construction Marks (2003)

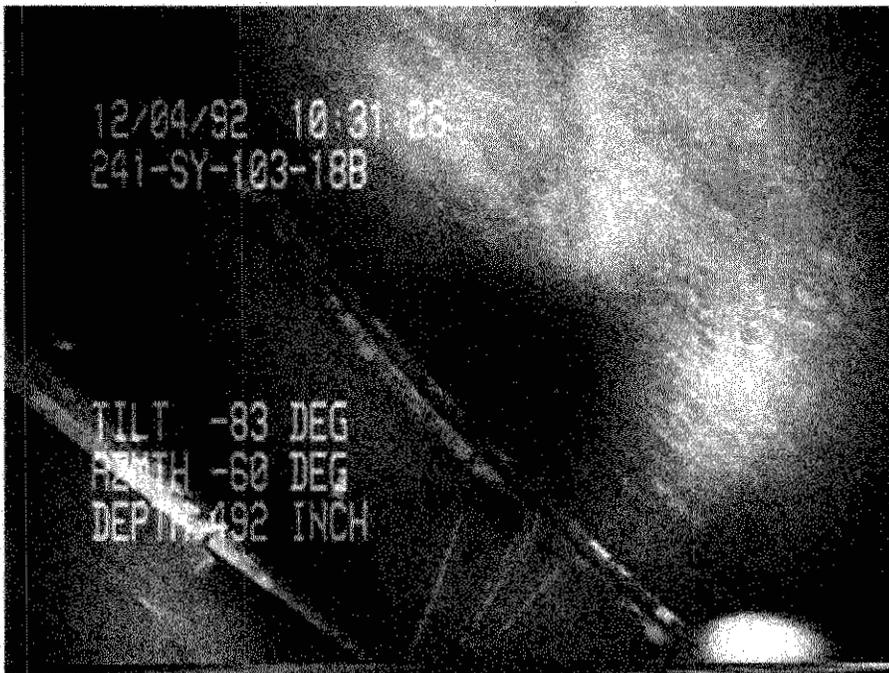
Figure 210 - SY-103 Riser 46 (18B), Primary Tank, View of Annulus From Riser 46 (1992)

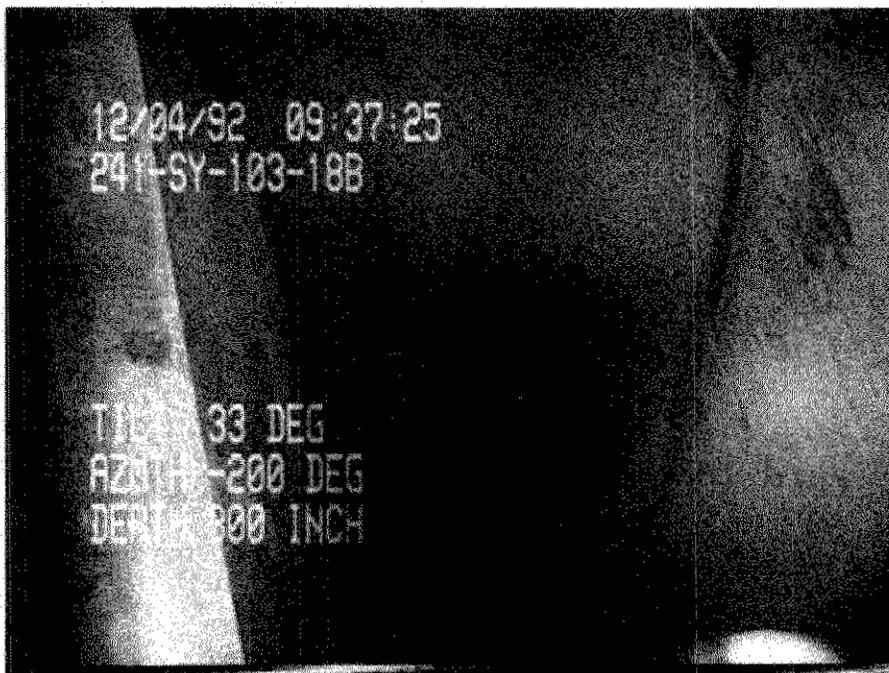
Figure 216 - SY-103 Riser 46 (18B), Primary Tank, Primary/Secondary Walls/Dome (Right, 1992)

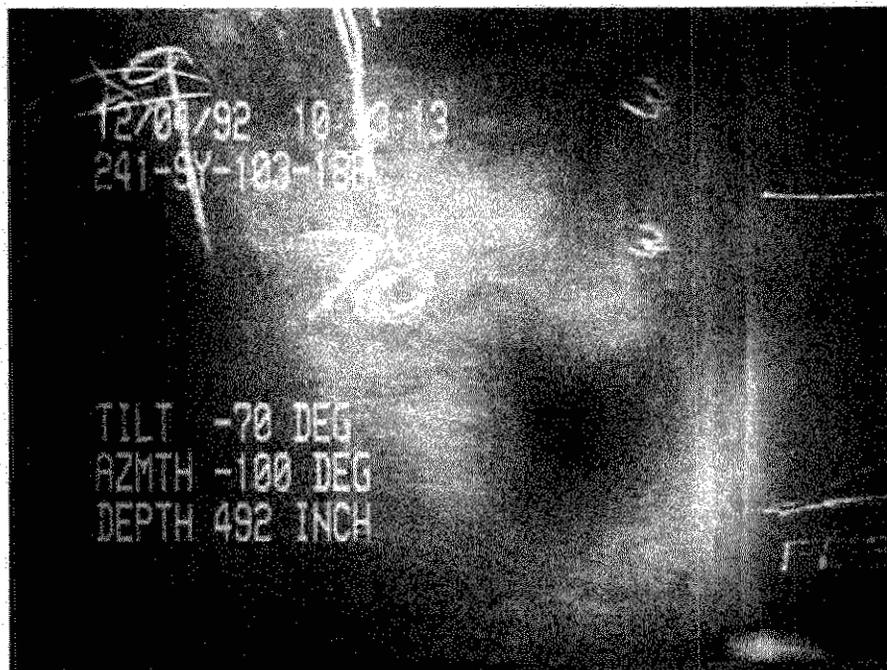
Figure 220 - SY-103 Riser 46 (18B), Primary Tank, Vertical Weld/Construction Marks (1992)

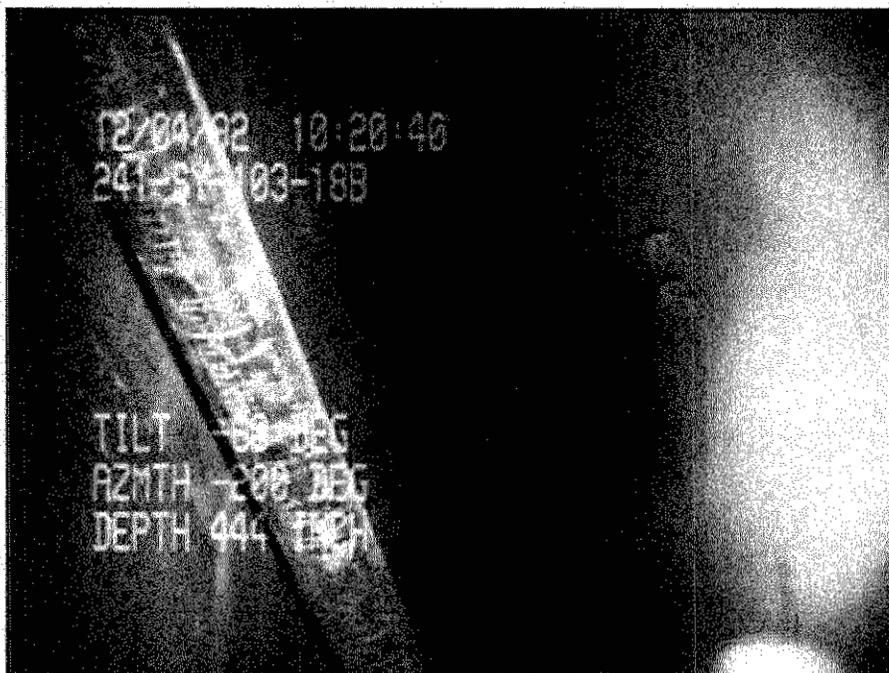
Figure 224 - SY-103 Riser 46 (18B), Secondary Tank Wall (Right, 1992)

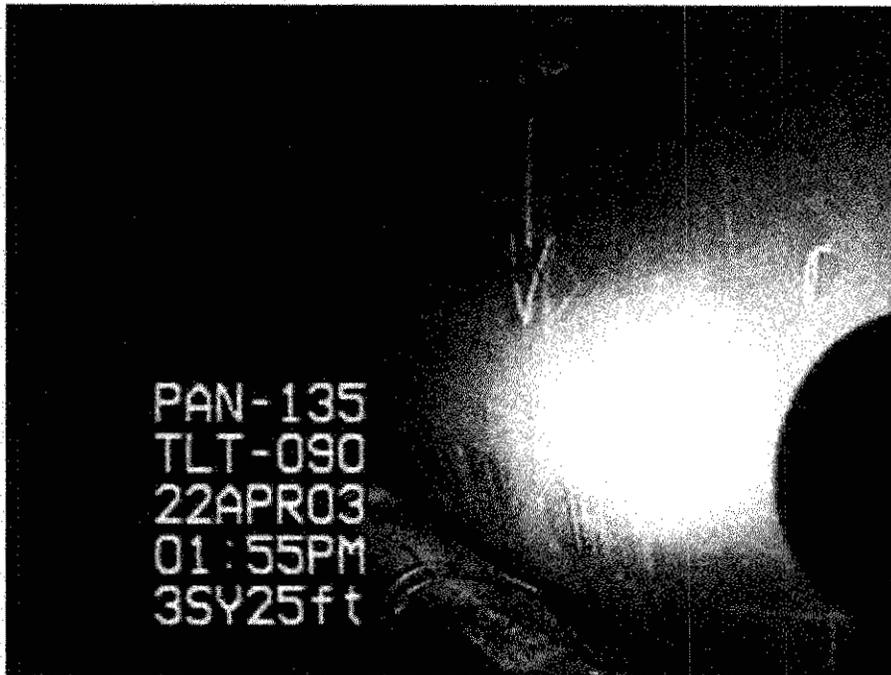
Figure 227 - SY-103 Riser 46, Primary Tank, Knuckle/Concrete Insulating Ring Junction (2003)

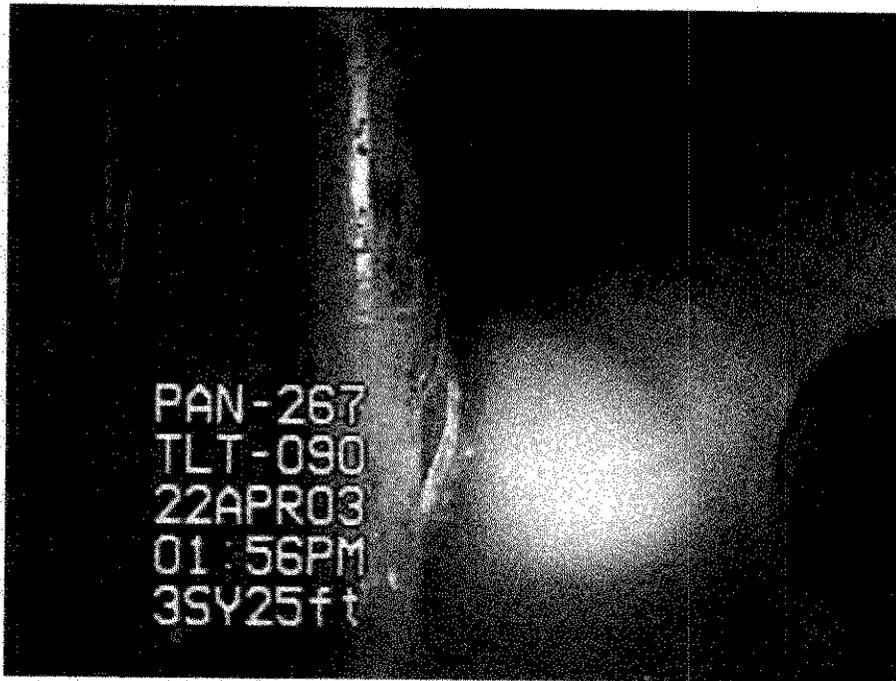
Figure 229 - SY-103 Riser 46, Primary Tank, Annulus Floor (Right, 2003)

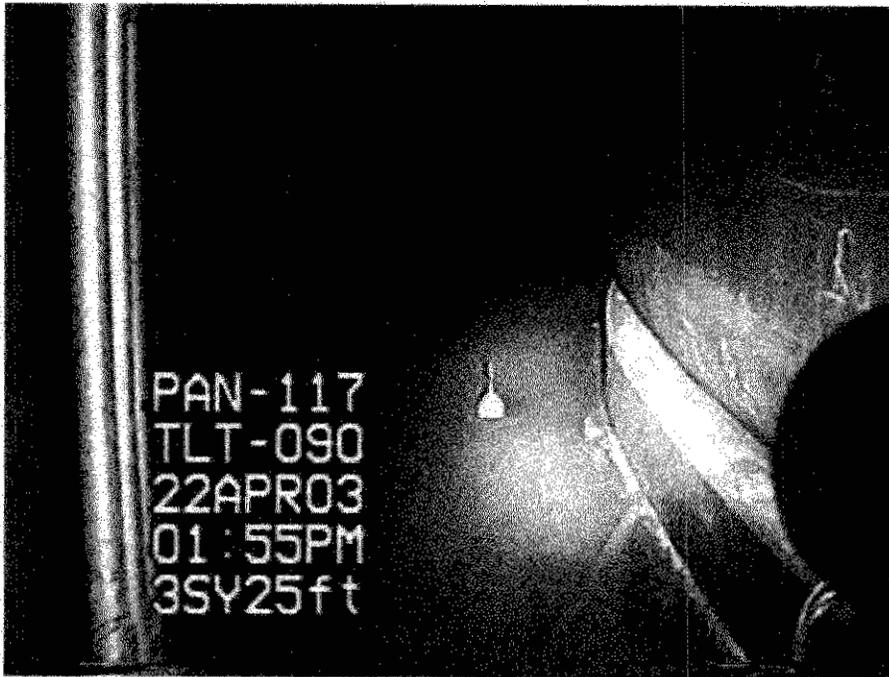
Figure 231 - SY-103 Riser 46, Primary Tank, Annulus Floor (Left, 2003)

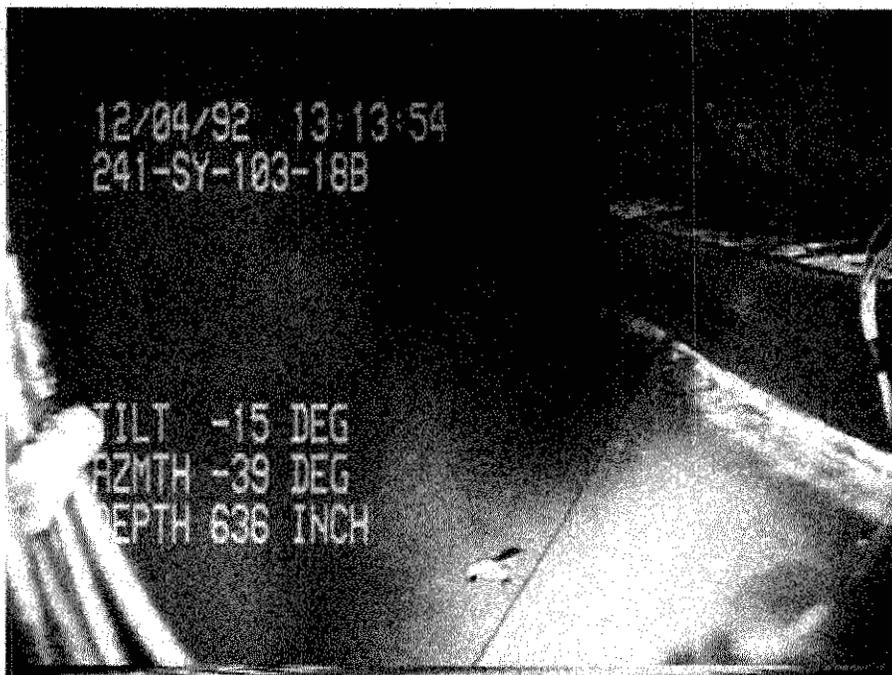
Figure 232 - SY-103 Riser 46 (18B), Primary Tank, Annulus Floor (Left, 1992)

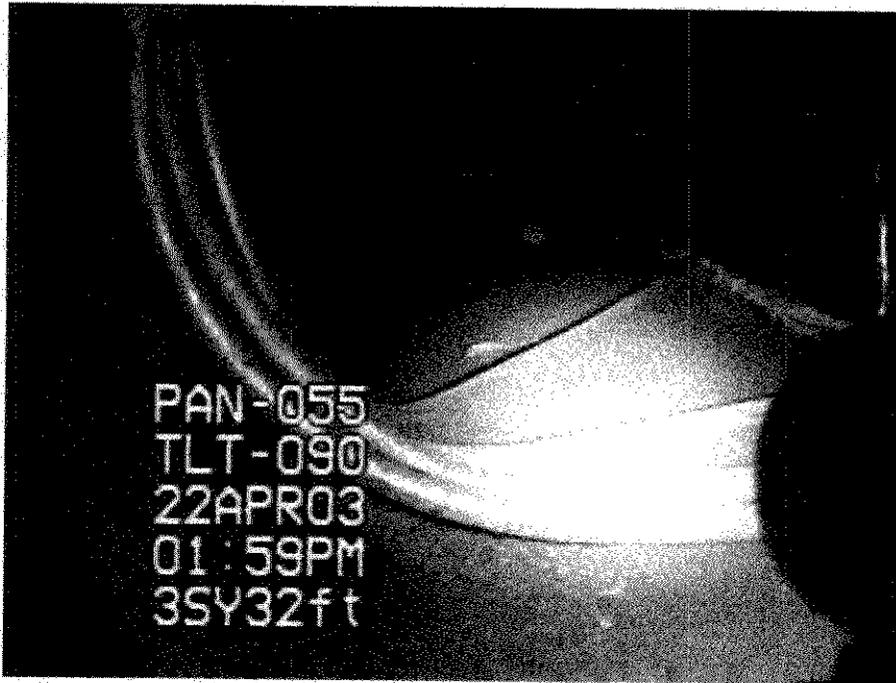
Figure 233 - SY-103 Riser 46, Primary Tank, Annulus Instrumentation (2003)

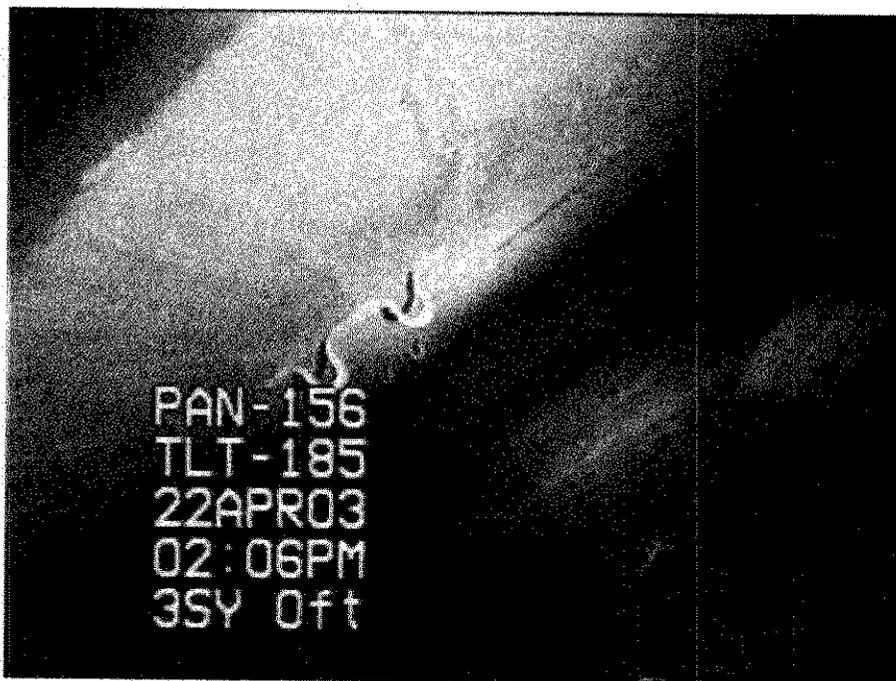
Figure 236 - SY-103 Riser 50, View of Annulus from Riser 50 (2003)

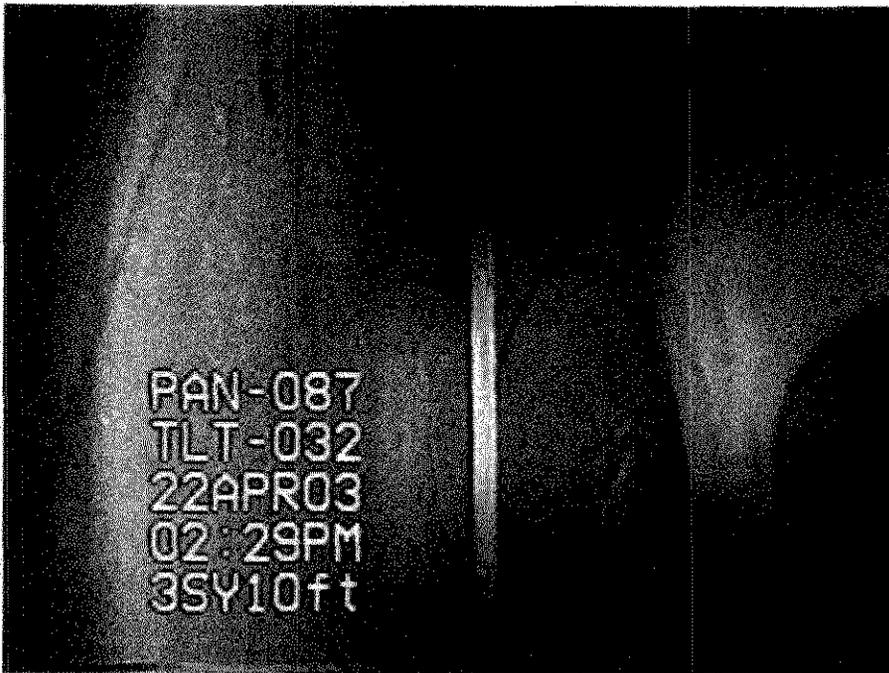
Figure 240 - SY-103 Riser 50, Primary Tank, Primary/Secondary Tanks/Dome (Left, 2003)

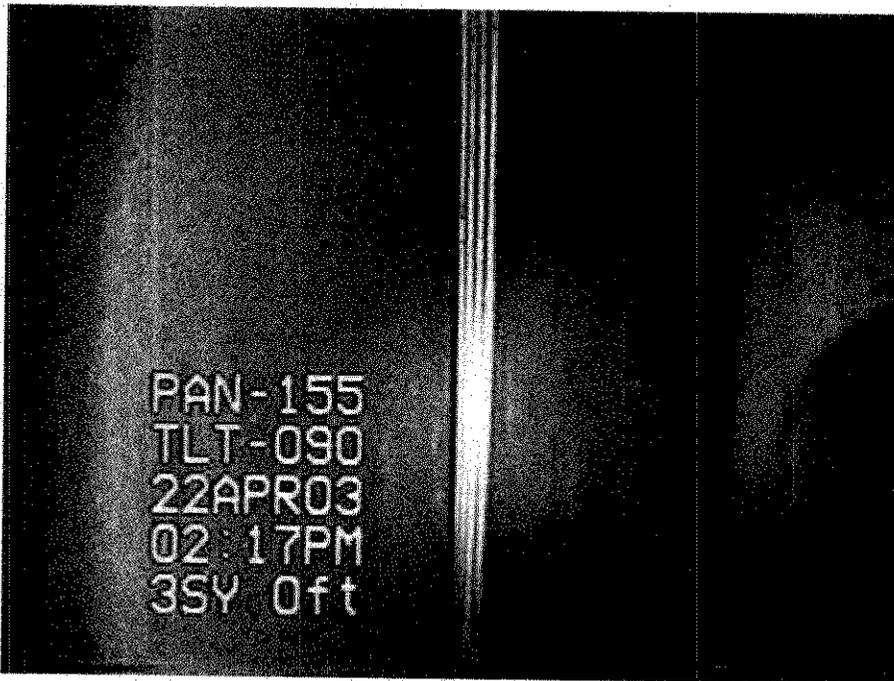
Figure 244 - SY-103 Riser 50, Secondary Tank Wall (Left, 2003)

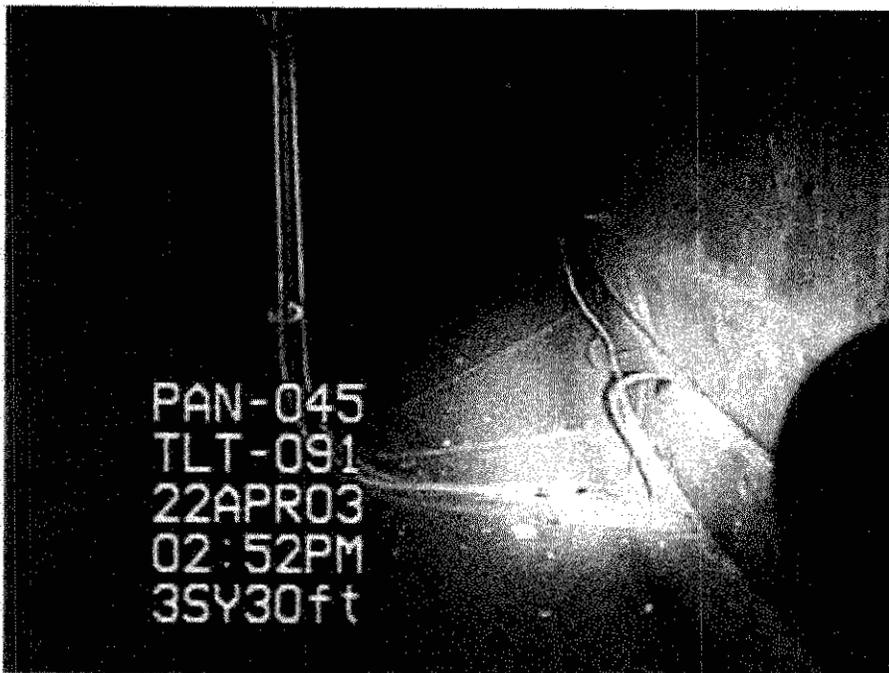
Figure 248 - SY-103 Riser 50, Primary Tank, Annulus Floor/Instrumentation (Left, 2003)
